Re: Sarasota County
Central County Solid Waste Disposal Complex
Permit No. 0130542-022-S0/01 (Mod# 0130542-023-SO/IM)
WACS No. 51614
Above-Ground Leachate Storage Tank

TANK INSPECTION REPORT

Sarasota County, FL
1.8 MG Leachate Storage Tank
4000 Knights Trail Road
Nokomis, Florida

December 22, 2015

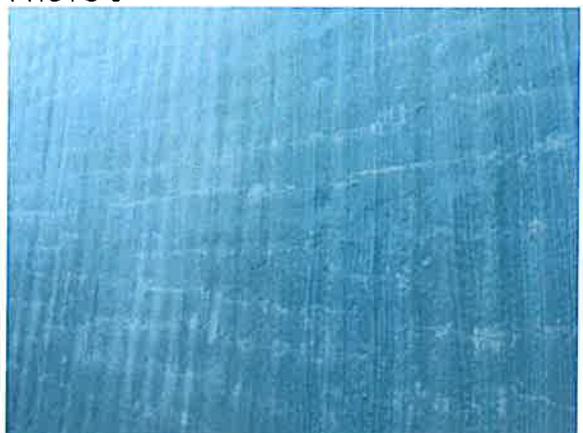
PHOTO 7

3. Interior Tank Wall (Outer Tank): The interior wall of the outer tank is in good condition. The bottom 10' of the wall was sounded and no hollows were found. The tank wall is painted and the coating is in good condition. (Photo 5) Minor cracking was noted over the entire surface of the wall and this is common on a tank wall in which the tank always remains empty. (Photos 6-7) These cracks appear superficial in nature and pose no structural concerns for the tank wall.

Cracking on interior wall of outer tank

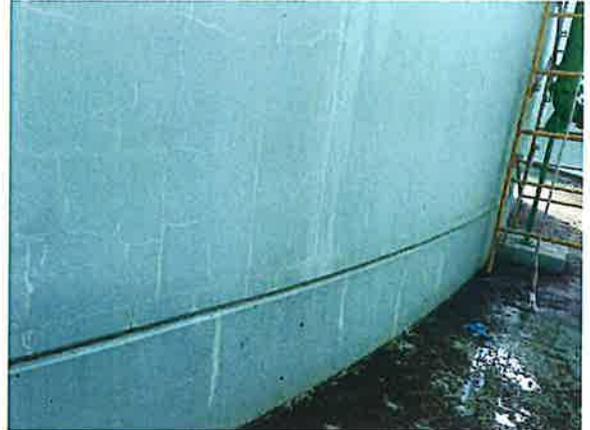
PHOTO 9

4. Exterior Tank Wall (Inner Tank): The exterior wall of the inner tank was found to be in good condition and no hollows were found when the bottom 10' of the wall was sounded. The tank wall was painted and the coatings are in good condition. Minor cracking was noted all over the wall, (Photos 8-9) and one main crack was noted that spanned the length of the wall approximately 15' up the wall. (Photo 10) Several areas, approximately 10' long, of efflorescence were noted along this crack. The efflorescence appears to be from rain getting into the crack and leaching out. This does not appear to pose a structural problem. (Photo 11)

Hairline cracking on the exterior wall of the inner tank

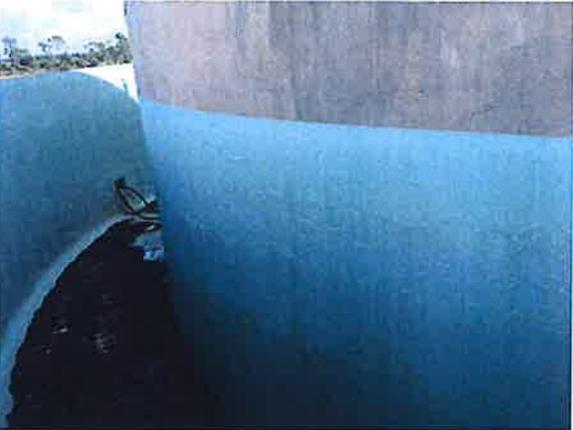
PHOTO 10

Hairline cracking on the exterior wall of the inner tank

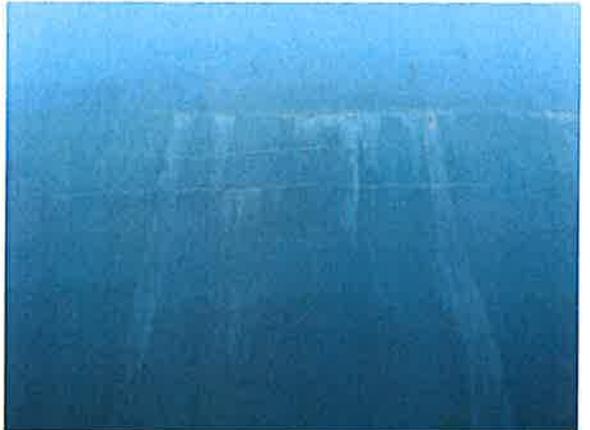
PHOTO 11

Large crack on exterior wall of inner tank

Precon recommends that this crack be sealed either by injecting epoxy into the crack or applying a coating to the surface. At this time it is not essential that the crack be addressed. If it is not sealed, it should be monitored.

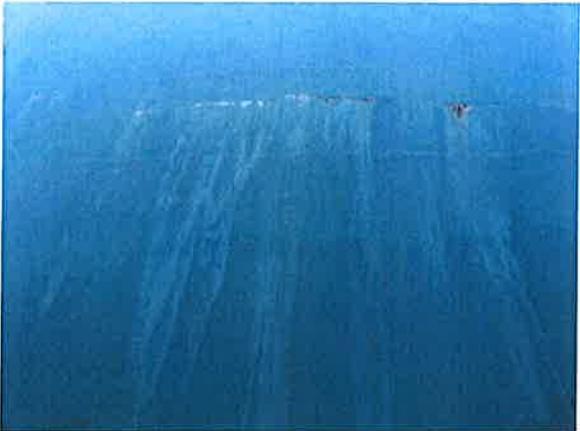
PHOTO 12

Large crack on exterior wall of inner tank

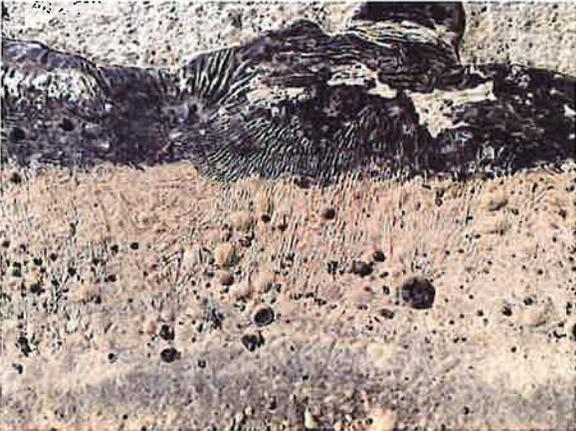
PHOTO 17

5. Interior Tank Wall (Inner Tank): The interior wall was found to be in good condition. It appears to have a coal tar epoxy coating on the wall just above the monolithic floor wall connection which is also in good condition. During the last inspection, Precon noted a bubbling in the elastomeric urethane coating that was installed at the floor wall connection. These bubbles are found along the perimeter of the tank and appear to be between the top coat and the coating beneath it. Since the last inspection, several of these bubbles have popped and the overall size of the bubbles has gotten larger. (Photos 12-15) The coating underneath the bubbles seems to be in good condition, and it appears that the waterstop and diaphragm are also working as intended, as no signs of leaks were noted coming into the outer containment tank. Precon does not think any repair on this area is necessary since the tank is not showing signs of leakage. However, if the County wishes, a surface mounted waterstop could be applied over the entire tank floor wall joint.

Burst bubbles of elastomeric urethane coating

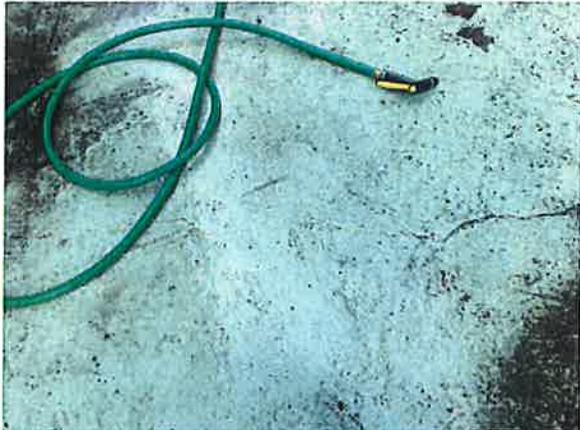
PHOTO 14

6. Tank Floor (Outer Tank): The tank floor was found to be in good structural condition. Several minor cracks were noted at the base of the wall and along the floor. (Photo 16) Five larger cracks were also noted. These cracks are wider and, if not addressed, could be a cause of leaks in the future. (Photos 17-19)

Large cracks in floor of outer tank

Precon recommends addressing the larger cracks by routing them out, pressure washing the cracks, filling the routed sections with epoxy and applying surface mounted waterstops over the cracks. This will provide a flexible watertight seal.

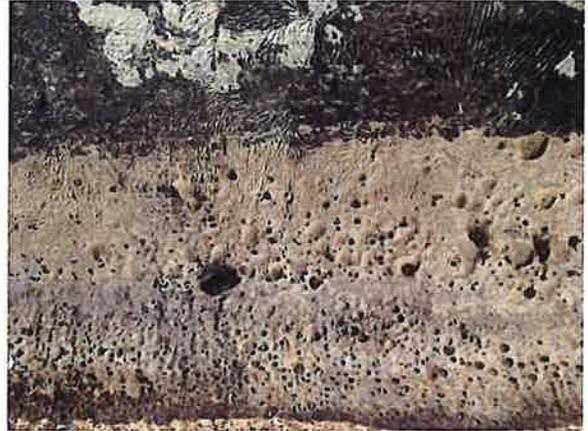
PHOTO 16

Burst bubbles of elastomeric urethane coating

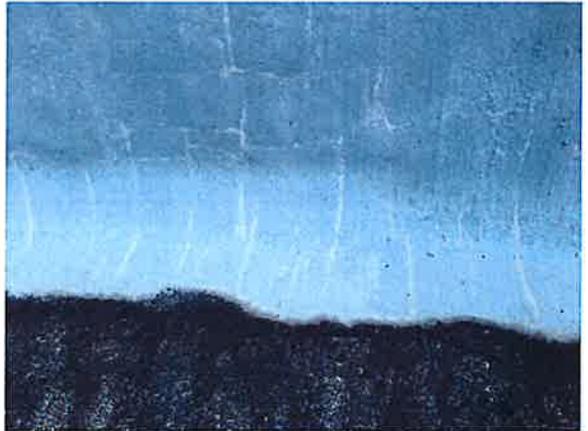
Cracking at the floor wall joint of the interior wall of outer tank
PHOTO 18

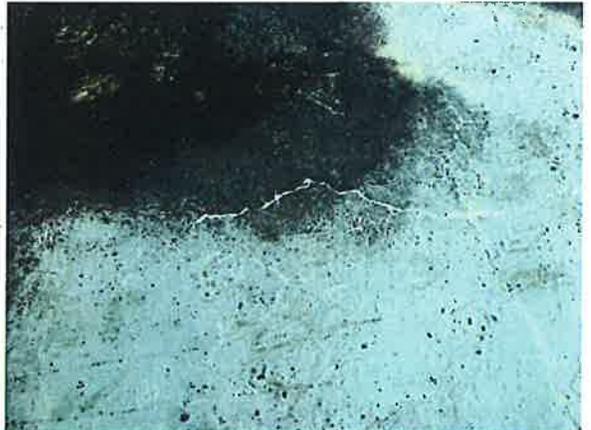
PHOTO 19

Large cracks in floor of outer tank

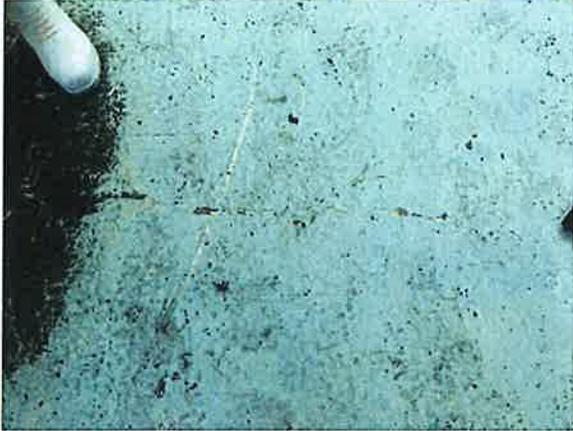
PHOTO 20

Large cracks in floor of outer tank
