Re: Liner Repairs to Hillsborough County Southeast Landfill Effluent Pond B
FDEP Permit No. 35435-014-SO/01
Jones Edmunds Project No. 08449-030-04

**RE: Report on Liner Repairs – Pond B
Southeast County Landfill
Permit No. 35435-014-SO/01
Tampa, Florida**

Civil Design Services, Inc. (CDS) is submitting this report to document the repairs and quality assurance observations made during the repairs by our firm to the geomembrane HDPE liner system in Effluent Pond B at the Southeast County Landfill. This Report was prepared to fulfill the requirements of Specific Condition Part C-6.d of the above referenced FDEP Solid Waste Operations Permit.

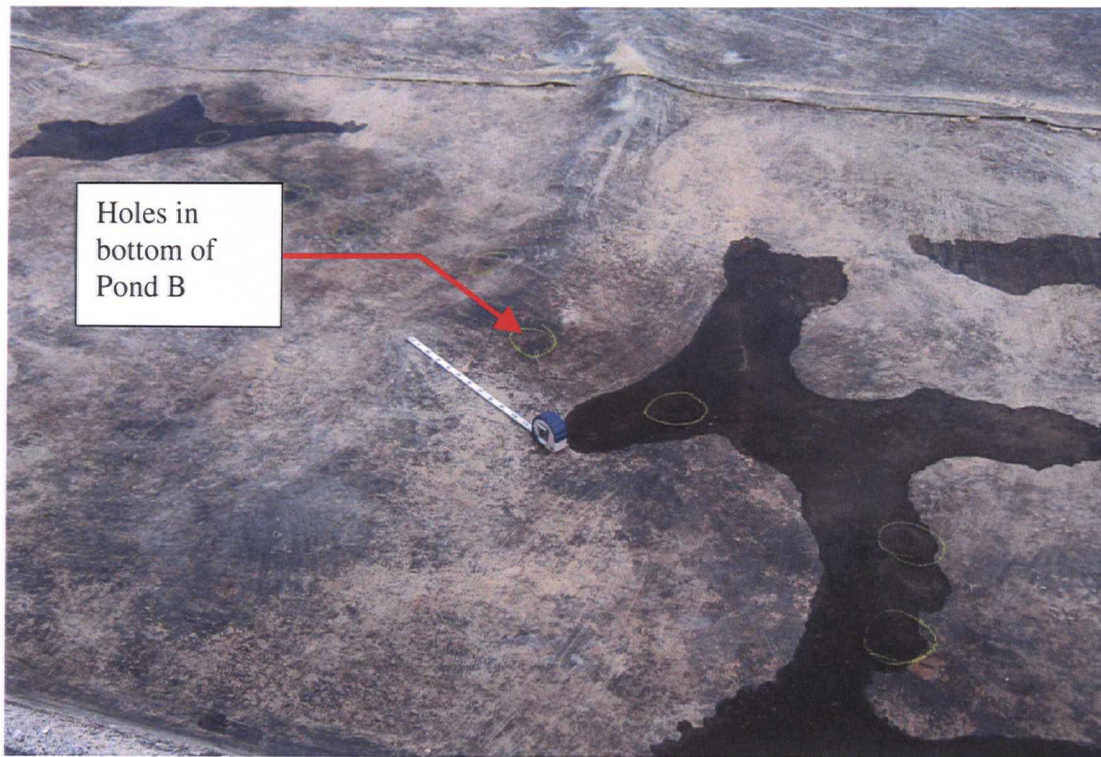
Holes in
bottom of
Pond B

Photograph No. 1 – Photograph taken by SWMD of holes found in the bottom of Pond B.

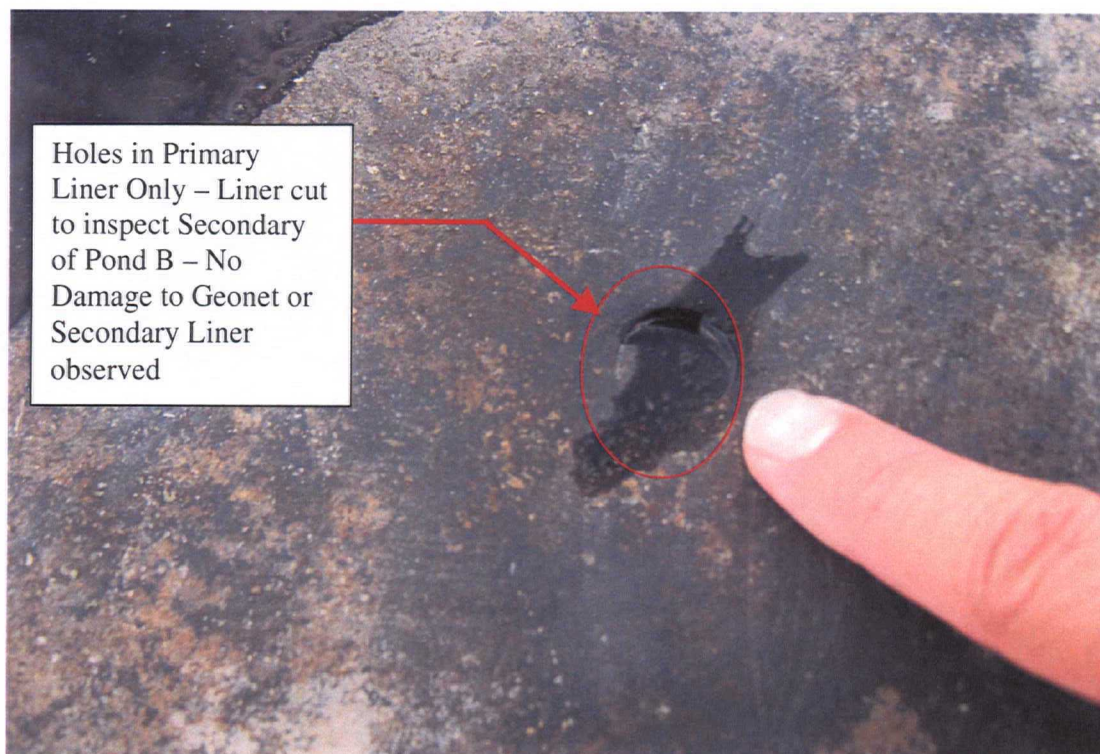
Holes in Primary
Liner Only – Liner cut
to inspect Secondary
of Pond B – No
Damage to Geonet or
Secondary Liner
observed

Photograph No. 2 – Close up of typical damaged area in bottom of Pond B.

- 10:30 am to 11:45 am – CDS cut primary liner in damage areas in the bottom of Pond B to inspect geonet and secondary liner. No damage was observed to geonet or secondary geomembrane. Comanco then placed extrusion beads over damaged areas (holes). The holes were extrusion welded with beads sealing the individual damaged area. Then single larger patch was placed over all individual beads.

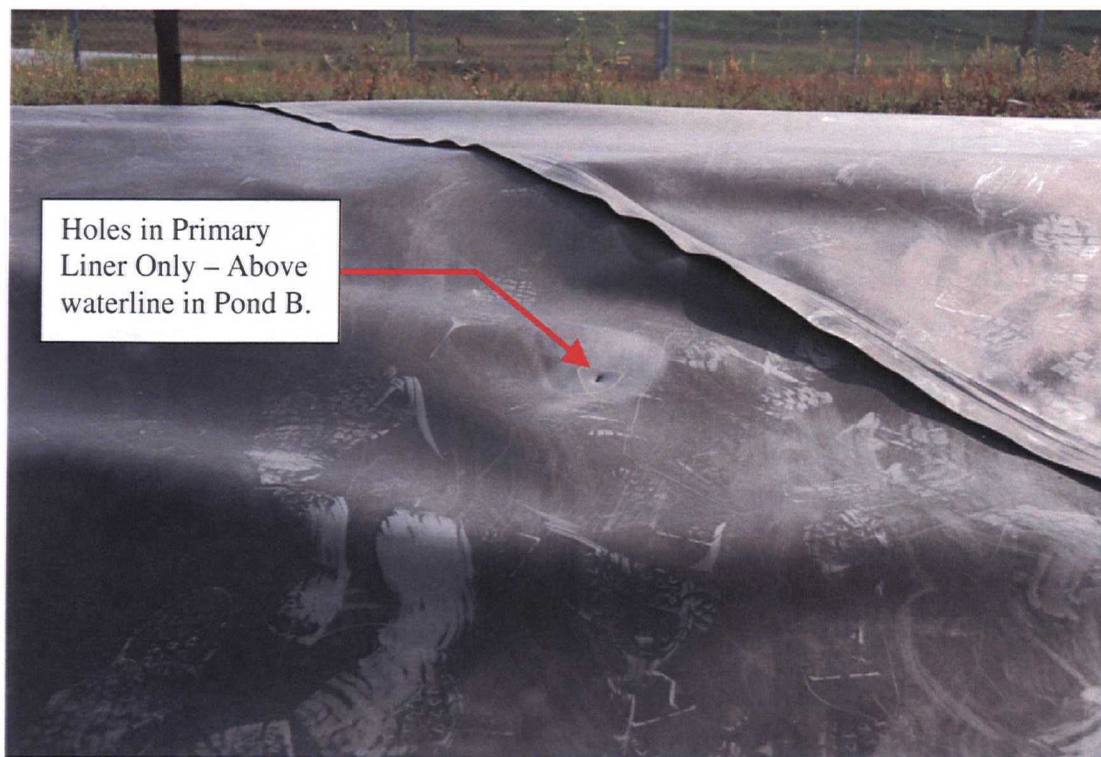
Photograph No. 3 – Pond B inspected. Several small holes found above waterline. Northeast Corner of Pond B.

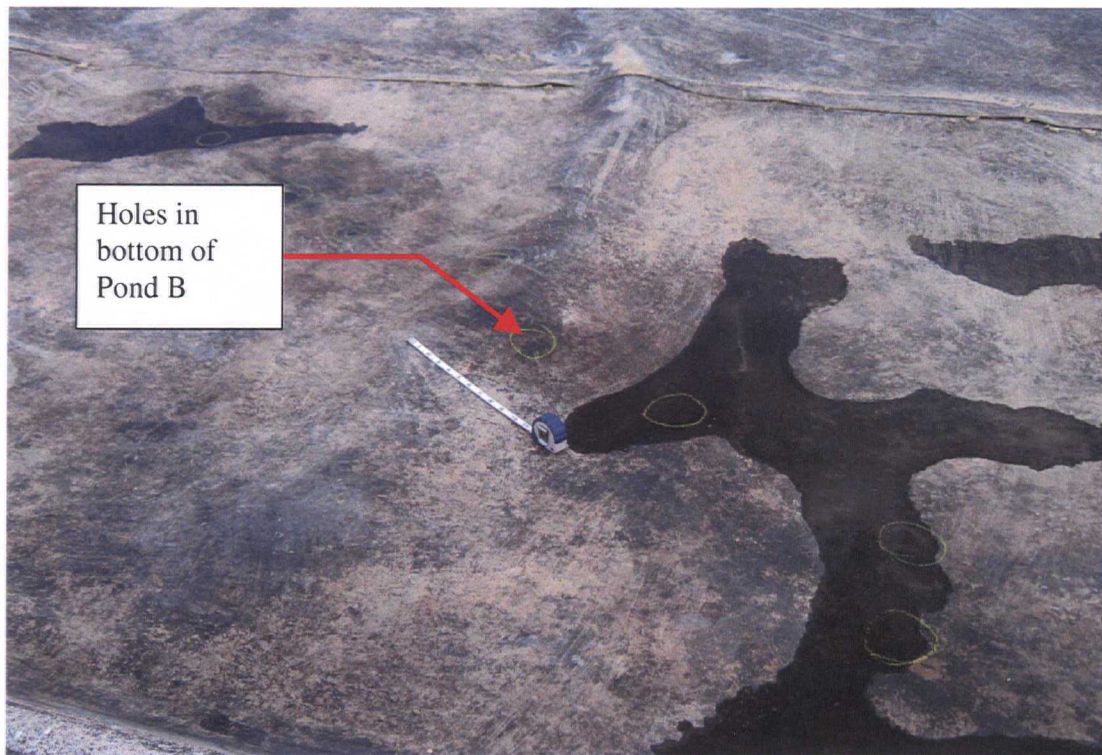
Holes in
bottom of
Pond B

Photograph No. 1 – Photograph taken by SWMD of holes found in the bottom of Pond B.

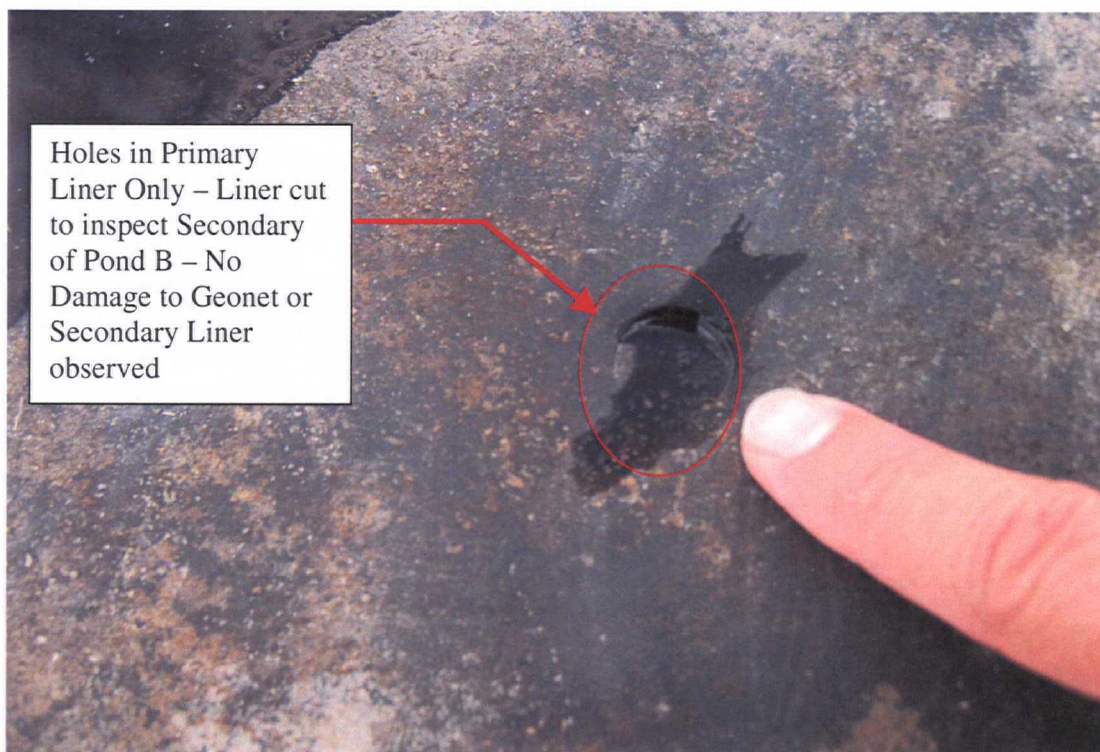
Holes in Primary
Liner Only – Liner cut
to inspect Secondary
of Pond B – No
Damage to Geonet or
Secondary Liner
observed

Photograph No. 2 – Close up of typical damaged area in bottom of Pond B.

- 10:30 am to 11:45 am – CDS cut primary liner in damage areas in the bottom of Pond B to inspect geonet and secondary liner. No damage was observed to geonet or secondary geomembrane. Comanco then placed extrusion beads over damaged areas (holes). The holes were extrusion welded with beads sealing the individual damaged area. Then single larger patch was placed over all individual beads.

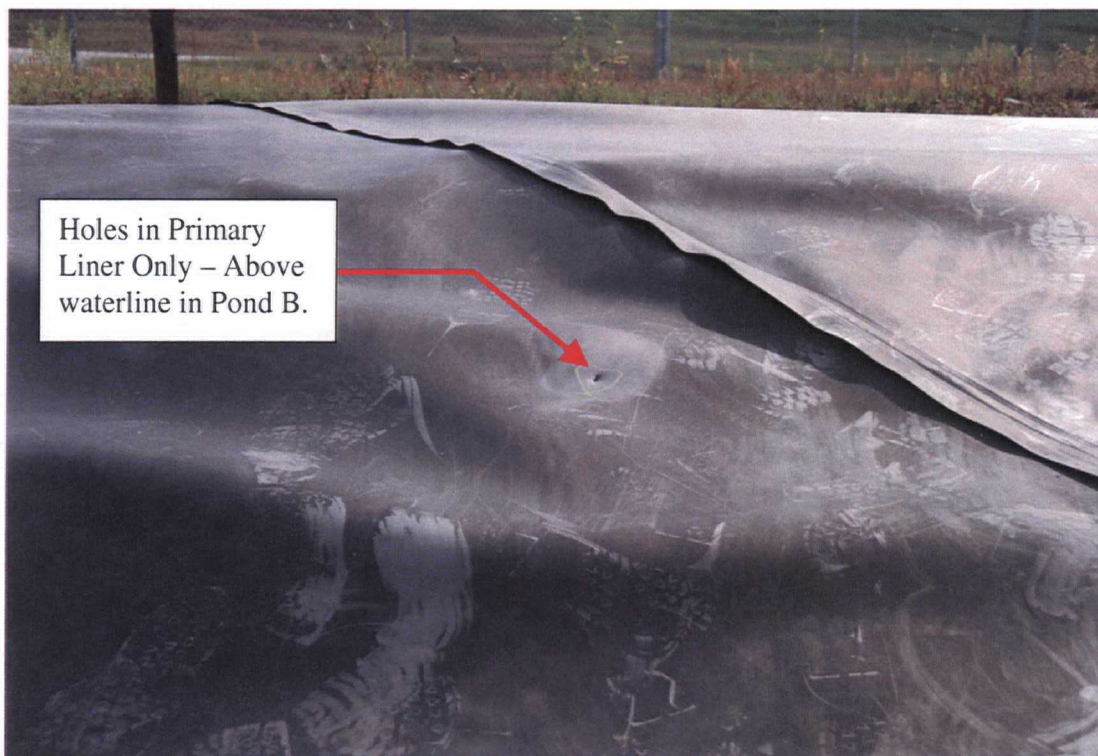
Photograph No. 3 – Pond B inspected. Several small holes found above waterline. Northeast Corner of Pond B.
