From: Joseph O'Neill [joneill@jonesedmunds.com]
Sent: Tuesday, August 22, 2006 3:42 PM
To: Pelz, Susan
Cc: Joseph O'Neill; Richard Siemering; Carlos Restrepo
Subject: Section 8- Leachate Pipe Profiles

HILLSBOROUGH COUNTY
SOUTHEAST COUNTY LANDFILL
SECTION 8 SITE A
LEACHATE PIPE SETTLEMENT CALCULATION
FIGURE 1. SITE PLAN

Subject: Response to Request for Additional Information
Southeast County Landfill, Hillsborough County
Capacity Expansion Section 8
Certification of Construction Completion
Permit No. 35453-009-SC
Jones Edmunds Project No. 08449-020-01

ATTACHMENT 1
Revised Primary and Secondary As-Built Panel Layouts

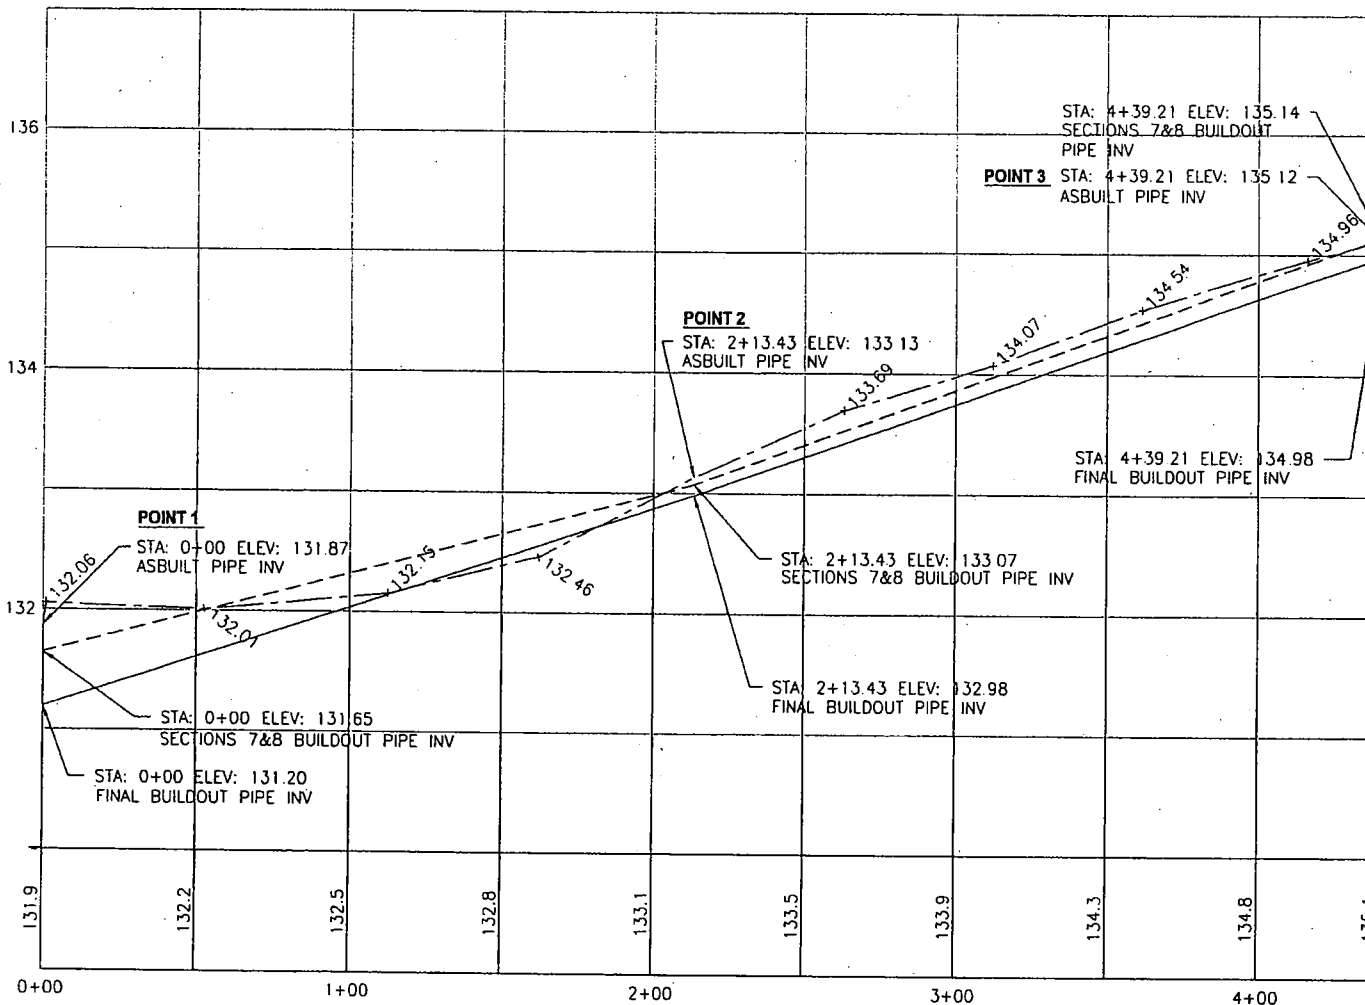
HILLSBOROUGH COUNTY
SOUTHEAST COUNTY LANDFILL
SECTION 8 SITE A
LEACHATE PIPE SETTLEMENT CALCULATION
FIGURE 2. PROFILE "A"

The as-built pipe survey has numerous individual elevations and we have an exaggerated vertical scale shown on the profile hence the "wavy" profile. We only have three settlement points (as shown on the Sec8Pipe Profiles.pdf). We connected the three points with straight lines therefore there may be places in between the post-settlement points where the settled profile has the "appearance" of being "above" the initial as-built pipe profile.

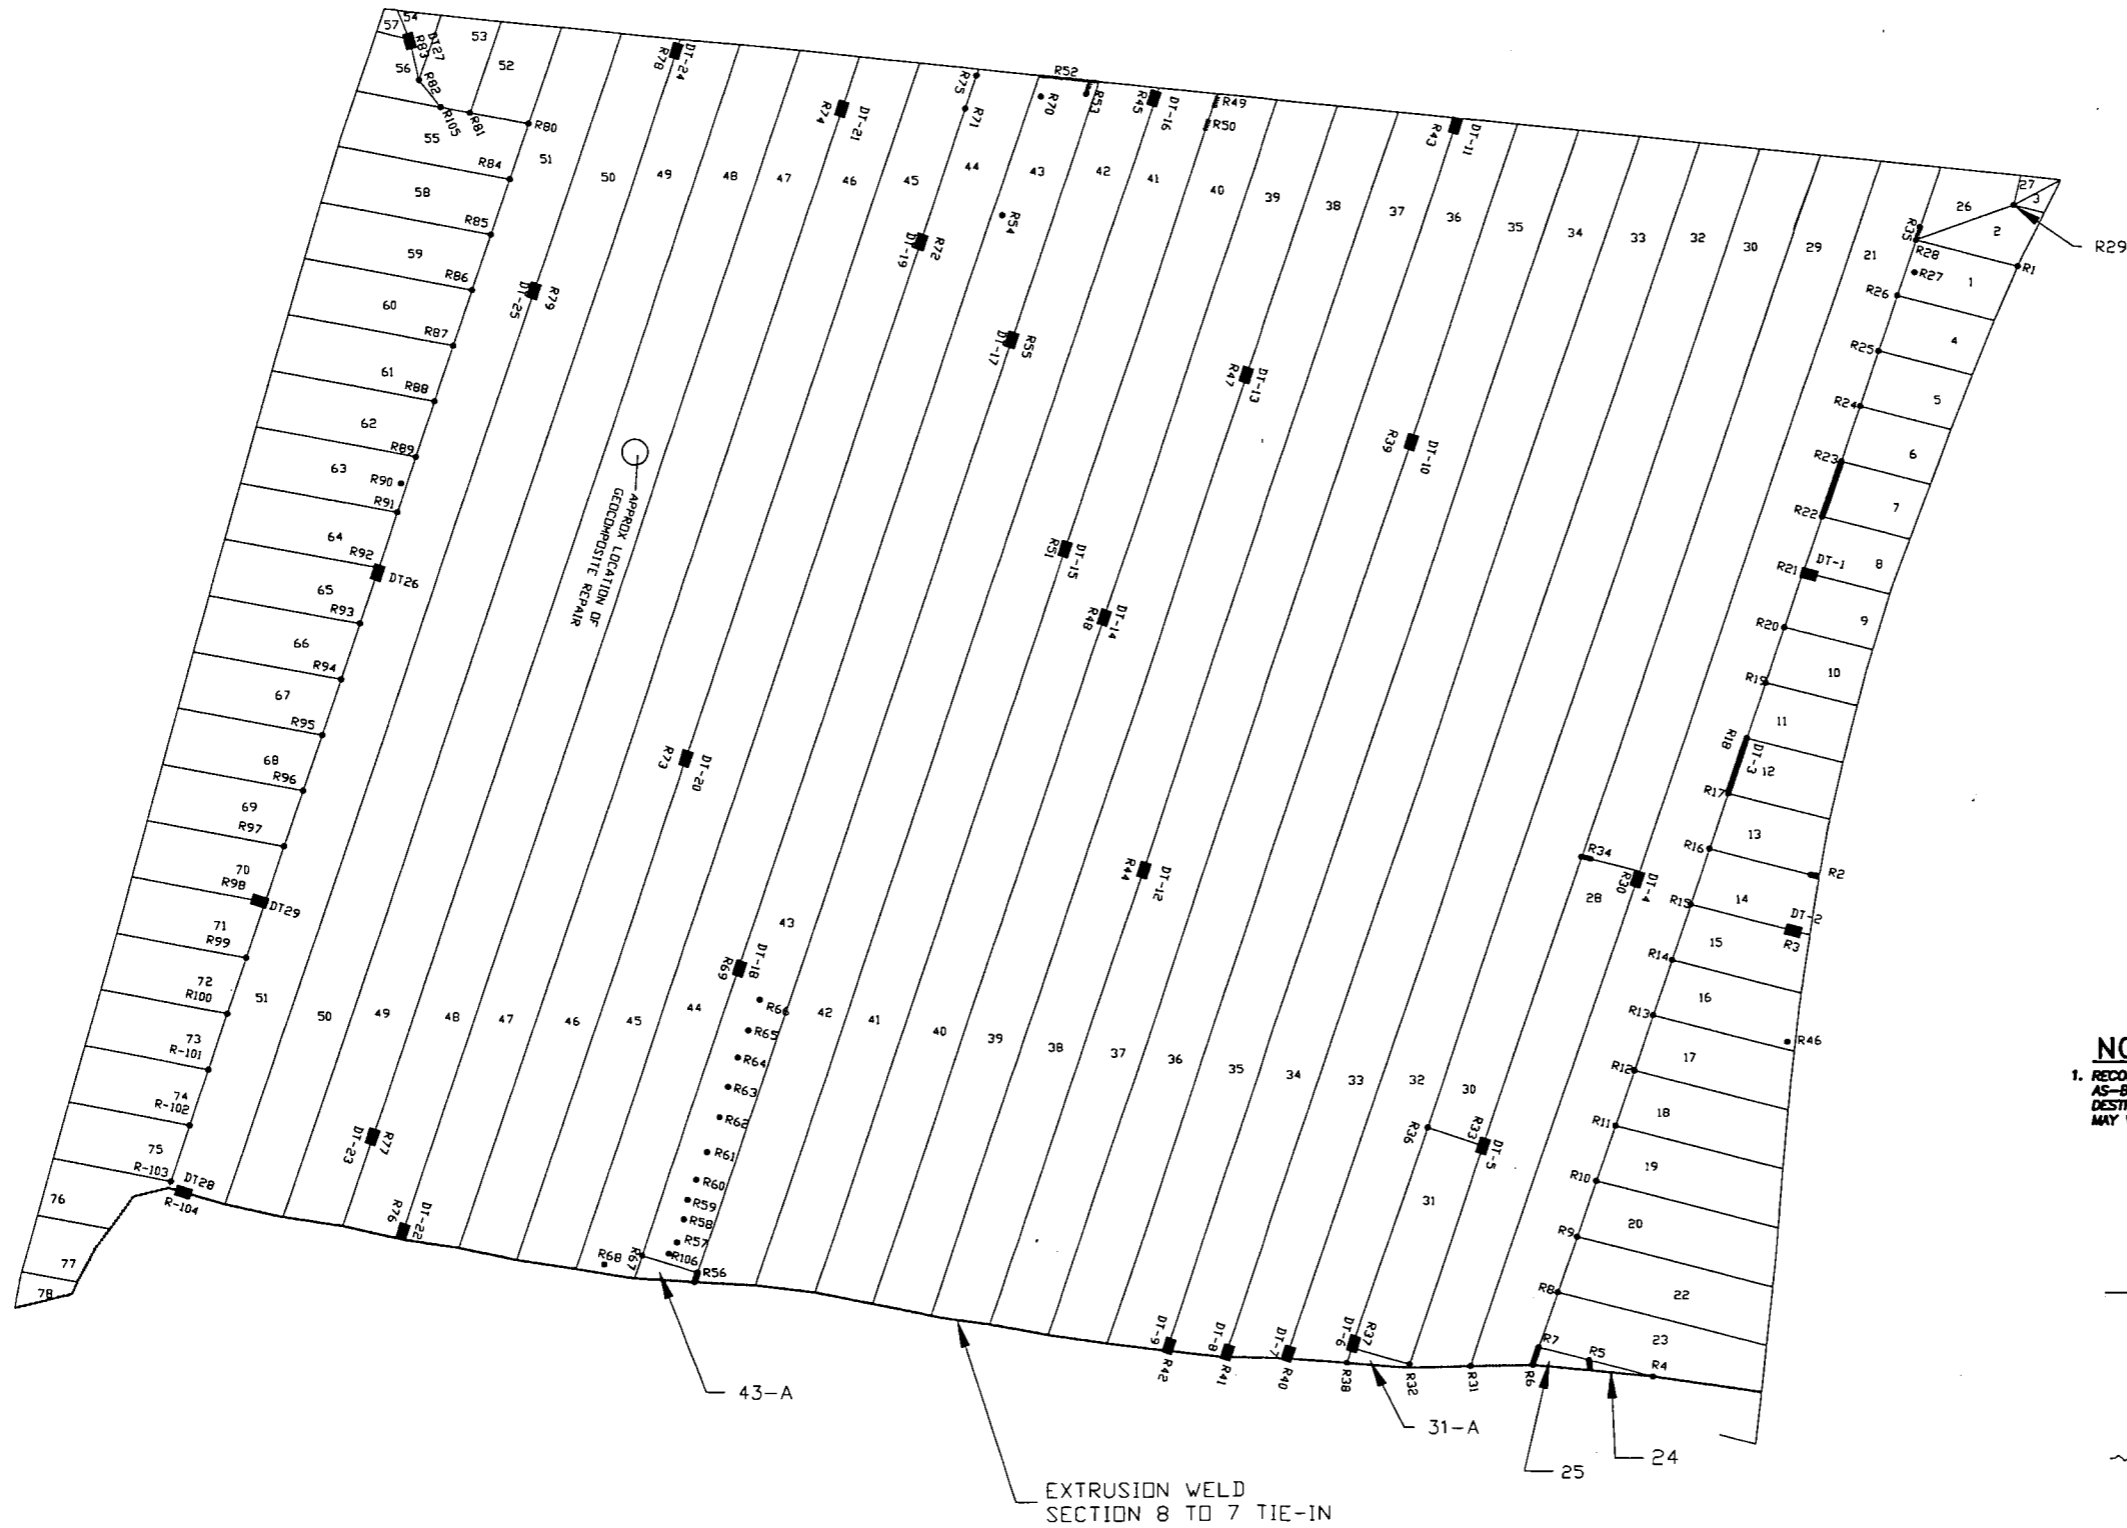
Response 1: As discussed during the meeting, no damage was observed to the primary geomembrane as shown in the submitted photographs; however, the location of the damaged geocomposite was mistakenly placed on the secondary as-built panel layout. Provided in Attachment 1 is a revised Primary As-Built panel layout that shows the damage location (approximately over Primary Panel 48).

Response 5: We have reviewed the repair logs, non-destructive logs, and coordinated with the QES Field QA technician and it appears that Repair No. 44 was mistakenly placed in the wrong location on the as-built panel layout drawings. Repair No. 44 (identified as "CAP") should have been placed on the north end of seam 27/28. A revised secondary panel layout drawing is provided in Attachment 1.

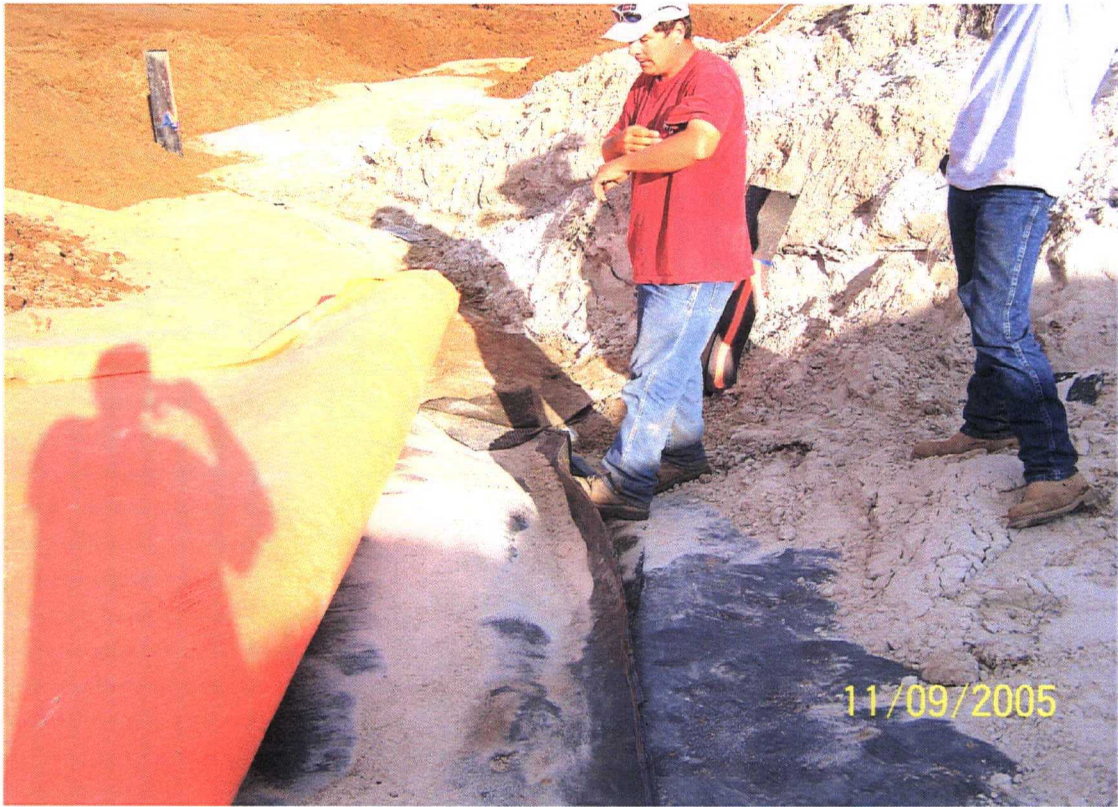
Response 3: Additional photographs are provided in Attachment 2. As shown, no damage occurred to the primary geomembrane.

Attachment 2 – Photograph of “Blow-out” of separation berm. No damage to geomembrane

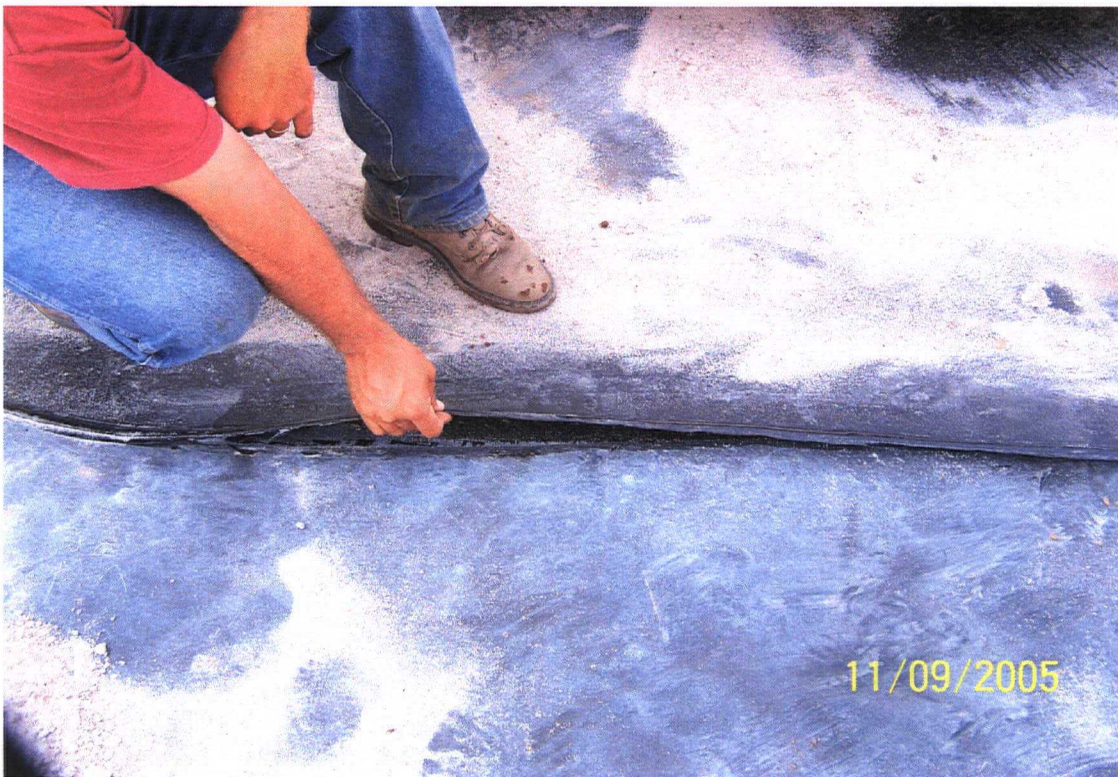
Attachment 2 – Close-up of “Blow-out” along separation berm extrusion weld

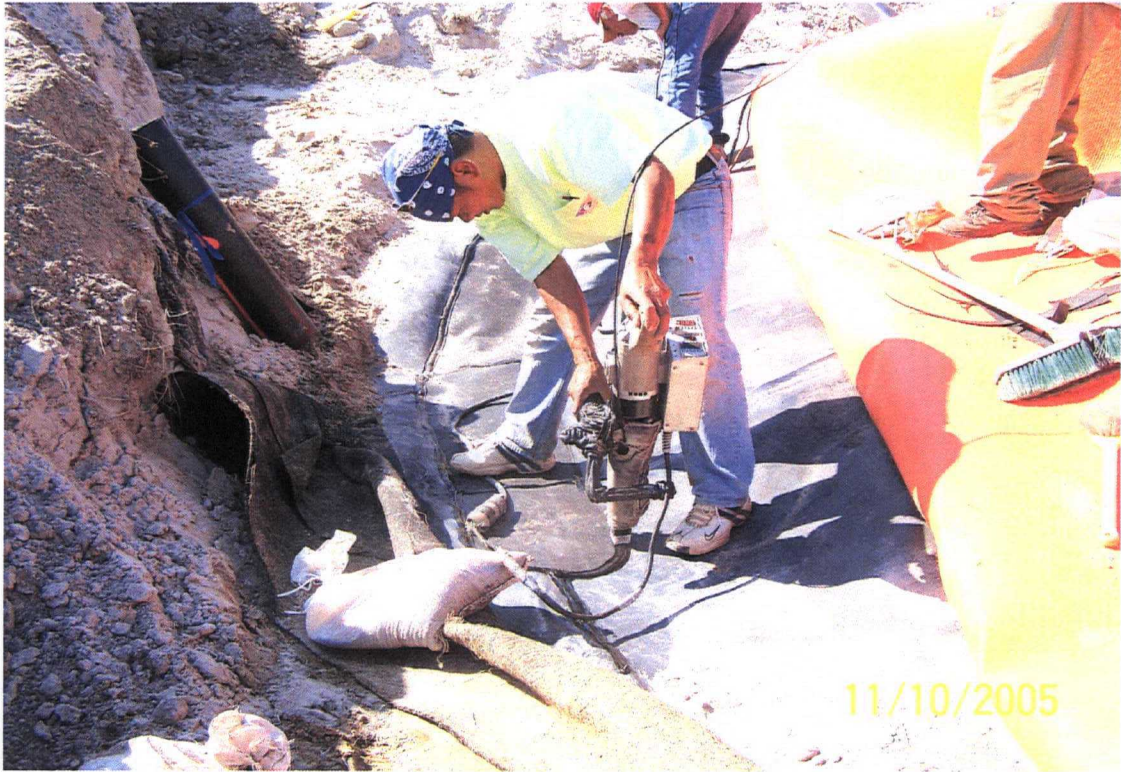
Attachment 2 – Repair of “Blow-out”

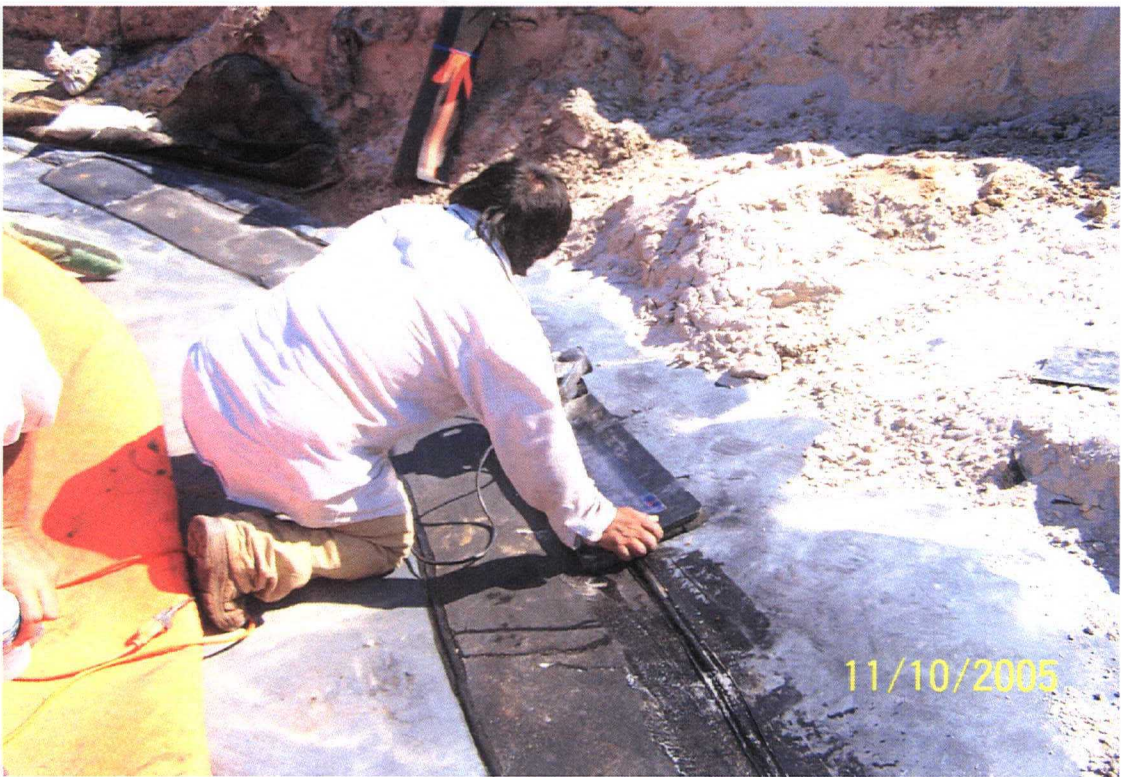
Attachment 2 – Vacuum box of repairs

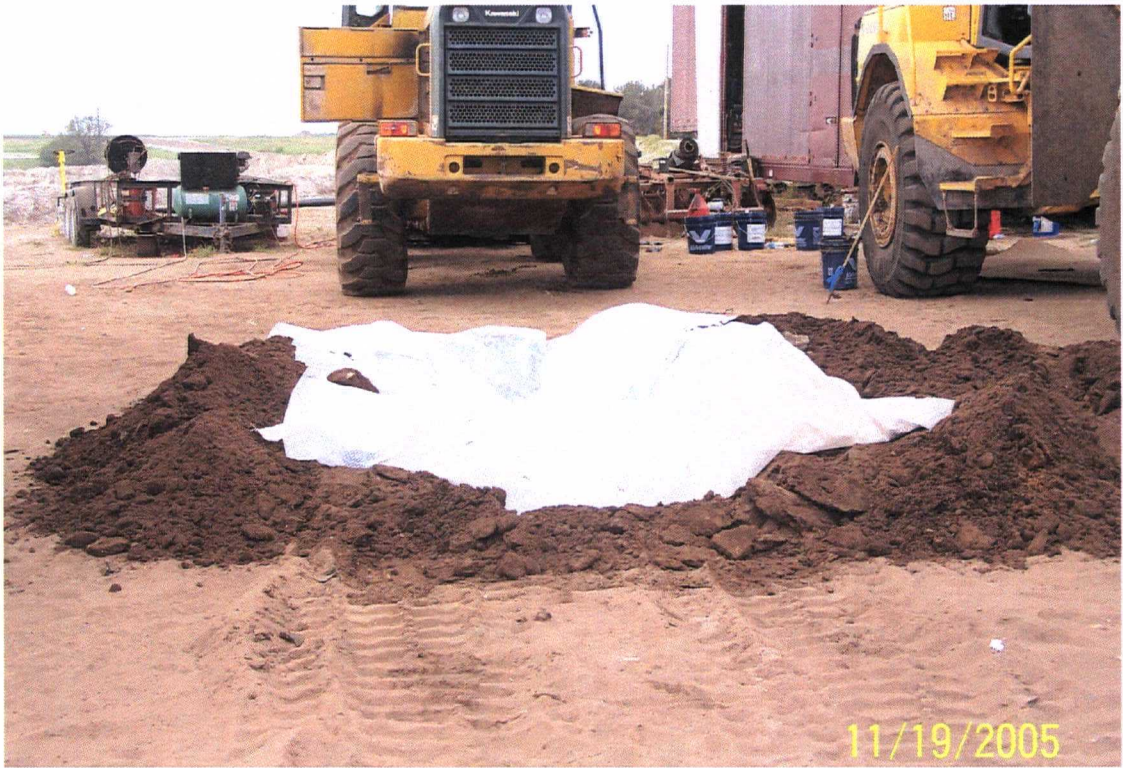
Response 4: The area referred to in the November 19, 2005 QES Daily Field Report was in the ERC layout area (outside of the Section 8 lined area). Provided in Attachment 3 is a photograph of the area in question.

Attachment 3 – “Lined” Area in ERC layout area

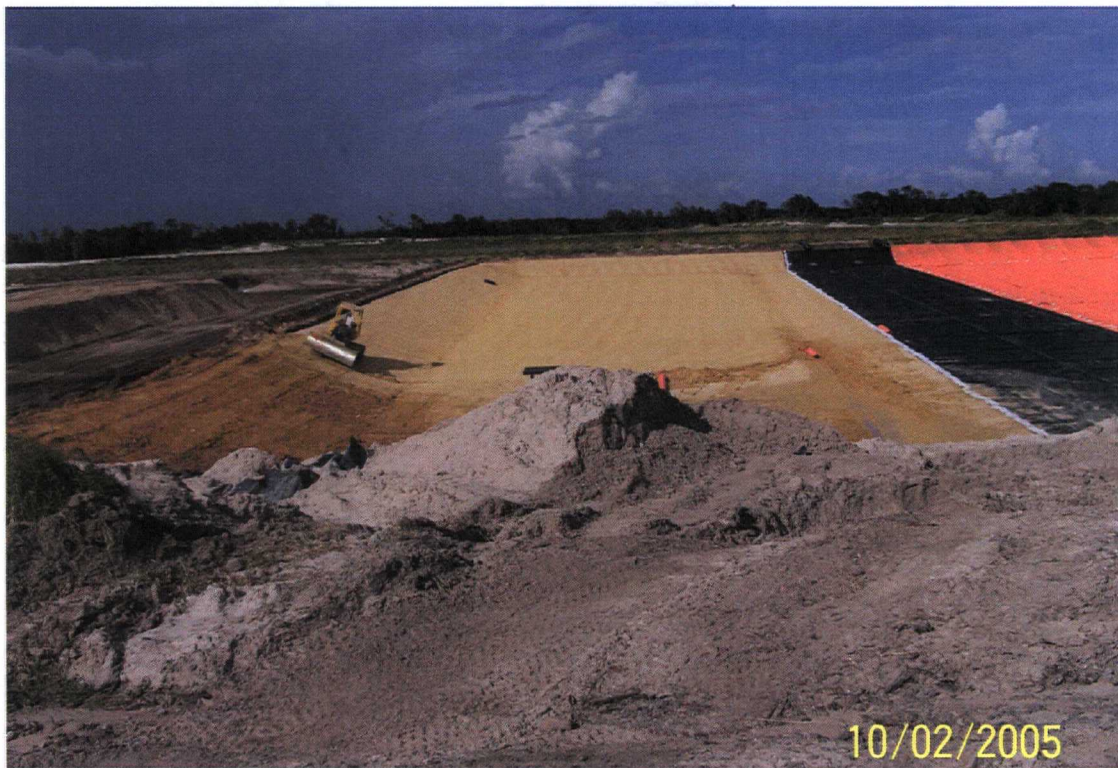
Attachment 7 – Subgrade reworked prior to geomembrane deployed

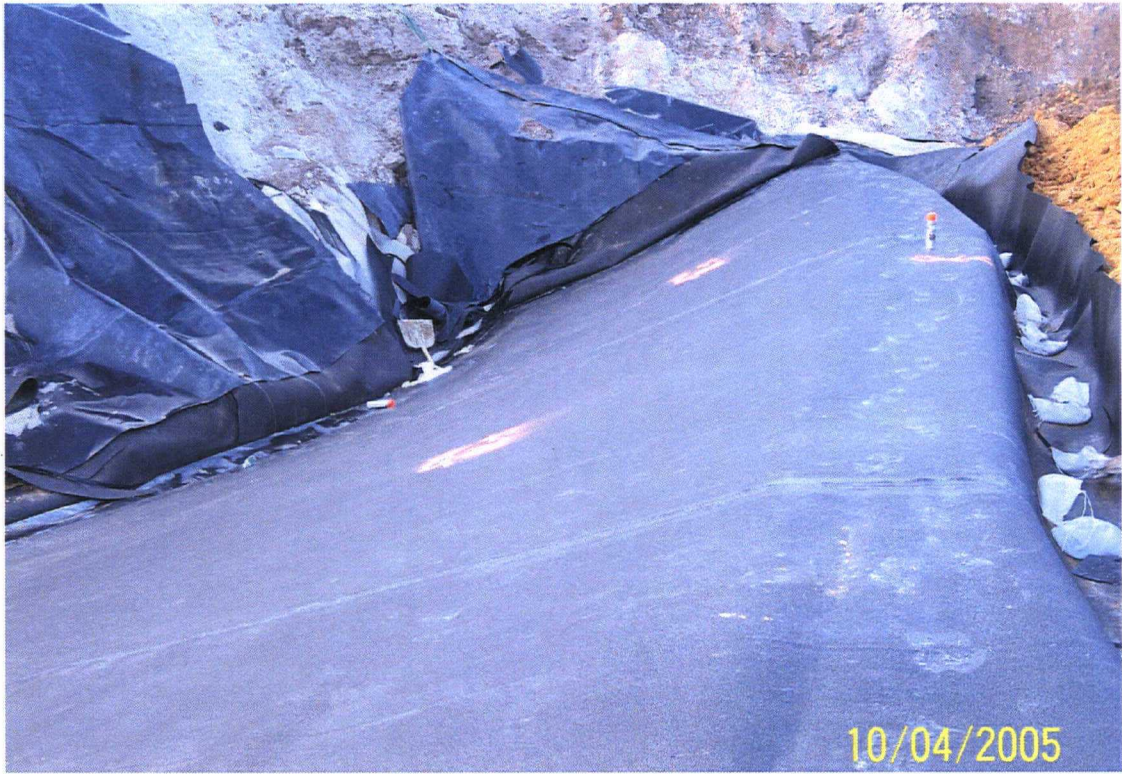
Attachment 7 – Secondary geomembrane tie-in in south west corner with Section 7
