**Re: Southeast County Landfill  
Phases I-VI Leachate Collection System  
Water Jet Cleaning and Video Inspection Report  
FDEP Permit No.: 35435-014-SO/01  
WACS Facility ID No.: SWD/29/41193**

# **Hillsborough County Solid Waste Southeast County Landfill High-pressure Water-jetting & Explosion-proof Video-inspection**

DATE : 3/24/2011  
TO : Walter Gray, Larry Ruiz – Hillsborough County Solid Waste  
FROM : Ralph Calistri (floridajetclean@yahoo.com)  
SUBJECT : Hillsborough County Southeast Landfill – LCS Maintenance

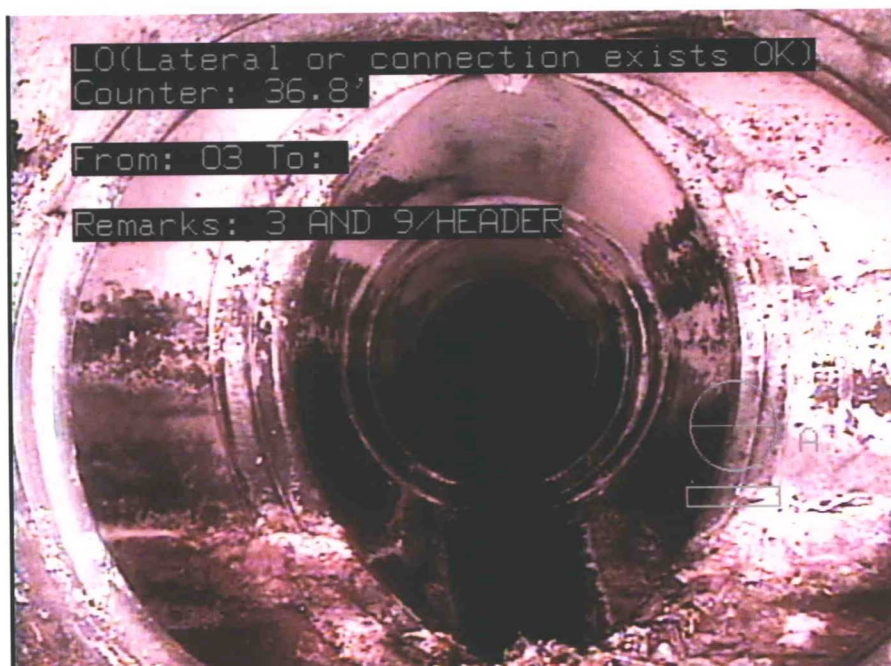
Distance: 36.8 Ft

Obs: Lateral or connection exists OK

Comments: 3 AND 9/HEADER

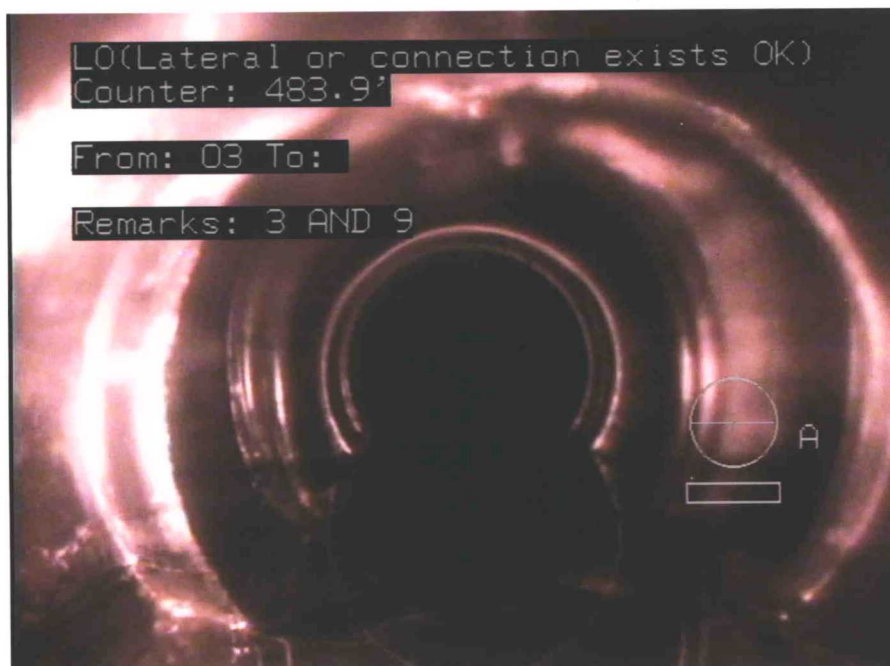
Distance: 483.9 Ft

Obs: Lateral or connection exists OK

Comments: 3 AND 9

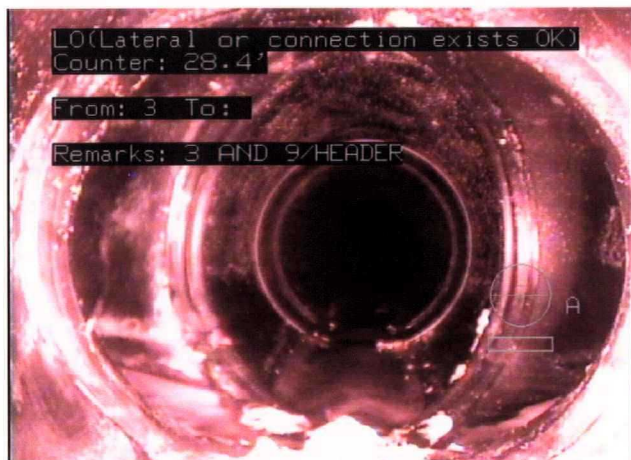
Distance: 28.4 Ft

Obs: Lateral or connection  
exists OK

3 AND 9/HEADER

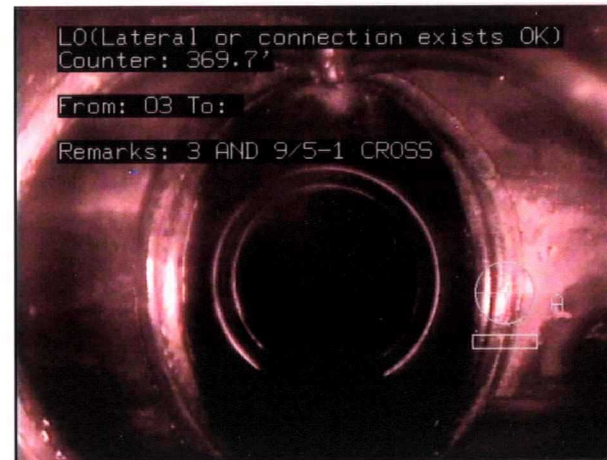
Distance: 369.7 Ft

Obs: Lateral or connection  
exists OK

3 AND 9/5-1 CROSS

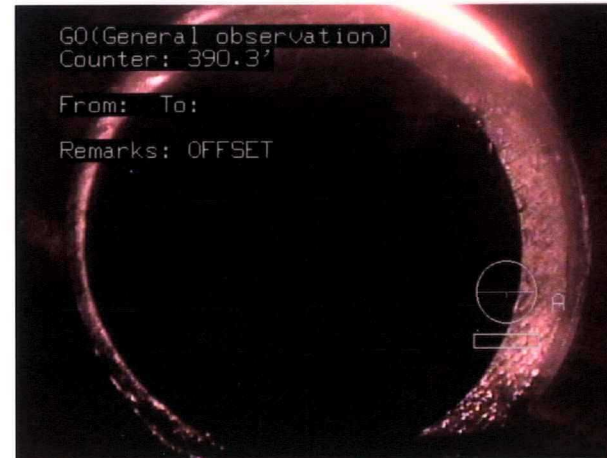
Distance: 390.3 Ft

- In Cleanout Pipe 5-3 at approximately 390 feet, the camera encountered an apparent offset in the pipe. After review of the Phases V and VI Construction Quality Assurance Report prepared in 1992, the LCS piping was joined using fusion, flange and electro-fusion couplings. After reviewing the video of this location, it appears that the offset may be an electro-fusion coupling. Drainage rock and debris does not appear to be falling into the space between the pipe and the reflection in the video indicates a solid material behind the pipe, which may be the wall of an electro-fusion couple. Since the camera was able to navigate past this location and the pipe was jet cleaned the entire length, it appears that the pipe is functioning normally, therefore HDR does not believe any actions are required at this location based on the above observations.

Also, at this location, the camera stopped at approximately 420 feet. The reason for the stoppage could not be determined since the picture was dark, however, since the pipe was jet cleaned the entire length, a blockage or obstruction is not present. The camera stoppage was mostly likely due to loss of traction or from pipe welds that could not be navigated. HDR does not recommend any action for this location based on the above observations.

Obs: General observation

OFFSET

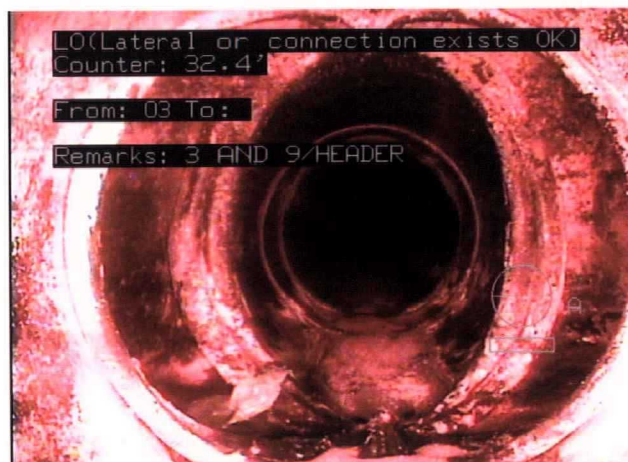
Distance: 32.4 Ft

Obs: Lateral or connection  
exists OK

3 AND 9/HEADER

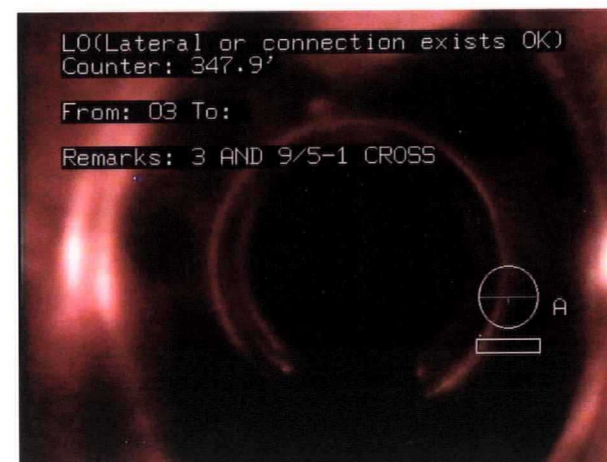
Distance: 347.9 Ft

Obs: Lateral or connection  
exists OK

3 AND 9/5-1 CROSS

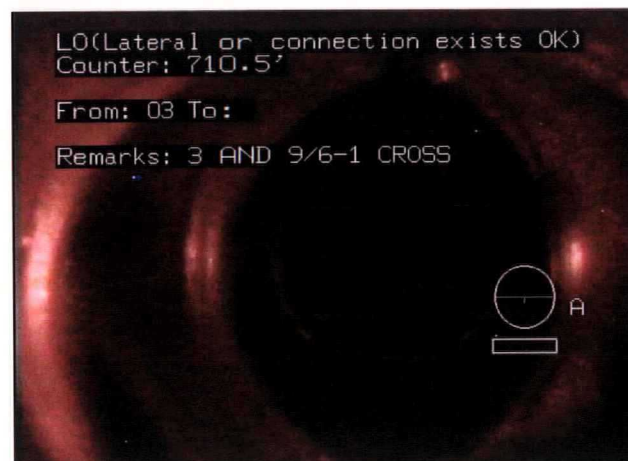
Distance: 710.5 Ft

Obs: Lateral or  
connection exists  
OK

3 AND 9/6-1 CROSS

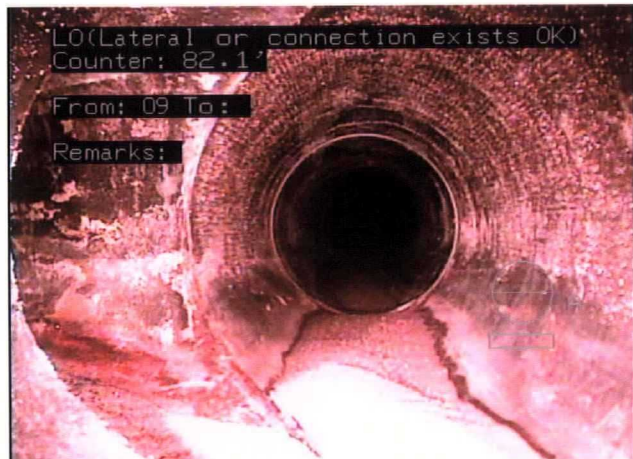
Distance: 82.1 Ft

Obs: Lateral or connection  
exists OK

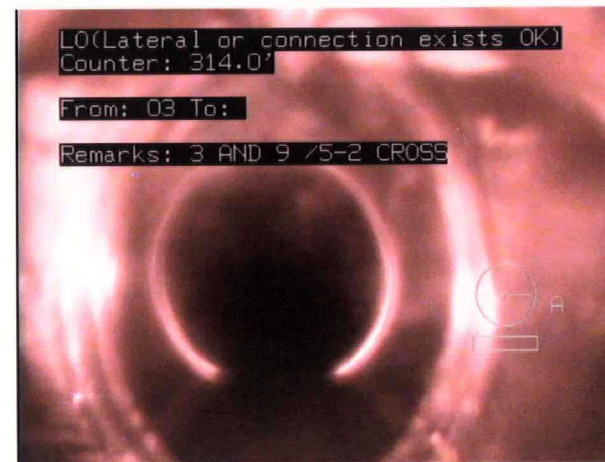
Distance: 314.0 Ft

Obs: Lateral or connection  
exists OK

3 AND 9 /5-2 CROSS

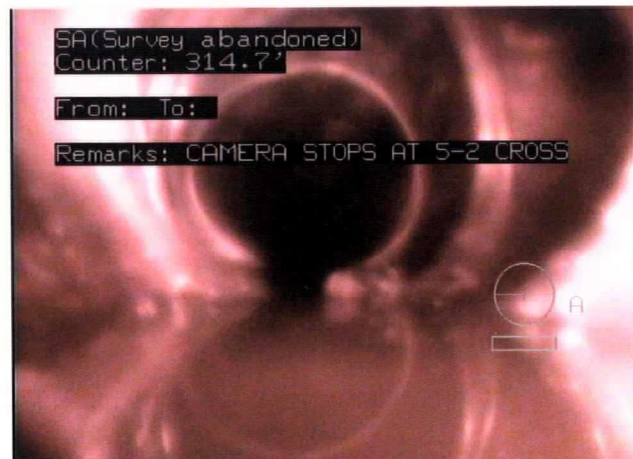
Distance: 314.7 Ft

Obs: Survey abandoned

CAMERA STOPS AT 5-2  
CROSS
