Subject: Response to Request for Additional Information
Southeast County Landfill, Hillsborough County
Capacity Expansion Section 8
Certification of Construction Completion
Permit No. 35453-009-SC
Jones Edmunds Project No. 08449-020-01

HILLSBOROUGH COUNTY
SOUTHEAST COUNTY LANDFILL
SECTION 8 SITE A
LEACHATE PIPE SETTLEMENT CALCULATION
FIGURE 1. SITE PLAN

ATTACHMENT 1
Revised Primary and Secondary As-Built Panel Layouts

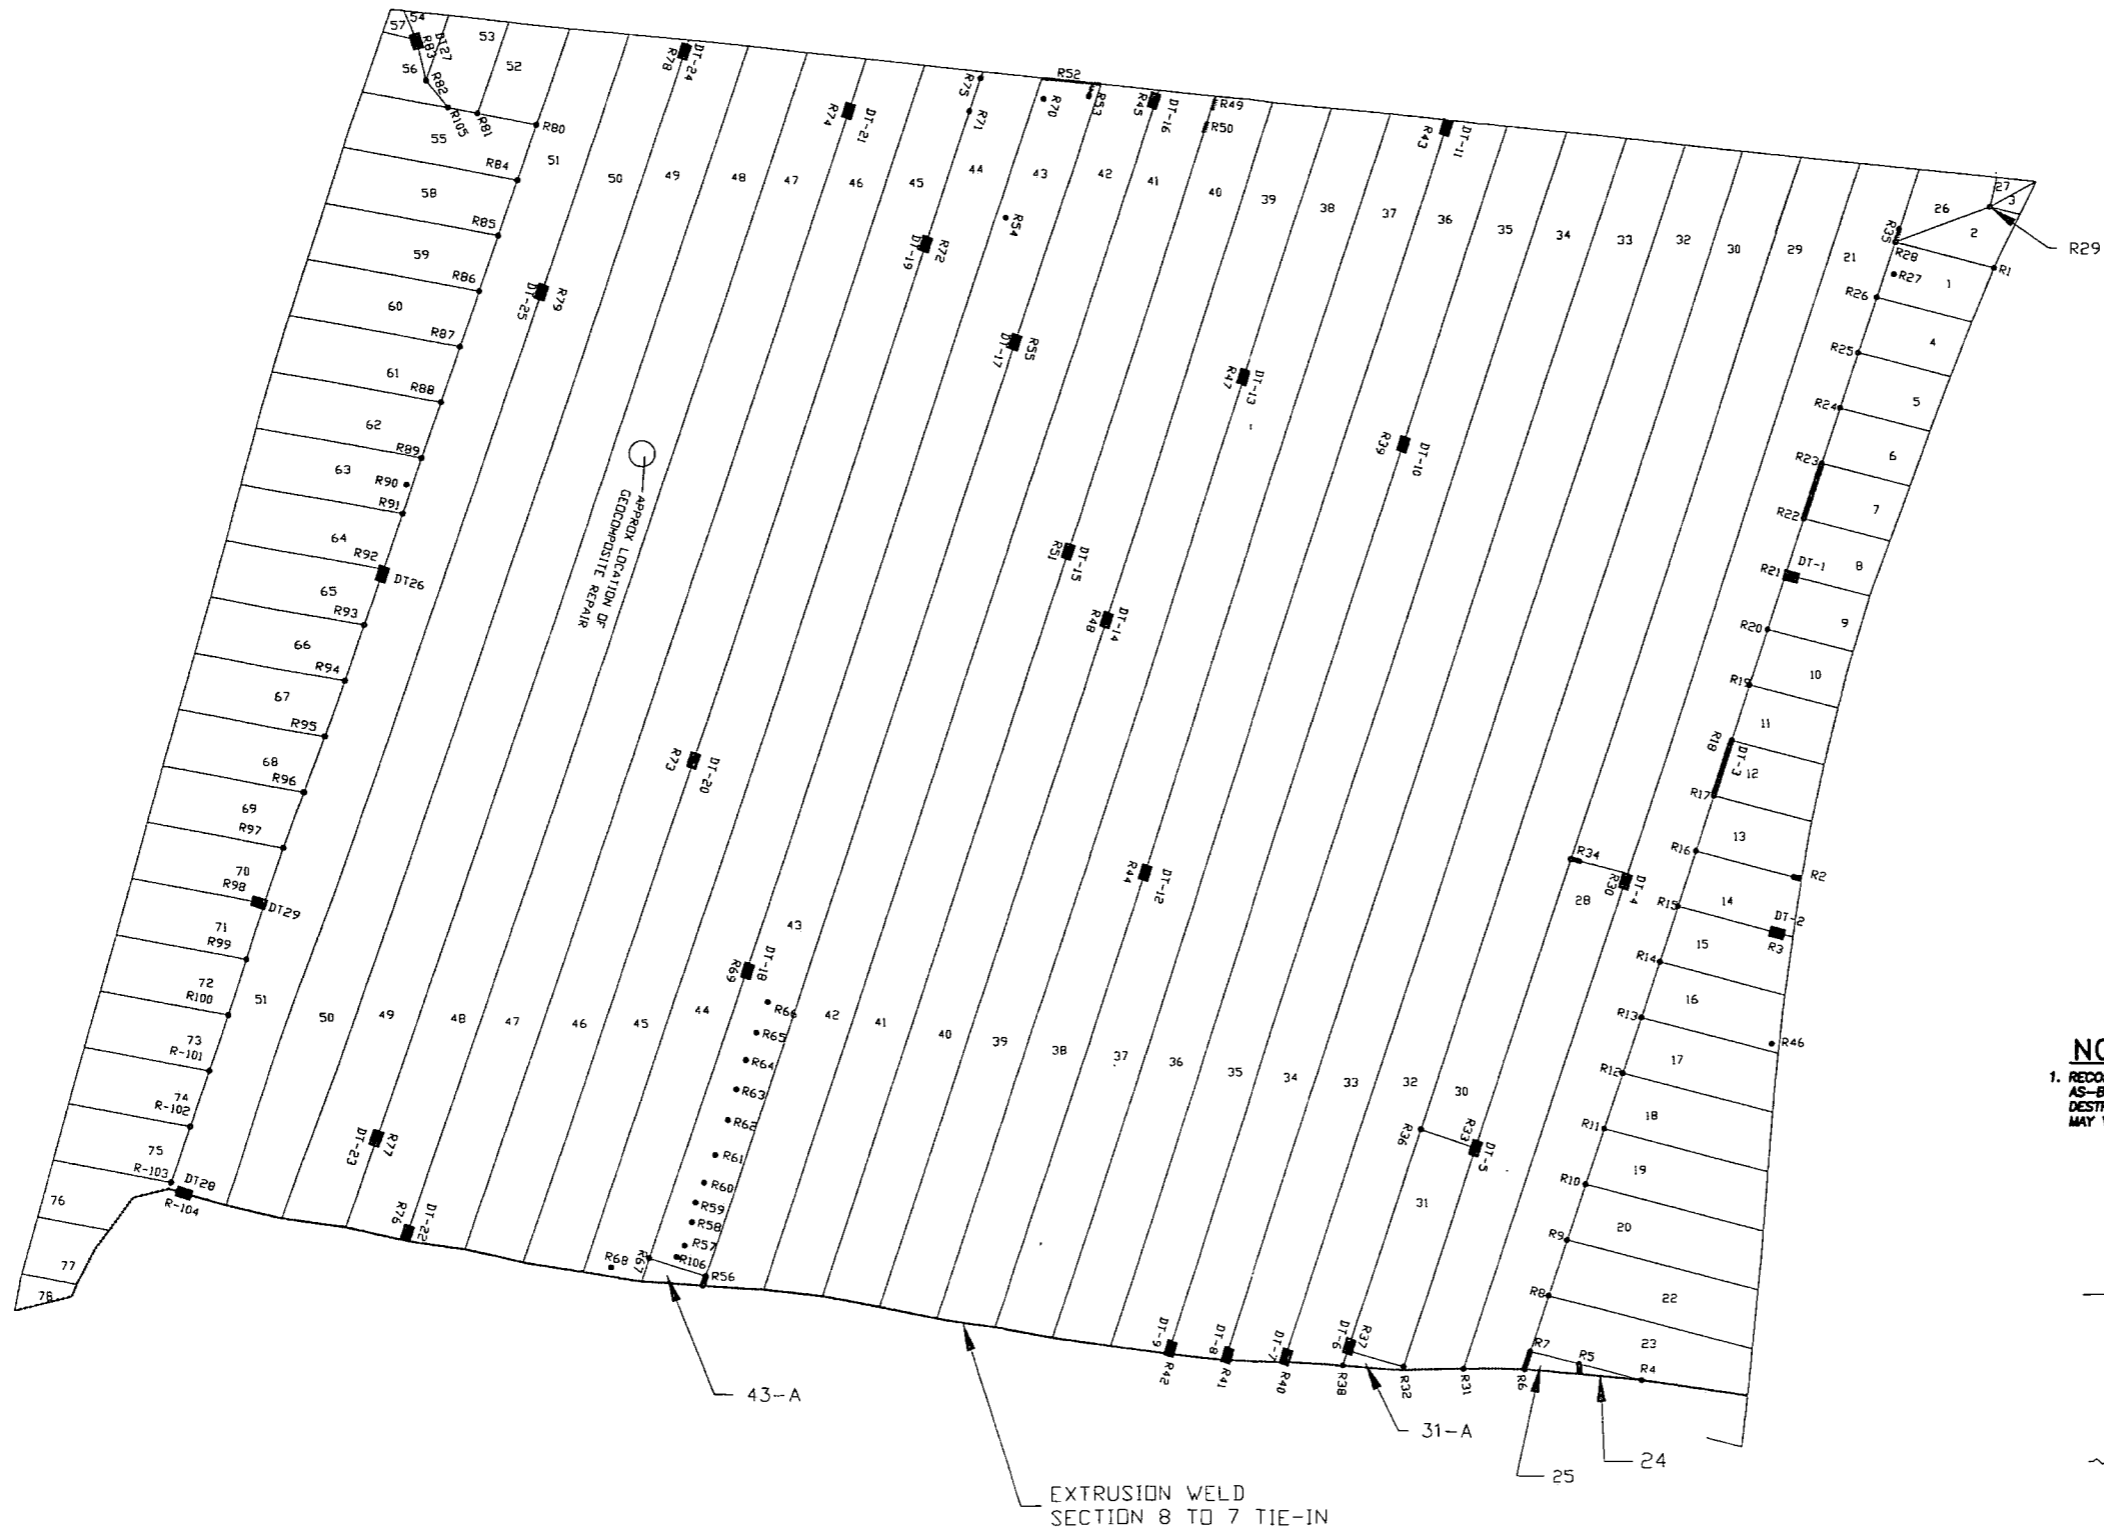
Response 1: As discussed during the meeting, no damage was observed to the primary geomembrane as shown in the submitted photographs; however, the location of the damaged geocomposite was mistakenly placed on the secondary as-built panel layout. Provided in Attachment 1 is a revised Primary As-Built panel layout that shows the damage location (approximately over Primary Panel 48).

Response 5: We have reviewed the repair logs, non-destructive logs, and coordinated with the QES Field QA technician and it appears that Repair No. 44 was mistakenly placed in the wrong location on the as-built panel layout drawings. Repair No. 44 (identified as "CAP") should have been placed on the north end of seam 27/28. A revised secondary panel layout drawing is provided in Attachment 1.

Response 2: A revised Geomembrane Panel Layout is provided in Attachment 1 with the corrected location of the geocomposite "tear".

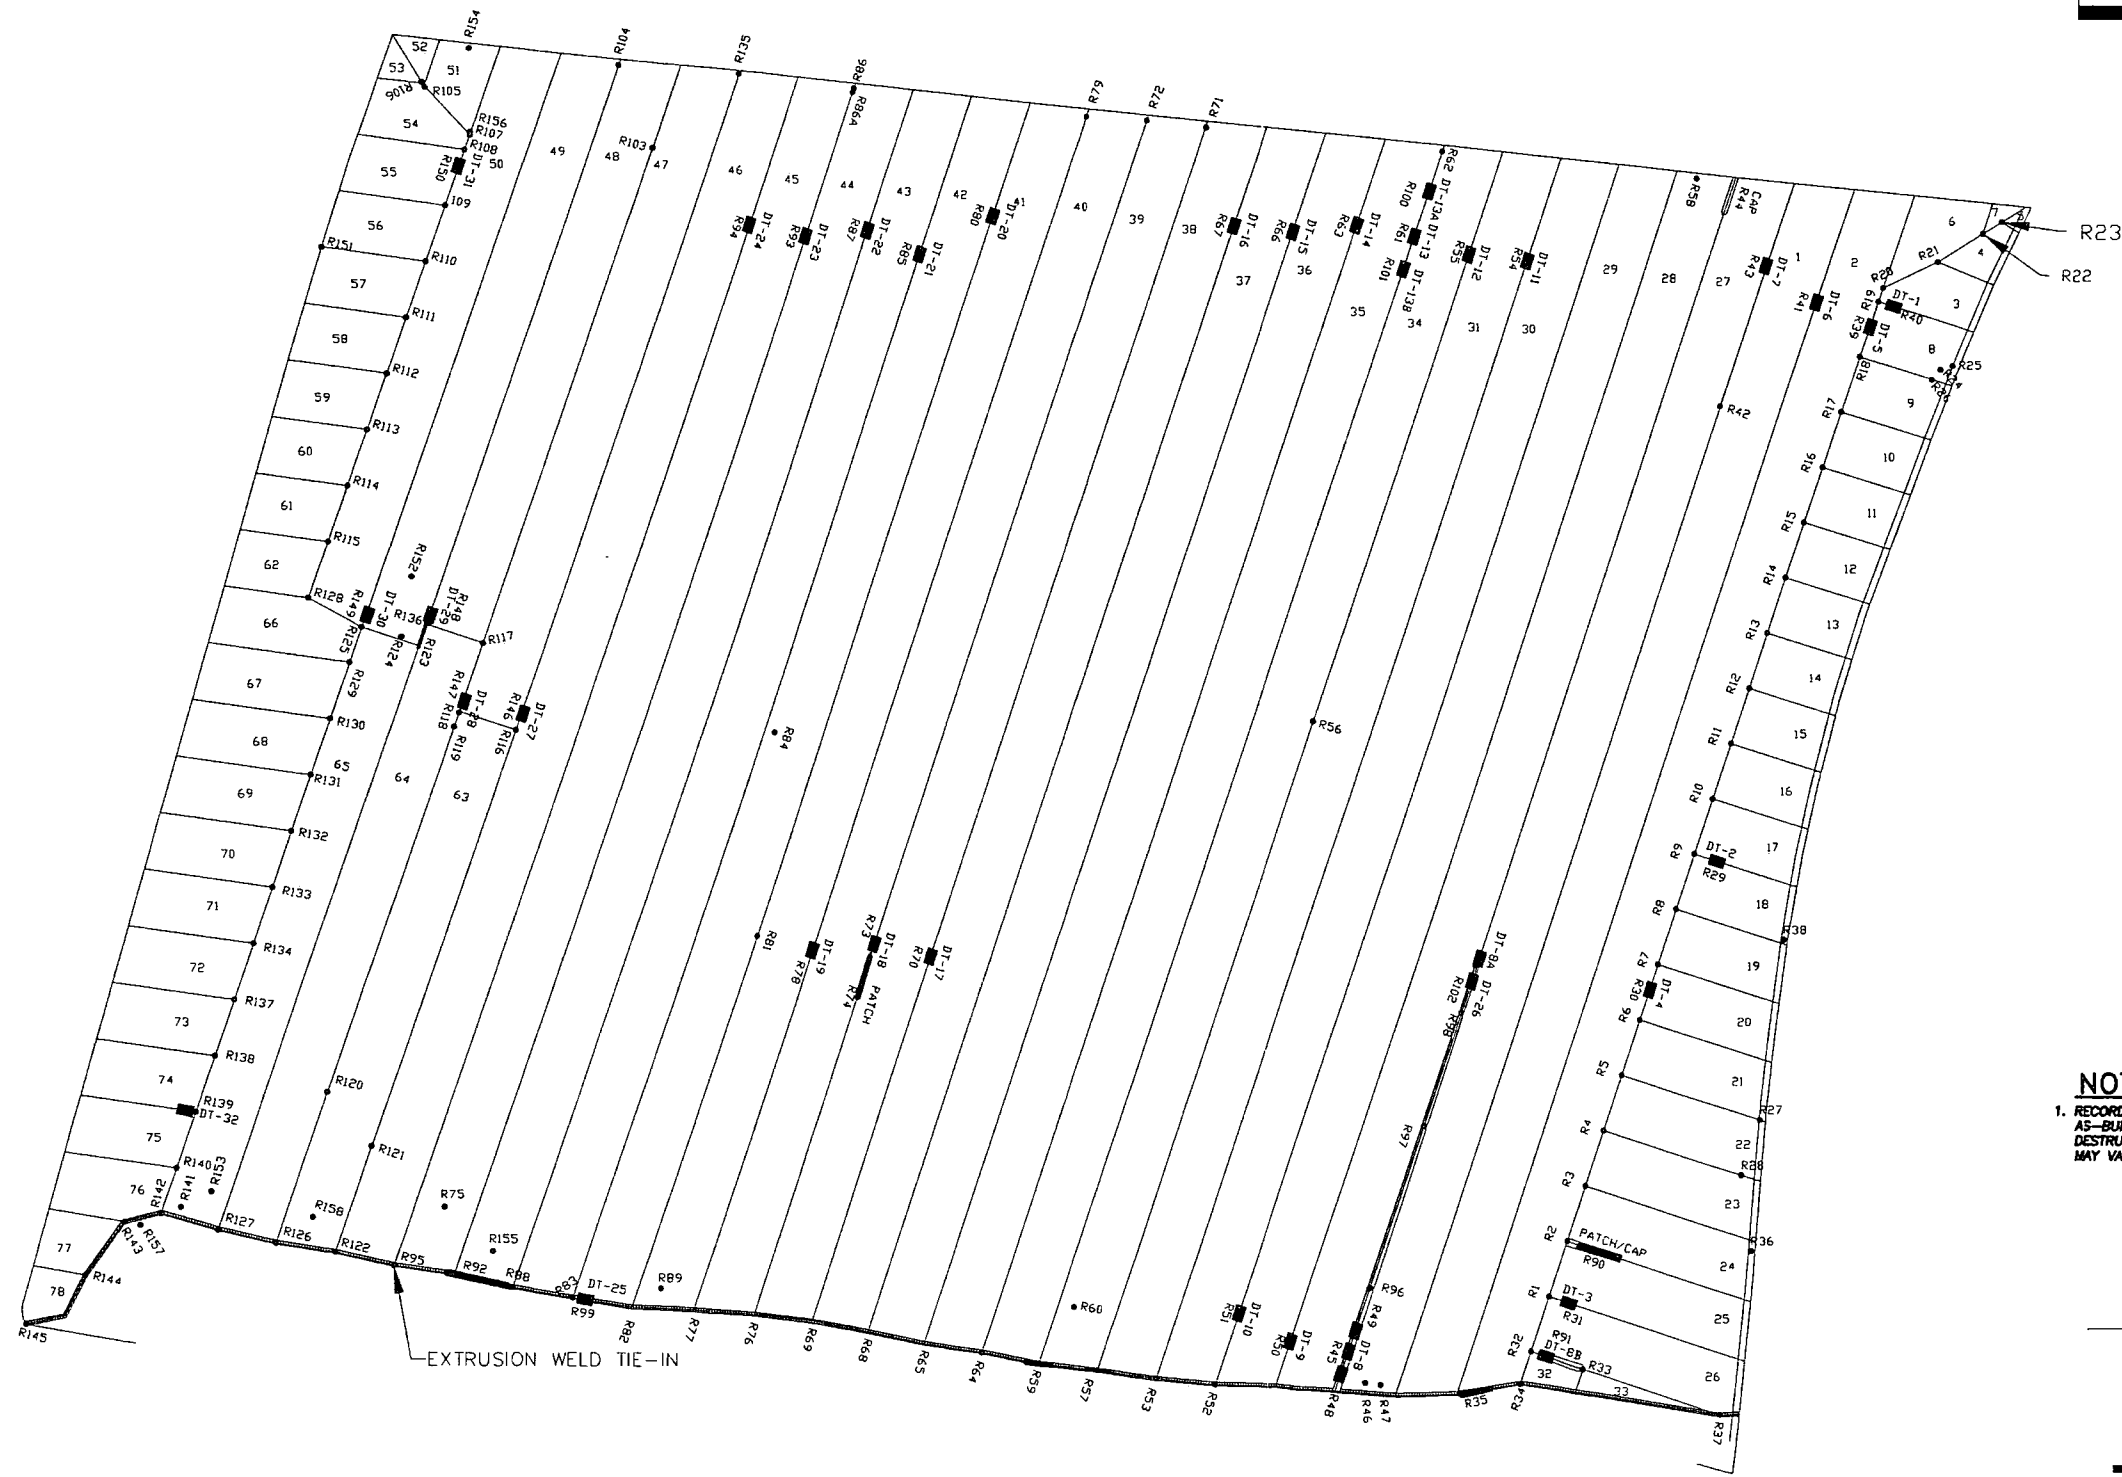
Seam 7-8-21 was fusion welded and failed to hold air pressure. Repair Number 22 was the repair of that entire seam. The length of the repair was incorrectly typed into the geomembrane log. The length of Repair Number 22 has been revised to show the entire length was repaired with a cap strip and vacuum box tested. In addition, the Primary as-built panel layout has been modified to show the cap strip.

Seam 12-13-21 was fusion welded and failed to hold air pressure. Repair Number 17 was the repair of that entire seam. The length of the repair was incorrectly typed into the geomembrane log. The length of Repair Number 17 has been revised to show the entire length was repaired with a cap strip and vacuum box tested. In addition, the Primary as-built panel layout has been modified to show the cap strip.

Seam 25-21-TIE-IN was fusion welded and failed to hold air pressure. The seaming log (Sheet 2) indicates that the length of the seam was approximately 7 feet in length. The length of Repair Number 6 was incorrect. The corrected length of the cap strip is 5 feet. The combined length of Repair Numbers R6 (5 feet) and R7 (2 feet) is 7 feet (the entire seam length). The length of Repair Number 6 has been revised to show the entire length was repaired with a cap strip and vacuum box tested. In addition, the Primary as-built panel layout has been modified to show the cap strip.

Seam 23-24-25 was fusion welded and failed to hold air pressure. The seaming log (Sheet 1) indicates that the length of the seam was approximately 6 feet in length. The length of Repair Number 5 was incorrect. The corrected length of the cap strip is 6 feet (the entire seam length). The length of Repair Number 5 has been revised to show the entire length was repaired with a cap and vacuum boxed. In addition, the Primary as-built panel layout has been modified to show the cap strip.

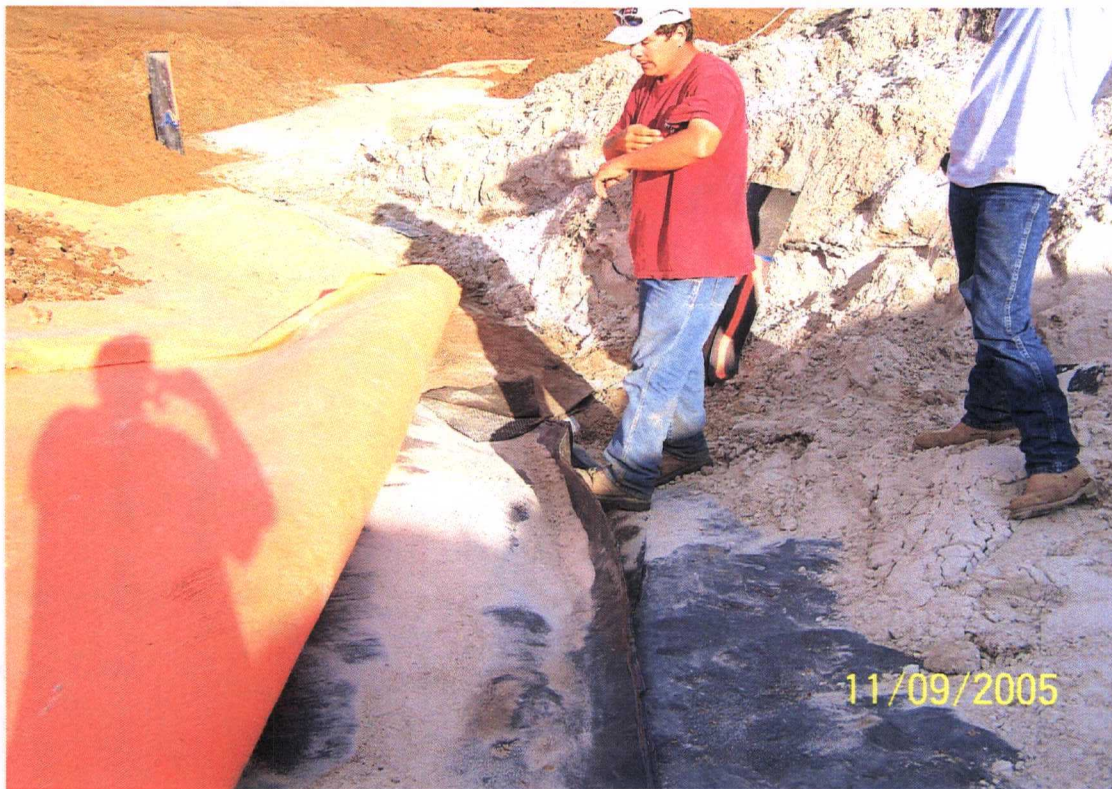
Response 3: Additional photographs are provided in Attachment 2. As shown, no damage occurred to the primary geomembrane.

Attachment 2 – Photograph of “Blow-out” of separation berm. No damage to geomembrane

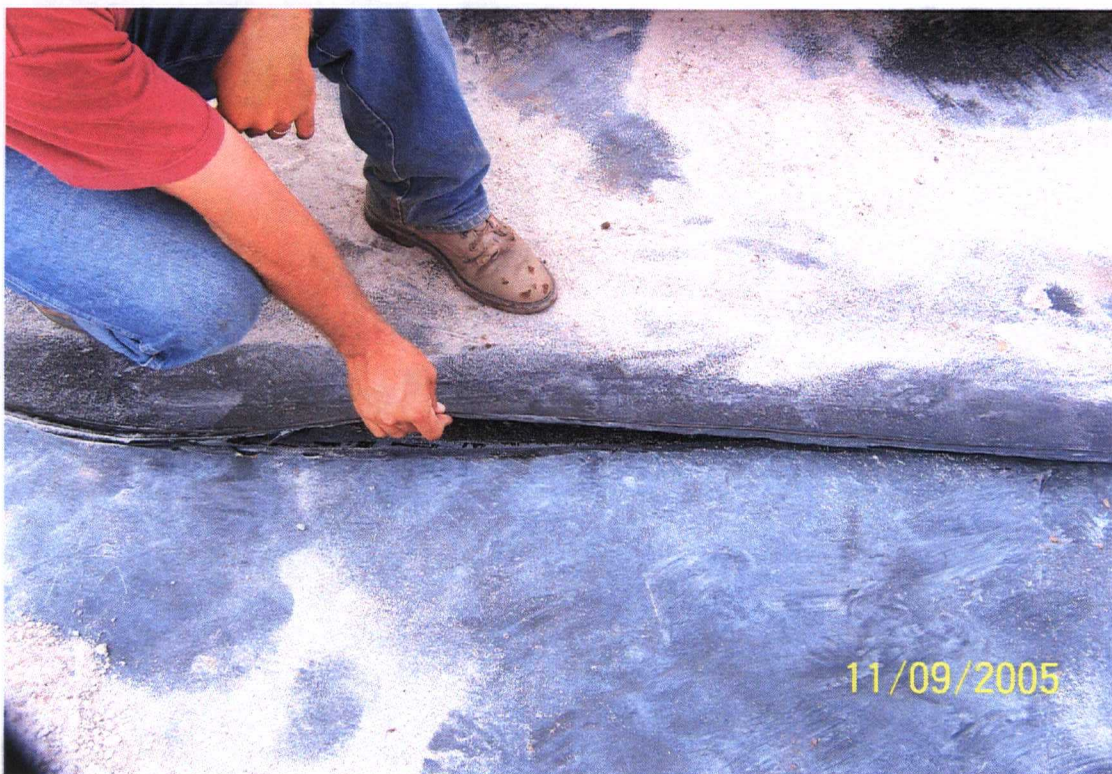
Attachment 2 – Close-up of “Blow-out” along separation berm extrusion weld

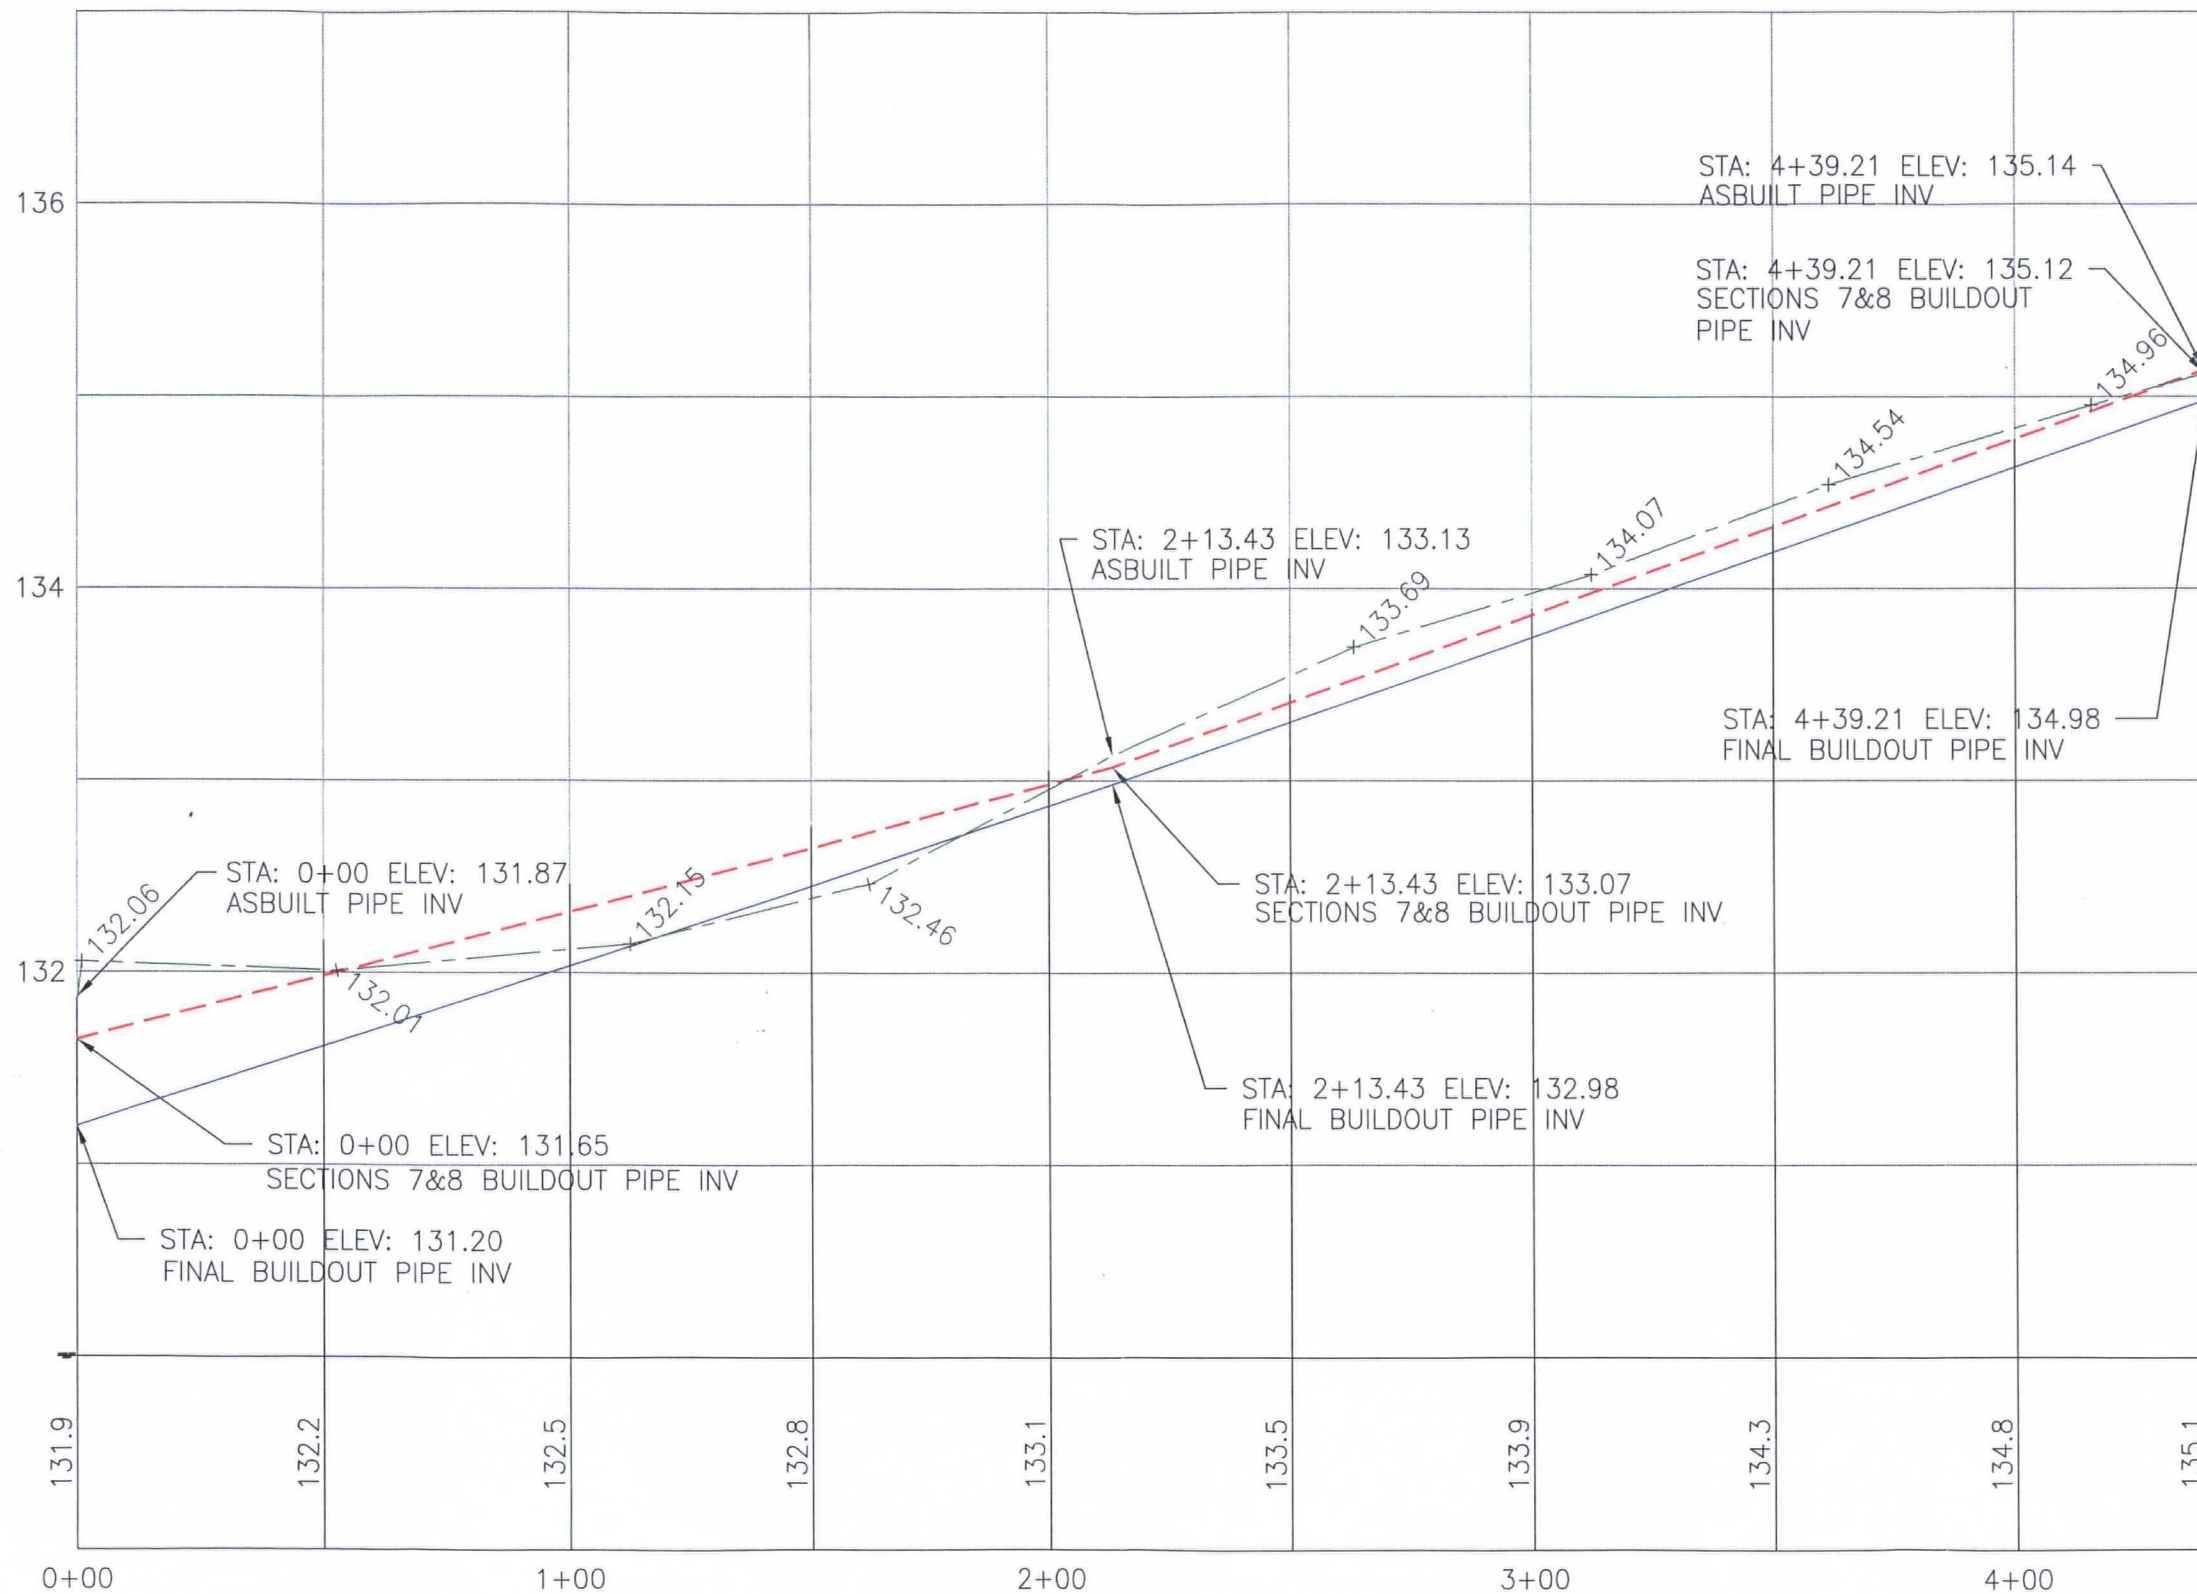
HILLSBOROUGH COUNTY
SOUTHEAST COUNTY LANDFILL
SECTION 8 SITE A
LEACHATE PIPE SETTLEMENT CALCULATION
FIGURE 2. PROFILE "A"

The as-built pipe survey has numerous individual elevations and we have an exaggerated vertical scale shown on the profile hence the "wavy" profile. We only have three settlement points (as shown on the Sec8Pipe Profiles.pdf). We connected the three points with straight lines therefore there may be places in between the post-settlement points where the settled profile has the "appearance" of being "above" the initial as-built pipe profile.

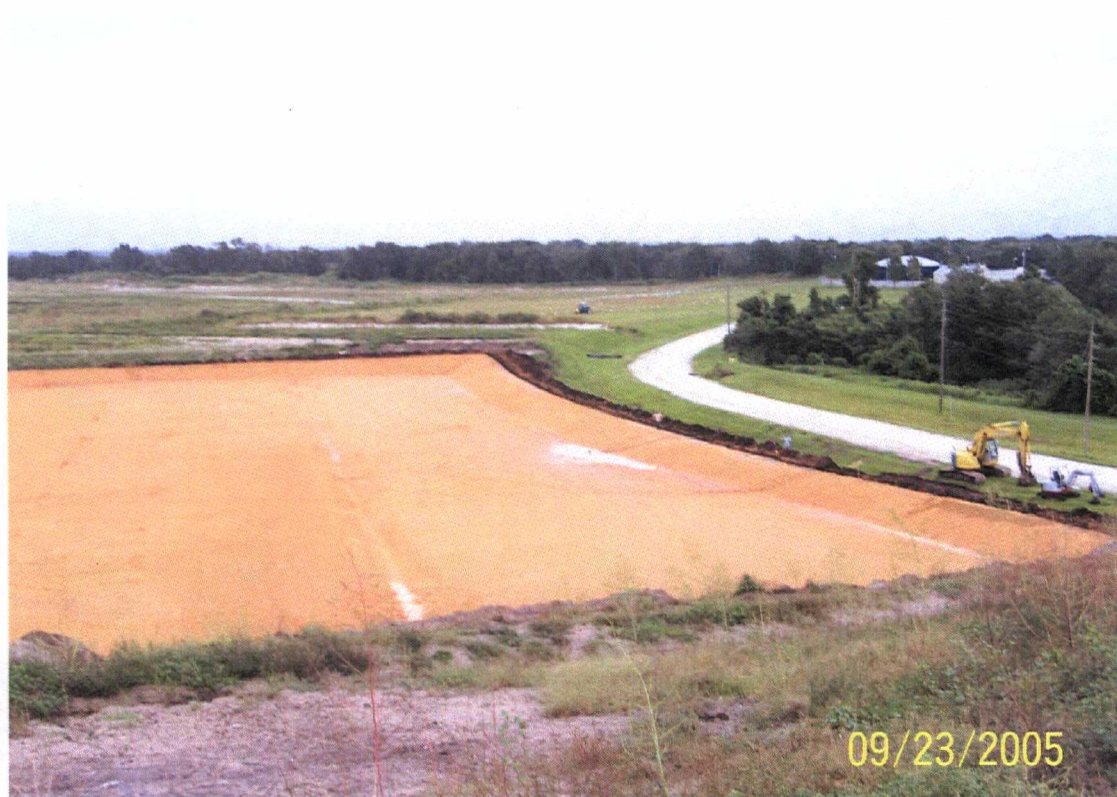
Attachment 7 – Subgrade prepared but rain delayed geomembrane deployment

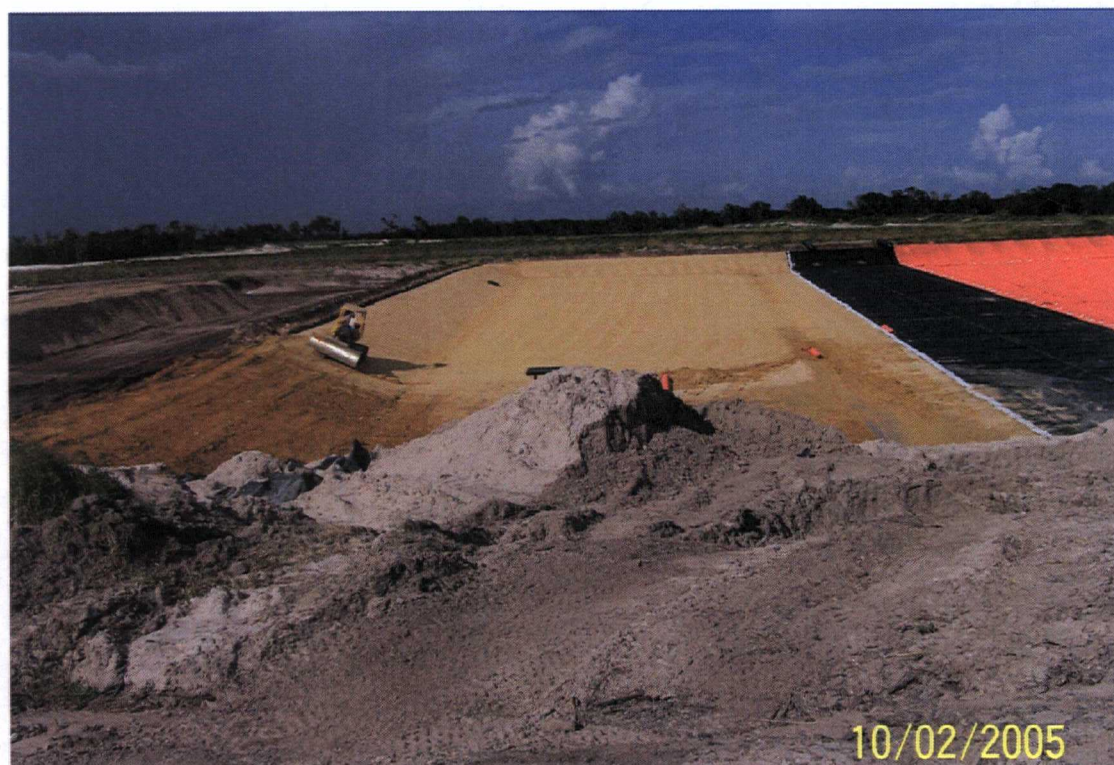
Attachment 7 – Subgrade reworked prior to geomembrane deployed
