**HILLSBOROUGH COUNTY
SOUTHEAST COUNTY LANDFILL
CAPACITY EXPANSION, SECTION 8
CERTIFICATION OF CONSTRUCTION
COMPLETION REPORT
RESPONSE TO DEP REQUEST FOR
ADDITIONAL INFORMATION**

Permit #35453-009-SC

Subject: Response to Request for Additional Information
Southeast County Landfill, Hillsborough County
Capacity Expansion Section 8
Certification of Construction Completion
Permit No. 35453-009-SC
Jones Edmunds Project No. 08449-020-01

**CERTIFICATION OF CONSTRUCTION
COMPLETION REPORT**

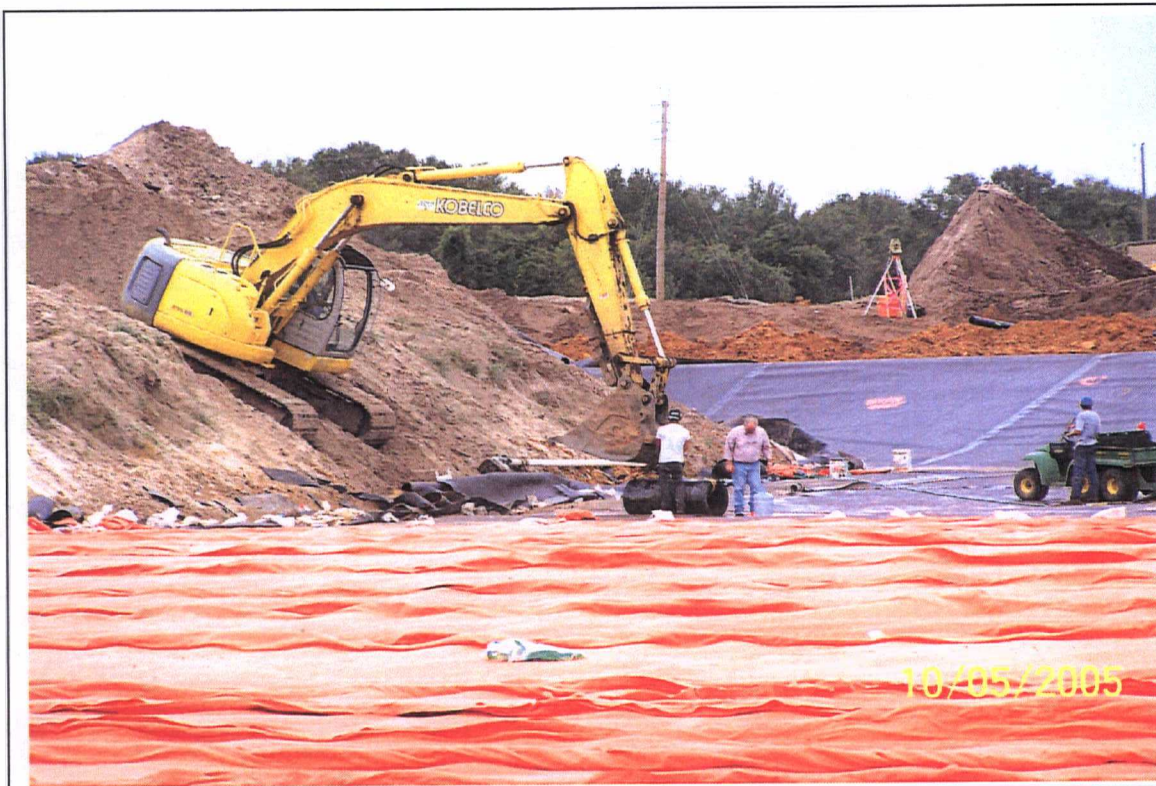
ATTACHMENT R3.c.1
PHOTOGRAPH OF HDPE PIPE

Response 3.c.1): A large-diameter HDPE pipe was used to smooth out grades near the area where the HDPE leachate collection pipe transitioned to meet/match the existing Section 7 leachate collection pipe. Some high points were observed in limited small areas. However, rather than excavate the area and potentially mix subgrade and subbase soils together, the HDPE was used to smooth or "depress" the high point. The pipe used for smoothing out the grade was discarded and not used in the project. A photograph showing the use of the HDPE pipe for smoothing out the grade is included in Attachment R3.c.1.

Response 3.c.1, 10/05/2005 – Southeast County Landfill, Section 8 Capacity Expansion, Hillsborough County, Florida
Use of scrap HDPE pipe to smooth grades.

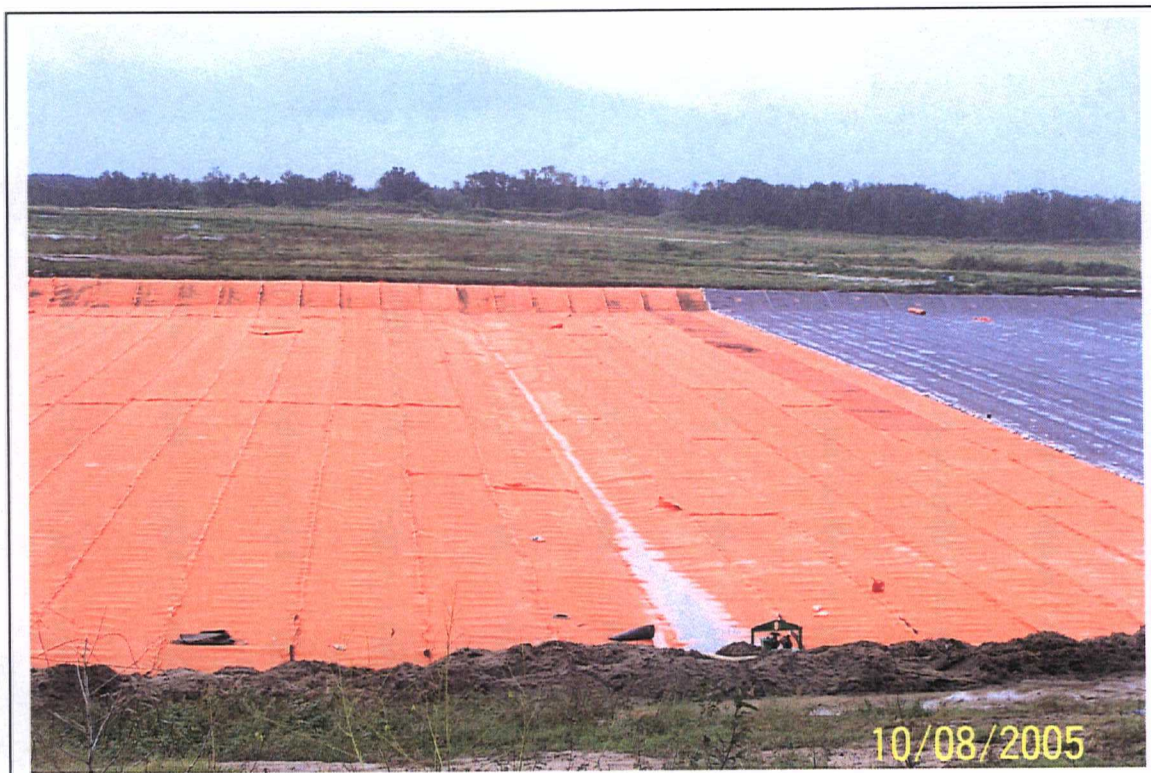
ATTACHMENT R3.c.2
PHOTOGRAPH OF WET DRAINAGE

Response 3.c.2, 10/08/2005 – Southeast County Landfill, Section 8 Capacity Expansion, Hillsborough County, Florida
“Wet Drainage” on top of geocomposite.

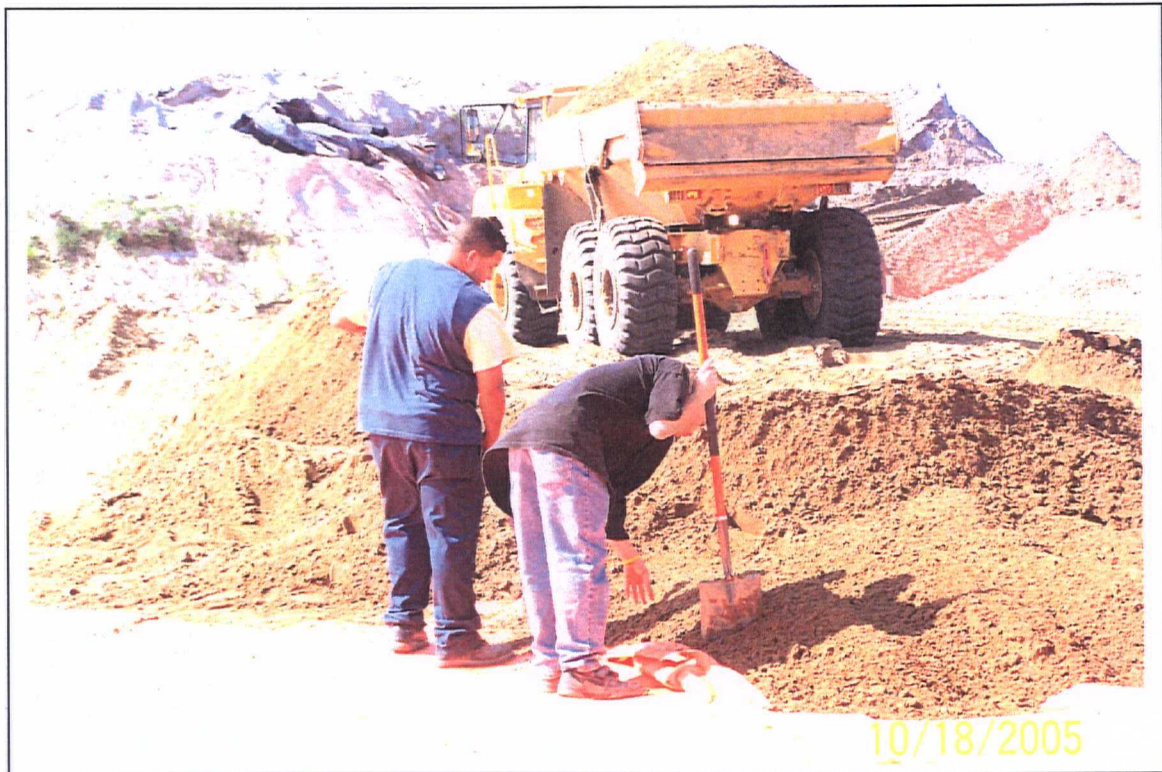
ATTACHMENT R3.c.3
PHOTOGRAPH OF SMALL ROCKS AND STICKS

Response 3.c.3): Small amounts of debris (e.g., sticks and rocks) were sometimes observed in the protective cover soil. The placement of the protective cover soil was closely monitored for such type of "debris" and if observed, was removed from the soil by hand. A photograph showing the small rocks and sticks is included in Attachment R3.c.3.

Response 3.c.3, 10/18/2005 – Southeast County Landfill, Section 8 Capacity Expansion, Hillsborough County, Florida
Workers picking out small amounts of debris from protective cover soil.

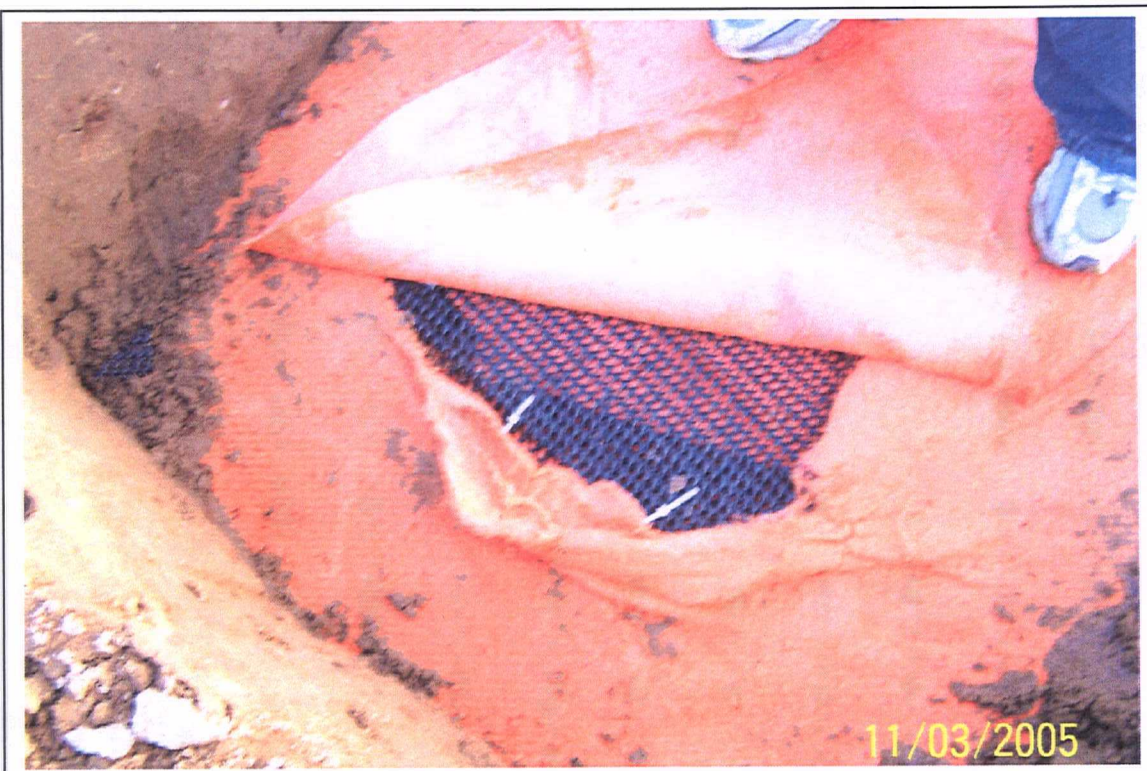
ATTACHMENT R3.c.4
REVISED PANEL LAYOUT DRAWING AND
PHOTOGRAPHS

indicate where the dozer hit the geocomposite (middle of Panel 48, approximately 160 feet south of the anchor trench, as shown in Attachment R3.c.4). The geocomposite was lifted off the geomembrane and the geomembrane was inspected for damage. No damage to the geomembrane was observed. The geocomposite was repaired. Photographs of the damaged geocomposite are included in Attachment R3.c.4.

Response 3.c.4, 11/03/2005 – Southeast County Landfill, Section 8 Capacity Expansion, Hillsborough County, Florida
Damage to the geocomposite which was later repaired.

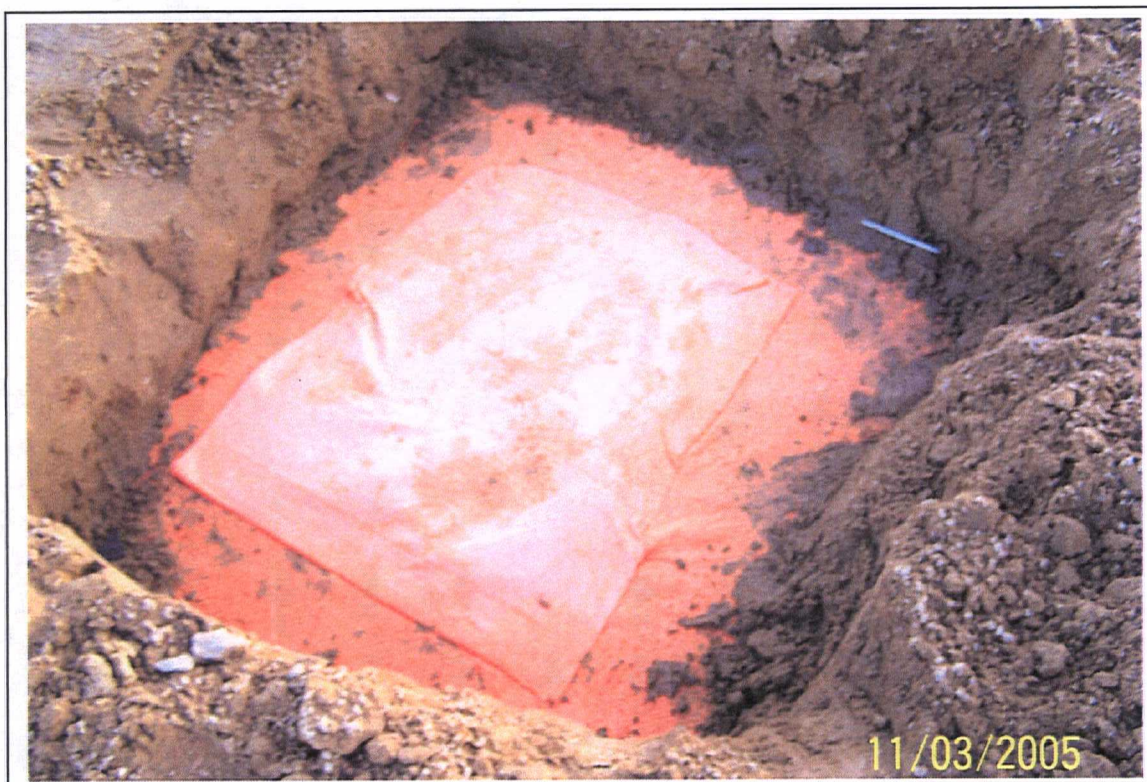
Response 3.c.4, 11/03/2005 – Southeast County Landfill, Section 8 Capacity Expansion, Hillsborough County, Florida
Repaired geocomposite.

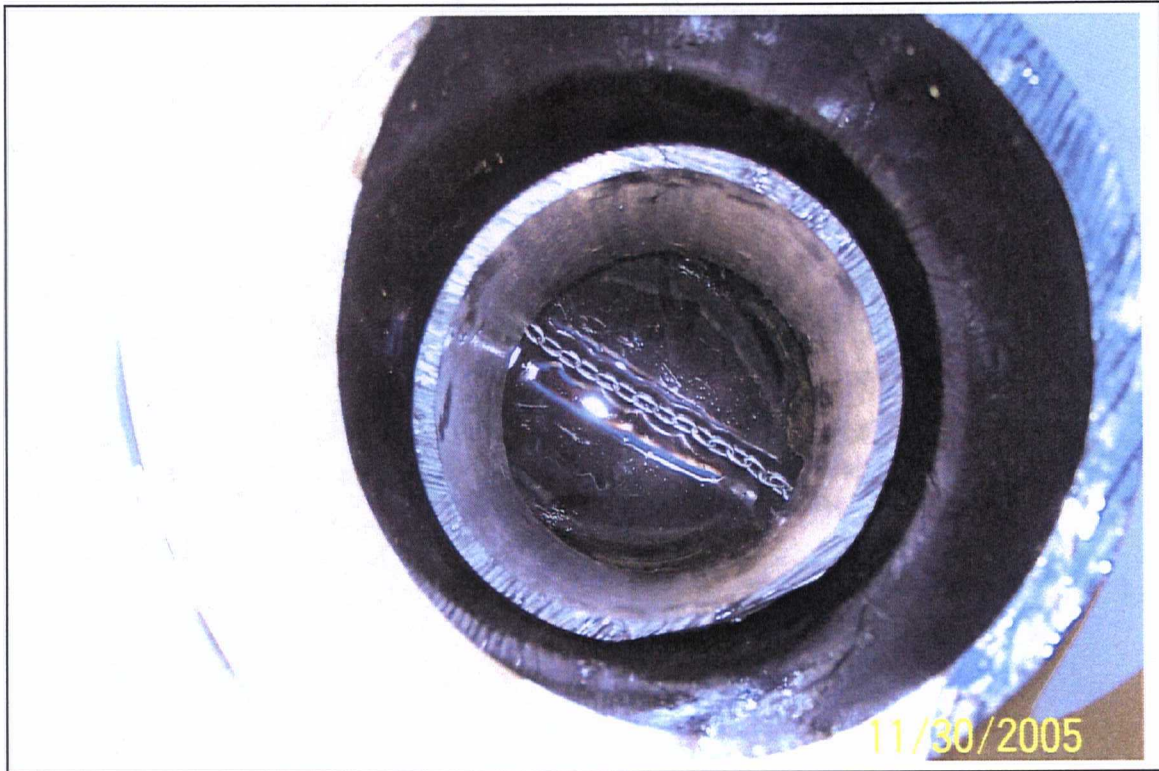
ATTACHMENT R3.c.9
PHOTOGRAPH OF BALL PLUG VALVE

Response 3.c.9): The use of a pneumatic ball plug requires that the plug be re-inflated at times to provide an adequate seal. However, when the plug slightly deflates, leakage may occur until the plug is re-inflated. Leakage occurred at times at all three locations where the new HDPE leachate collection piping was connected to the existing Section 7 leachate collection piping along the south area of Section 8. A photograph of the tee and ball plug valve is included in Attachment R3.c.9.

Response 3.c.9, 11/30/2005 – Southeast County Landfill, Section 8 Capacity Expansion, Hillsborough County, Florida
Water leaking through ball plug valve.

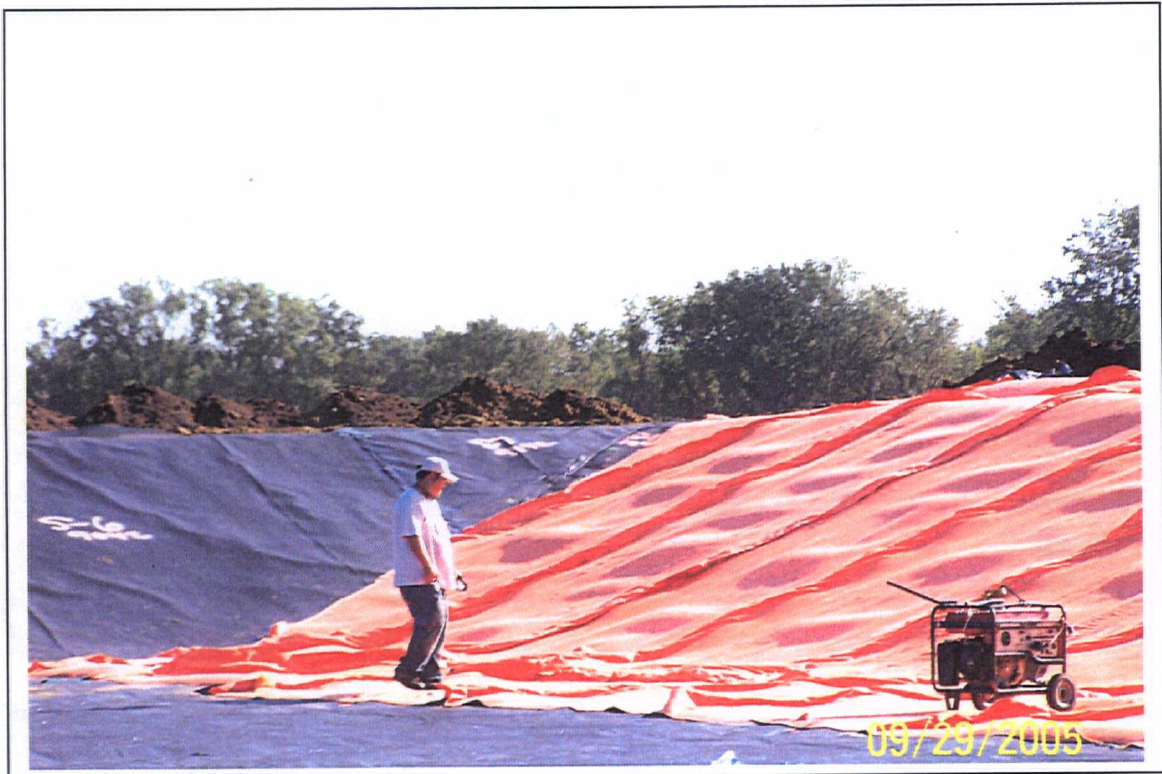
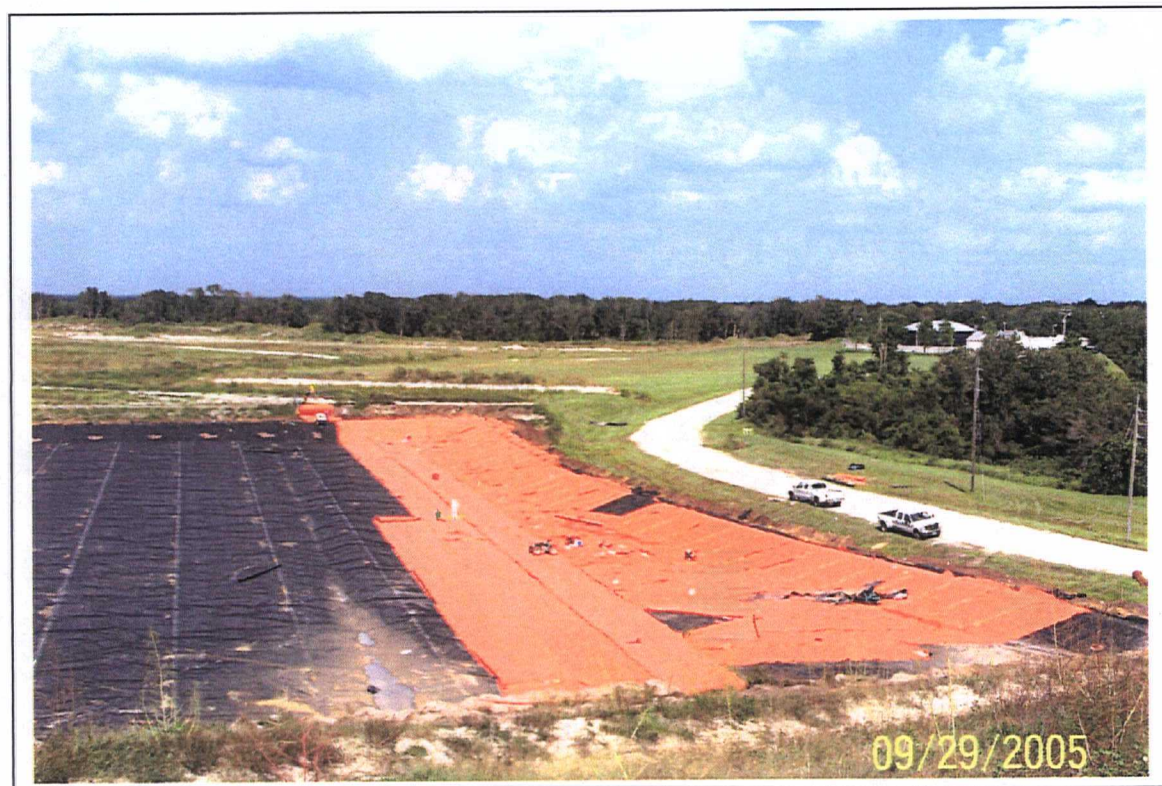
ATTACHMENT R11.a
PHOTOGRAPHS OF SECONDARY GEOCOMPOSITE

Response 11.a, 09/29/2005 – Southeast County Landfill, Section 8 Capacity Expansion, Hillsborough County, Florida
Installation of secondary geocomposite.

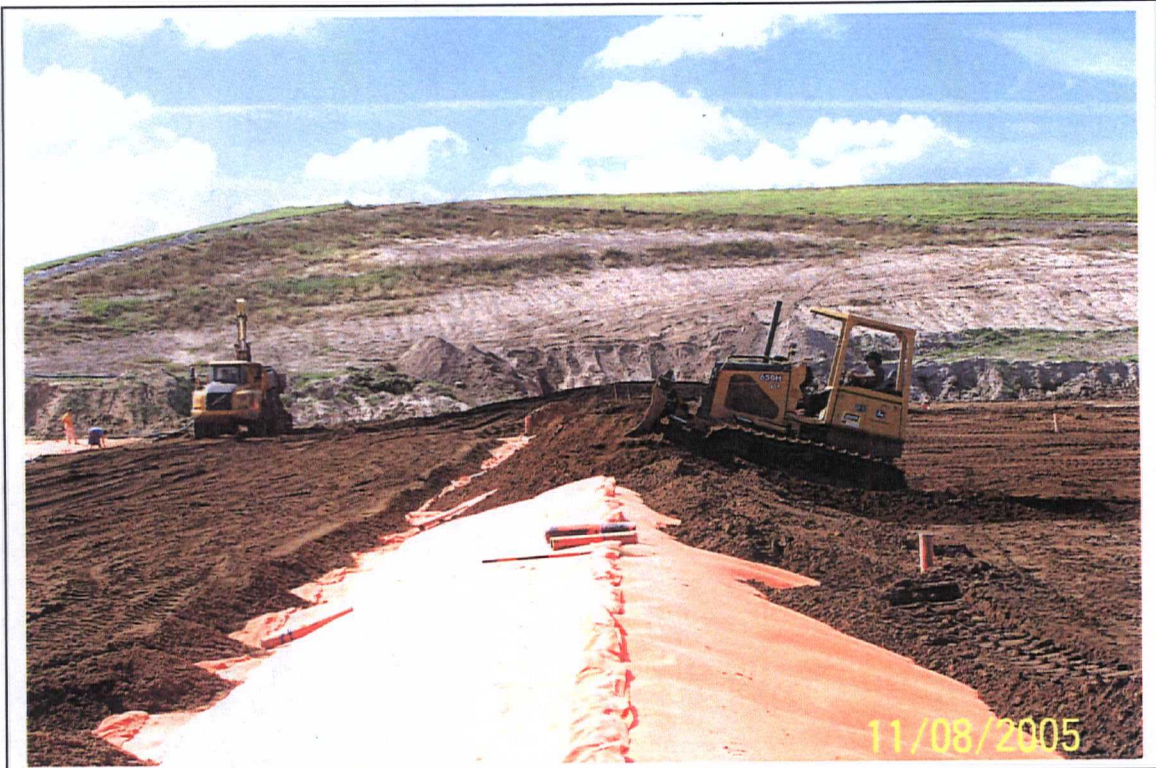
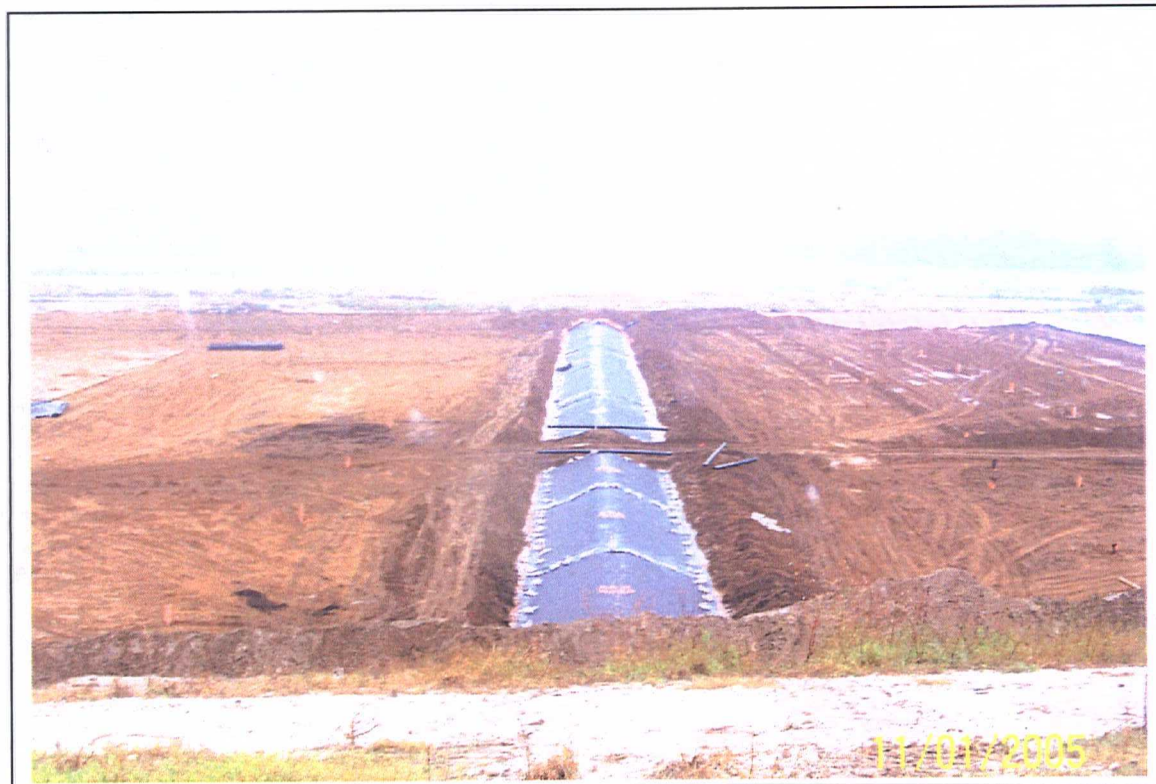
ATTACHMENT R13
PHOTOGRAPHS OF SEPARATION BERMS

Response 13, 11/08/2005 – Southeast County Landfill, Section 8 Capacity Expansion, Hillsborough County, Florida
Installation of separation berms.

Response 13, 11/01/2005 – Southeast County Landfill, Section 8 Capacity Expansion, Hillsborough County, Florida
Installation of separation berms.

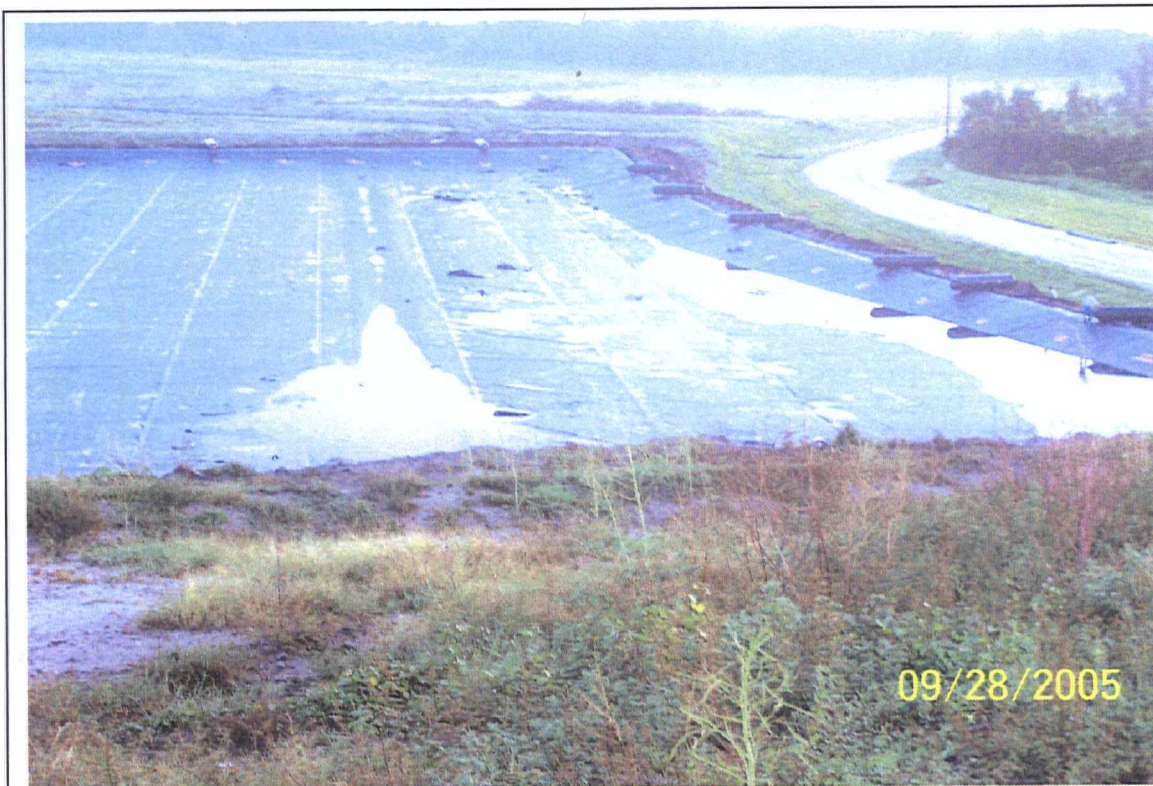
Response 21.a.8, 9/28/2005 – Southeast County Landfill, Section 8 Capacity Expansion, Hillsborough County, Florida
Stormwater on liner after storm event.

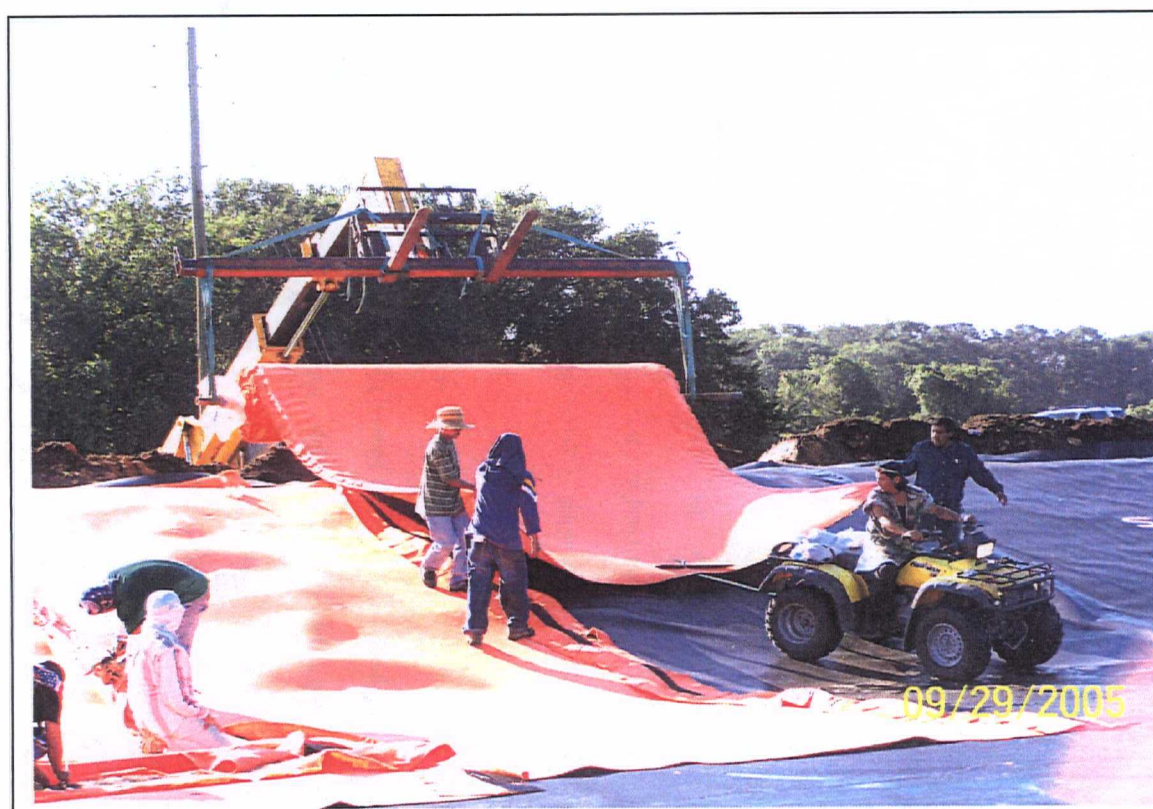
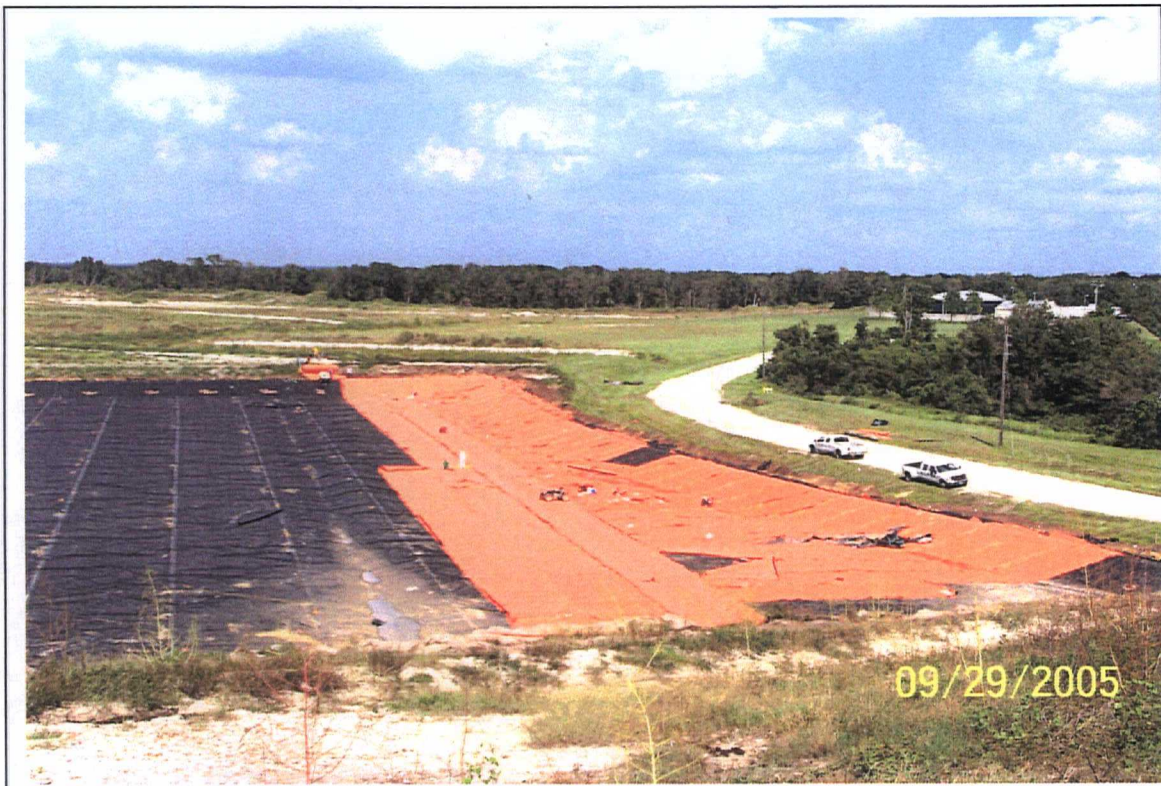
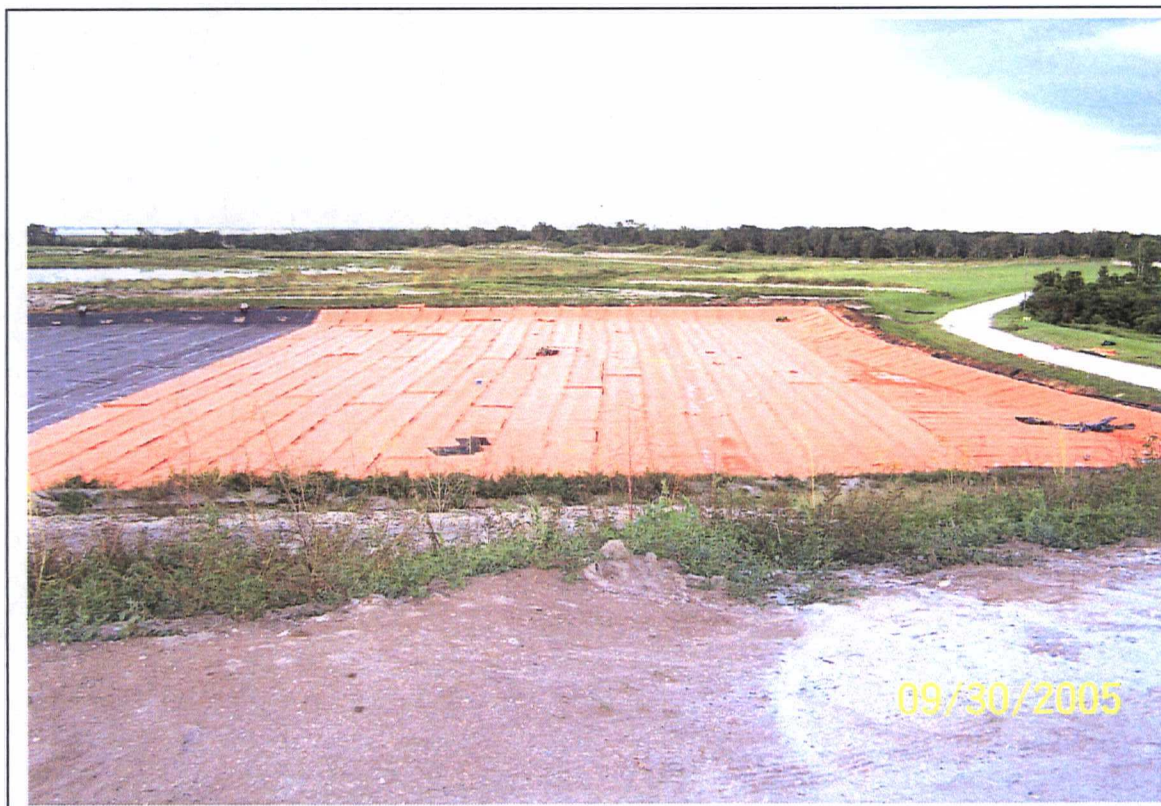
ATTACHMENT R21.A.8
PHOTOGRAPHS FOR 9/28/05 THROUGH 9/30/05

Response 21.a.8, 9/29/2005 – Southeast County Landfill, Section 8 Capacity Expansion, Hillsborough County, Florida
Deployment of secondary geocomposite.

Response 21.a.8, 9/29/2005 – Southeast County Landfill, Section 8 Capacity Expansion, Hillsborough County, Florida
Secondary geomembrane and geocomposite along east area of cell.

Response 21.a.8, 9/30/2005 – Southeast County Landfill, Section 8 Capacity Expansion, Hillsborough County, Florida
Secondary geocomposite.
