**HILLSBOROUGH COUNTY
SOUTHEAST COUNTY LANDFILL
CAPACITY EXPANSION, SECTION 8
CERTIFICATION OF CONSTRUCTION
COMPLETION REPORT
RESPONSE TO DEP REQUEST FOR
ADDITIONAL INFORMATION**

Permit #35453-009-SC

Subject: Response to Request for Additional Information
Southeast County Landfill, Hillsborough County
Capacity Expansion Section 8
Certification of Construction Completion
Permit No. 35453-009-SC
Jones Edmunds Project No. 08449-020-01

**CERTIFICATION OF CONSTRUCTION
COMPLETION REPORT**

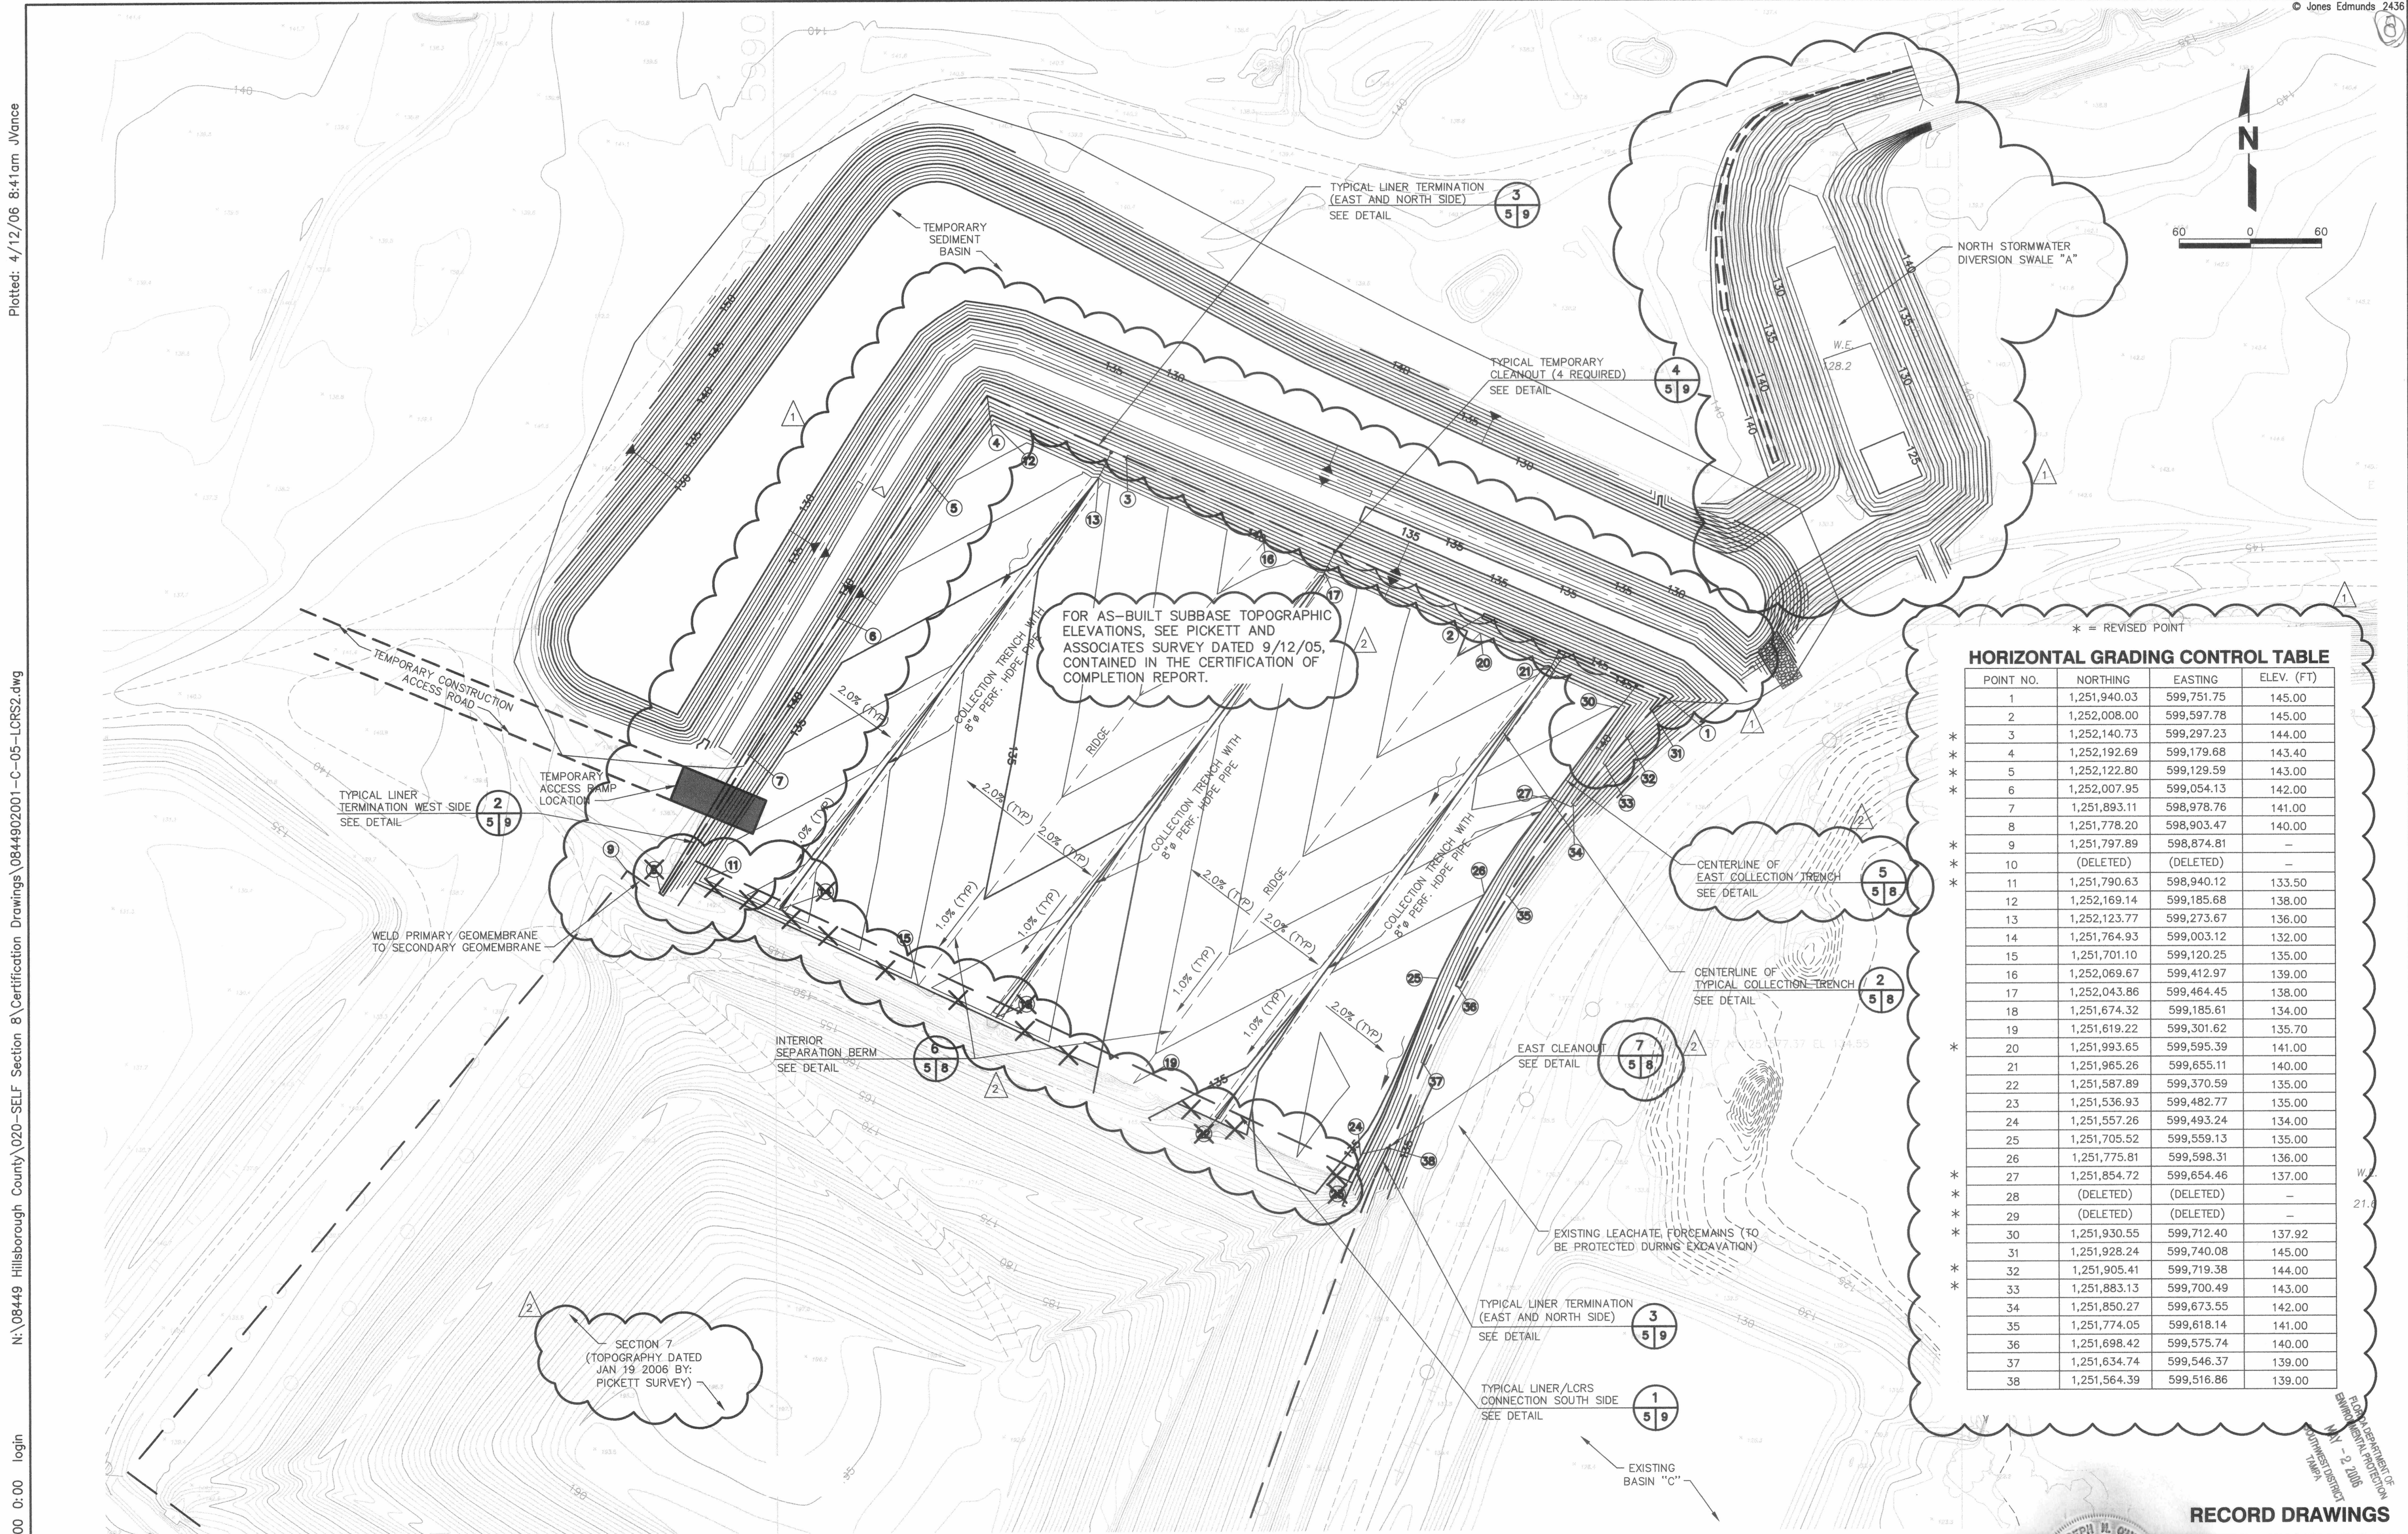
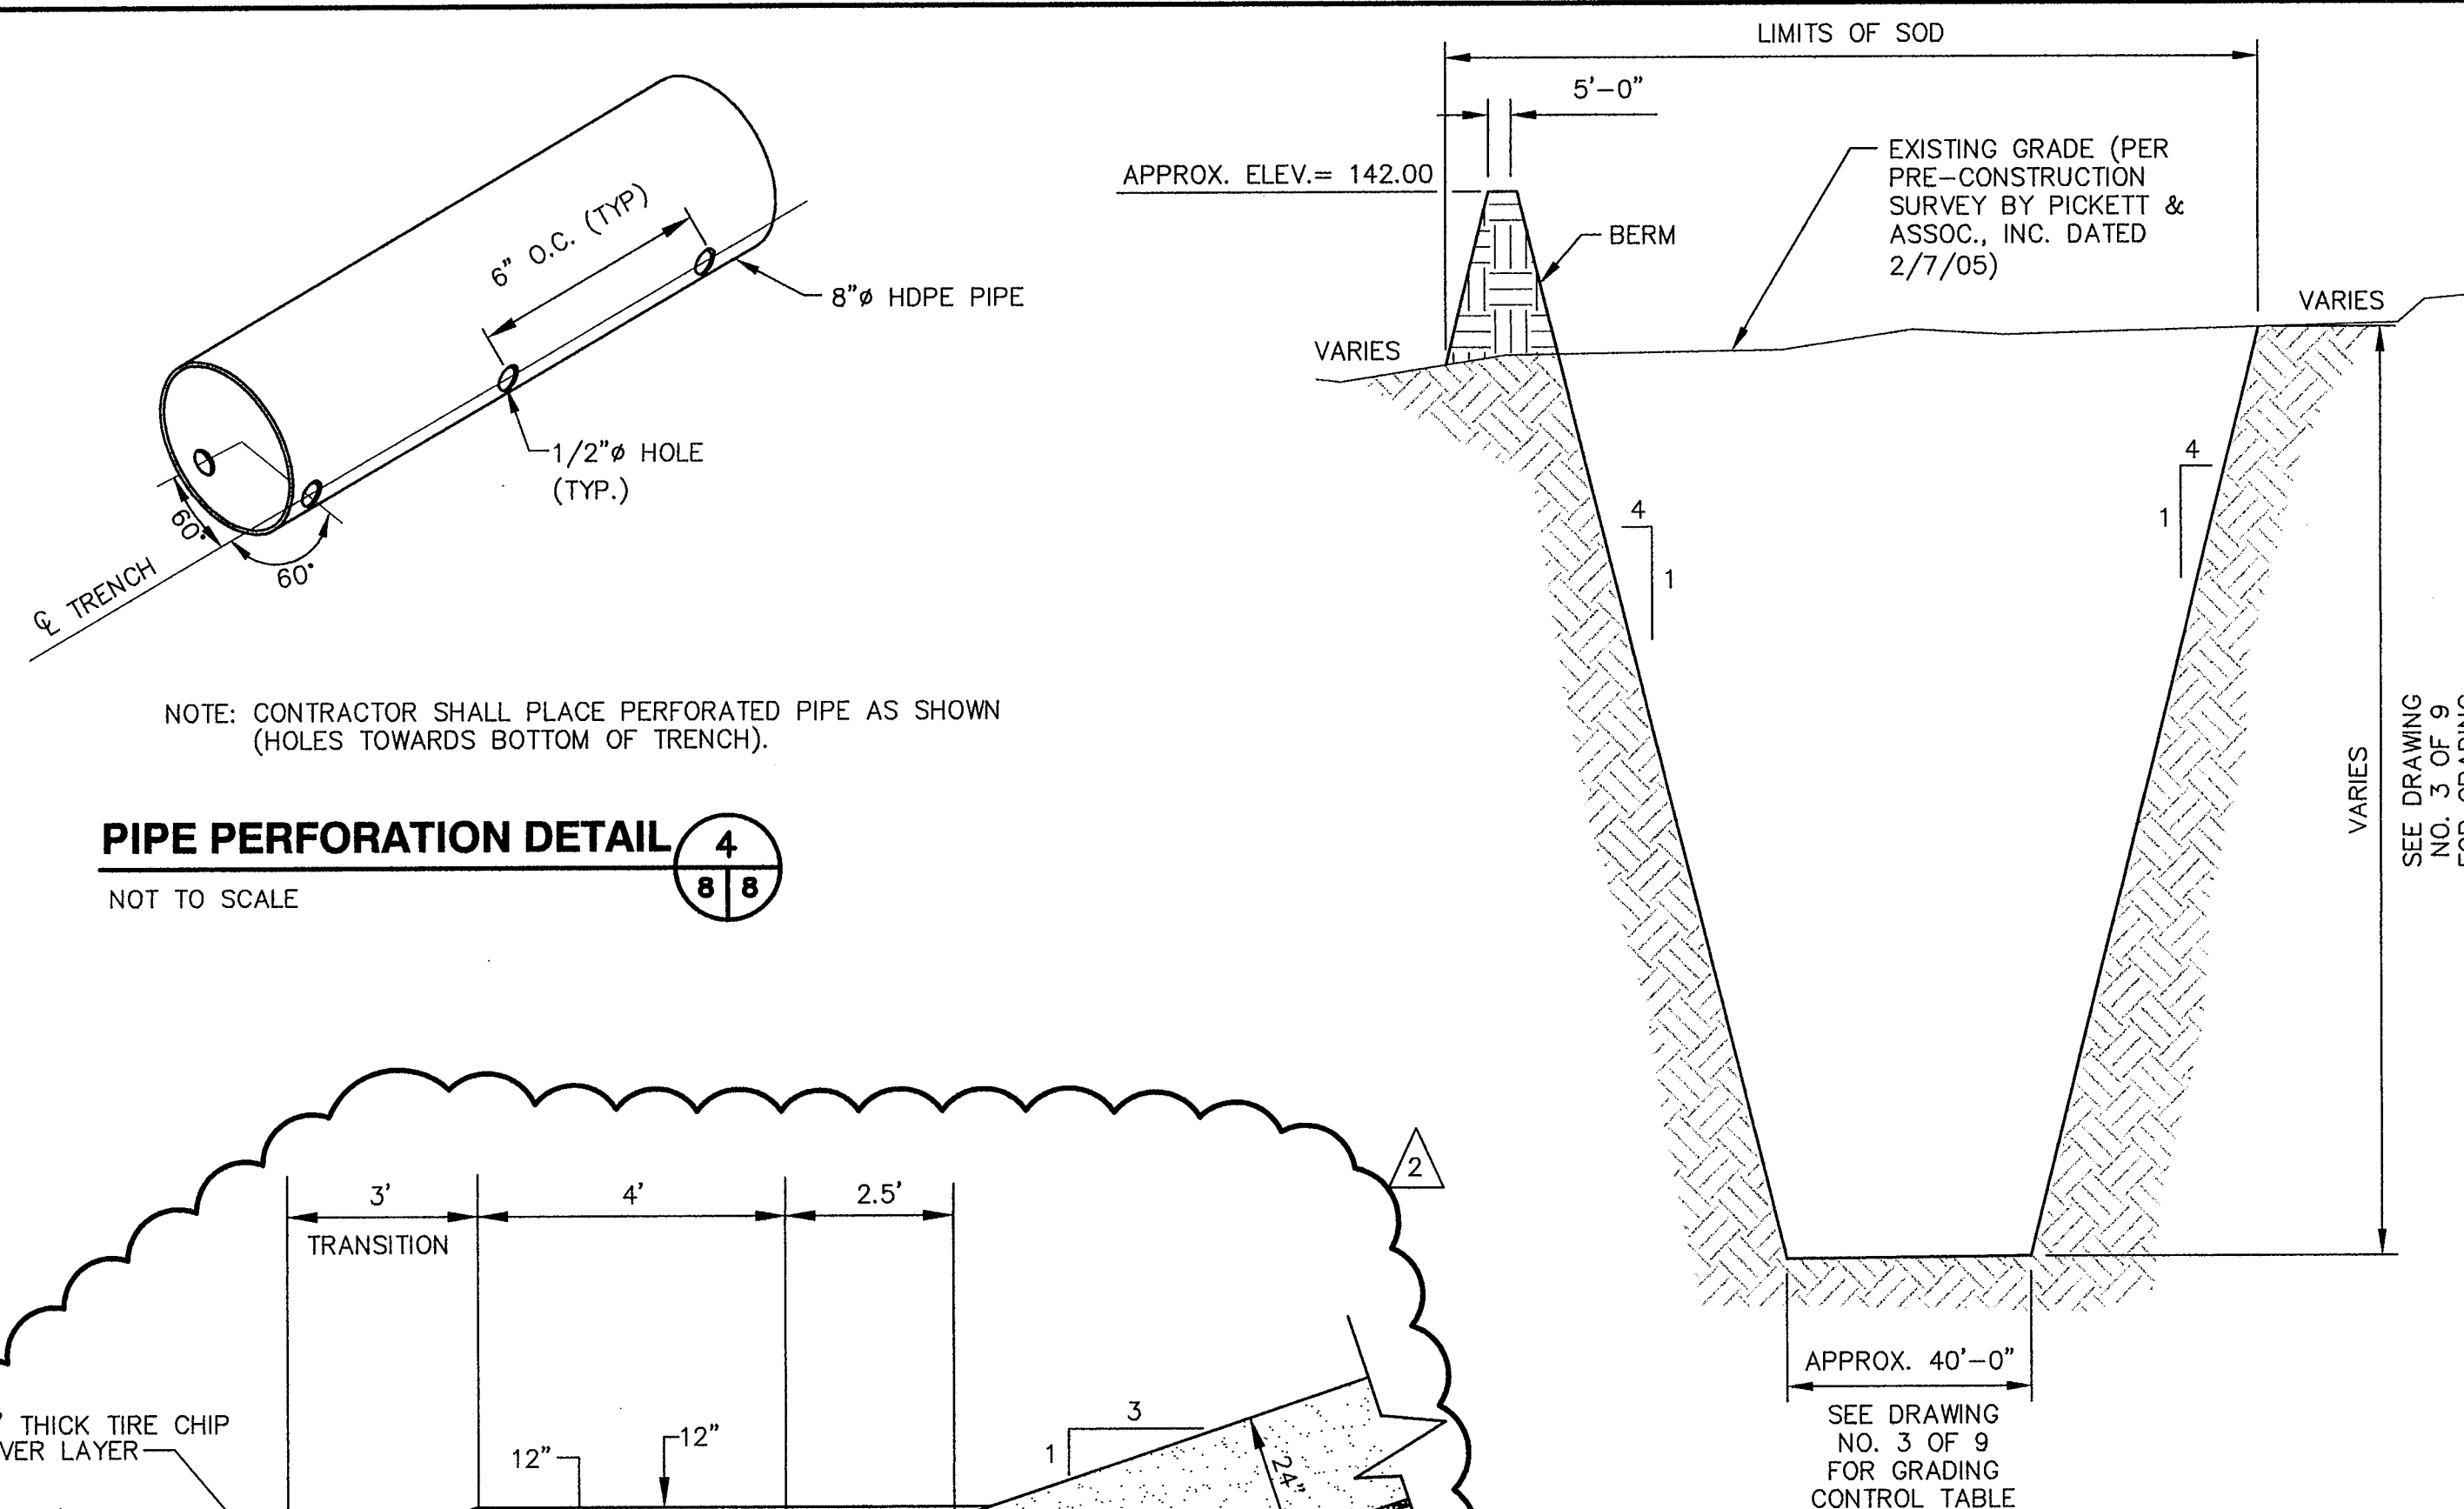
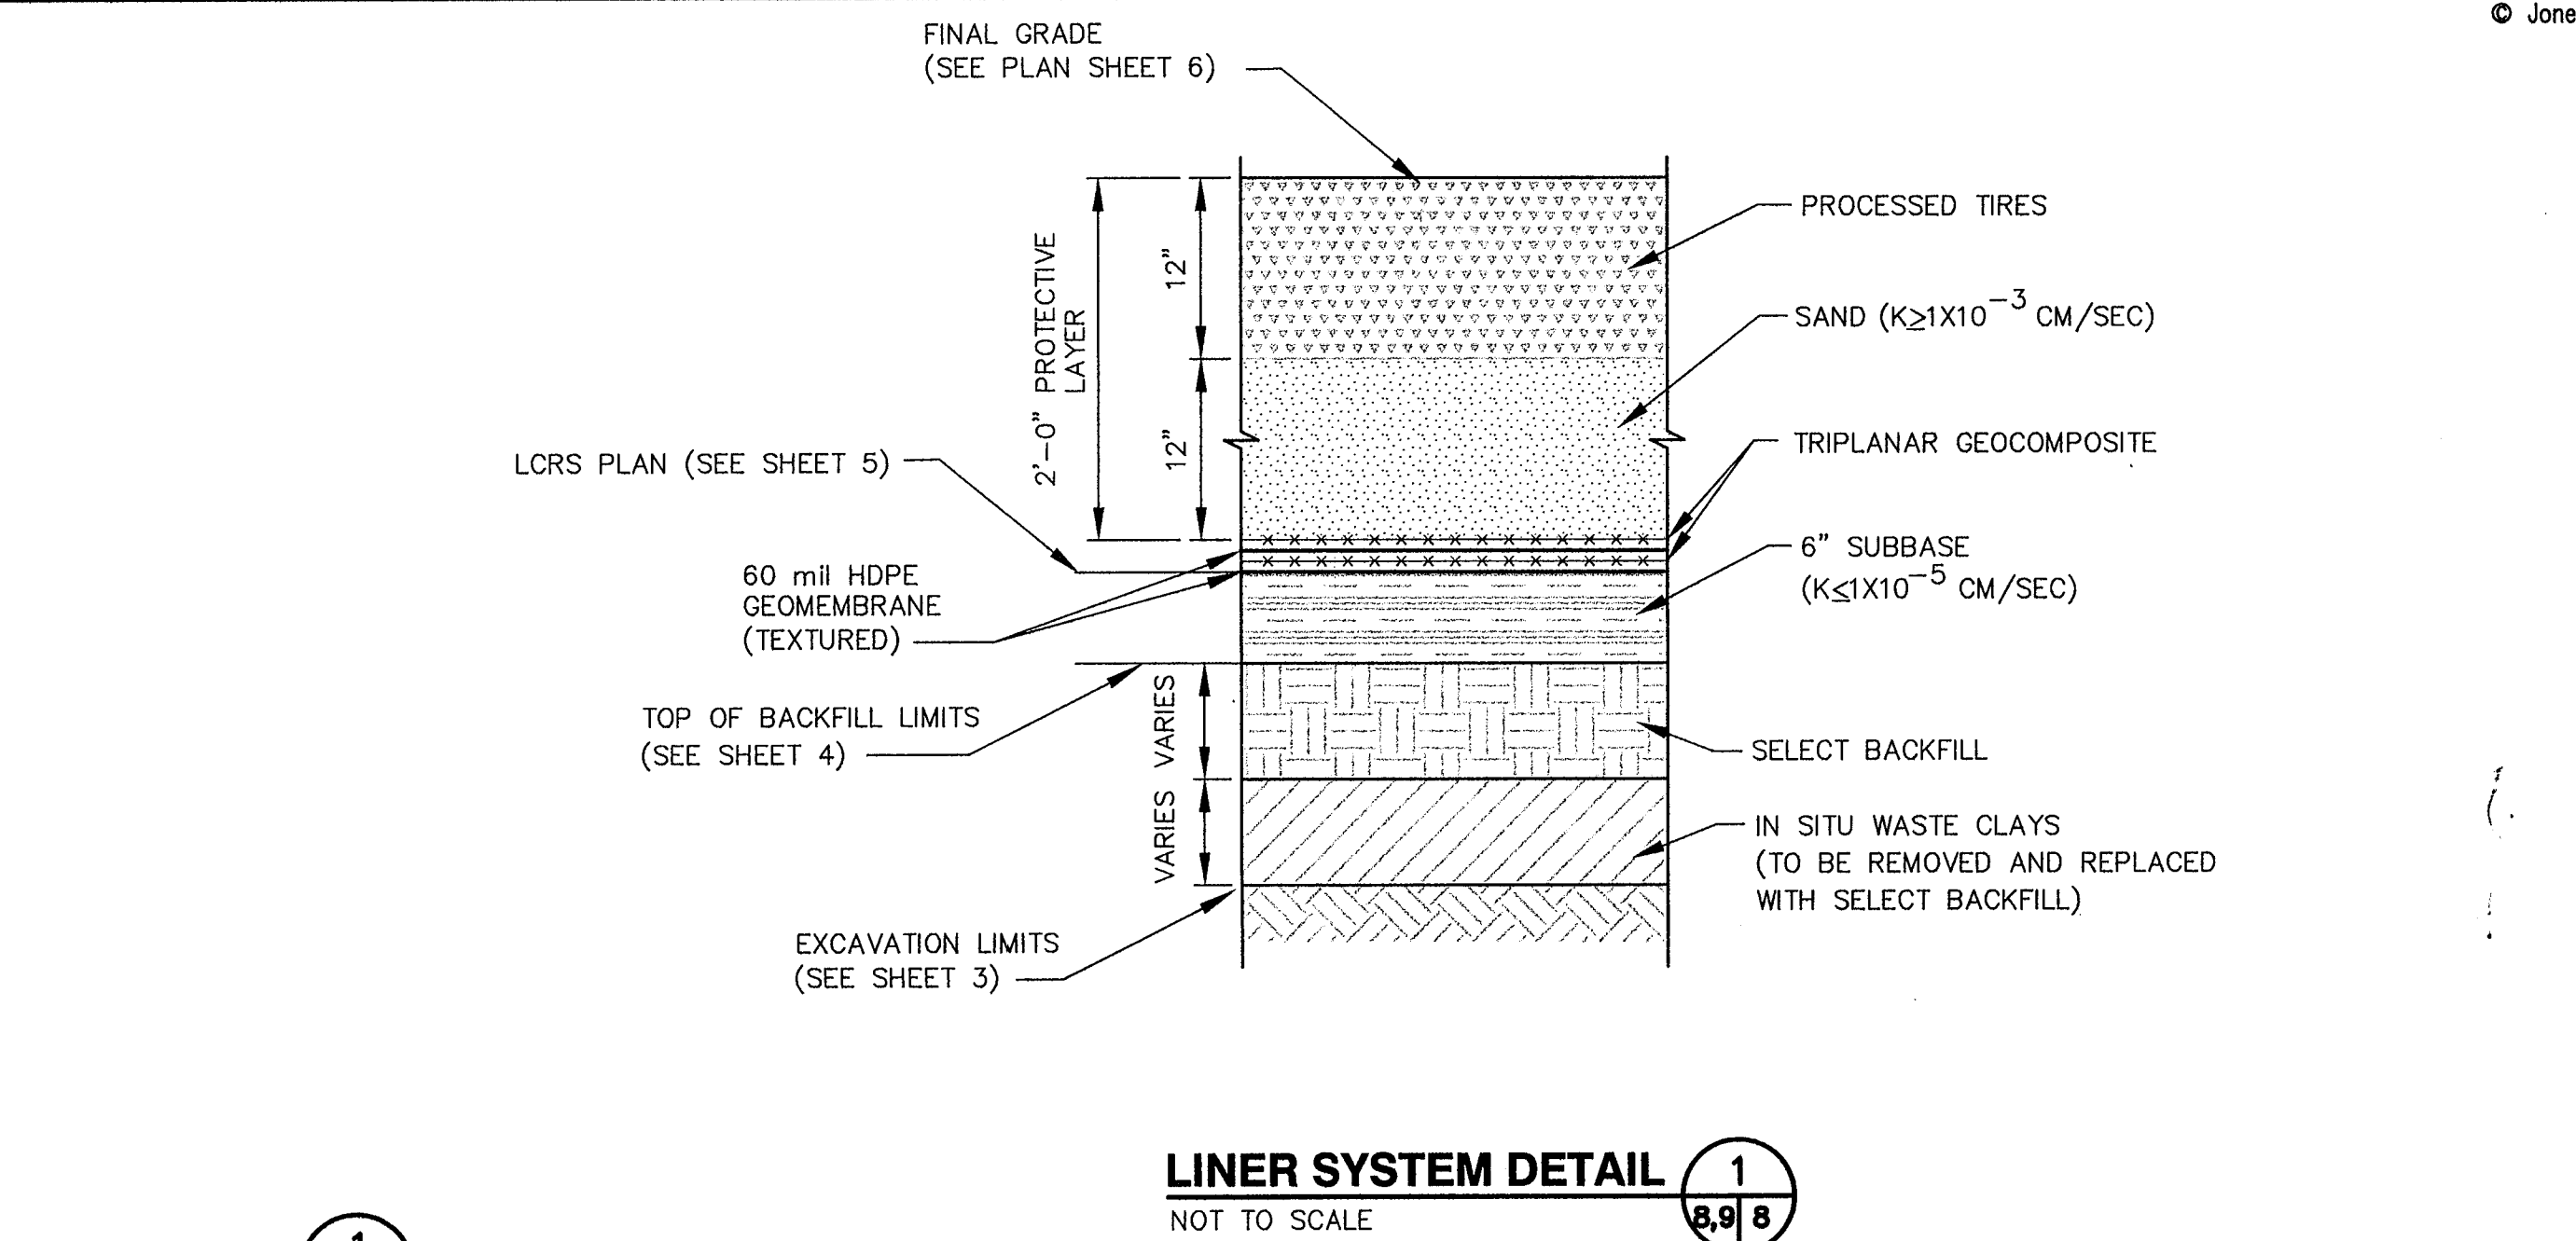
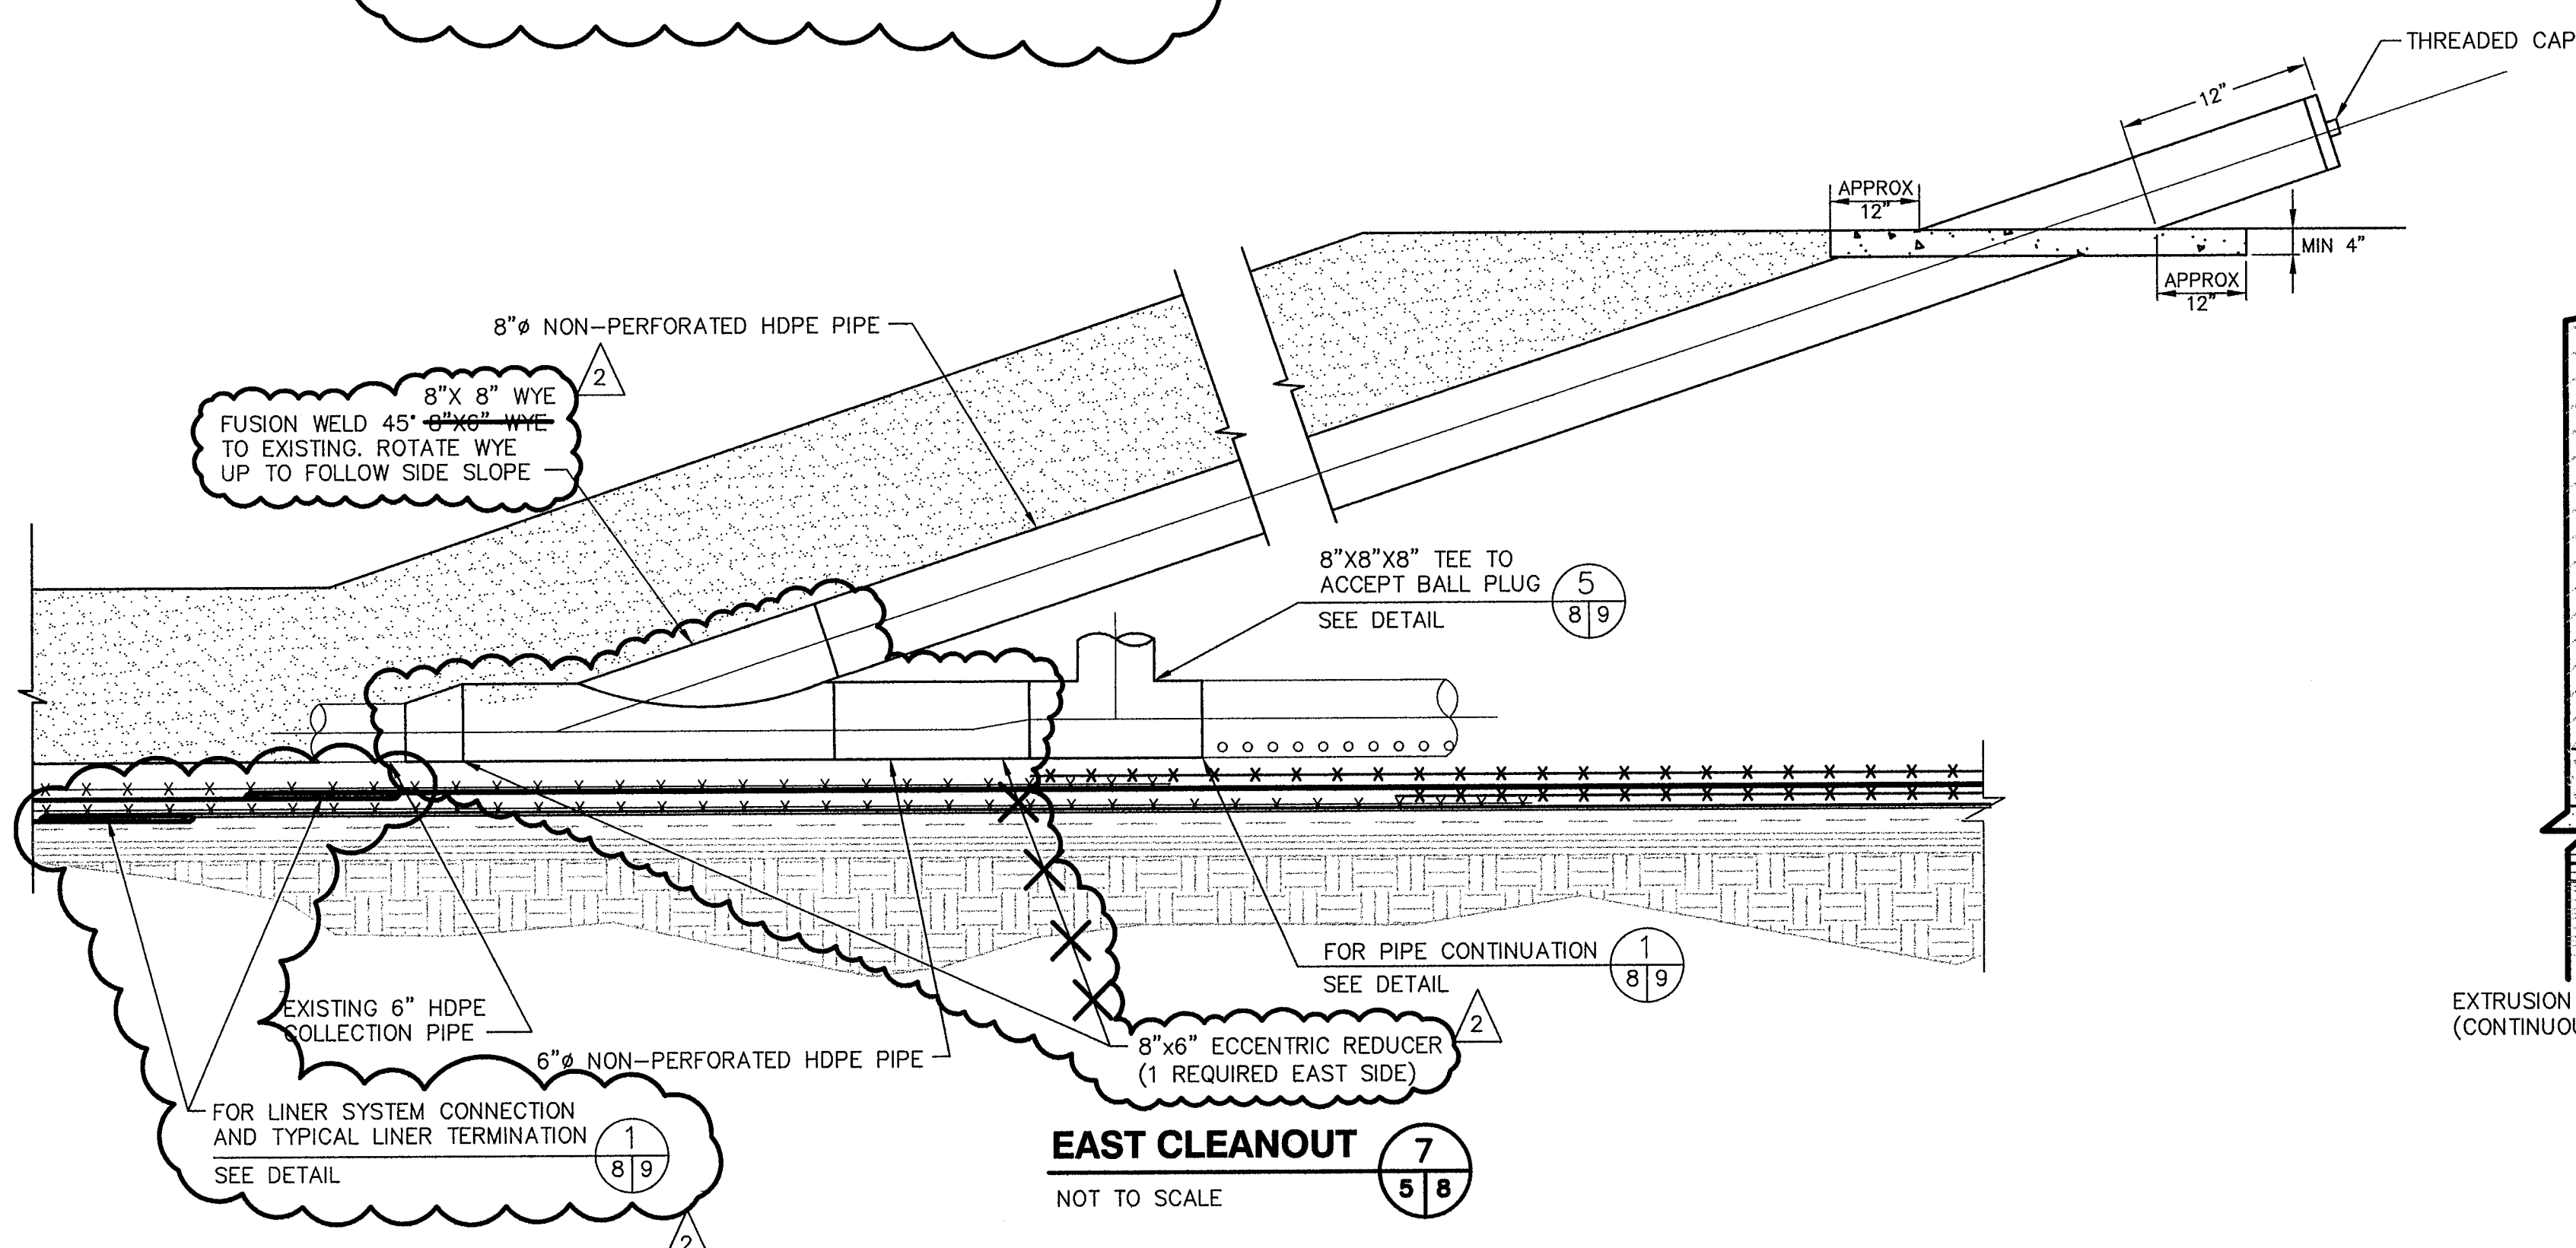
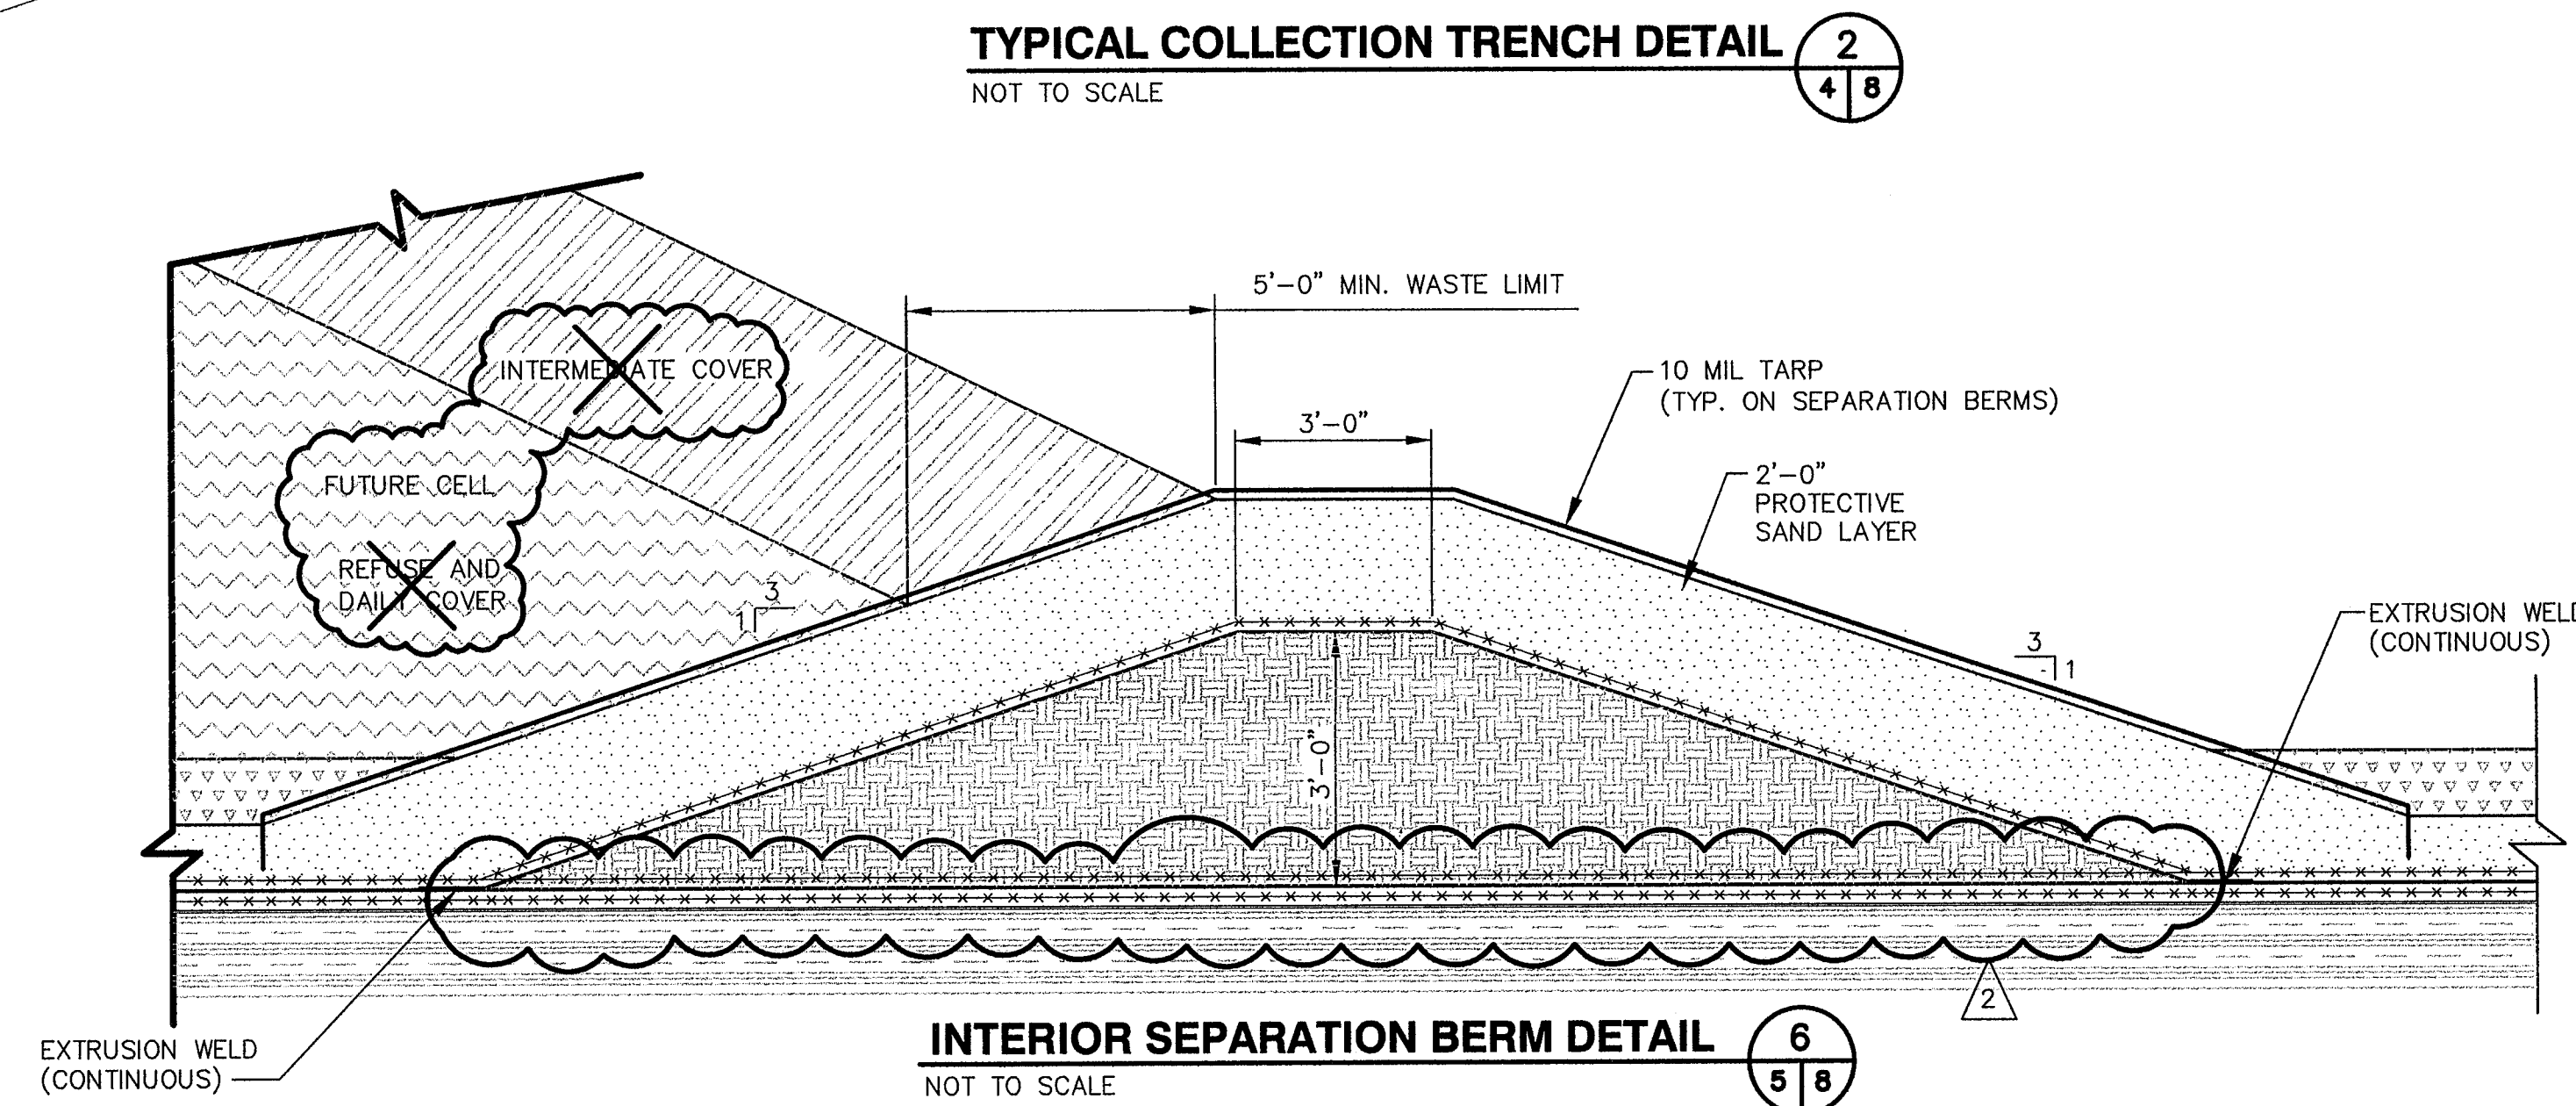
ATTACHMENT R26
REVISED DRAWINGS – SHEETS 5 AND 8

LTR.	DATE	REVISIONS	BY	APPRD.
1	2/28/06	SCS REVISIONS - NORTH SWALE MODIFIED		
2	2/28/06	EAST COLLECTION TRENCH DETAIL ADDED;		
		ADDITIONAL ROCK PLACED OVER PIPES;	JHV	JHO
		8x8 WYE ADDED; GEOCOMPOSITE ADDED
