LEACHATE TREATMENT
and
RECLAMATION
FACILITY TANK ASSESSMENT

HILLSBOROUGH COUNTY
SOUTHEAST COUNTY LANDFILL

**TANK ASSESSMENT INSPECTION REPORT
LEACHATE TREATMENT AND RECLAMATION FACILITY
SOUTHEAST COUNTY LANDFILL
HILLSBOROUGH COUNTY, FLORIDA**

TANK ASSESSMENT INSPECTION REPORT

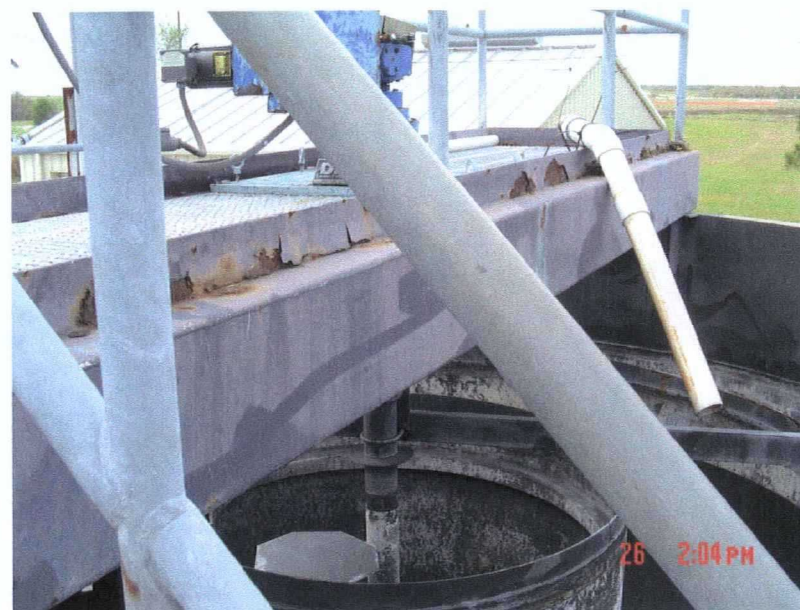
The coating in each of the compartments is in very good overall condition. Dry Film Thickness (DFT) measurements were taken and ranged from 15 to 30 mils. The coating on the interior of the First Stage Aeration Tank is peeling. The areas under the peeled coating still have 10-15 mils of coating on them. Apparently the peeling is caused by a failure of cohesion between coating layers. No corrosion was visible in the areas of peeled coatings. The coating in the other compartments is in very good condition. Minor coating peeling and corrosion were found on the side of the catwalk.

6. Catwalk side.

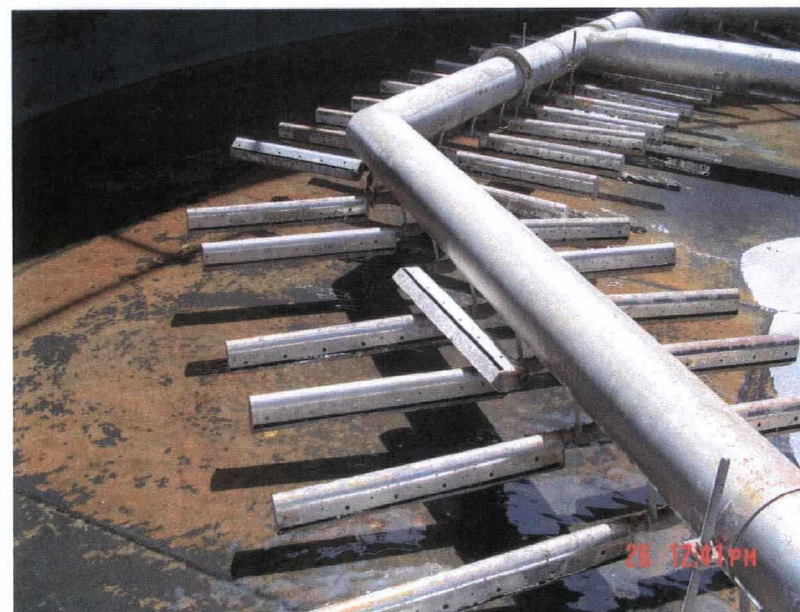
The stainless steel piping in three compartments was tested using a continuity tester. At the time of the inspection the piping was NOT isolated from the carbon steel tank.

8. Aerators.

1. Isolate the stainless steel piping from the carbon steel tank. We would suggest disassembling the pipe supports, cleaning the rubber and mounts, and carefully re-assembling. After assembly, re-check for isolation.

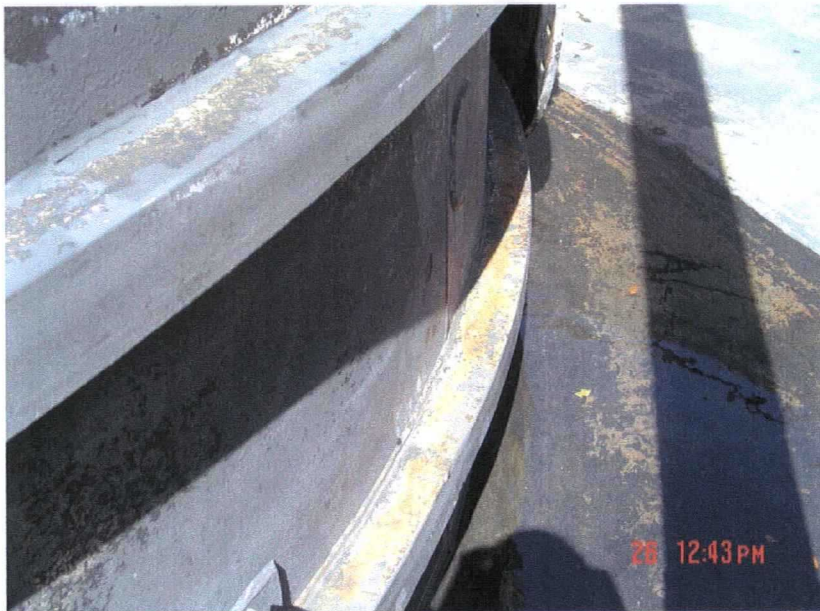
11. Stiffner corrosion in aeration section.

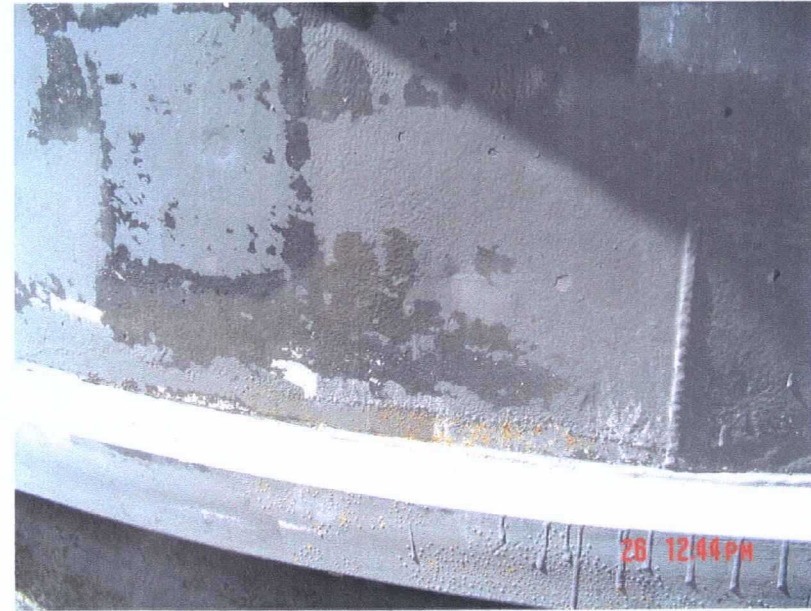
12. Wall corrosion in aeration section.

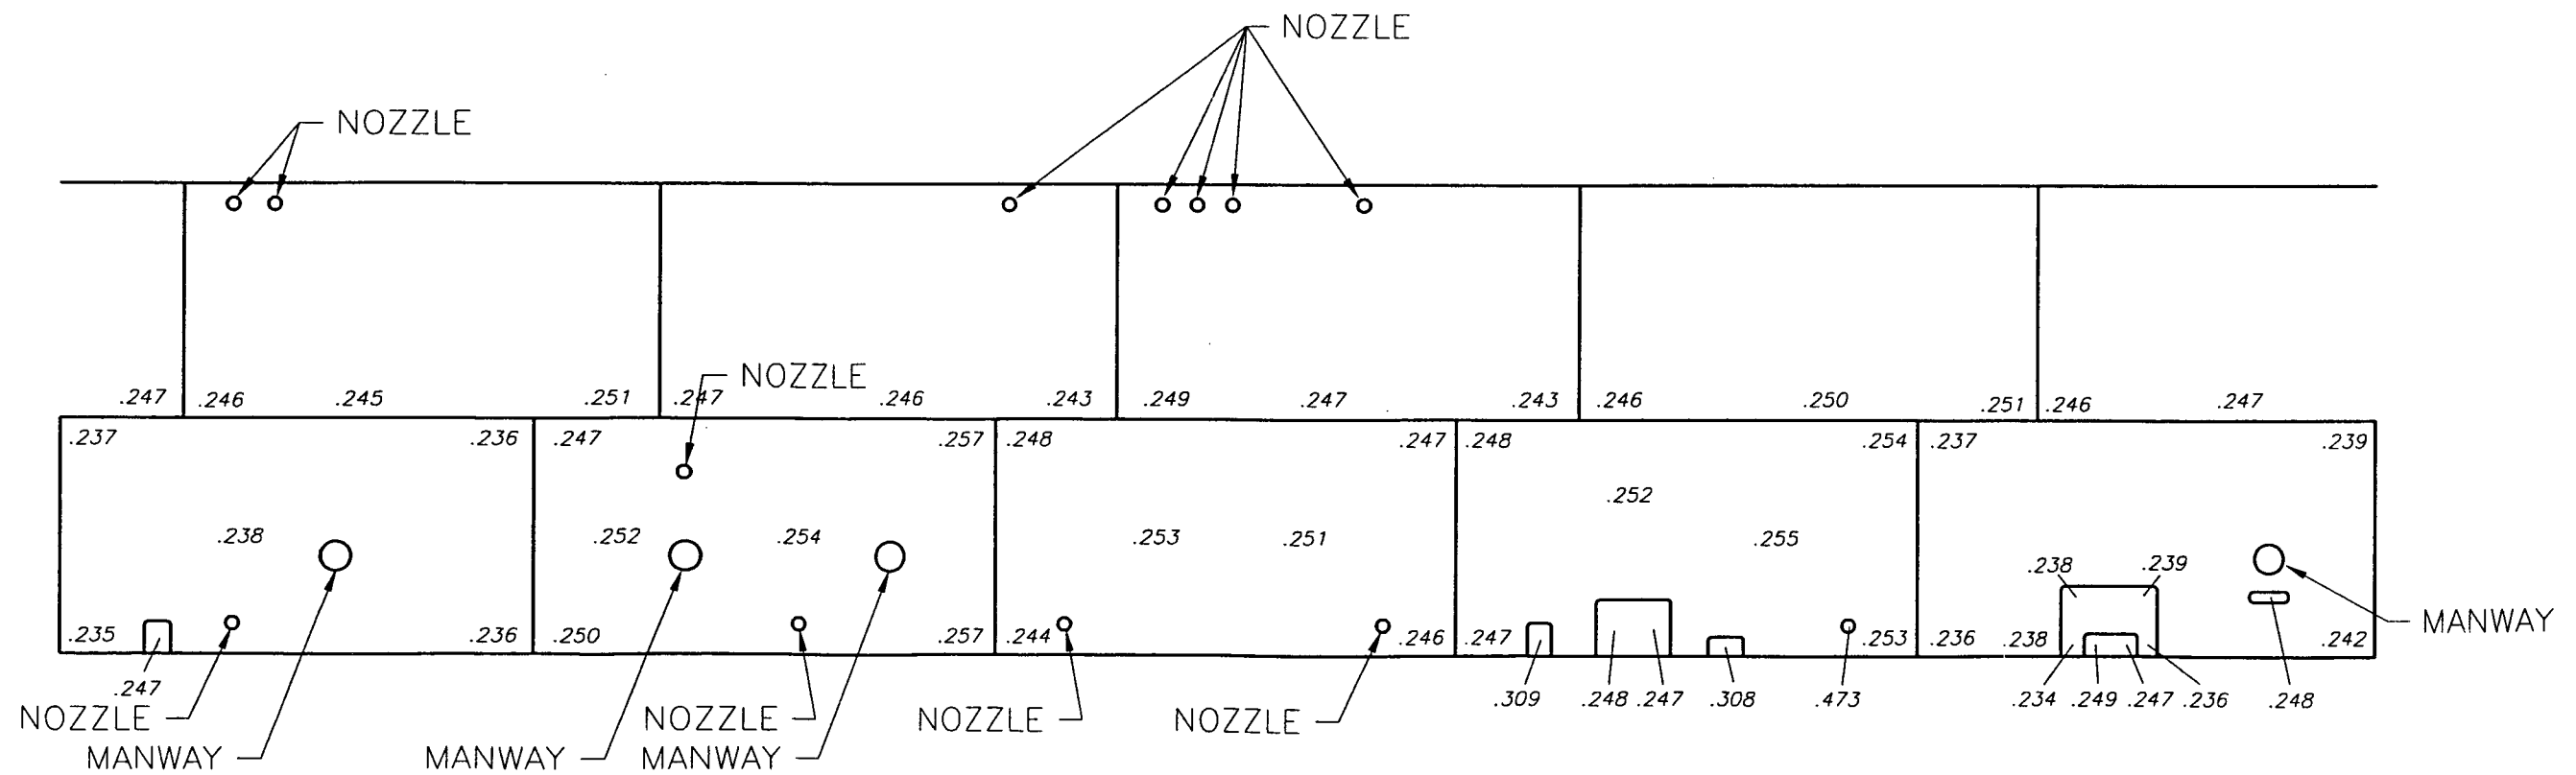
SHELL PLATE ROLLOUT
 HILLSBOROUGH COUNTY
 SOUTHEAST LANDFILL - PACT FACILITY

UTM readings on the exterior shell ranged from 0.235" to 0.257", which indicates a ¼" nominal plate thickness that is in good condition. Several lap welded patch plates have been installed on the tank shell, which were fabricated from ¼", 5/16", and ½" plate. UTM's on each of the patch plates indicated little or no metal loss.

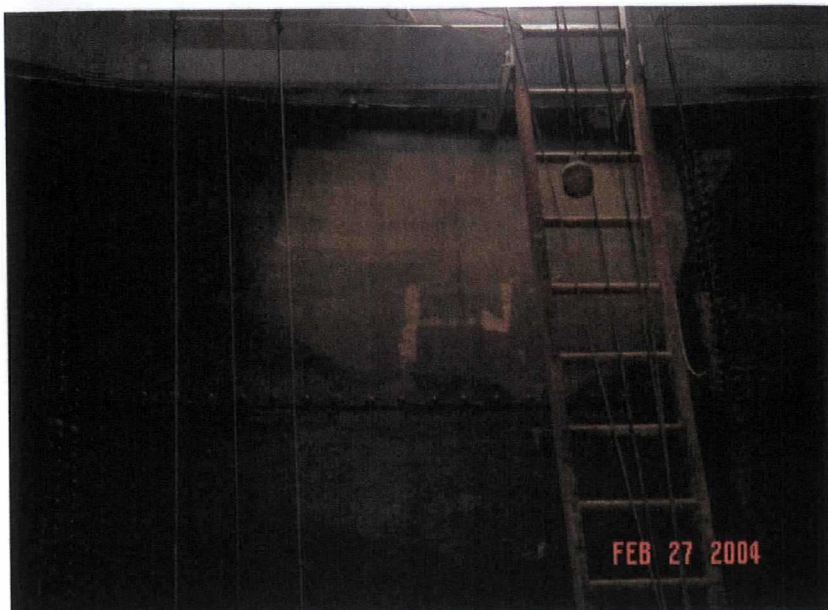
17. Interior ladder top.

1. Replace corroded bolts on interior ladder brackets.
2. Replace missing bolt caps on the interior of the tank and re-seal.
3. Replace guide arm on level indicator float.
4. Maintain proper settings and operation of the cathodic protection system.

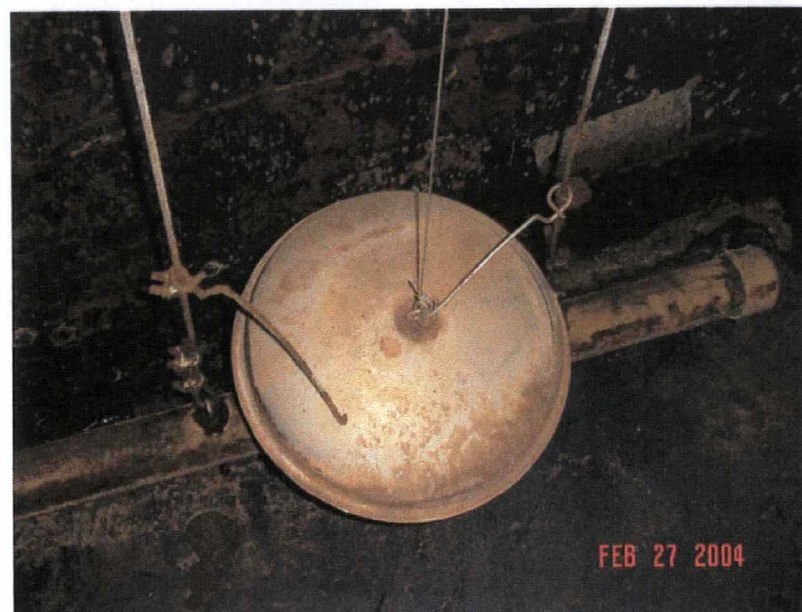
20. Liquid level indicator float.
