Leachate Collection and Removal System Effectiveness Evaluation

Pasco County Resource Recovery Facility

Report Assessing the Effectiveness of the Leachate Collection and Removal System at the Pasco County Resource Recovery Facility

June 2016

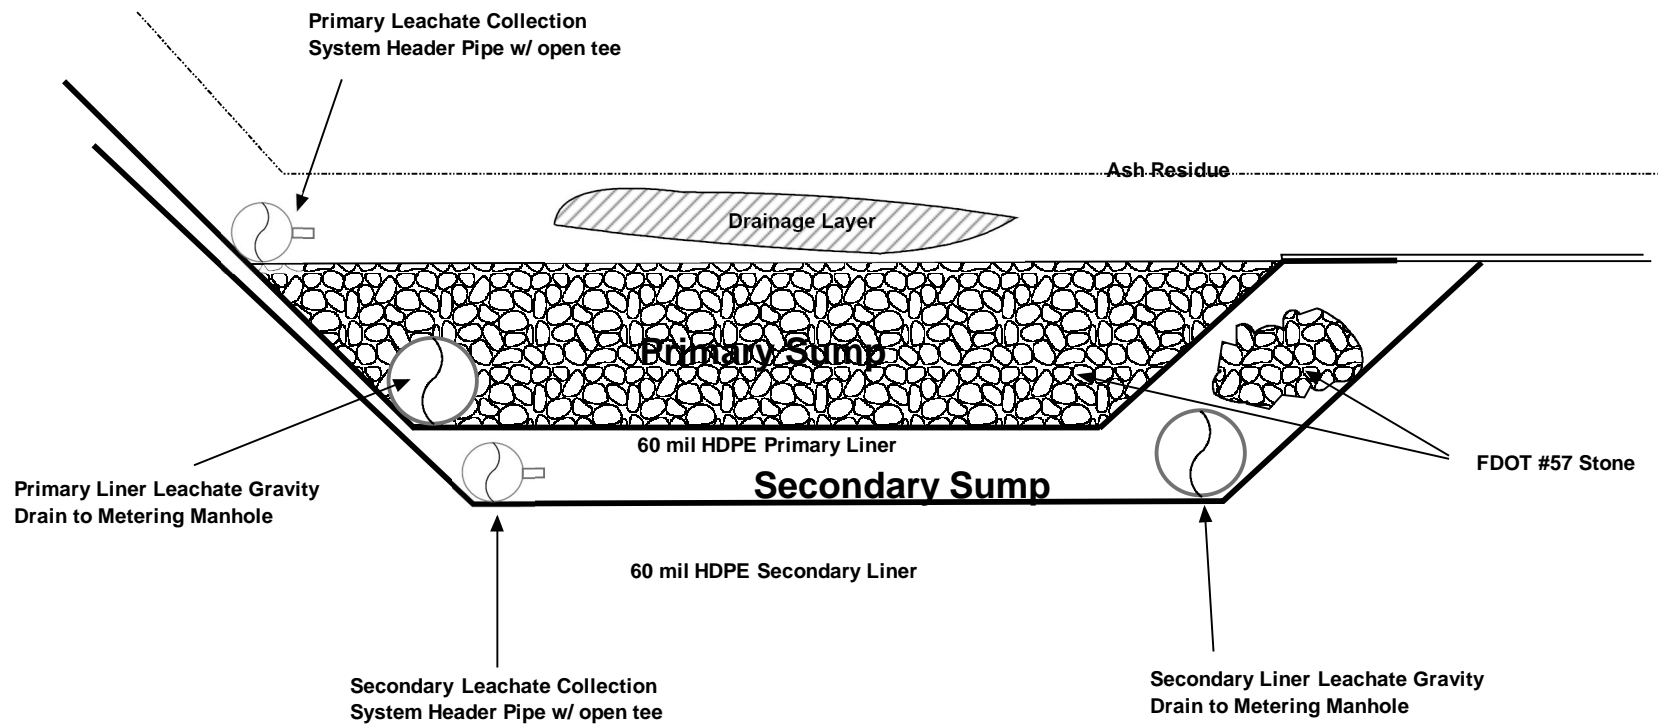
FIGURE 5
SECTION THROUGH PRIMARY TEE AND INTO SUMP
DISPOSAL CELL A2

The original leachate evacuation principle for Ash Disposal Cell A2 incorporated the concept of accumulating leachate from the primary and secondary liner systems in Leachate Collection Sumps before mechanically pumping the accumulated leachate by way of submerged pumps through sideslope risers to the common header serving A1, A2, and A3. Leachate collected by the primary and secondary header pipes within the disposal cell (and the associated lateral pipes) emptied through open tees in the primary and secondary header pipes into a collection sump filled with FDOT #57 coarse stone. As the leachate accumulated within the sump, the submerged pumps would periodically pump the leachate into the common disposal header.

In an effort to make the A2 leachate system consistent with that of Disposal Cells A1 and A3, the decision was made to remove the submerged pumps in the sideslope risers and install gravity drains (through liner penetrations) to drain the primary and secondary collection sumps. The gravity drains emptied into metering manholes, from which the leachate drained once again to the common disposal header. **Figure 5** shows the concept of the modified leachate removal system with open tees from the primary and secondary headers emptying through the sump drainage material to gravity drain lines. These modifications to Disposal Cell A2 were undertaken in conjunction with the construction of Disposal Cell A3 and remain in effect today.

A review of the operating record indicates that little to no leachate is flowing to the metering manhole of the primary liner system. A review of the Florida JetClean Report indicates that leachate *is* properly flowing through the entirety of the primary leachate header pipe and that the gravity drain *is free* of obstruction between the metering manhole and the collection sump. This indicates that the leachate is not properly flowing between the open tee on the leachate header pipe and the gravity drain (by way of the stone-filled sump). The most likely reason for this is that the stone within the sump has become calcified and no longer allows leachate to flow to the gravity drain. The secondary liner leachate collection system appears to be working properly and not affected by such blockage within the secondary sump.

Proper drainage of the A2 disposal cell must be restored to remain in compliance with Chapter 62-701, F.A.C. The following are potential options for restoring the functionality of cell A2:

1. In-situ chemical treatment of the drainage rock within the sump to restore its ability to drain leachate;
2. Excavation of ash to expose the 8" tee on the primary leachate header followed by hard-piping the tee to the gravity drain line (thus by-passing the sump);
3. Abandonment of the gravity line draining the sump accompanied by construction of a side slope riser type pumping system and associated forcemain to evacuate leachate from the disposal cell.

Following a discussion with the FDEP Southwest District Solid Waste staff on April 7, 2016, it was agreed that the option providing the highest likelihood of success would be Option 3. A follow up teleconference was conducted with FDEP Bureau of Solid Waste Staff on May 10, 2016, and it was further agreed that Option 3 presented a viable option for restoring the functionality of the A2 leachate removal system. Accordingly, Pasco County should initiate design and permitting of a side slope riser riser type pumping system to restore the functionality of cell A2. All other leachate removal system components at the Pasco County Resource Recovery Facility are operating properly.
