December 18, 2018

RE: Citrus County Central Landfill (WACS ID# 39859)  
Leachate Tanks Modifications and Inspection  
Jones Edmunds Opportunity No.: 03860-057-01

## TANK INSPECTION

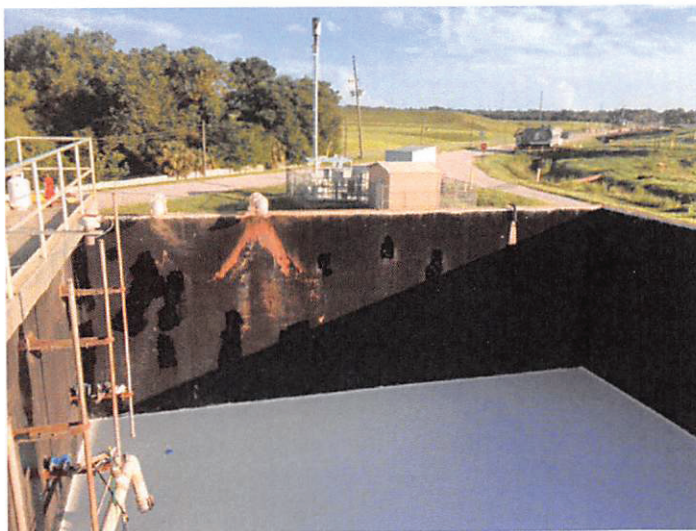
Photo 1: East Leachate Tank with the new bottom liner and the repairs completed on the blisters in the walls.

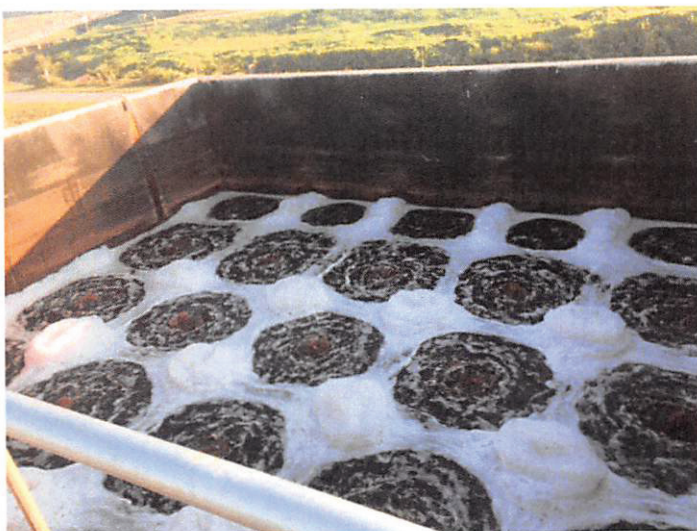
Photo 2: East Leachate Tank is filled and all diffusers are working as designed.

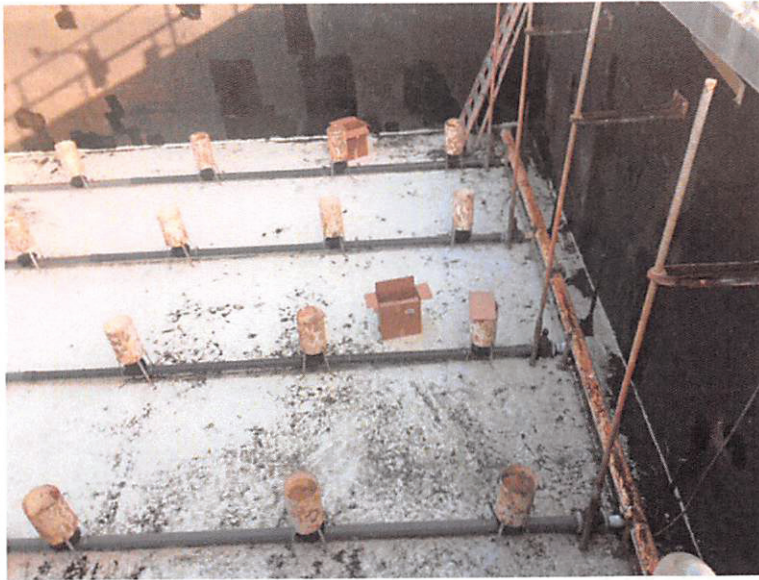
Photo 3: West Leachate Tank with the new bottom liner and the repairs completed on the blisters in the walls. The new diffuser piping has been installed. The Grit on the new white bottom liner is the sand blasting material from the wall repairs.

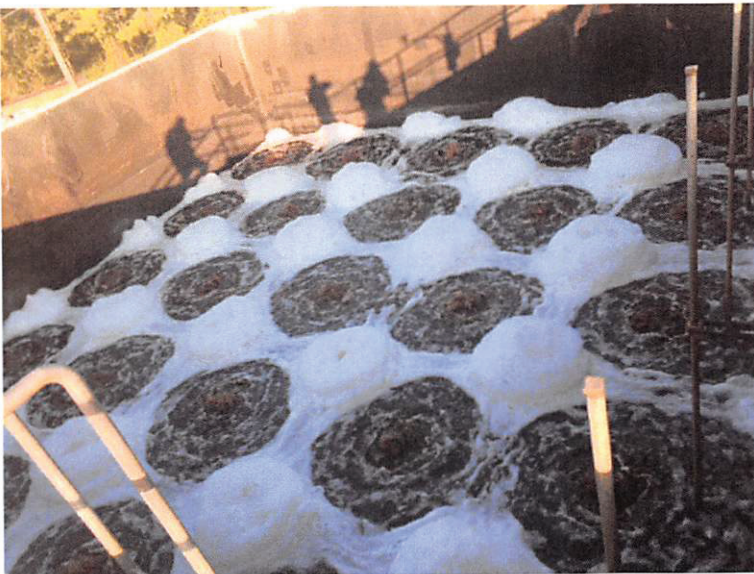
Photo 4: West Leachate Tank is filled and all diffusers are working designed.

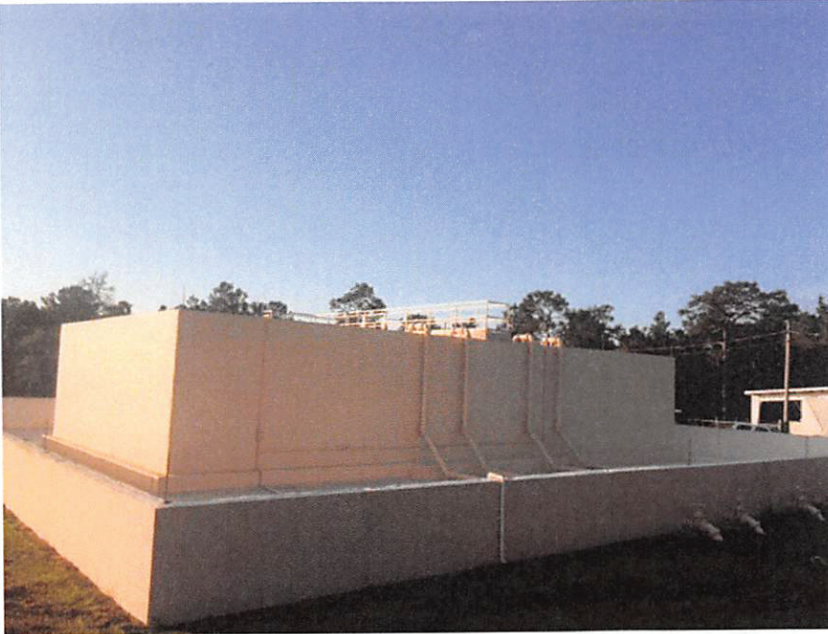
Photo 5: Exterior of the tanks and all ductile Iron Piping has been recoated.

The exterior of the tanks were recoated along with recoating the exterior of the containment basin. Any rust corrosion on the ductile iron piping was repaired and the exterior ductile iron piping was recoated as well. Additionally, the expansion joint sealant was removed and

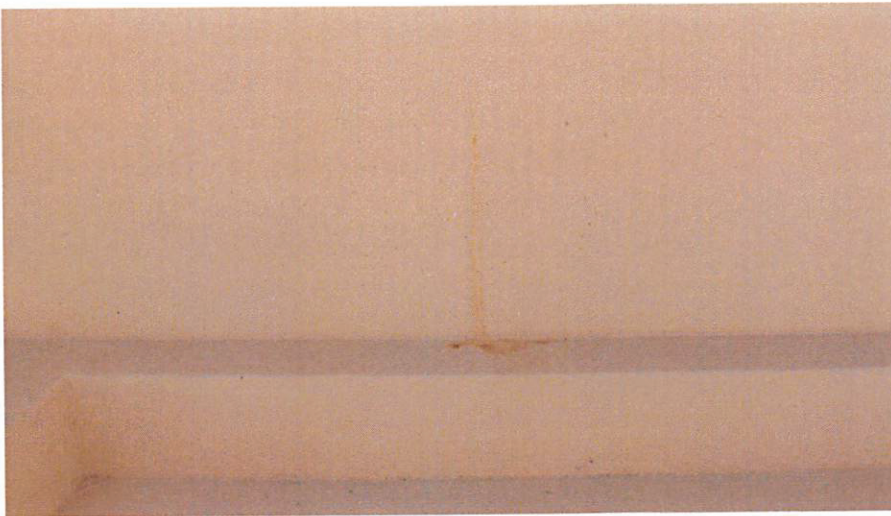
After completion of the project, a very small leak was identified in the wall of the leachate tank. The Contractor who completed all of the work on the tanks was notified of the issue and the leak was repaired with a hydrophilic injection. There have been no additional issues with the work on the tanks.

Photo 6: Small leak in the tank wall that was repaired as a Warrantee item by the Contractor.
