Re: Sarasota County
Central County Solid Waste Disposal Complex
Permit No. 0130542-028-SO-IM)
WACS No. 51614
Above-Ground Leachate Storage Tank Inspection

In-Depth Inspection Report for

Sarasota County

Lechate Storage Tank

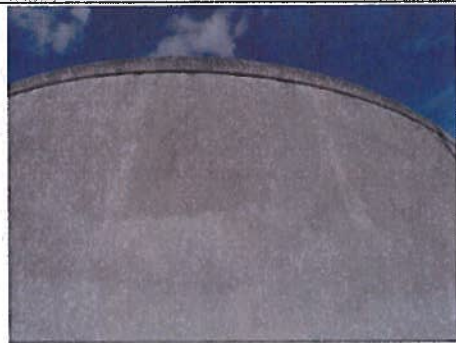
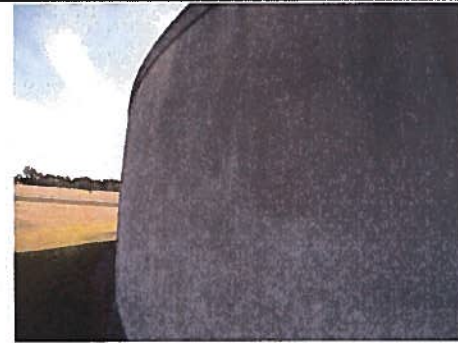
Wall Condition

Signs of Leaking? Y ☐ N ☒
 Dents / Holes? Y ☐ N ☒ Type: None
☐ De-lamination: N/A
☐ Deterioration: N/A
☒ Pop-outs: Minor
☐ Voids: N/A
☐ Unevenness: N/A
☒ Cracking: Moderate Type: Hairline / Shrinkage
☐ Growth: N/A Type: None
☒ Staining: Minor Type: Mildew / Moisture
☐ Exposed Aggregate: N/A
☐ Exposed Reinforcement: N/A
☒ Spalling: Minor

- Prestressed concrete walls (no coating)
- Minor spalling noted on upper walls near opening
- Mildew staining localized on upper walls
- Consistent ratings noted throughout

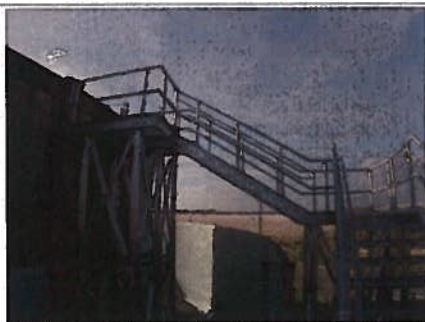
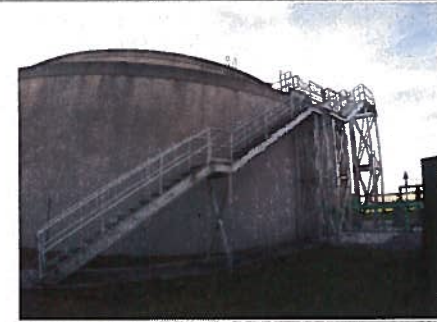
Access Stairway Condition

Ladder Type: Aluminum welded
 OSHA Adherence? Y ☐ N ☒
 Vandal Guard Present? Y ☐ N ☒
 Locked? Y ☐ N ☒ N/A ☒
 Safety Climb Type: Guided rail
 OSHA Adherence? Y ☐ N ☒

☐ Oxidation: N/A
☐ De-lamination: N/A
☒ Staining: Moderate Type: None
☐ Blistering: N/A
☐ Chalking: N/A
☐ Checking: N/A
☐ Cracking: N/A Type: None
☐ Pinholes: N/A
☐ Saggs/Runs: N/A

- Equipped w/ multiple stairways and access ladders (3 Outer stairways & 2 Inner ladders)
- All shared equally ratings (no discrepancies)
- Moderate signs of mildew staining noted throughout
- Constructed of aluminum (no coating)

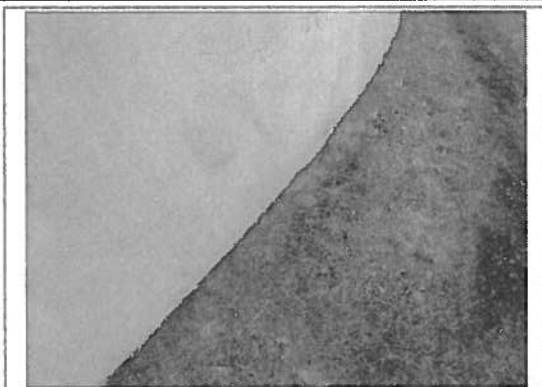
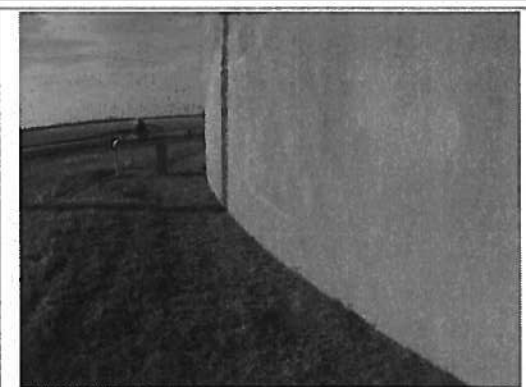
Foundation Condition

Additional Notes: - Buried foundation (unable to fully evaluate)
- Backfilled approx. 12"

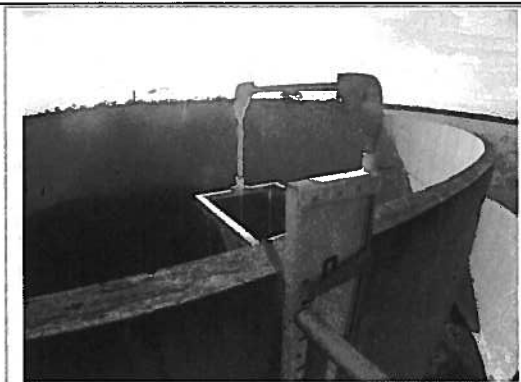
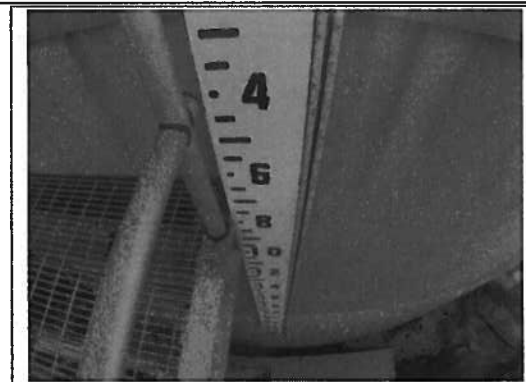
Float Level Indicator Condition

- ☐ None: N/A
- ☒ Uniform Surface Corrosion: None, or < 0.01%
- ☒ Concentrated Cell Corrosion: Minute: < 0.03%
- ☐ Rust Noduling/Pitting: N/A
- ☐ Galvanic: N/A
- ☐ De-alloying: N/A
- ☐ Intergranular: N/A
- ☐ Stress Corrosion Cracking: N/A
- ☐ Erosion Corrosion: N/A

Additional Notes: - Attached an accurate
- Minimal discrepancies to be noted
- Minor biological growth / staining noted

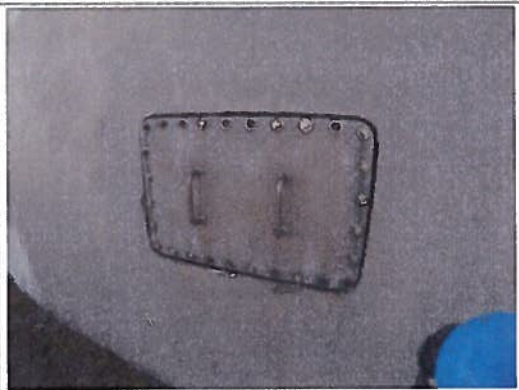
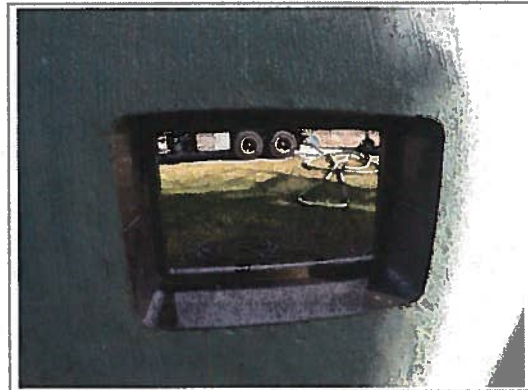
Manway #1 Condition

- ☐ Oxidation: N/A
- ☐ De-lamination: N/A
- ☒ Staining: Minor
- ☐ Blistering: N/A
- ☐ Chalking: N/A
- ☐ Checking: N/A
- ☐ Cracking: N/A
- ☐ Growth: N/A
- ☐ Pinholes: N/A
- ☐ Saggs/Runs: N/A

- Outer manway ratings
- Consistent ratings throughout (26.5" x 16.5")
- Constructed of stainless steel
- Minimal discrepancies to be noted (no coating)
- Minor spalling noted around penetration

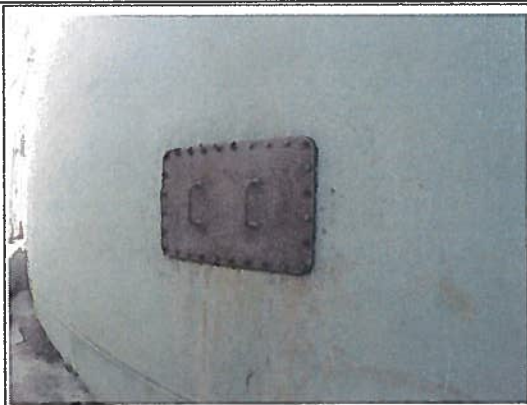
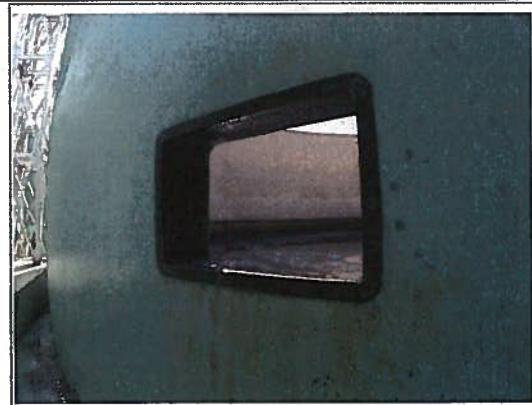
Manway #2 Condition

- ☐ Oxidation: N/A
- ☐ De-lamination: N/A
- ☒ Staining: Minor
- ☐ Blistering: N/A
- ☐ Chalking: N/A
- ☐ Checking: N/A
- ☐ Cracking: N/A
- ☐ Growth: N/A
- ☐ Pinholes: N/A
- ☐ Saggs/Runs: N/A

- Inner manway ratings
- Consistent ratings throughout (26.5" x 16.5")
- Constructed of stainless steel
- Minimal discrepancies to be noted (no coating)

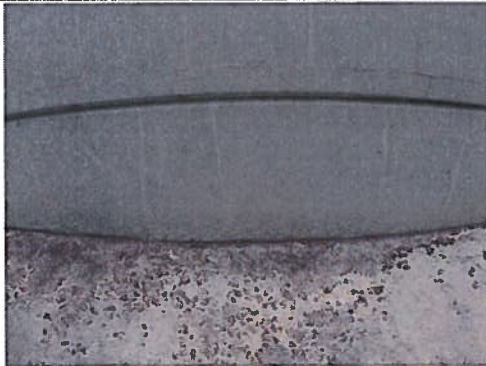
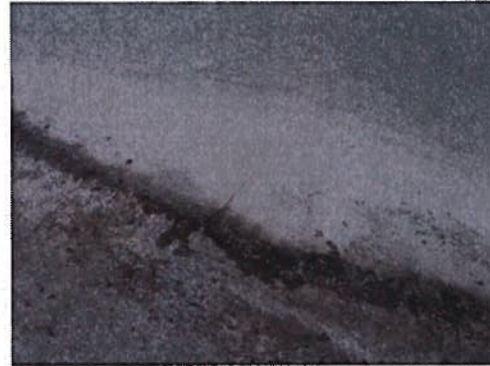
Tank Floor & Wall Seam Condition

- ☒ De-lamination: Minute: < 0.03%
☐ Deterioration: N/A
☐ Pop-outs: N/A
☐ Voids: N/A
☐ Unevenness: N/A
☒ Cracking: Moderate
☐ Growth: N/A
☒ Staining: Minor
☐ Exposed Aggregate: N/A
☐ Exposed Reinforcement: N/A
☐ Spalling: N/A

Type: Hairline / Shrinkage
 Type: None
 Type: Sediment

Additional Notes:
 - Inner & Outer wall seams share similar ratings
 - Minimal discrepancies to be noted
 - Consistent ratings noted throughout
 - No signs of leaking or seepage noted

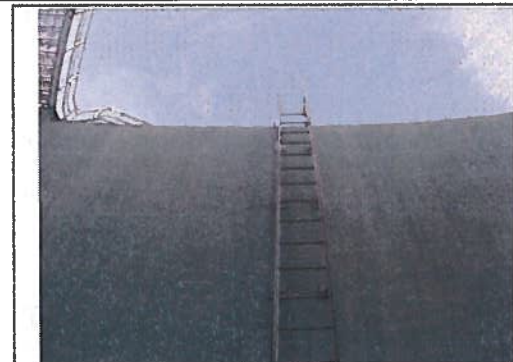
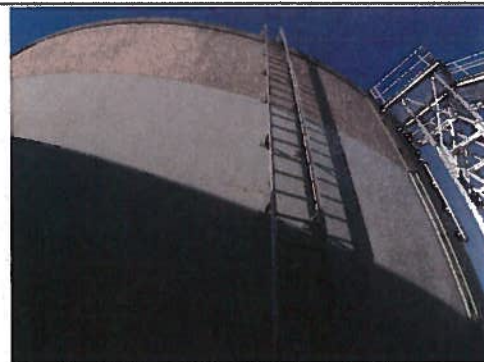
Ladder Condition

- ☐ Oxidation: N/A
☐ De-lamination: N/A
☒ Staining: Minor
☐ Blistering: N/A
☐ Chalking: N/A
☐ Checking: N/A
☐ Cracking: N/A
☐ Growth: N/A
☐ Pinholes: N/A
☐ Saggs/Runs: N/A

Additional Notes:
 - Equipped w/ 2 ladders inside of containment tank
 - Both ladders share equal ratings (consistent)
 - Constructed of aluminum (no coating)
 - Guided rail safety climb

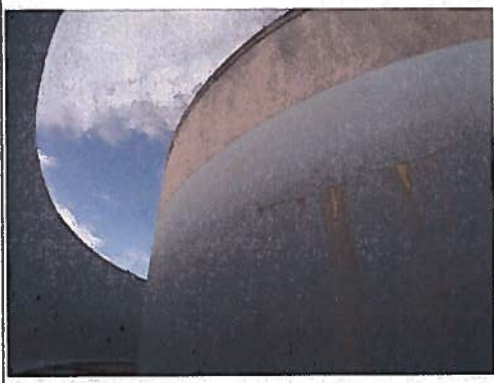
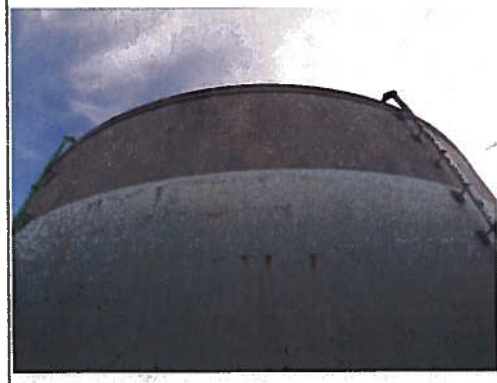
Containment Tank Wall Condition

- ☒ De-lamination: Minute: < 0.03%
☒ Deterioration: None, or < 0.01%
☒ Pop-outs: Minor
☐ Voids: N/A
☐ Unevenness: N/A
☒ Cracking: Heavy Type: Hairline / Shrinkage
☒ Growth: N/A Type: None
☒ Staining: Minor Type: Corrosive
☐ Exposed Aggregate: N/A
☒ Exposed Reinforcement: Minor

- ☐ None: N/A
☒ Uniform Surface Corrosion: Extensive: < 1%
☐ Concentrated Cell Corrosion: N/A
☐ Rust Noduling/Pitting: N/A Depth: N/A
☐ Galvanic: N/A
☐ De-alloying: N/A
☐ Intergranular: N/A
☒ Stress Corrosion Cracking: Few Isolated: < 0.1%
☐ Erosion Corrosion: N/A

- Additional Notes:
- Tank has 2 walls (inner & outer)
 - Walls share similar ratings
 - Inner wall only partially coated
 - Minor unlocalized areas of corrosion on inner wall
 - Consistent cracking noted throughout both walls

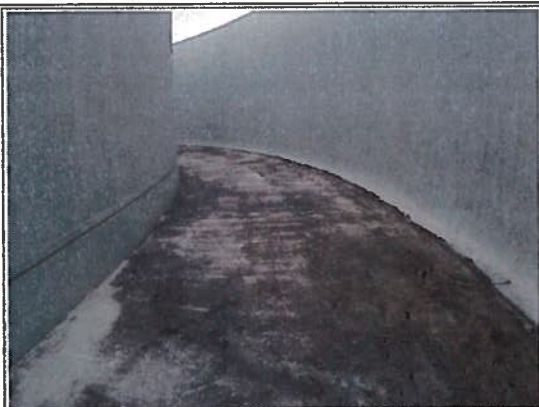
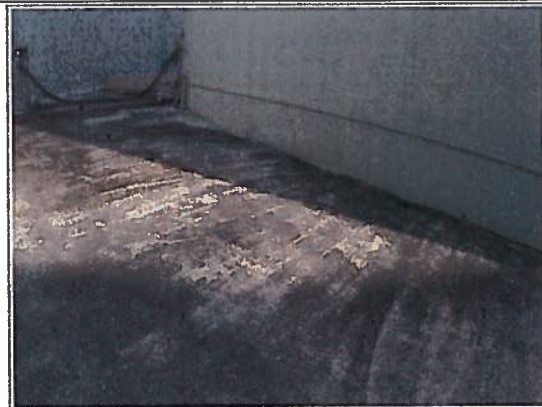
Containment Tank Floor Condition

- ☐ Oxidation: N/A
☒ De-lamination: None, or < 0.01%
☒ Staining: Heavy Type: Mildew / Dirt / Bio
☐ Blistering: N/A
☒ Chalking: Minor
☒ Checking: Moderate
☒ Cracking: Minor Type: Hairline
☒ Growth: Minor Type: Biological
☐ Pinholes: N/A
☐ Saggs/Runs: N/A

- Additional Notes:
- Consistent ratings noted throughout
 - Crossover plumbing in good / excellent condition
 - Drain penetrates through sump in floor
 - Minor unevenness noted throughout concrete floor

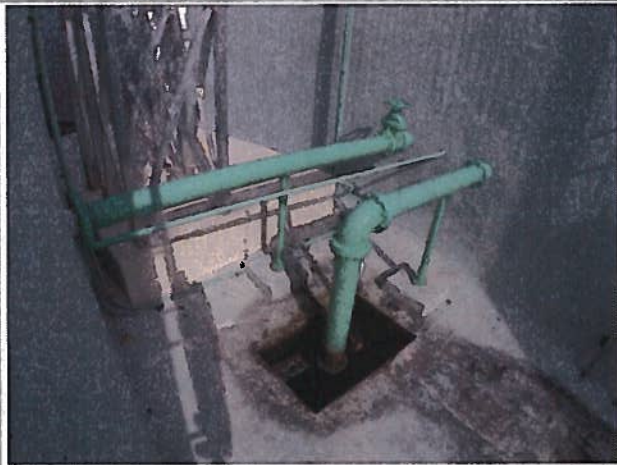
Crossover Plumbing

- All crossover plumbing in good / excellent condition
- Consistent ratings noted throughout
- High-fill inlet constructed on stainless steel
- All others coated & constructed of carbon steel
- No discharge location (fully contained)

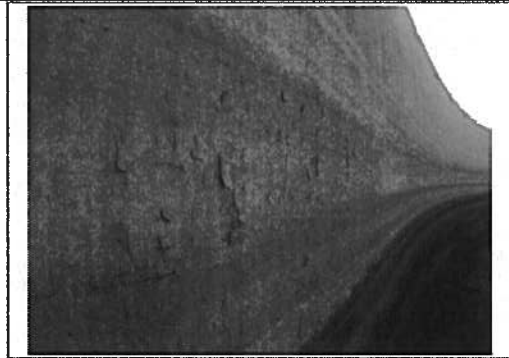
Tank Wall Condition

- ☒ De-lamination: To Extent of 3%
- ☒ Deterioration: Minute: < 0.03%
- ☒ Pop-outs: Minor
- ☐ Voids: N/A
- ☐ Unevenness: N/A
- ☒ Cracking: Moderate
- ☐ Growth: N/A
- ☒ Staining: Heavy
- ☐ Exposed Aggregate: N/A
- ☐ Exposed Reinforcement: N/A
- ☒ Spalling: Minor
- ☒ Saggs/Runs: Minor

- Consistent ratings noted throughout
- Prestressed coated concrete walls
- Moderate signs of bug holing
- Heavier staining noted on lower walls
- Heavy blistering noted on floor to wall seams
- Minor chalking & checking noted throughout coating

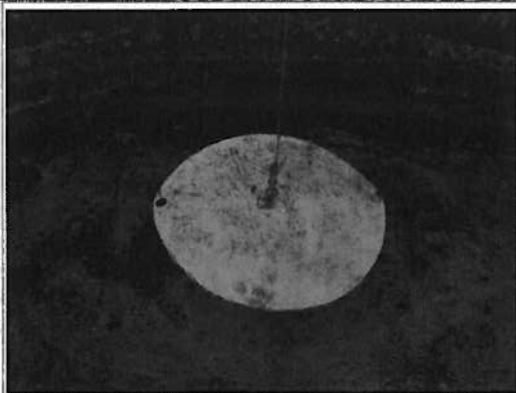
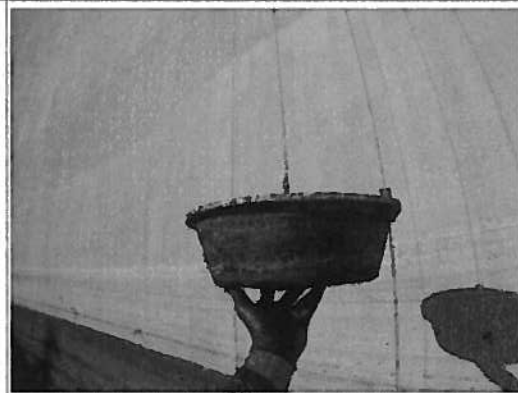
Float Condition

- ☐ None: N/A
- ☒ Uniform Surface Corrosion: None, or < 0.01%
- ☒ Concentrated Cell Corrosion: Few Isolated: < 0.1%
- ☐ Rust Noduling/Pitting: N/A
- ☐ Galvanic: N/A
- ☐ De-alloying: N/A
- ☐ Intergranular: N/A
- ☐ Stress Corrosion Cracking: N/A
- ☐ Erosion Corrosion: N/A

- Constructed of fiberglass
- Attached and accurate (Anchored properly)
- Heavy staining noted throughout

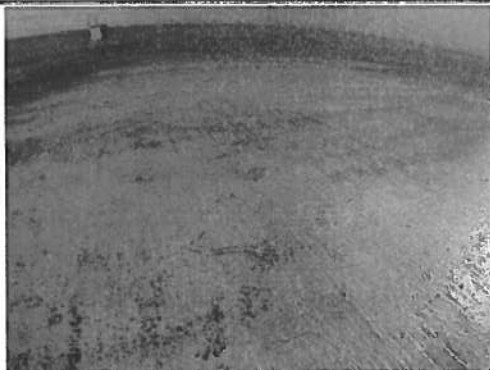
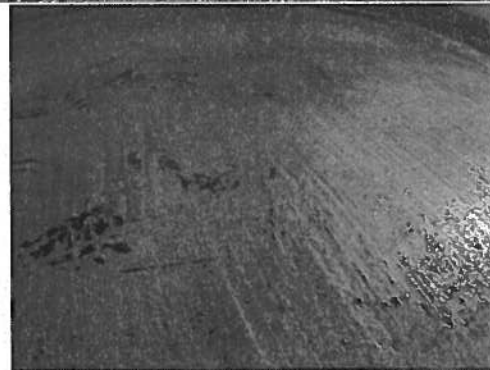
Tank Floor Condition

- ☒ De-lamination: Extensive: < 1%
☐ Deterioration: N/A
☒ Pop-outs: Minor
☐ Voids: N/A
☒ Unevenness: Minor
☐ Cracking: N/A
☐ Growth: N/A
☒ Staining: Heavy
☐ Exposed Aggregate: N/A
☐ Exposed Reinforcement: N/A
☐ Spalling: N/A

Additional Notes: - Consistent ratings noted throughout
 - Heavy blistering noted on floor to wall seam
 - Coating present and in-tact
 - No signs of leaking or seepage noted throughout

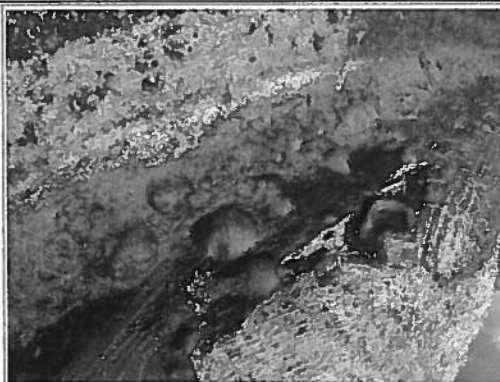
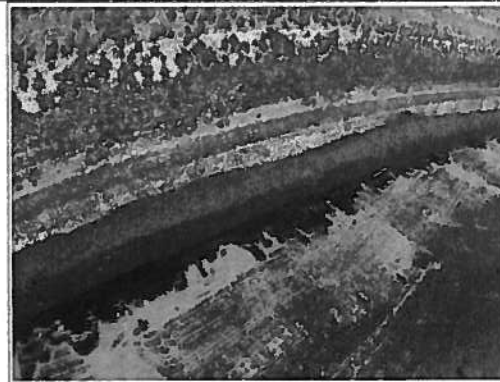
Floor to Wall Seam Condition

- ☐ Oxidation: N/A
☒ De-lamination: Extensive: < 1%
☒ Staining: Heavy
☒ Blistering: Heavy
☐ Chalking: N/A
☒ Checking: Minor
☐ Cracking: N/A
☐ Growth: N/A
☐ Pinholes: N/A
☒ Saggs/Runs: Moderate

Additional Notes: - Sloped floor to wall seams
 - Consistent rating noted throughout
 - Has elastomeric urethane floor-wall boot (blistering)
 - No signs of leaking or seepage noted

1. Routine Clean & Inspect every 3 years per sludge accumulation / report findings
2. Replace severely corroded / de-alloying plumbing components (internal: inlet & outlet)
3. Pressure wash & re-coat containment tank (grout / repair areas as needed)
4. Consider replacement of elastomeric urethane floor-wall boot due to heavy blistering

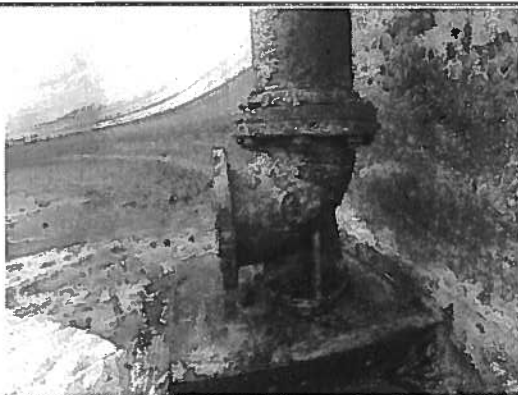
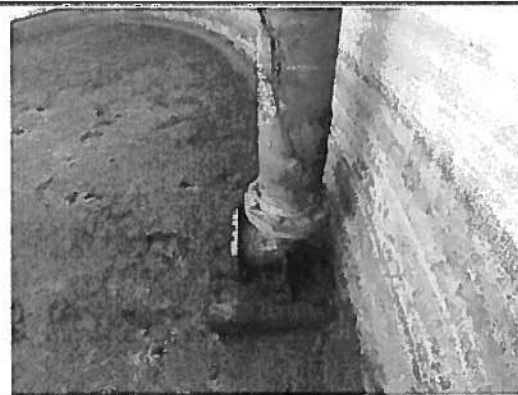
Inlet Condition

☒ Uniform Surface Corrosion: Approx. 100%

☒ Concentrated Cell Corrosion: Approx. 50%

☒ Rust Noduling/Pitting: To Extent of 10%

Overall Condition: Poor

Additional Notes: - Consistent ratings noted throughout
- Severe corrosion present (coating failure)
- Stainless stand-offs in excellent condition
- Ultrasonic measurement readings: 373" - 369"
- High & Low fill opening flange

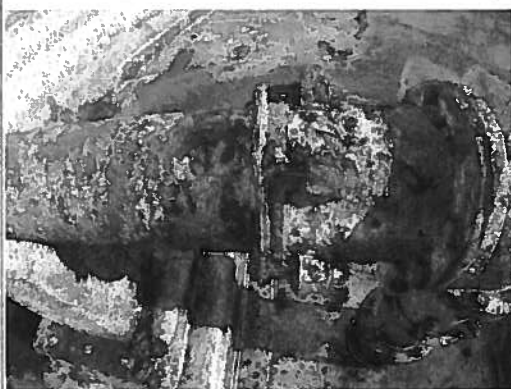
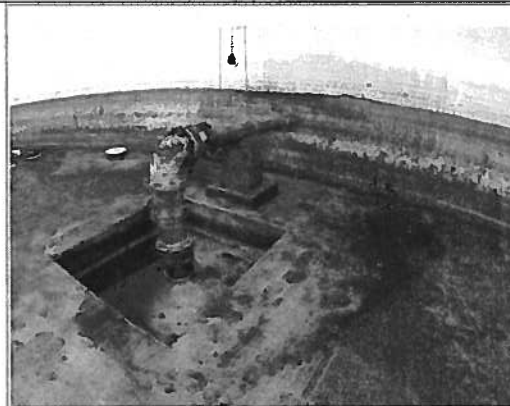
Outlet Condition

☒ Uniform Surface Corrosion: Approx. 50%

☒ Concentrated Cell Corrosion: Approx. 50%

☒ Stress Corrosion Cracking: Approx. 33%

Overall Condition: Poor

Additional Notes: - Severe corrosion noted throughout (coating failure)
- Penetrates through stainless flange in lower wall
- House within concrete floor sump (60"x60"x12")
- Ultrasonic thickness readings: 331 - 365
- 29" Outer circumference

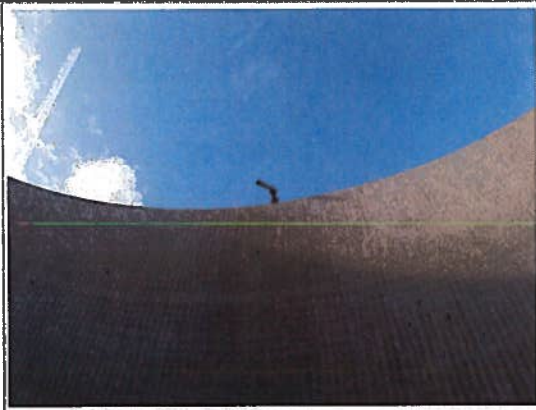
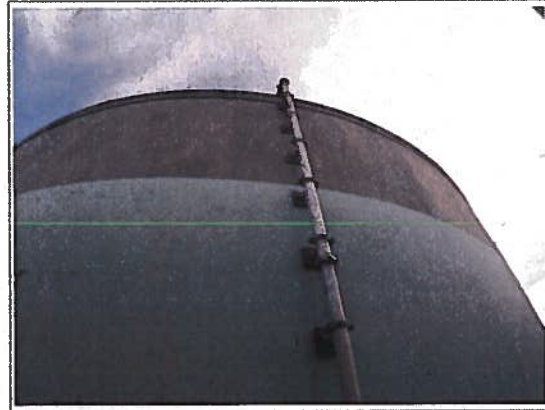
Secondary High-Fill Inlet Condition

Additional Notes: - Constructed of stainless steel
- No coating present
- No discrepancies to be noted
