Southeast County Landfill - Monitoring Well TH-71A Chloride

**SOUTHEAST COUNTY LANDFILL
CAPACITY EXPANSION AREA RUNOFF**

SCS ENGINEERS

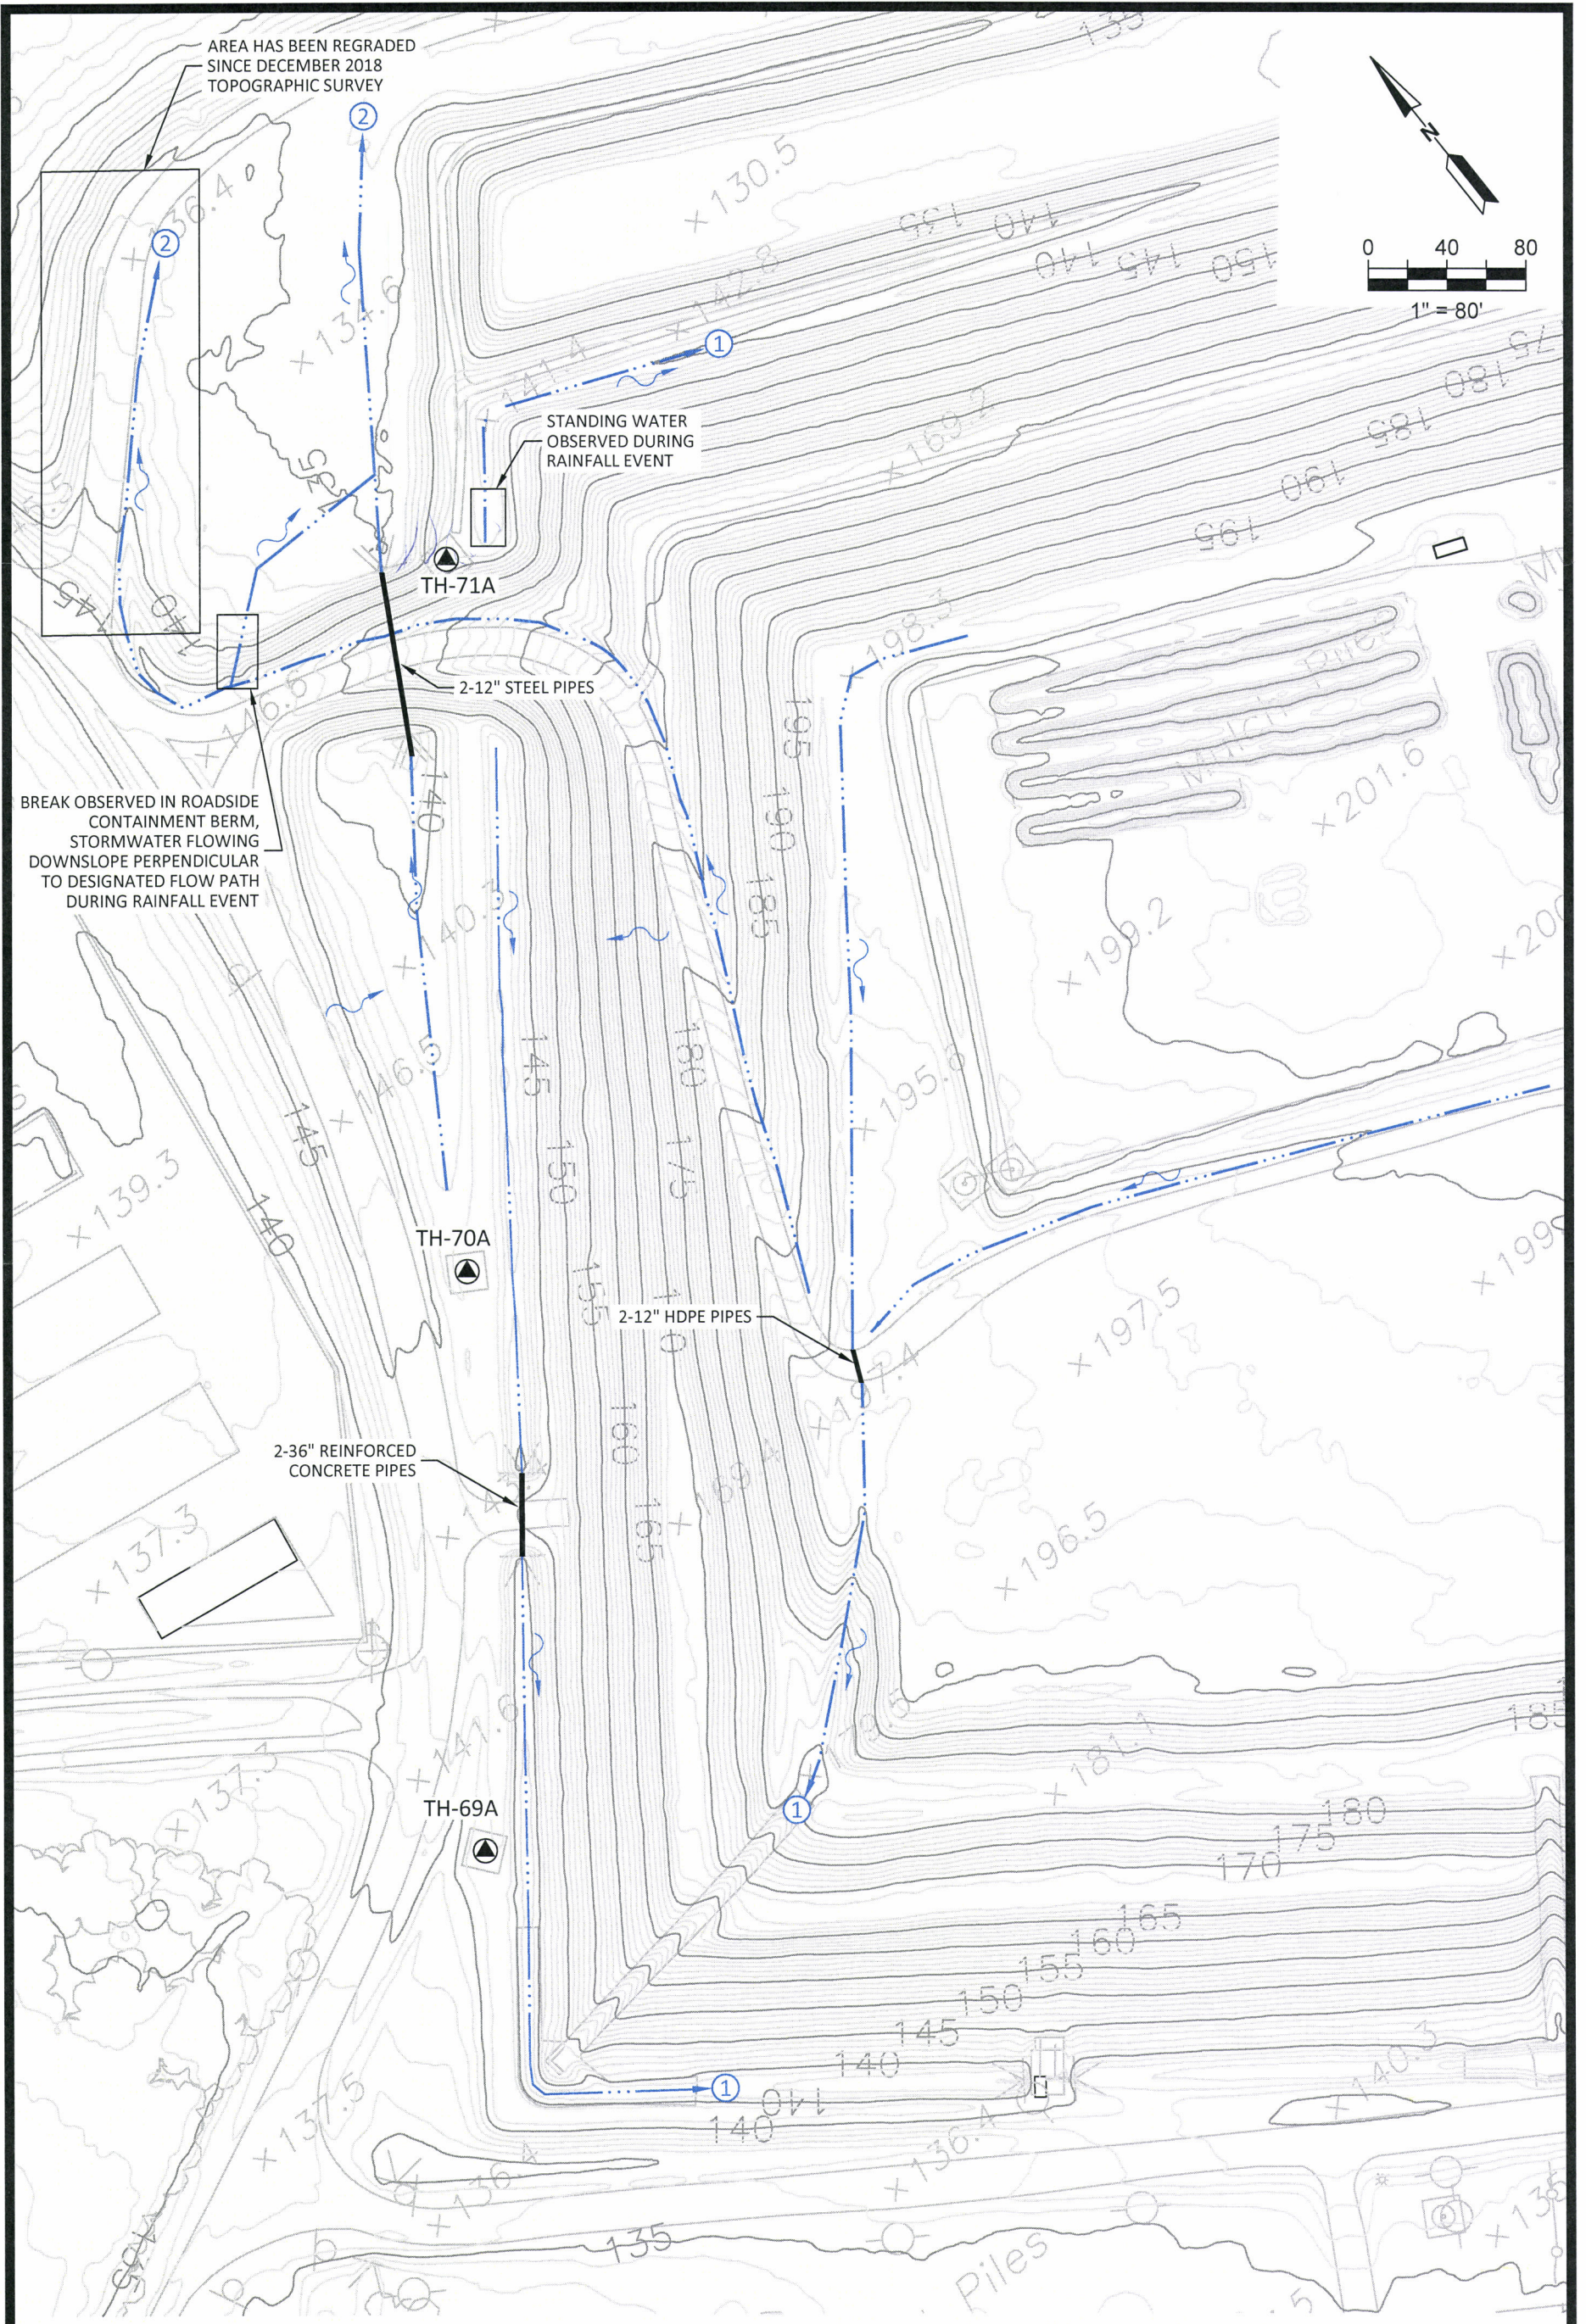
AREA HAS BEEN REGRADED
SINCE DECEMBER 2018
TOPOGRAPHIC SURVEY

STANDING WATER
OBSERVED DURING
RAINFALL EVENT

BREAK OBSERVED IN ROADSIDE
CONTAINMENT BERM,
STORMWATER FLOWING
DOWNSLOPE PERPENDICULAR
TO DESIGNATED FLOW PATH
DURING RAINFALL EVENT
