Subject: Facility ID: 39859-Citrus County Central Landfill: Response to Warning Letter #WL19-107SW09SWD

RE: Citrus County Central Class I Landfill

Warning Letter #WL19-107SW09SWD

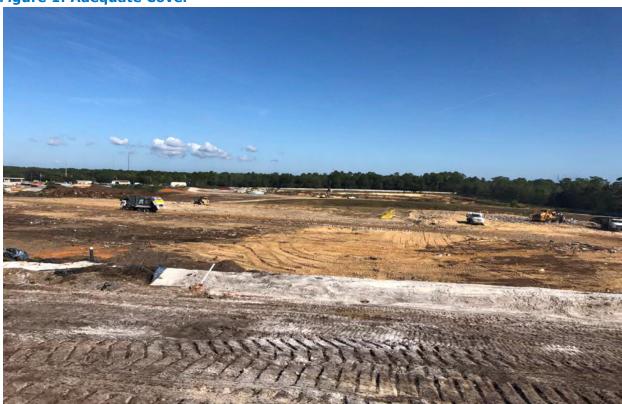
Comment 2.19: Explanation: The Department received a complaint on September 26, 2019 regarding cover used at the Facility. During the inspection, insufficient initial and intermediate cover, especially on the west end of Phase III, was observed. Exposed waste was apparent across the surface of Phase III.

Response 2.19: The County is working to ensure that adequate cover per the Rule is applied and maintained. Additionally, the BOCC recently approved a contract for purchase and use of an ADC material to augment the use of soil cover.

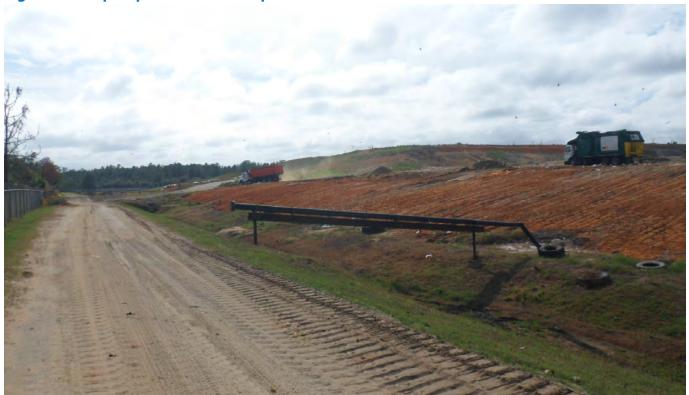
Figure 2: Seep Repairs on East Slope

Comment 2.28: Explanation: The Department received a complaint on September 26, 2019 regarding landfill leachate seeps mixing with the stormwater system. During the inspection, active leachate seeps were observed on the east end of Phase III, potentially discharging to the stormwater system. Also, there was no perimeter berm present around the working face.

- Response 2.28: The identified seeps have been repaired (Figure 2) and a stormwater berm has been installed (Figure 3) and will be maintained around the working face to control any leachate runoff, keeping the leachate in the active cell. The County has implemented two action items so that any future seeps will be identified quickly and repaired.
 - 1. The County added monitoring for leachate seeps to the weekly inspection protocol. Every Monday, when the weekly inspection protocol is conducted, the inspector will walk the side slopes looking for leachate seeps. Figure 4 provides the updated inspection form.
 - 2. The County purchased 200 loads of red clay soil to use in the repair of any identified seeps. This material is stockpiled on site and ready for use when a seep is identified.

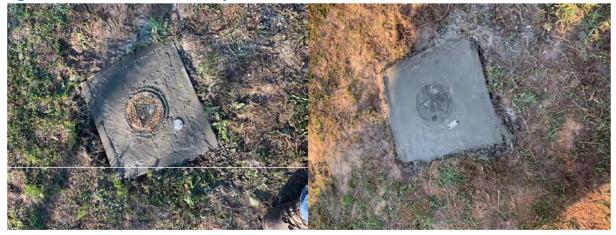
Figure 5: Photos of new well pads on MW-19 and MW-19D

Comment 2.37: Explanation: Well pads for MW-19 and MW-19D were cracked. Appendix 3.IV of the Permit requires notification if a well becomes damaged or inoperable.

Response 2.37: Jones Edmunds inspected the wells and determined that they were not damaged, just the pad was cracked. The Contractor who damaged the wells has replaced the pads and the new pads are shown in Figure 5. The well top of casings (TOCs)

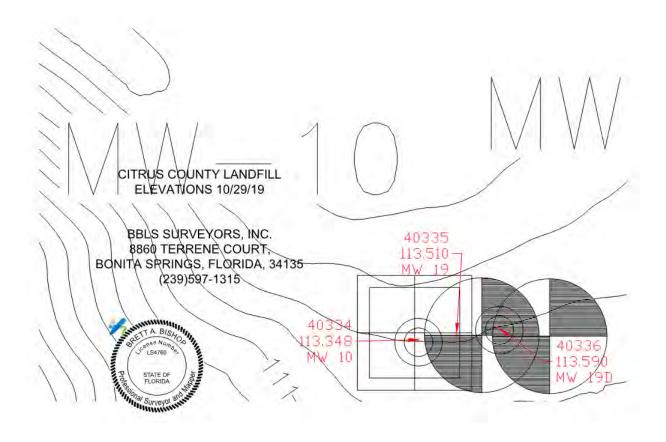
Figure 6: Survey of New TOC Elevations

MW-10: Previous TOC: 113.37: New TOC: 113.35

MW-19: Previous TOC: 113.50; New TOC: 113.51

MW-19D: Previous TOC: 113.59; New TOC: 113.59

were surveyed to ensure that there was no change in the elevation. The elevations are summarized for each well below and the survey is included as Figure 6:
