## **Citrus County Central Landfill Leachate Collection System Cleaning and Video Inspection**

**SUBJECT:** Summary of Leachate Collection System Cleaning and Inspection  
Jones Edmunds Project No. 03860-077-01

# **Jones Edmunds Citrus County Landfill Phases 1-3 Leachate Collection Pipe Maintenance**

# **SCS Engineers Citrus County Landfill 2015 Leachate Pipe Maintenance**

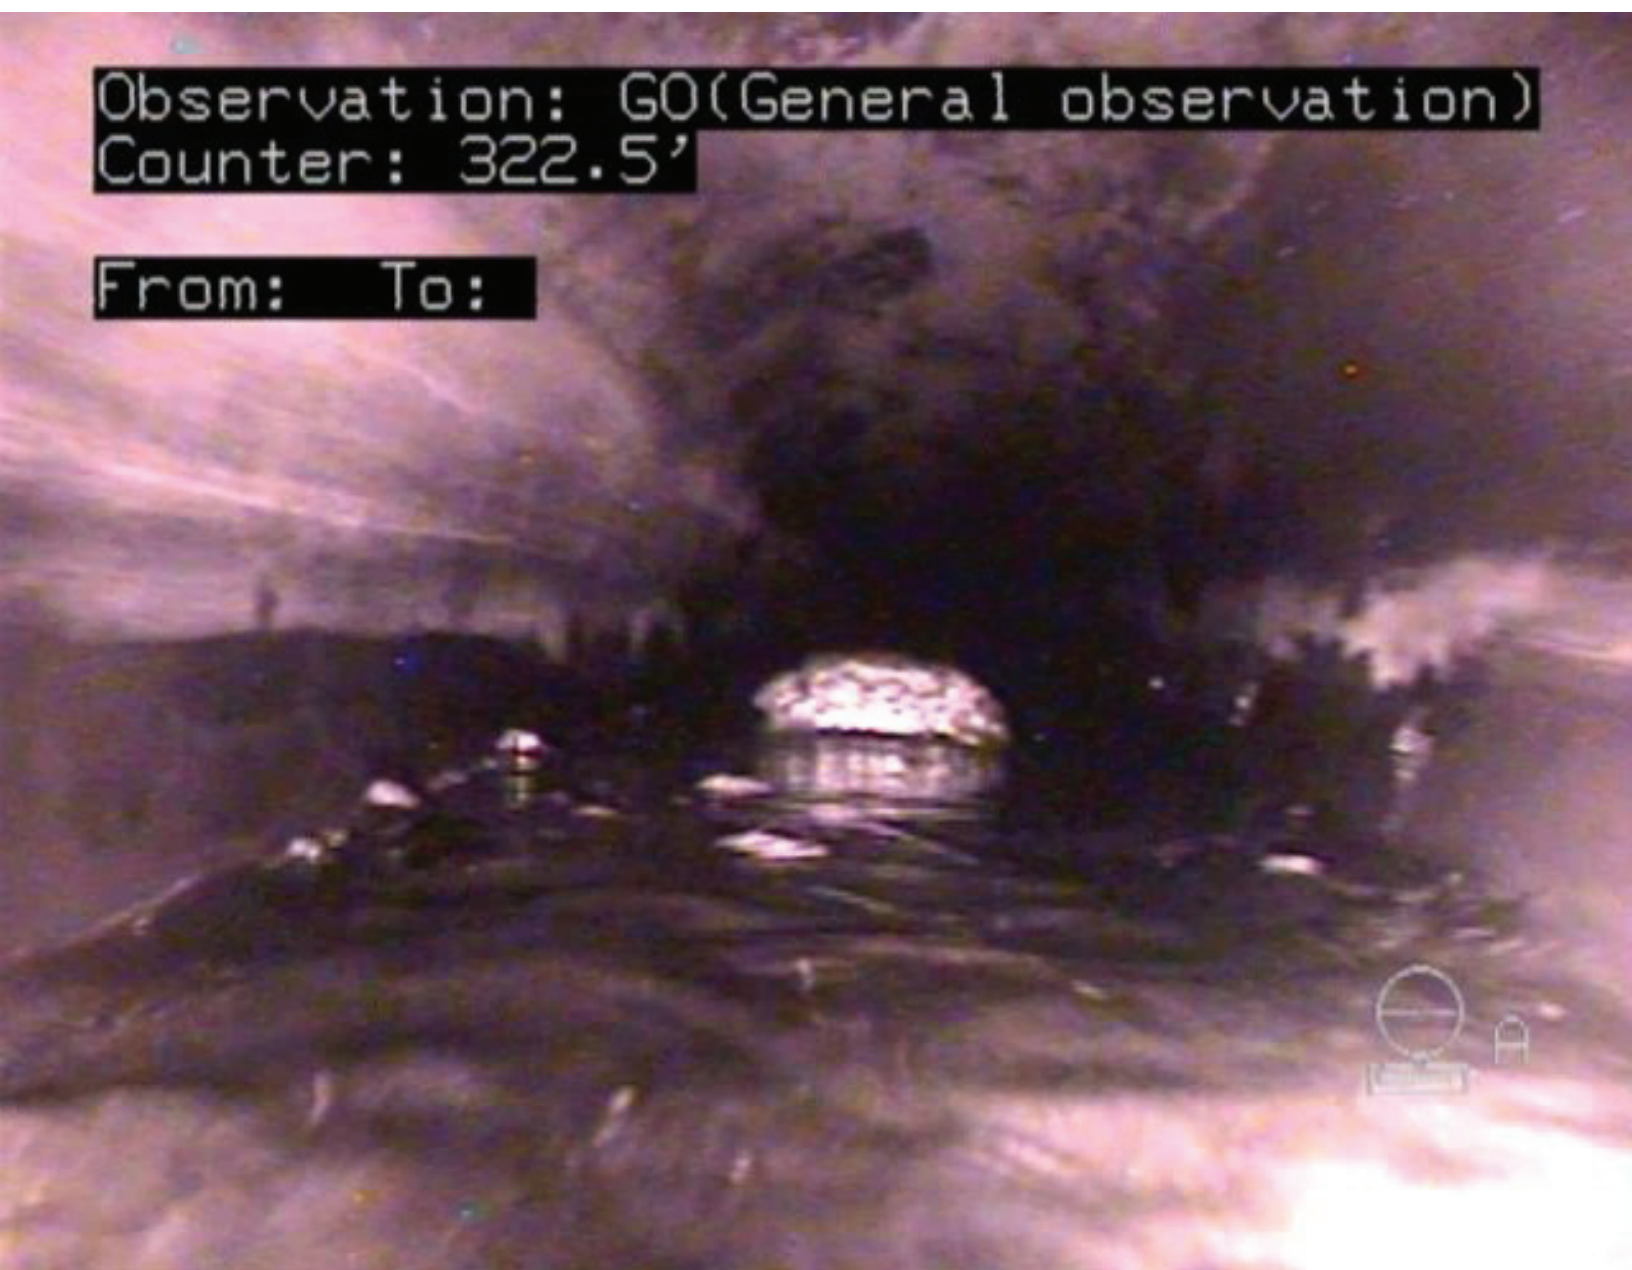
Observation: GO (General observation)  
Counter: 322.5'

Video Index Count 322.5 Ft  
 Code General observation  
 Remarks SAND  
 File Name 8.jpg

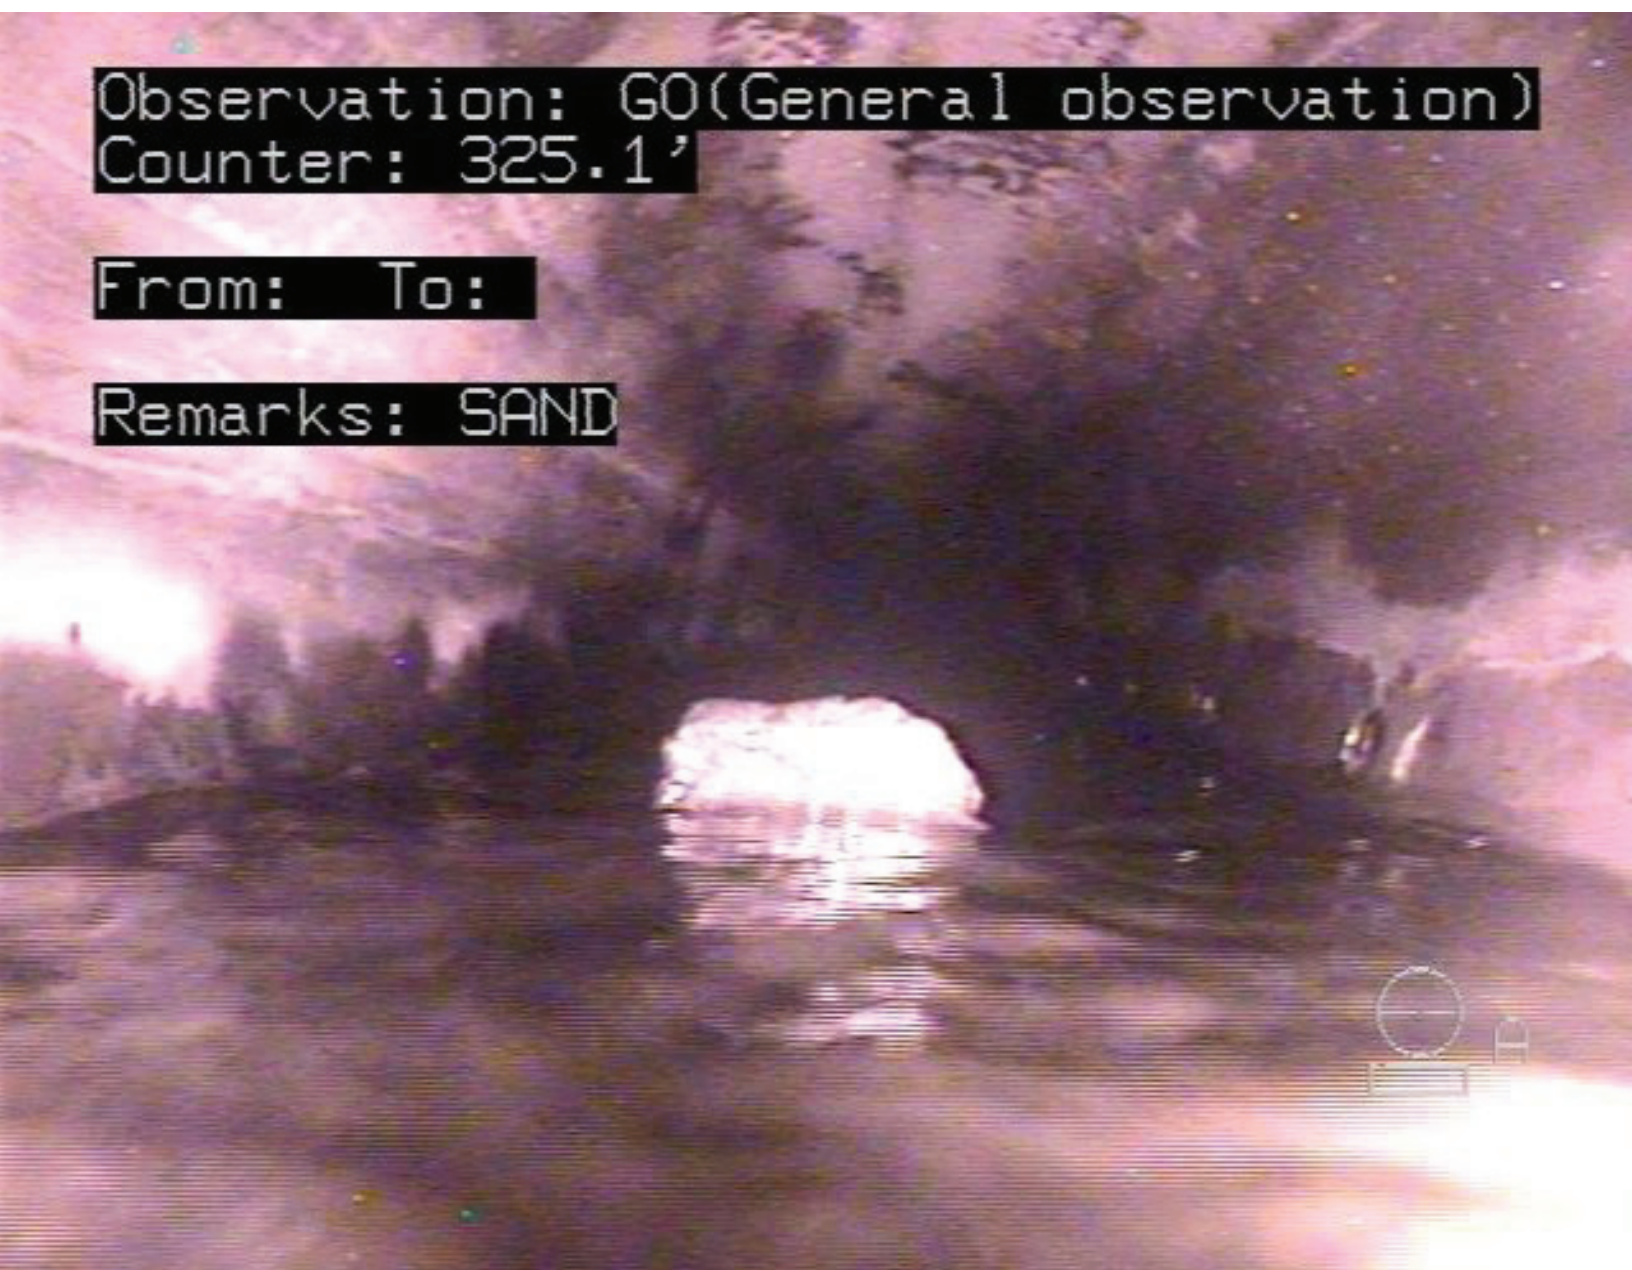
Observation: GO (General observation)  
Counter: 325.1'

Video Index Count 325.1 Ft  
 Code General observation  
 Remarks SAND  
 File Name 9.jpg

Remarks: SAND

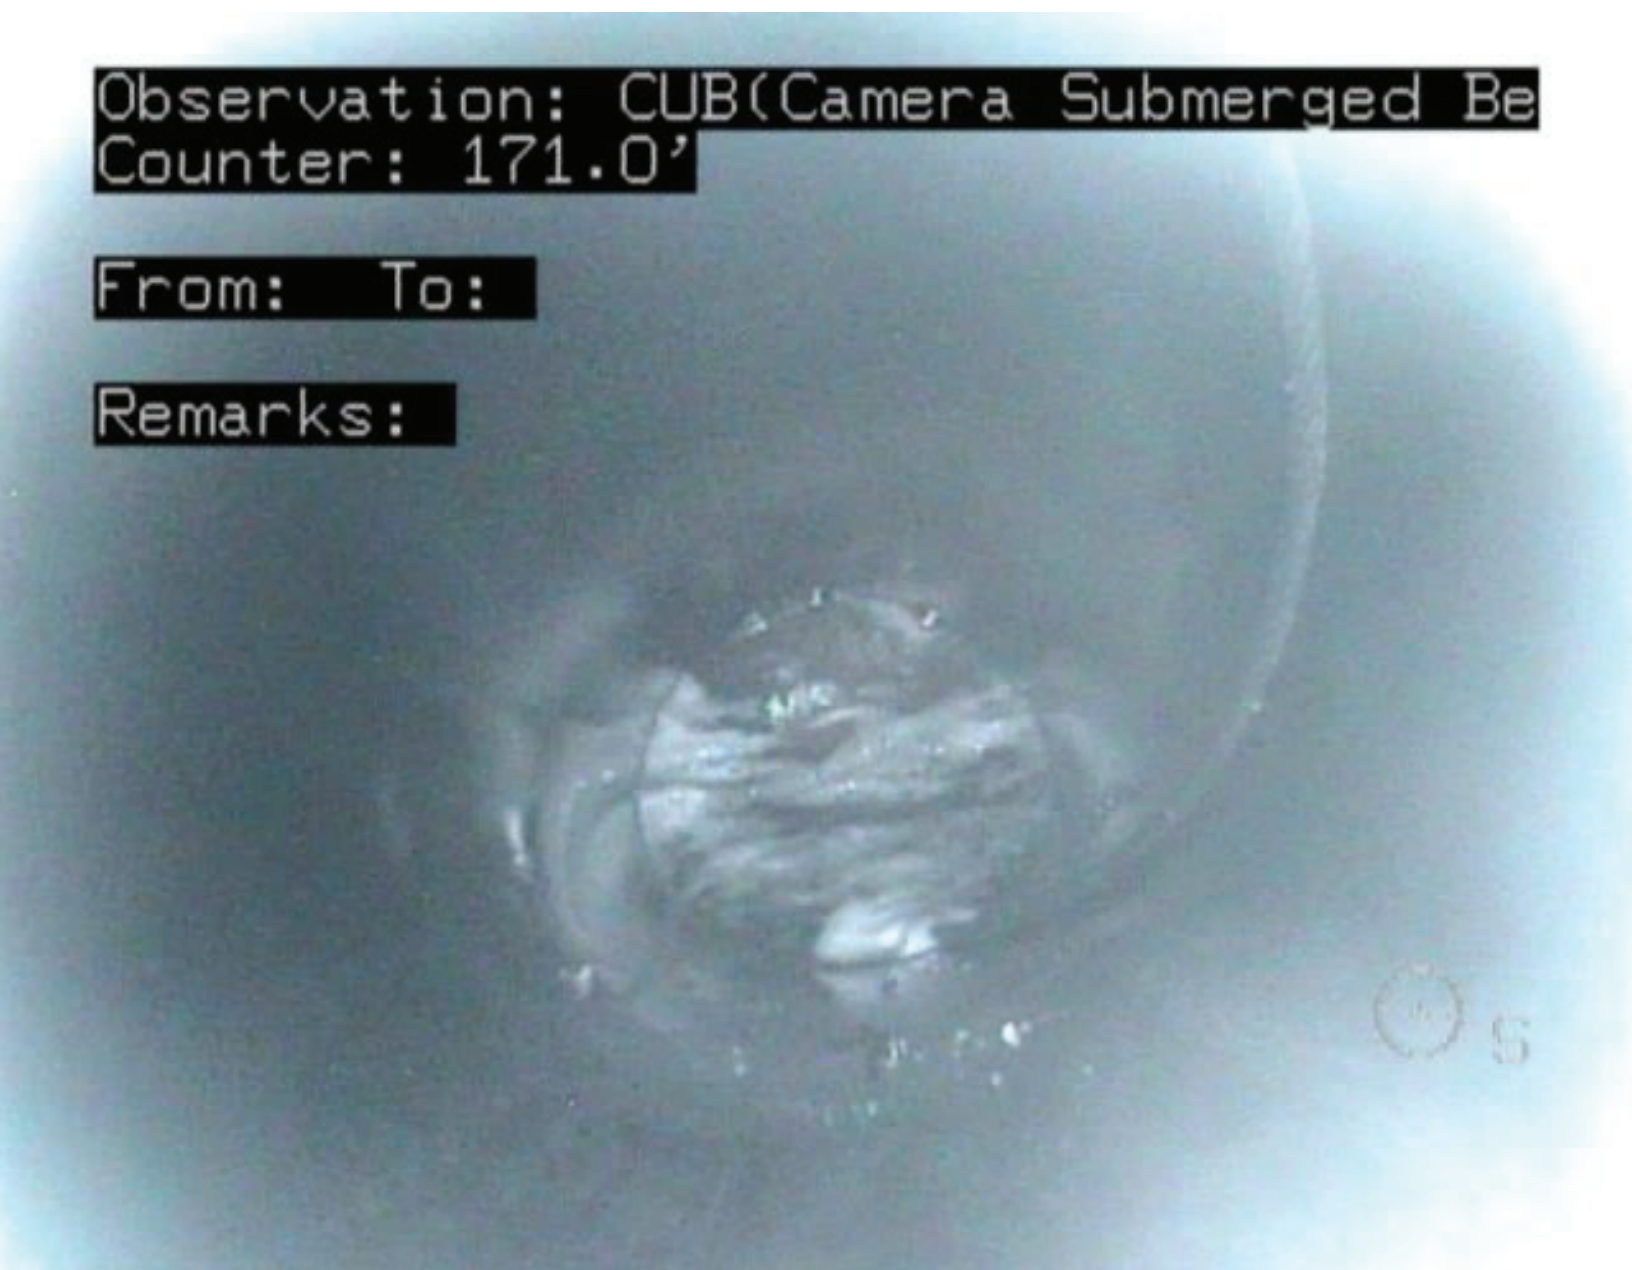
Observation: CUB(Camera Submerged Be  
Counter: 171.0'

Video Index Count 171.0 Ft  
 Code Camera Submerged Begin  
 Remarks  
 File Name 11.jpg

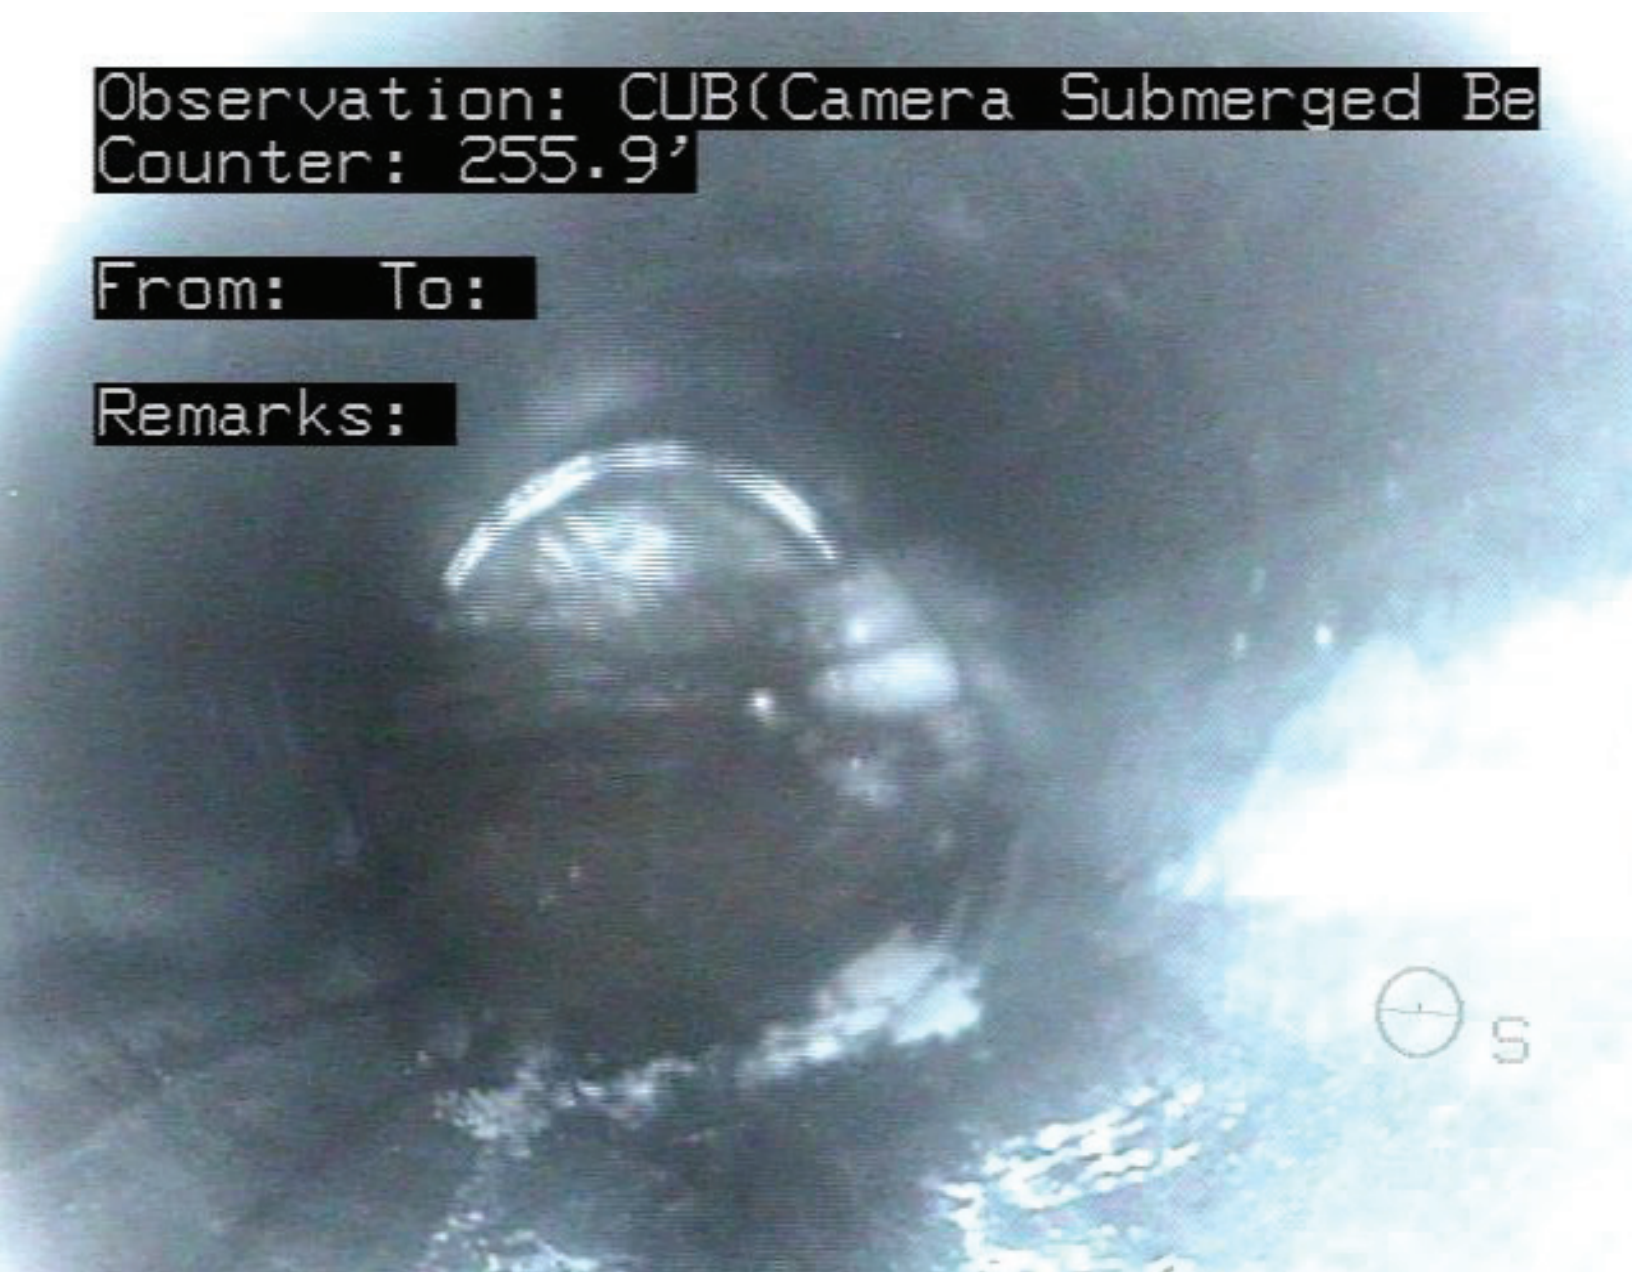
Observation: CUB(Camera Submerged Be  
Counter: 255.9'

Video Index Count 255.9 Ft  
 Code Camera Submerged Begin  
 Remarks  
 File Name 15.jpg

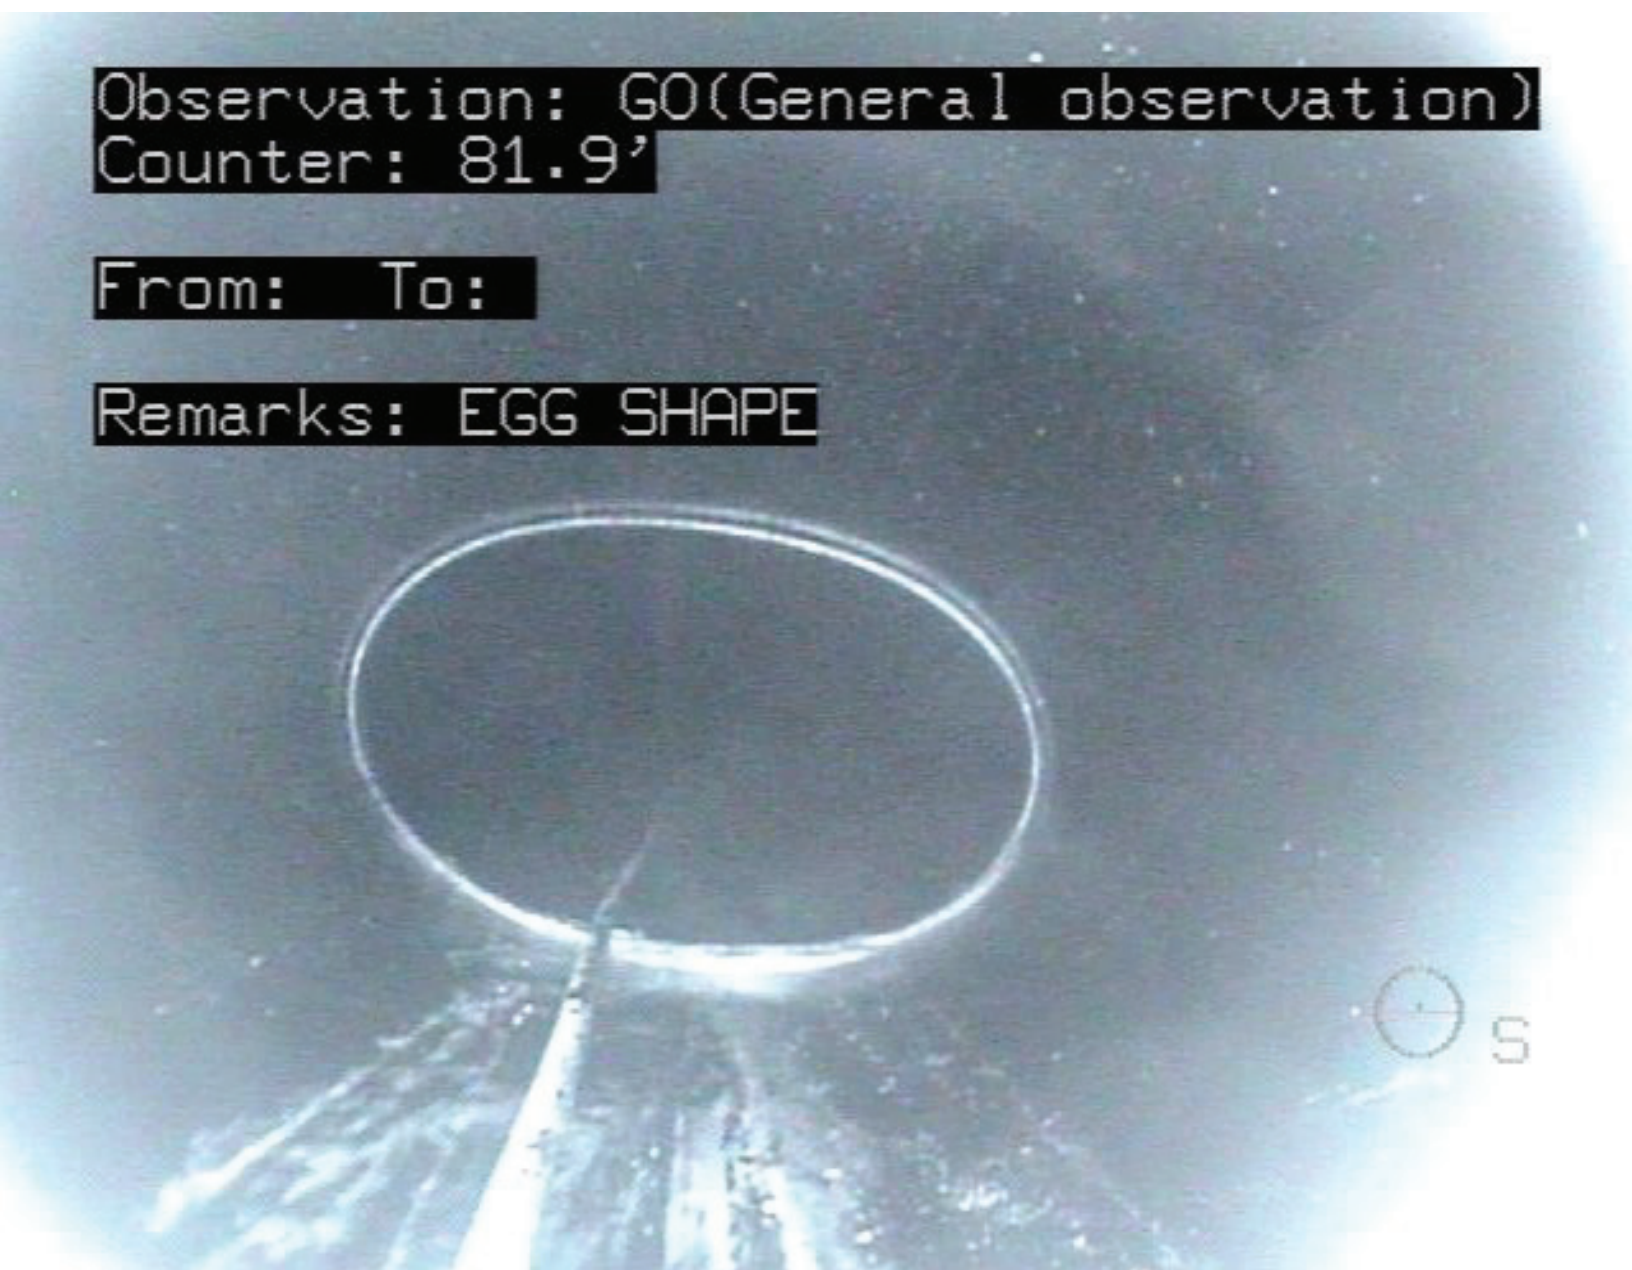
Observation: GO(General observation)  
Counter: 81.9'

- d) Video #3 is the longest because it appears the video recorder was left on after being removed (about 24:30 minutes).
4. Phase 1A: Setup 6 (WCO5 to ECO6): The video notes an egg-shaped pipe at approximately 81.9 feet (1:53 minutes). The video camera is unable to proceed due to the constricted pipe area at approximately 108.0 feet (2:00 minute) in the video.

Video Index Count 81.9 Ft  
 Code General observation  
 Remarks EGG SHAPE  
 File Name 18.jpg

Remarks: EGG SHAPE

The 2020 Jetclean Report noted that the high-pressure jet was unable to pass the Phase 1A blockage due to crushing, whereas the water jet was able to proceed in 2015. This may indicate that the pipe has become more constricted during this period, hindering its ability to convey leachate to the sump. Further investigation is recommended in the Phase 1A leachate pipe to determine the cause and severity of this issue.

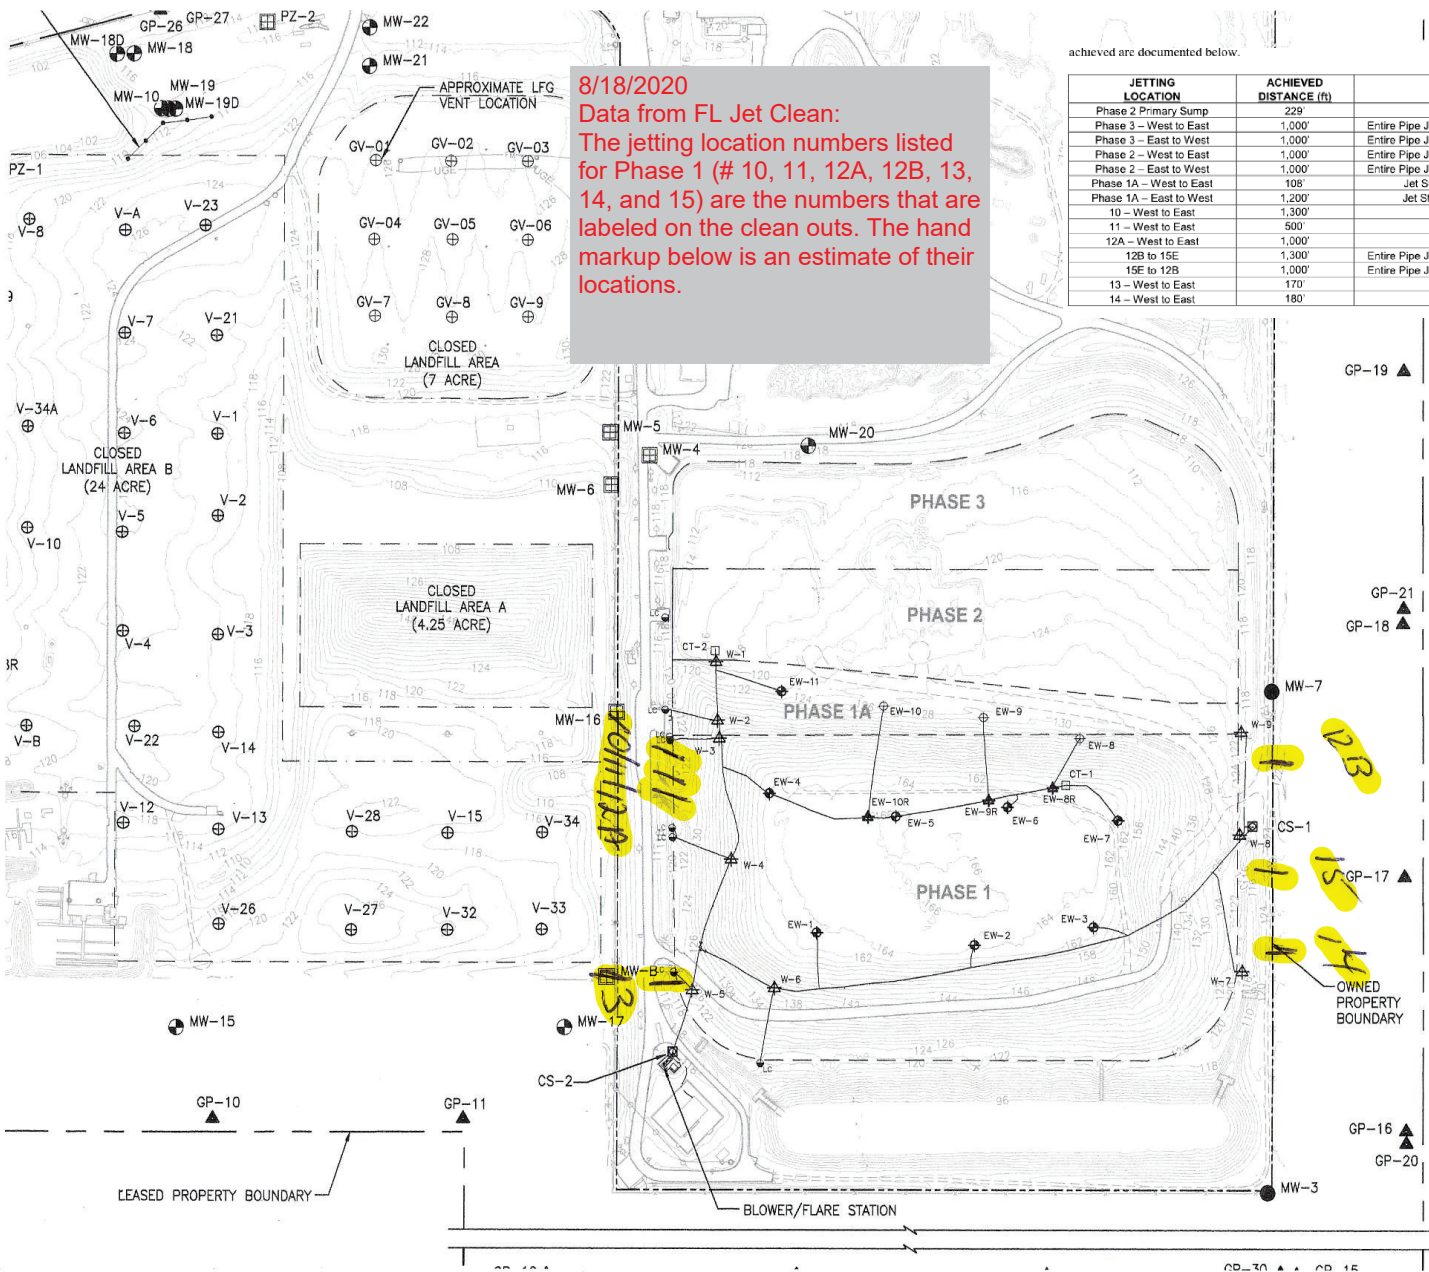
1. The partially crushed/egg-shaped pipe noted in Phase 1A of the 2020 Jetclean Report was also noted as partially crushed in the 2015 Jetclean Report. However, whereas the 2015 report noted that the water jet was able to pass the constricted pipe area, the 2020 report noted that the water jet stopped at this location.
2. In the Phase 2 pipe, the camera is noted as stopping at a different location in 2020 compared to 2015. The video commentary notes possible sand near the location where the camera stops.
3. The video inspection was able to proceed the entire length of the Phase 3 pipe in 2015, but the 2020 video inspection was only able to proceed a fraction of the total length from either direction. Sand was noted in the pipe in the 2020 inspection but not in the 2015 inspection.

Video Index Count 108.0 Ft  
 Code General observation  
 Remarks PIPE EGG SHAPE REDUCING ID  
 File Name 19.jpg

Remarks: PIPE EGG SHAPE REDUCING ID

Remarks: ID REDUCES

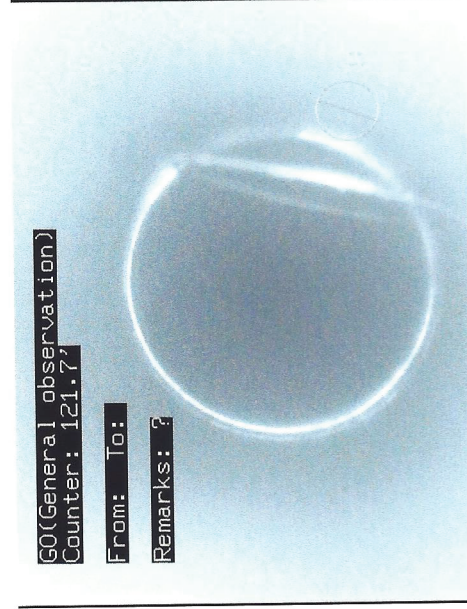
Date: 04/28/2015  
 Distance: 121.7 Ft  
 Obs: General observation  
 Comments:  
 ?

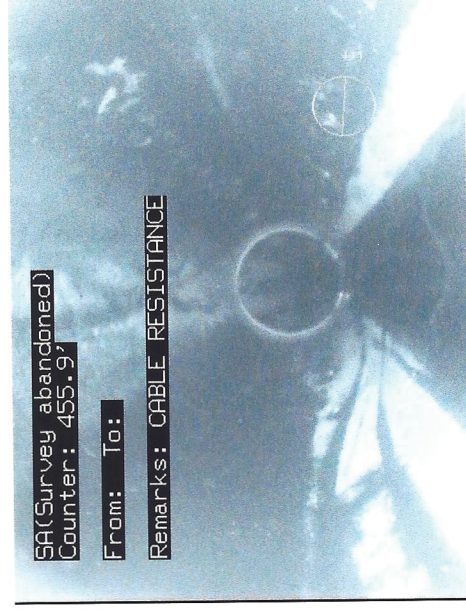
Date: 04/28/2015  
 Distance: 455.9 Ft  
 Obs: Survey abandoned  
 Comments:  
 CABLE RESISTANCE

SA(Survey abandoned)  
 Counter: 455.9'  
 From: To:  
 Remarks: CABLE RESISTANCE

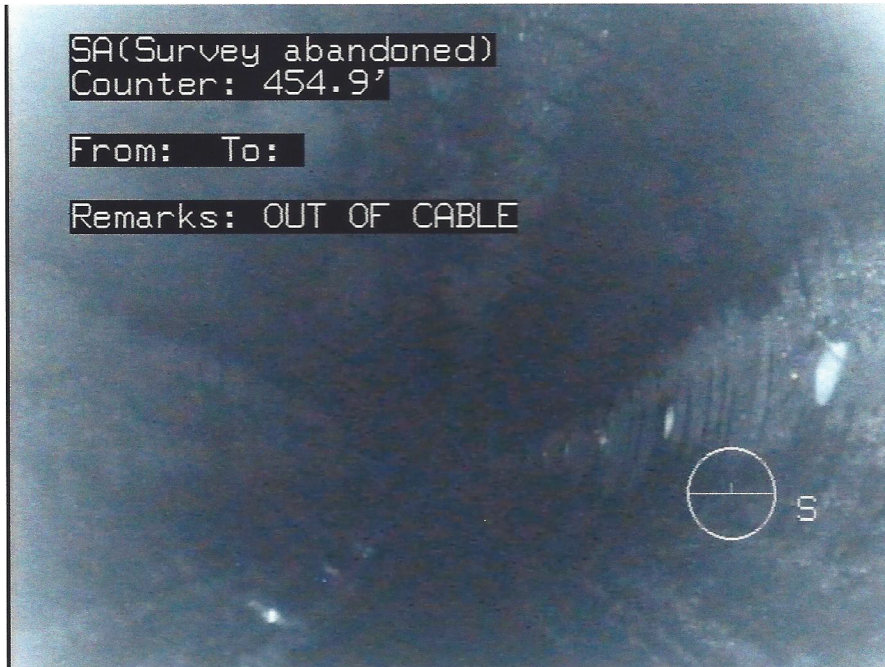
Comments: OUT OF CABLE
