**Florida Department of
Environmental Protection
Inspection Checklist**

Facility Name: CITRUS CENTRAL SLF
On-site Inspection Start Date: 12/04/2020
On-site Inspection End Date: 12/04/2020
WACS No.: 39859
Facility Street Address: 230 W GULF TO LAKE HWY
City: LECANTO
County Name: CITRUS
Zip: 34461

Routine Operation Inspection for Landfill - Class I

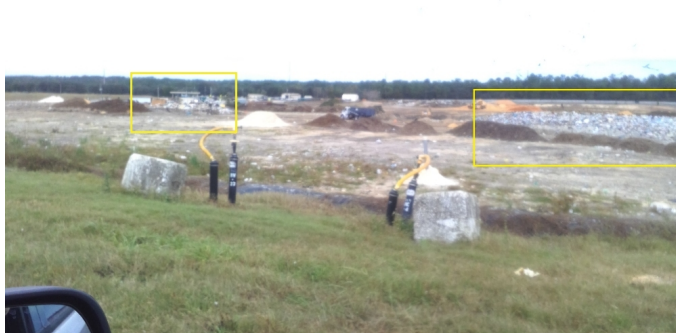
Explanation: Two working faces were observed in Phase III of the facility. One phase was dedicated to residential customers and the other to commercial customers. The operation of two working faces is not currently authorized by the Permit No. 21375-025-SO-01 and is not depicted in the facility's operation plan.

Two Working Faces

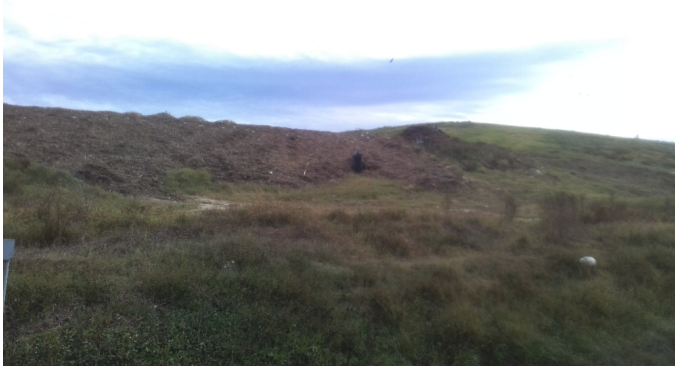
Explanation: During the inspection, litter was observed at the facility outside of the area immediately adjacent to the workface, including the stormwater swales, covered waste areas, the anchor trench tie-in berm, and areas beyond the fence on the east side of the landfill. Facility personnel were spotting litter on the west side of Phase II and III during the inspection. Photo documentation was provided to the Department via email on December 11, 2020, showing that litter was removed from the areas beyond the fence on the east side of the landfill and the access road adjacent to that fence. In addition, per this same email correspondence, litter fences are to be installed at the facility.

West Side of Phase II/III

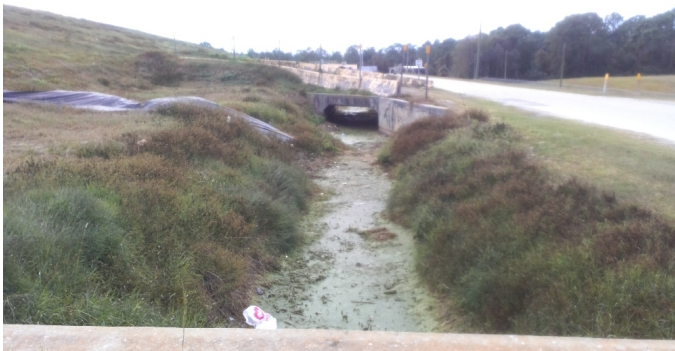
Western Stormwater Swale

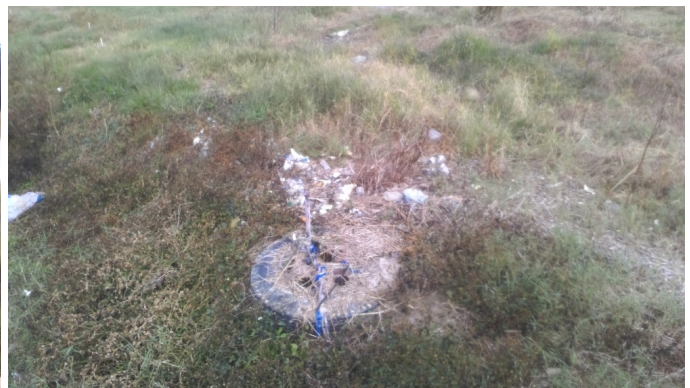
Area Adjacent to Stormwater Swale

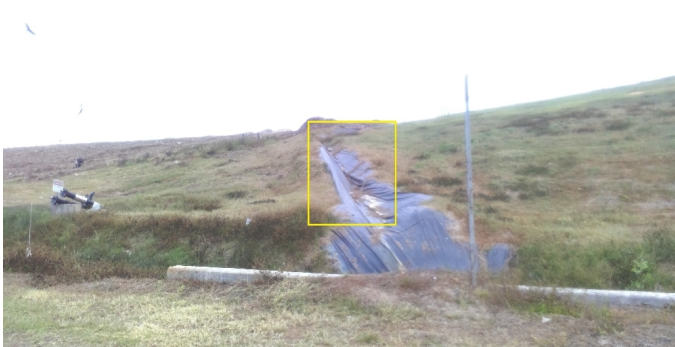
Anchor Trench Tie-In Berm

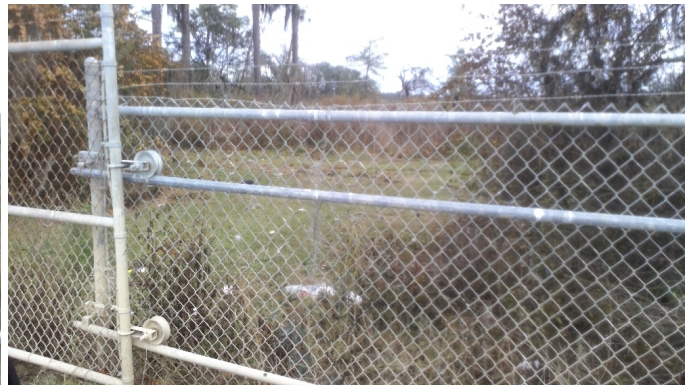
Litter Beyond Fence

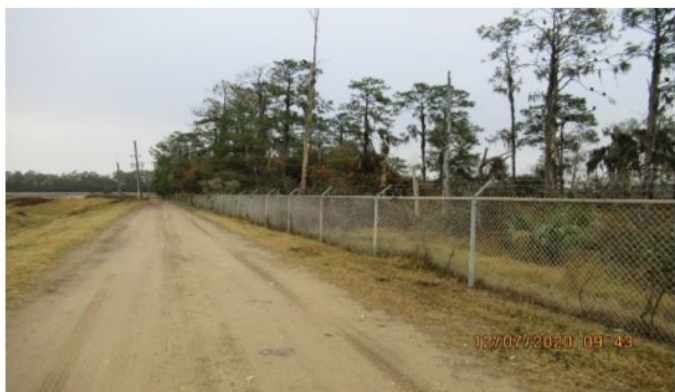
12/11/20: No Litter Beyond Fence

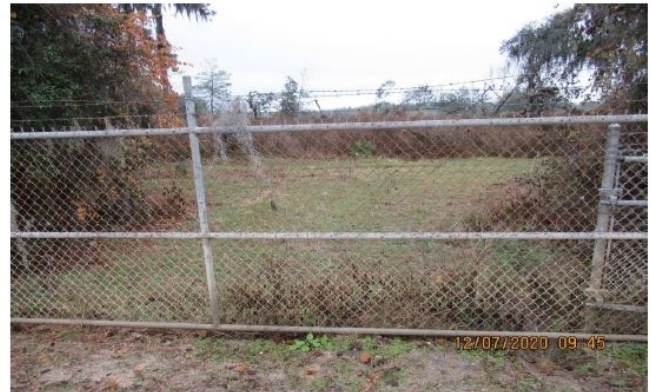
12/11/20: No Litter Beyond Fence

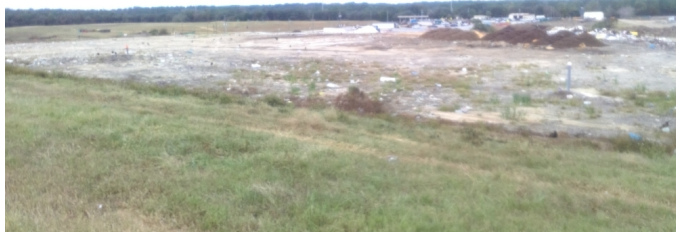
Explanation: This is the second consecutive violation for this item observed during inspection. The initial cover located in the central areas of Phase III was not adequate during the inspection. Facility staff indicated that some of the issues could be attributed to a break down of the compactor in the days prior to the inspection. Photo documentation was submitted to the Department electronically on December 18, 2020, demonstrating that the facility has begun to deposit initial cover on previously identified areas. However, following the inspection, the facility's dozer experienced a mechanical malfunction and is currently being repaired offsite. The facility is currently working to receive a rented dozer to complete the placement of initial cover in these areas.

Central Areas - Inadequate Cover

Corrective Action: Within 30 calendar days of the date listed on the attached letter, please provide the Department with documentation indicating one of the following:
 A) The the dozer was repaired and is currently functional at the facility, or;
 B) A rented dozer was obtained and is in use at the facility.

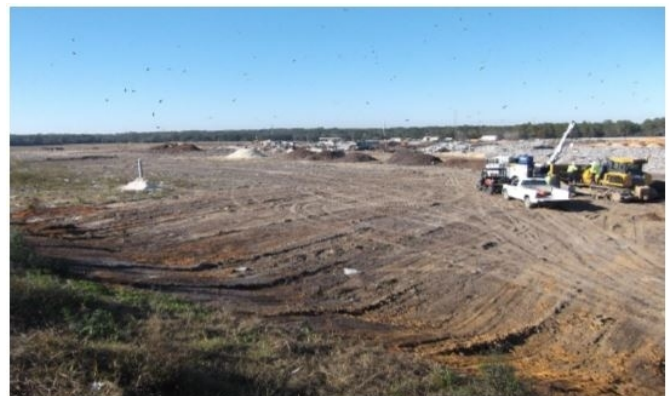
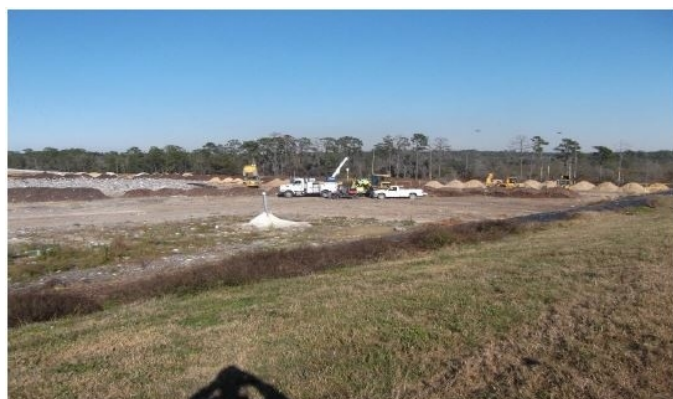
12/18/20: Work in Central Areas

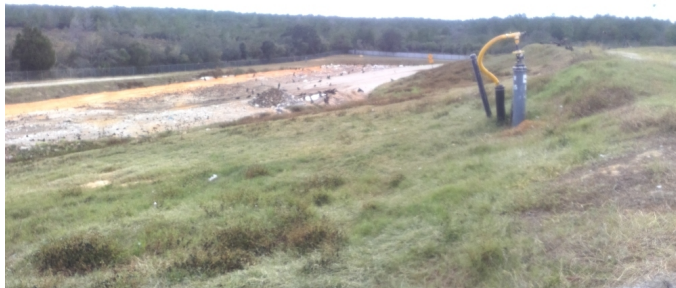
Explanation: This is the second consecutive violation for this item observed during inspection. The intermediate cover located on the southeastern corner of Phase I was not adequate during the inspection. The facility provided the Department with photo documentation via email on December 18, 2020, that the southeastern corner of Phase I received adequate intermediate cover. In addition, a bare spot was observed on the top of Phase I near the northern side slope that leads down to Phase II.

SE Corner, Phase I

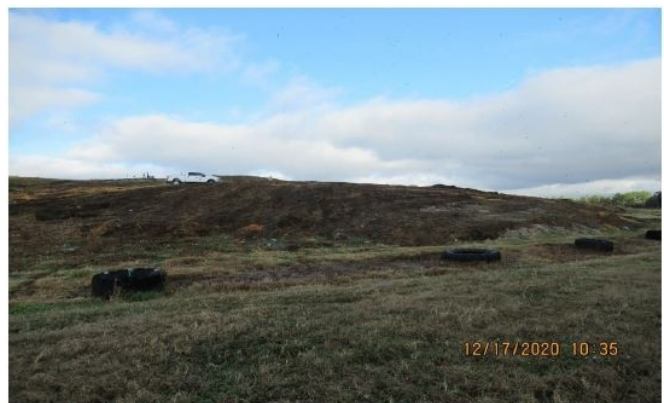
12/18/20: SE Corner w/ Cover

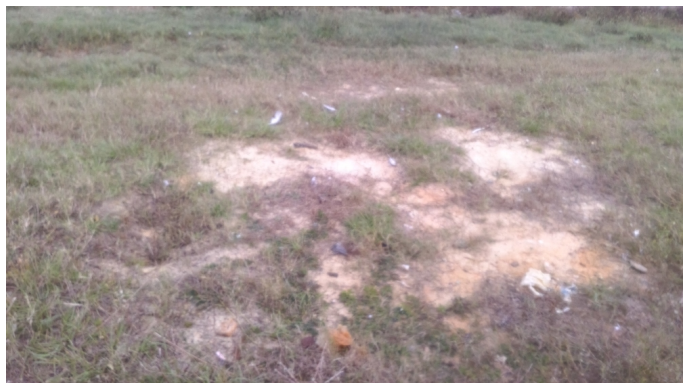
Bare Spot on Phase I

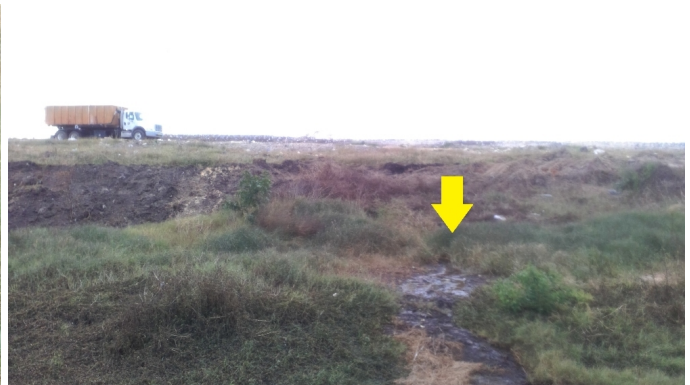
A) Five leachate seeps in total were observed at the eastern, northern, and western sides of the landfill. The western leachate seep was observed in Phase II and potentially discharged into the stormwater system. The northern leachate seeps (two seeps) were discharging outside of the edge of disposal and into the perimeter stormwater swale. The eastern leachate seeps (two seeps) were also

North Leachate Seep (1)

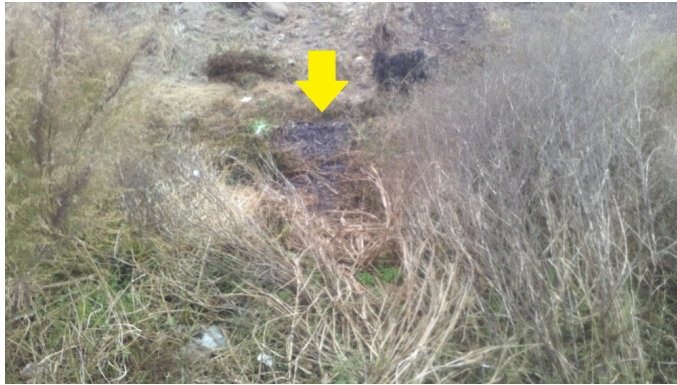
North Leachate Seep (2)

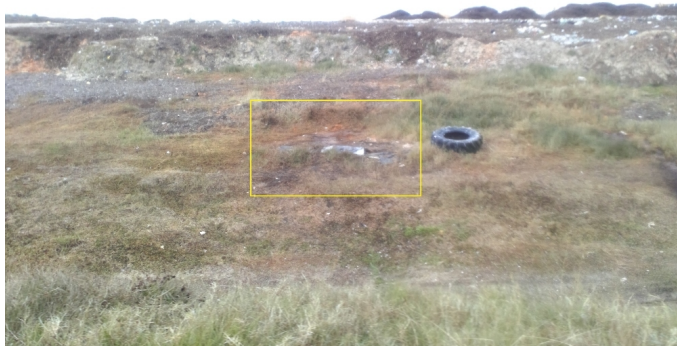
discharging outside of the edge of disposal and possibly into the stormwater management system. Per email correspondence dated December 11, 2020, the facility indicated that the recent installation of lateral gas wells may have created a conduit for water to infiltrate the landfill and to consequently cause these leachate seeps. Photo documentation was provided with this correspondence showing that the eastern and northern leachate seeps were repaired by placing cover on them.

East Leachate Seep (2)

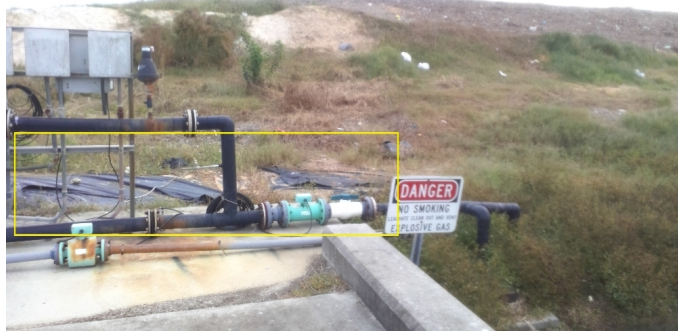
Explanation: Although odors were not observed beyond the landfill property boundary, the gas-like odors detected onsite were strong at the time of the inspection. Adjacent to the Phase III riser pipes, the gas odor was found to be incredibly strong. Upon inspection of the area adjacent to these pipes, Department staff observed a bare area and exposed geonet. It is believed that this area could be conduit for gas to escape the landfill. On December 11, 2020, the facility provided photo documentation via email showing that this bare area and geonet was covered with soil.

Bare Area & Exposed Geonet

Corrective Action: Please inspect the perimeter of Phase III for any excessive odors, bare spots, and/or exposed geonet. If observed, please cover the areas with soil. This activity should be incorporated into routine facility inspections to minimize gas emissions and odors.
