Re: Warning Letter #WL20-207SW09SWD
OGC File No. 05-1078
Citrus County Class I Central Landfill
Facility ID: 39859
Citrus County

**Florida Department of
Environmental Protection
Inspection Checklist**

Facility Name: CITRUS CENTRAL SLF
On-site Inspection Start Date: 12/04/2020
On-site Inspection End Date: 12/04/2020
WACS No.: 39859
Facility Street Address: 230 W GULF TO LAKE HWY
City: LECANTO
County Name: CITRUS
Zip: 34461

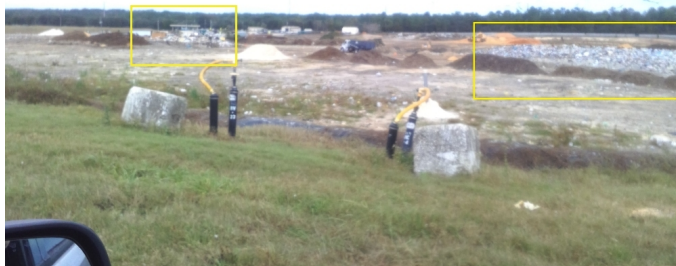
Two Working Faces

Explanation: Two working faces were observed in Phase III of the facility. One phase was dedicated to residential customers and the other to commercial customers. The operation of two working faces is not currently authorized by the Permit No. 21375-025-SO-01 and is not depicted in the facility's operation plan.

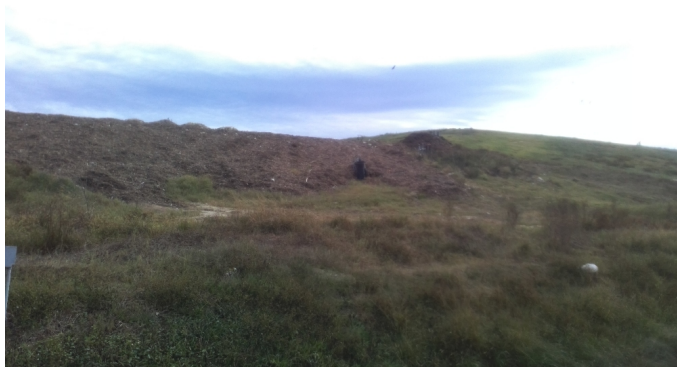
West Side of Phase II/III

Explanation: During the inspection, litter was observed at the facility outside of the area immediately adjacent to the workface, including the stormwater swales, covered waste areas, the anchor trench tie-in berm, and areas beyond the fence on the east side of the landfill. Facility personnel were spotting litter on the west side of Phase II and III during the inspection. Photo documentation was provided to the Department via email on December 11, 2020, showing that litter was removed from the areas beyond the fence on the east side of the landfill and the access road adjacent to that fence. In addition, per this same email correspondence, litter fences are to be installed at the facility.

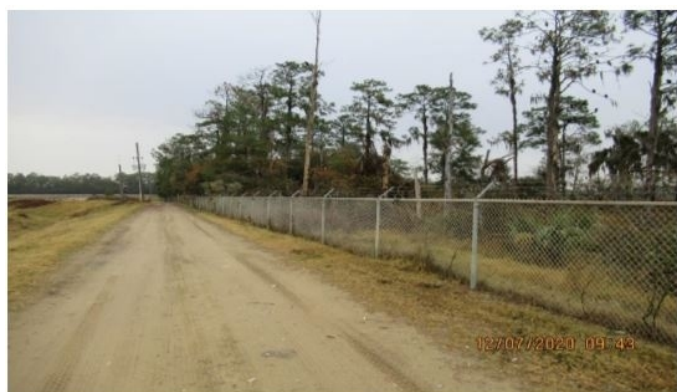
12/11/20: No Litter Beyond Fence

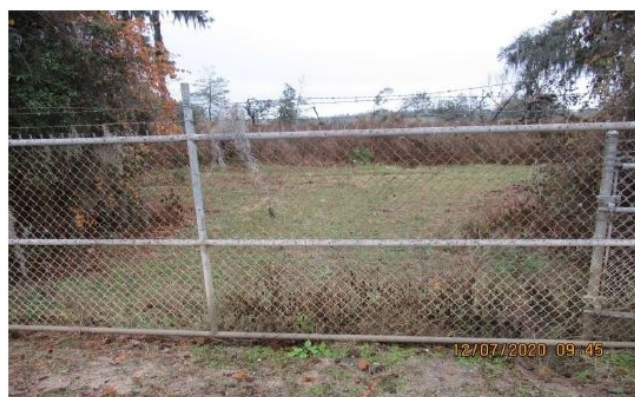
12/11/20: No Litter Beyond Fence

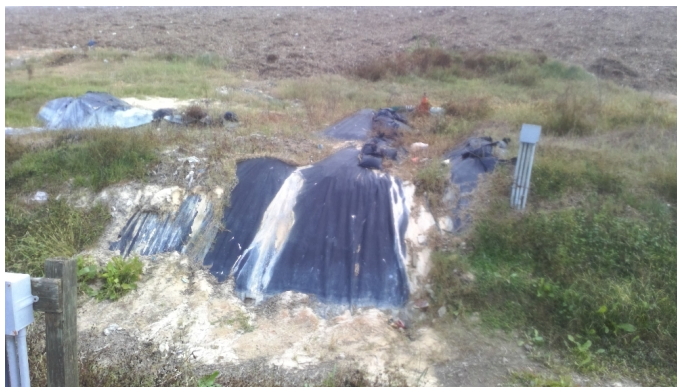
Explanation: Erosion was observed within the stormwater swale on the western side of the landfill during the inspection. The stormwater liner was exposed as a result of this erosion. Waste was also observed above and below the area of erosion.

Erosion & Washdown in Swale

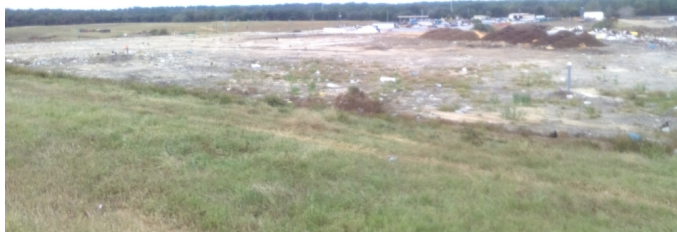
Explanation: This is the second consecutive violation for this item observed during inspection. The initial cover located in the central areas of Phase III was not adequate during the inspection. Facility staff indicated that some of the issues could be attributed to a break down of the compactor in the days prior to the inspection. Photo documentation was submitted to the Department electronically on December 18, 2020, demonstrating that the facility has begun to deposit initial cover on previously identified areas. However, following the inspection, the facility's dozer experienced a mechanical malfunction and is currently being repaired offsite. The facility is currently working to receive a rented dozer to complete the placement of initial cover in these areas.

Central Areas - Inadequate Cover

Corrective Action: Within 30 calendar days of the date listed on the attached letter, please provide the Department with documentation indicating one of the following:
 A) The the dozer was repaired and is currently functional at the facility, or;
 B) A rented dozer was obtained and is in use at the facility.

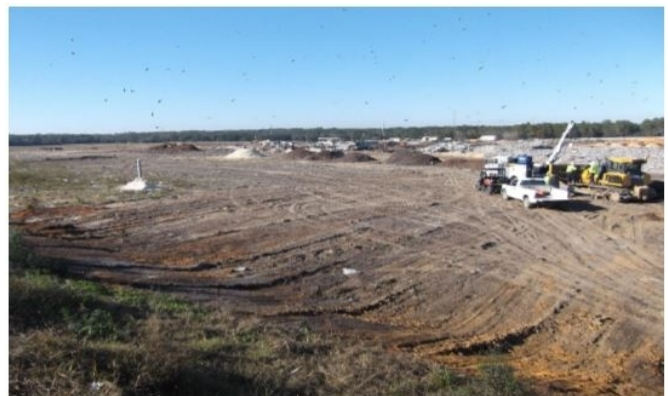
12/18/20: Work in Central Areas

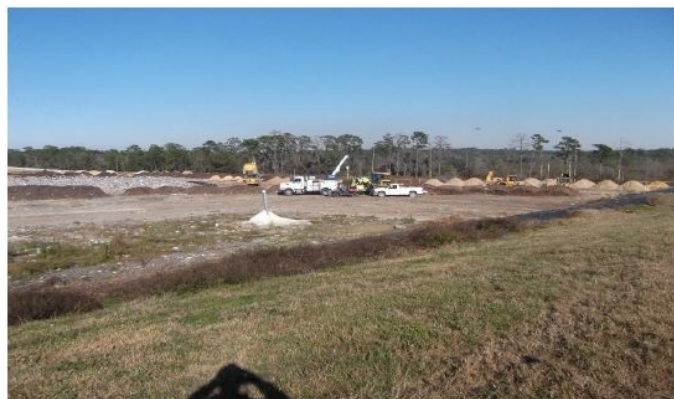
12/18/20: Work in Central Areas

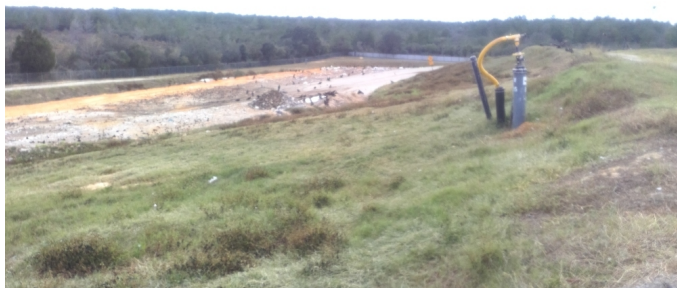
SE Corner, Phase I

Explanation: This is the second consecutive violation for this item observed during inspection. The intermediate cover located on the southeastern corner of Phase I was not adequate during the inspection. The facility provided the Department with photo documentation via email on December 18, 2020, that the southeastern corner of Phase I received adequate intermediate cover. In addition, a bare spot was observed on the top of Phase I near the northern side slope that leads down to Phase II.

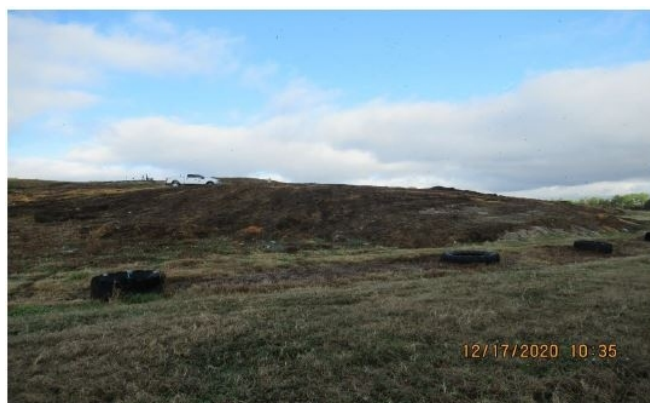
12/18/20: SE Corner w/ Cover

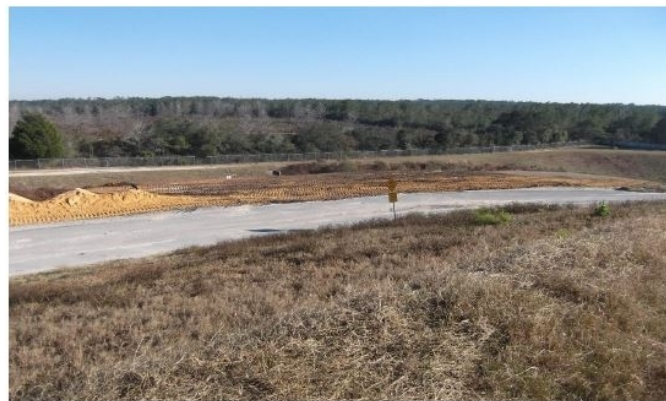
12/18/20: SE Corner w/ Cover

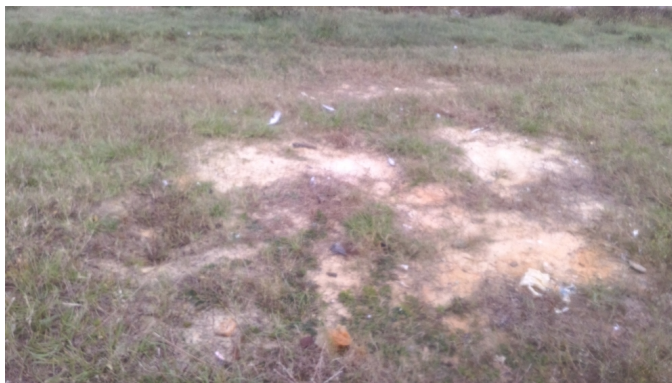
Bare Spot on Phase I

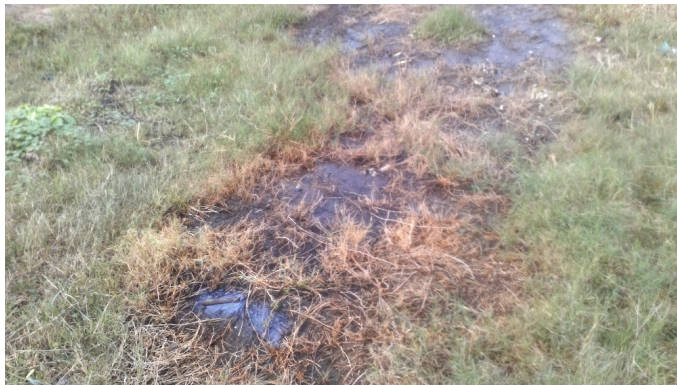
West Leachate Seep

A) Five leachate seeps in total were observed at the eastern, northern, and western sides of the landfill. The western leachate seep was observed in Phase II and potentially discharged into the stormwater system. The northern leachate seeps (two seeps) were discharging outside of the edge of disposal and into the perimeter stormwater swale. The eastern leachate seeps (two seeps) were also

A) The December 11 correspondence does not appear to contain photo documentation demonstrating that the seep located on the western side of the landfill is repaired. Please provide this documentation within 30 calendar days of the date listed on the attached letter. In addition, please continue to inspect the facility daily for leachate seeps to ensure that no discharges outside of the edge of disposal and discharges into the stormwater system occur. If this does occur, please notify the Department within 24 hours of occurrence. If seepage continues, the County may need to explore greater mitigation efforts, e.g. a constructed toe drain or some other tie-in to the leachate system to ensure leachate is not allowed to discharge beyond the liner system.

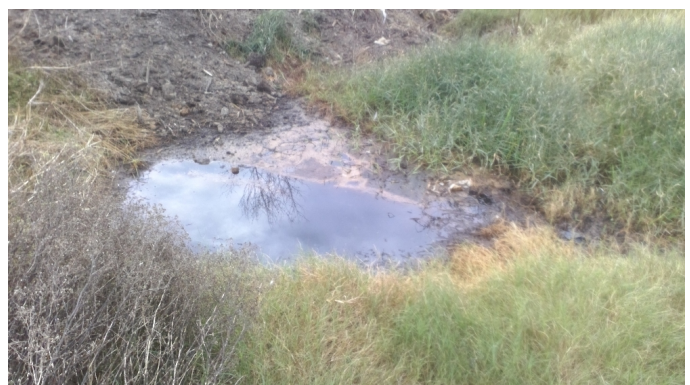
Puddle from Leachate Seep

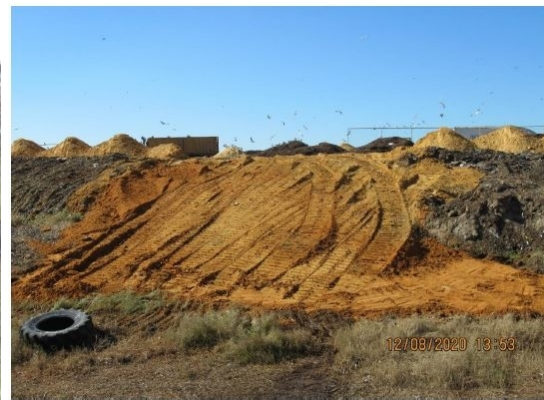
discharging outside of the edge of disposal and possibly into the stormwater management system. Per email correspondence dated December 11, 2020, the facility indicated that the recent installation of lateral gas wells may have created a conduit for water to infiltrate the landfill and to consequently cause these leachate seeps. Photo documentation was provided with this correspondence showing that the eastern and northern leachate seeps were repaired by placing cover on them.

East Seeps Repair

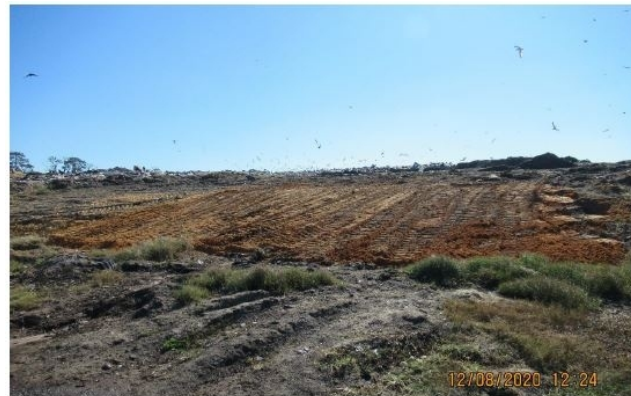
North Seeps Repair

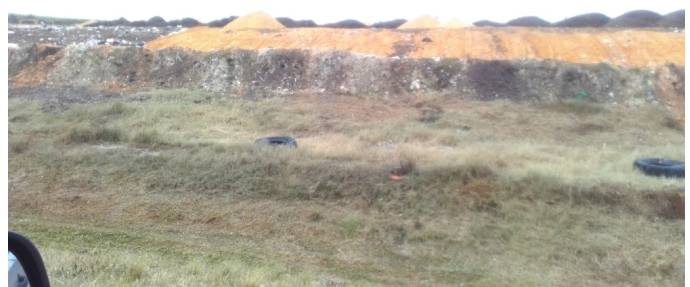
Waste Filled Berm

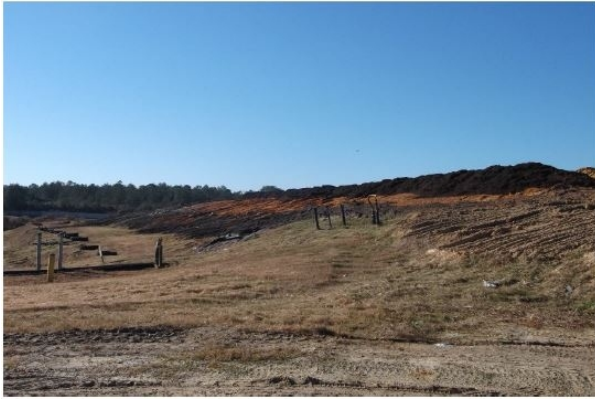
Berm of Clean Soil

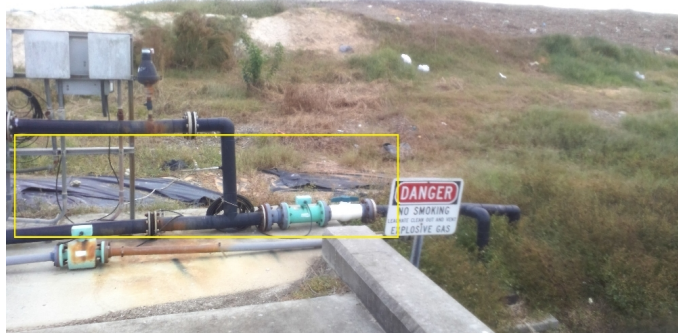
Explanation: Although odors were not observed beyond the landfill property boundary, the gas-like odors detected onsite were strong at the time of the inspection. Adjacent to the Phase III riser pipes, the gas odor was found to be incredibly strong. Upon inspection of the area adjacent to these pipes, Department staff observed a bare area and exposed geonet. It is believed that this area could be conduit for gas to escape the landfill. On December 11, 2020, the facility provided photo documentation via email showing that this bare area and geonet was covered with soil.

Bare Area & Exposed Geonet

Corrective Action: Please inspect the perimeter of Phase III for any excessive odors, bare spots, and/or exposed geonet. If observed, please cover the areas with soil. This activity should be incorporated into routine facility inspections to minimize gas emissions and odors.

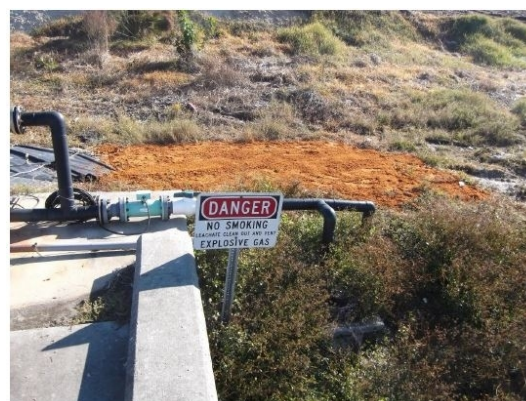
12/11/20: Soil Over Area

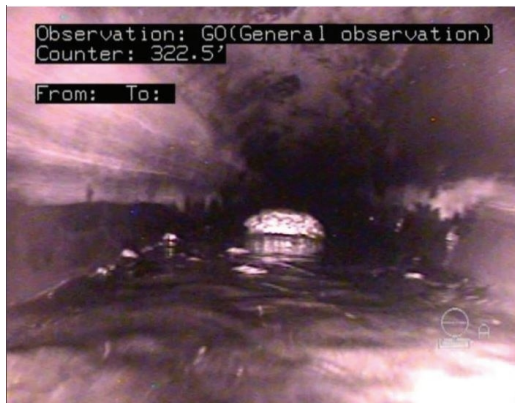
C) Per the Leachate Collection System Cleaning and Video Inspection Memorandum, four areas of pipe in which possible issues were encountered were observed. Two areas of pipe in which the camera stopped for unknown reasons are located in Phases II and III. The third area of pipe is also in Phase III. Within this area, sand is visible and caused the camera to stop. The fourth area of pipe is located in Phase IA and it was observed that the pipe is partially crushed, therefore causing the camera to stop. During the inspection, Department staff observed limestone within the onsite borrow pit. Based on the images provided by the leachate cleaning and inspection report, it is possible that calcification could be occurring within this area of the leachate system. In addition, Jones Edmunds indicates in this memorandum that the Phase IA pipe has become more constricted since 2015, and that more sand has accumulated in Phases II and III since 2015. The Jones Edmunds Cleaning and Inspection Memorandum indicates that additional investigation of these two areas is warranted.

C) Phase III - Sand Observed

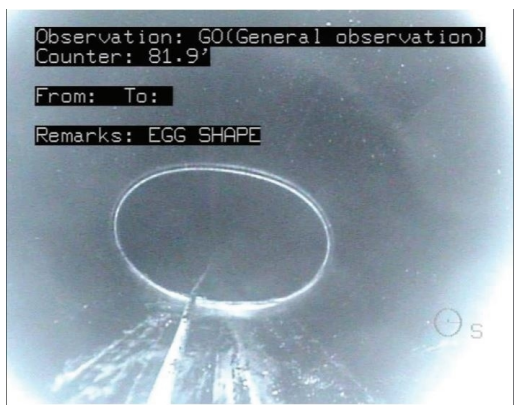
C) Phase IA Constricted Pipe

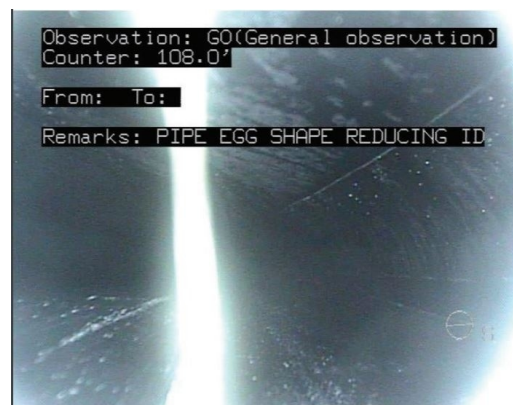
C) Phase IA Constricted Pipe

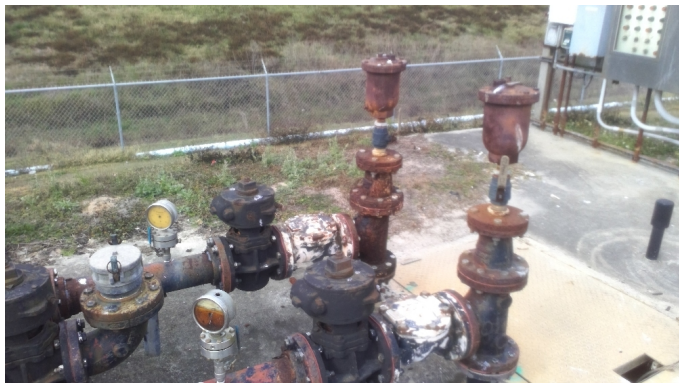
D) At the time of the inspection, exterior portions of the flare condensate flange and the piping above the leachate lift station were corroded. The air relief valve at the main lift station discharged a heavy stream of leachate into the air during the inspection. Email correspondence dated December 11 and 18, 2020 from the facility shows that the flare condensate flange was replaced.

D) Corroded Lift Station Pipes

D) Please provide photo documentation demonstrating that the corroded pipes at the lift station were replaced and that the air relief valve is replaced to prevent significant leachate discharge.

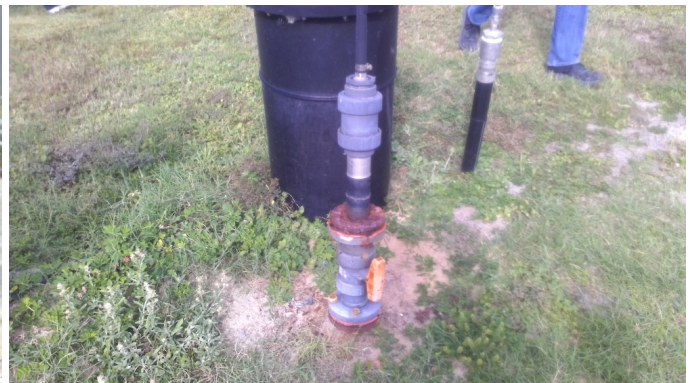
D) Corroded CS-2 Flange

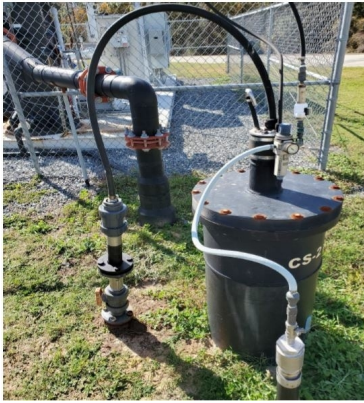
D) Replaced CS-2 Flange
