# CITRUS COUNTY CENTRAL LANDFILL

## RESPONSE TO FDEP

### REGARDING ON-SITE INSPECTION

**PERMIT NO.: Permit No. 21375-025-SO-01**

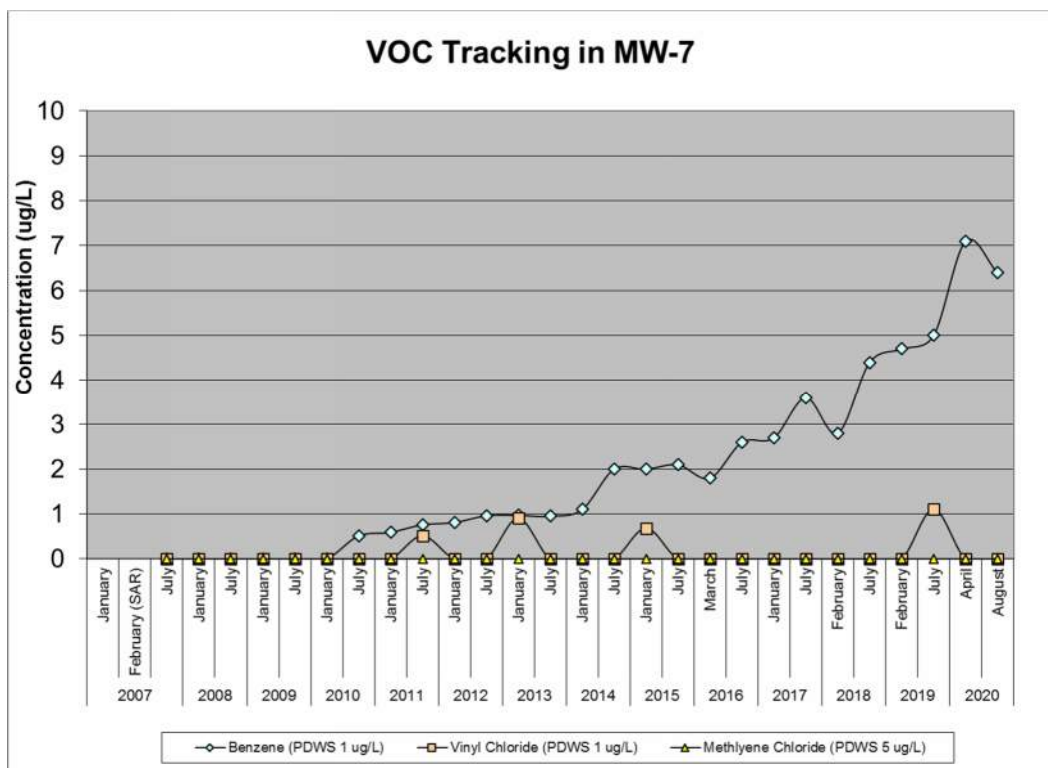
**We observed a decrease in VOCs in MW-7 for the first time in over 2 years during the Second Semiannual 2020 sampling event. The decrease followed an increase during the First Semiannual 2020 event. The active LFG system started pulling LFG from around MW-7 at the beginning of 2020, whereas the LFG migration control system on the closed cells was not running until June 2020. The initial increase may be attributed to pulling more gas over near MW-7 followed by the initial decrease as we continued removing LFG and lowering the partial pressure on the groundwater in this area. Lowering the pressure drives the reaction back so that the VOCs stay in the gas and out of the groundwater. We expect these concentrations to continue to decrease as the system continues operation.**

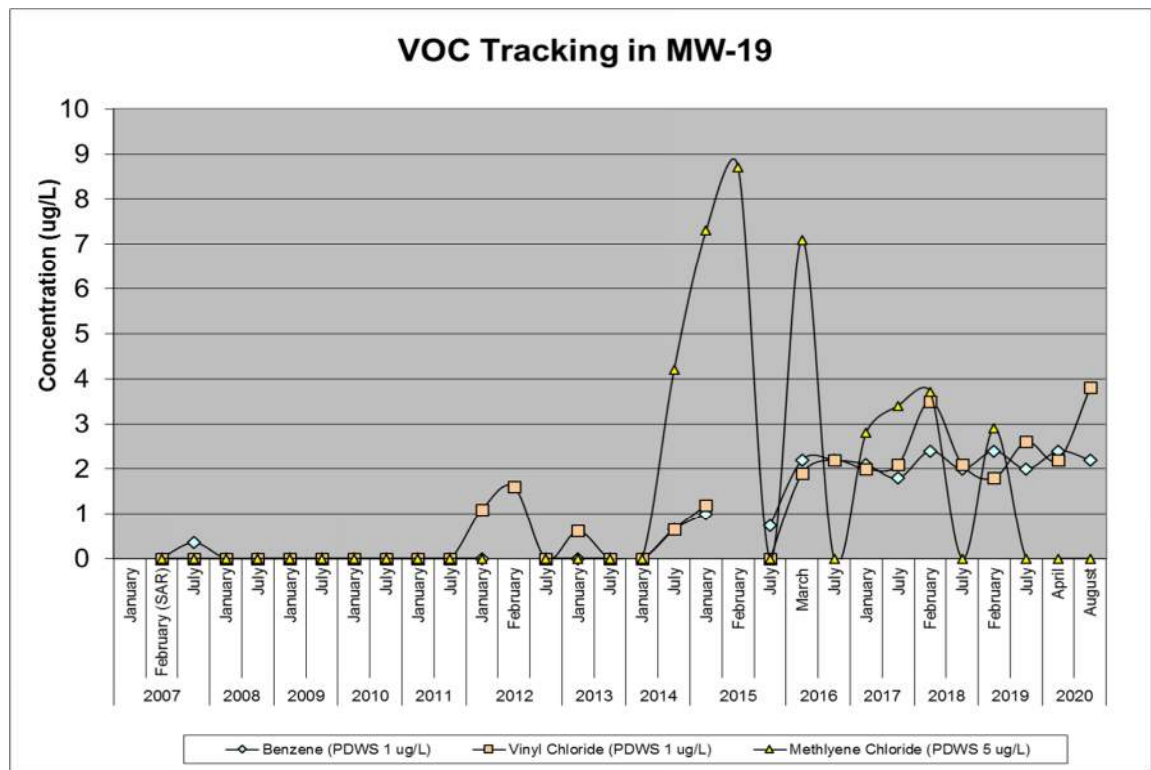
In MW-19D, we observed a slight decrease in Benzene but an increase in Vinyl Chloride during the Second Semiannual 2020 sampling event. Methylene Chloride, the most volatile of the three parameters and being the quickest to partition in and out of the groundwater, has been below the laboratory detection limit since the First Semiannual 2019 sampling event.

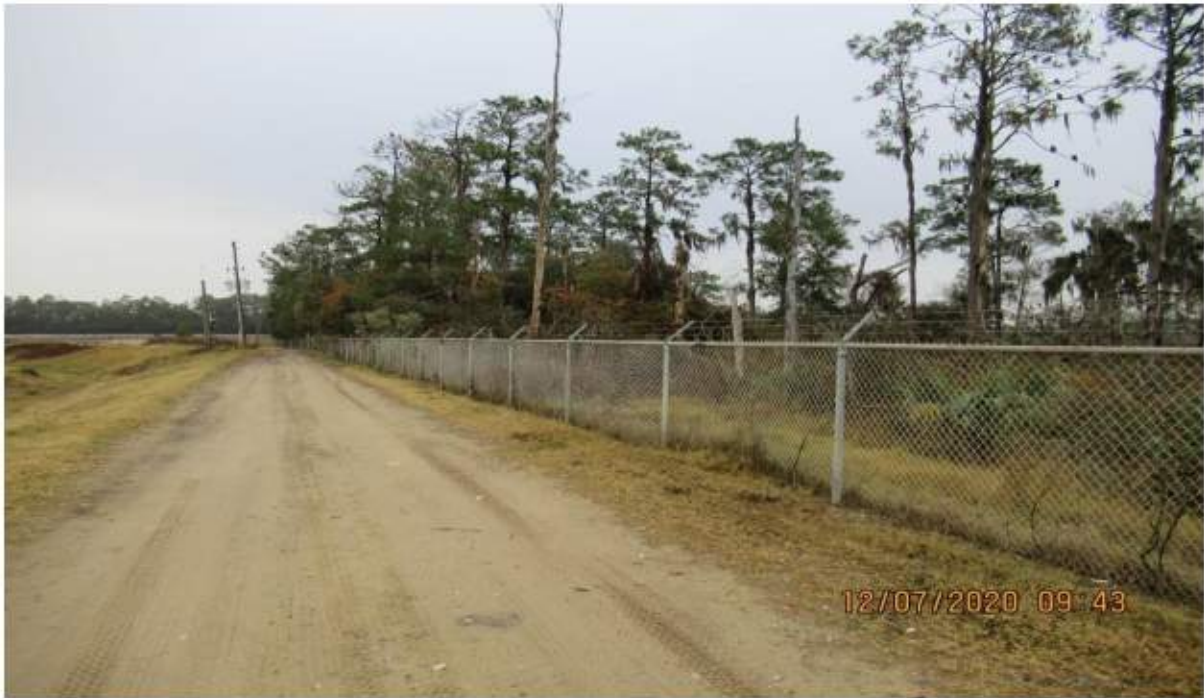
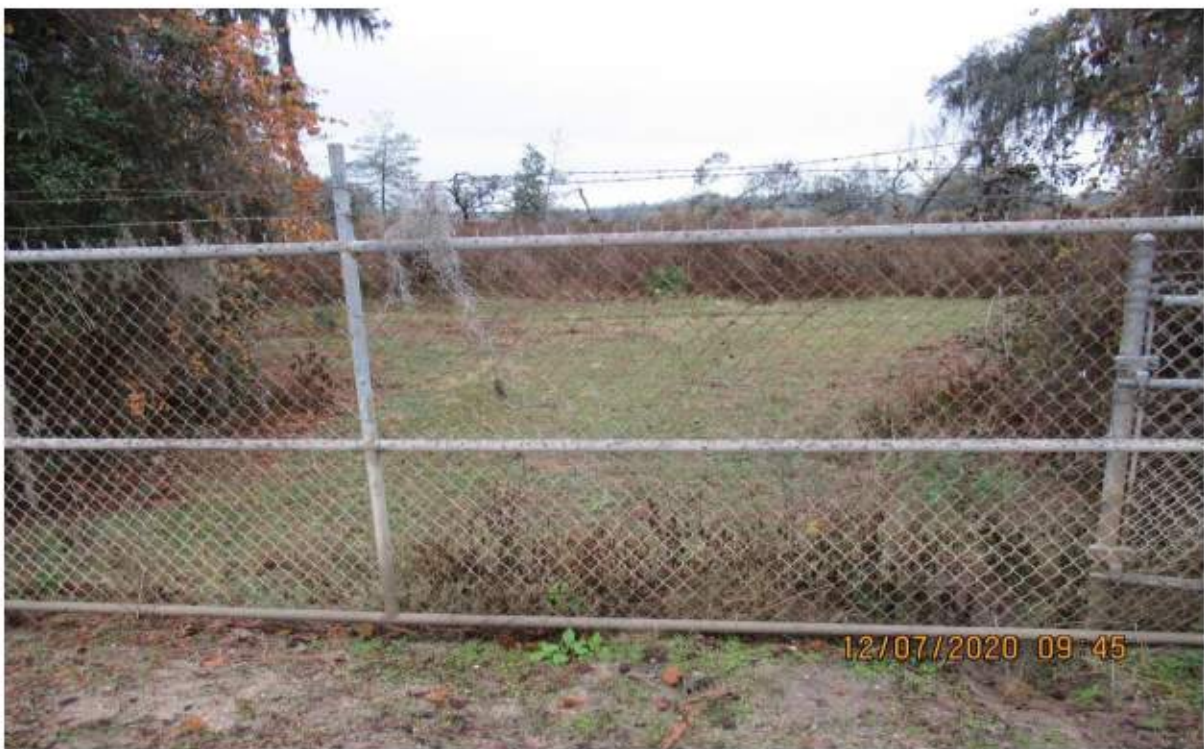
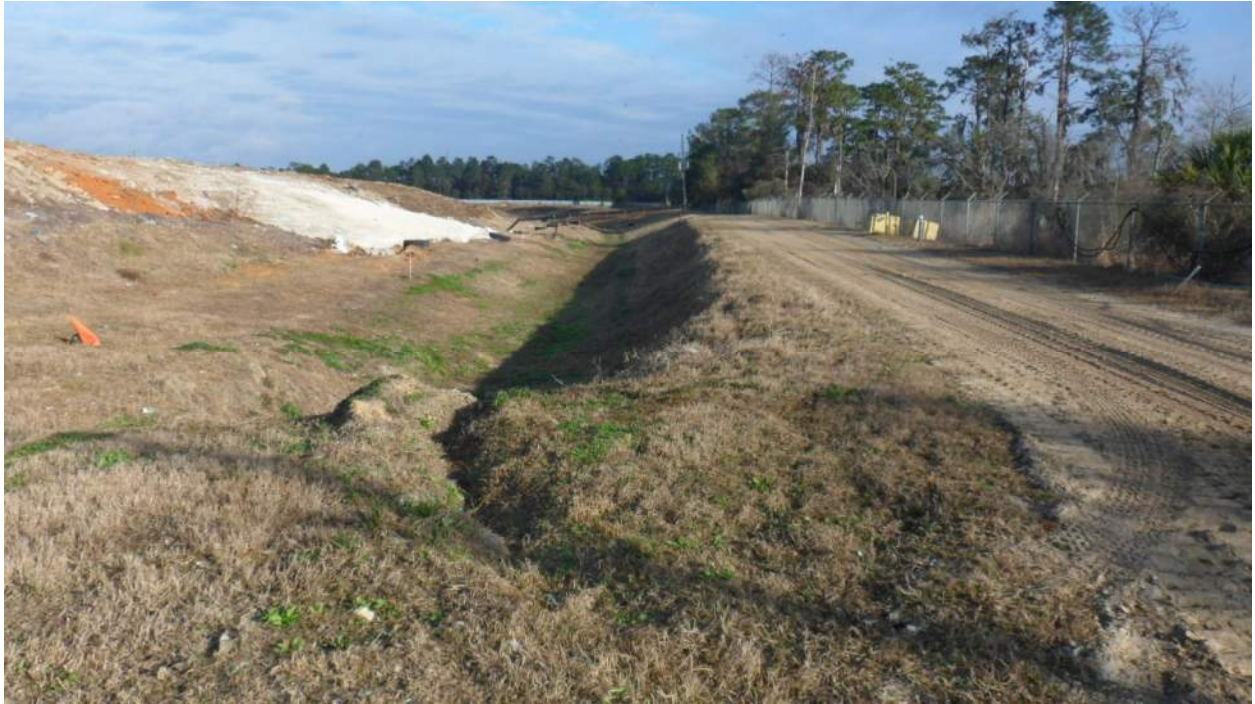
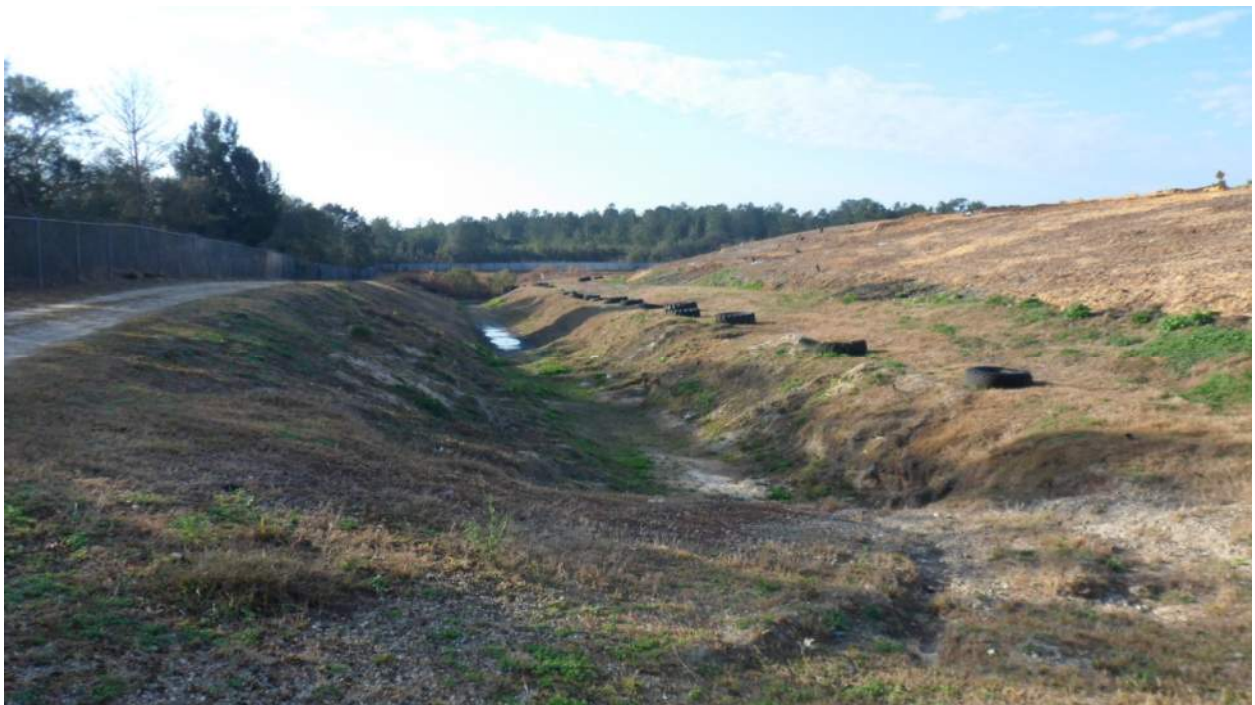
**Attachment 1**  
**Litter Removal Photographs**

Explanation: During the inspection, litter was observed at the facility outside of the area immediately adjacent to the workforce, including the stormwater swales, covered waste areas, the anchor trench tie-in berm, and areas beyond the fence on the east side of the landfill. Facility personnel were spotting litter on the west side of Phase II and III during the inspection. Photo documentation was provided to the Department via email on December 11, 2020, showing that litter was removed from the areas beyond the fence on the east side of the landfill and the access road adjacent to that fence. In addition, per this same email correspondence, litter fences are to be installed at the facility.

**Response 2.20: Litter has been removed from the stormwater swales, covered waste areas, and the anchor trench tie-in berms. Attachment 1 includes photographs. The County currently has in use 4 litter fences and is in the process of purchasing 8 additional fences. Procurement of the fences is underway and the expected board approval for purchase is in March of 2021.**

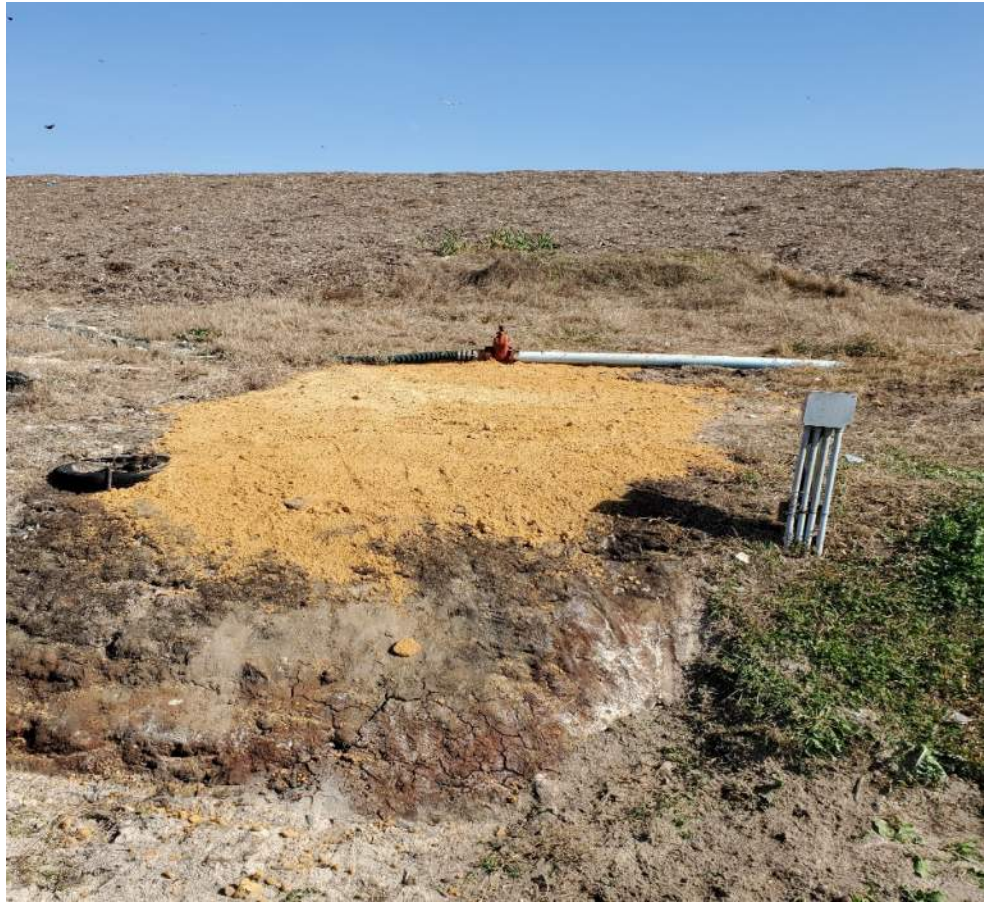
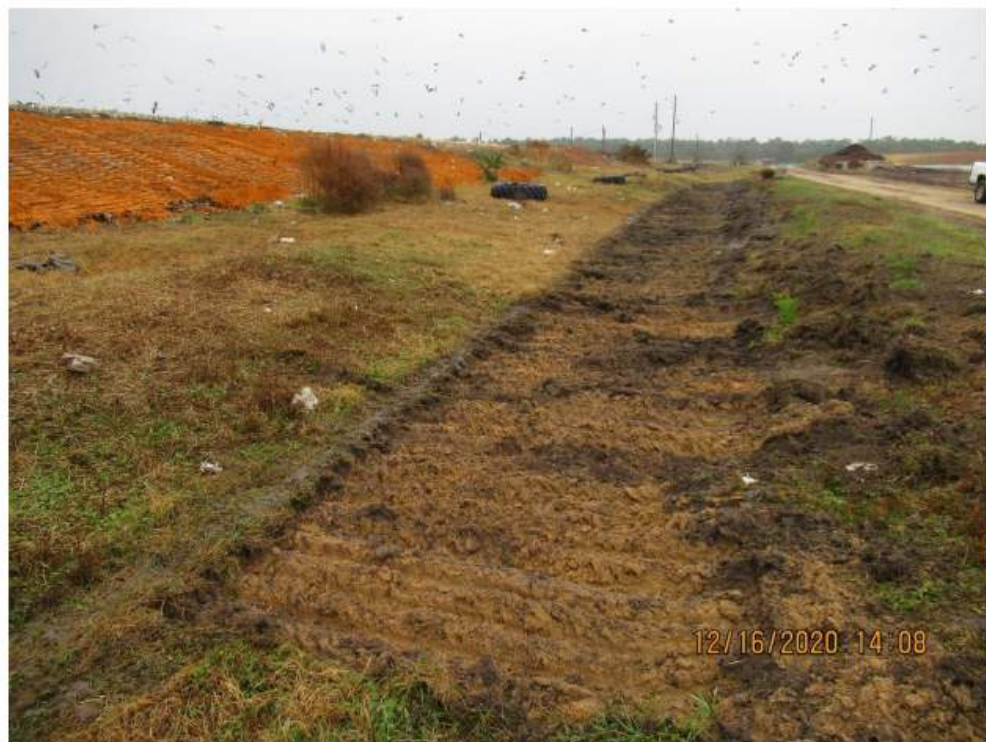
**Attachment 2**

Explanation: Erosion was observed within the stormwater swale on the western side of the landfill during the inspection. The stormwater liner was exposed as a result of this erosion. Waste was also observed above and below the area of erosion.

**Response 2.21: The stormwater swale on the west side of the landfill in Phase I has been repaired. Attachment 2 provides photographs of the repairs.**

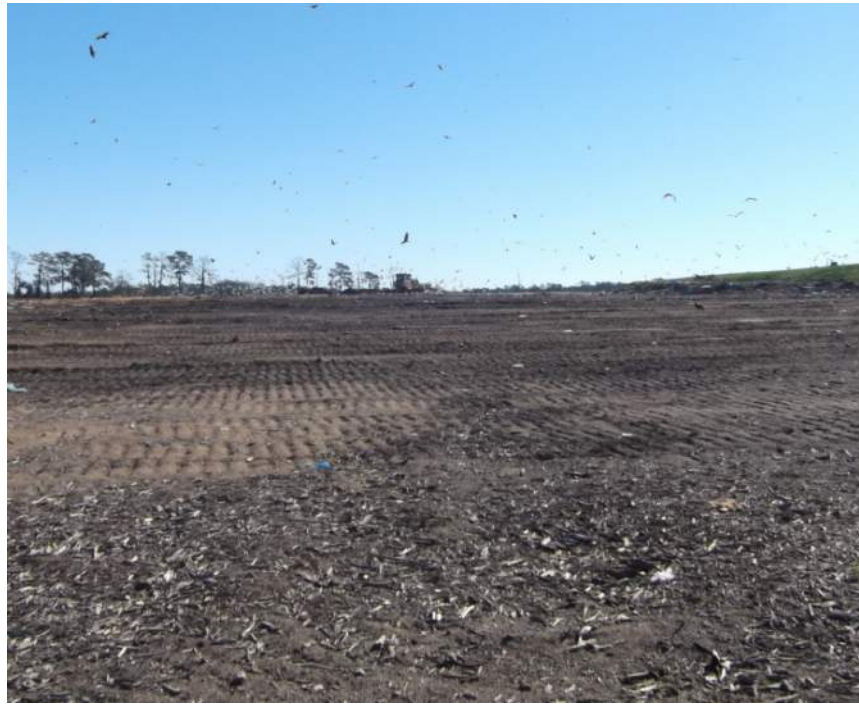
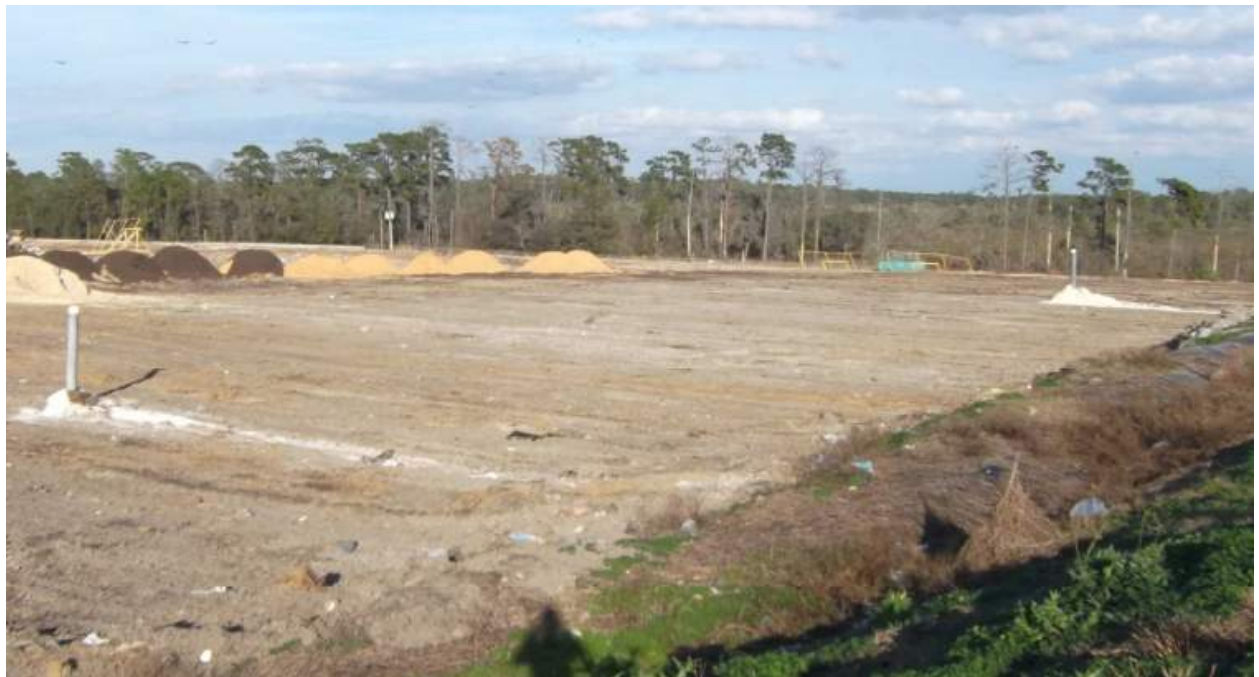
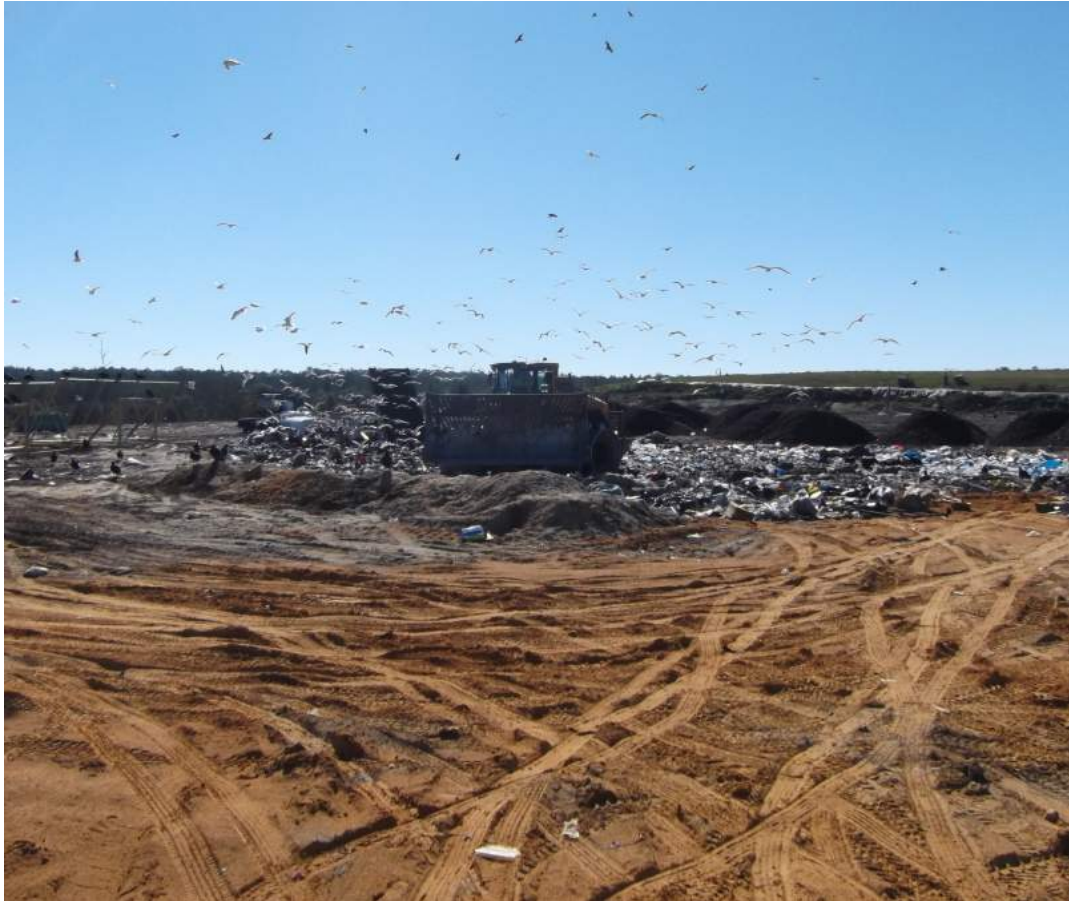
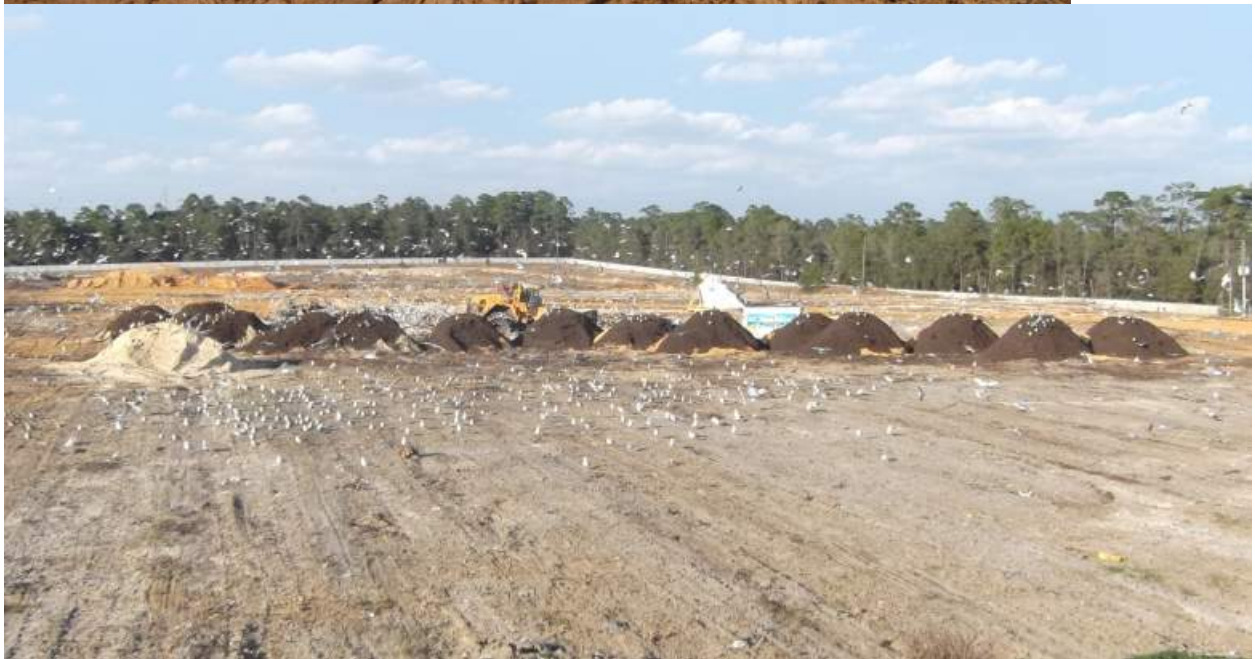
## **Attachment 3**

Explanation: This is the second consecutive violation for this item observed during inspection. The initial cover located in the central areas of Phase III was not adequate during the inspection. Facility staff indicated that some of the issues could be attributed to a break down of the compactor in the days prior to the inspection. Photo documentation was submitted to the Department electronically on December 18, 2020, demonstrating that the facility has begun to deposit initial cover on previously identified areas. However, following the inspection, the facility's dozer experienced a mechanical malfunction and is currently being repaired offsite. The facility is currently working to receive a rented dozer to complete the placement of initial cover in these areas.

**Response 2.18: The facility's compactor and dozer have been repaired, are back on site, and are in operation. The facility uses third parties for maintenance of their fleet. In cases where repairs cannot be made in a timely fashion, the County uses rental equipment. The County is procuring a new lease agreement for their equipment; the new lease agreement will include a requirement that the vendor will supply backup equipment within 24 hours of failure. The current lease agreement does not include this provision.**

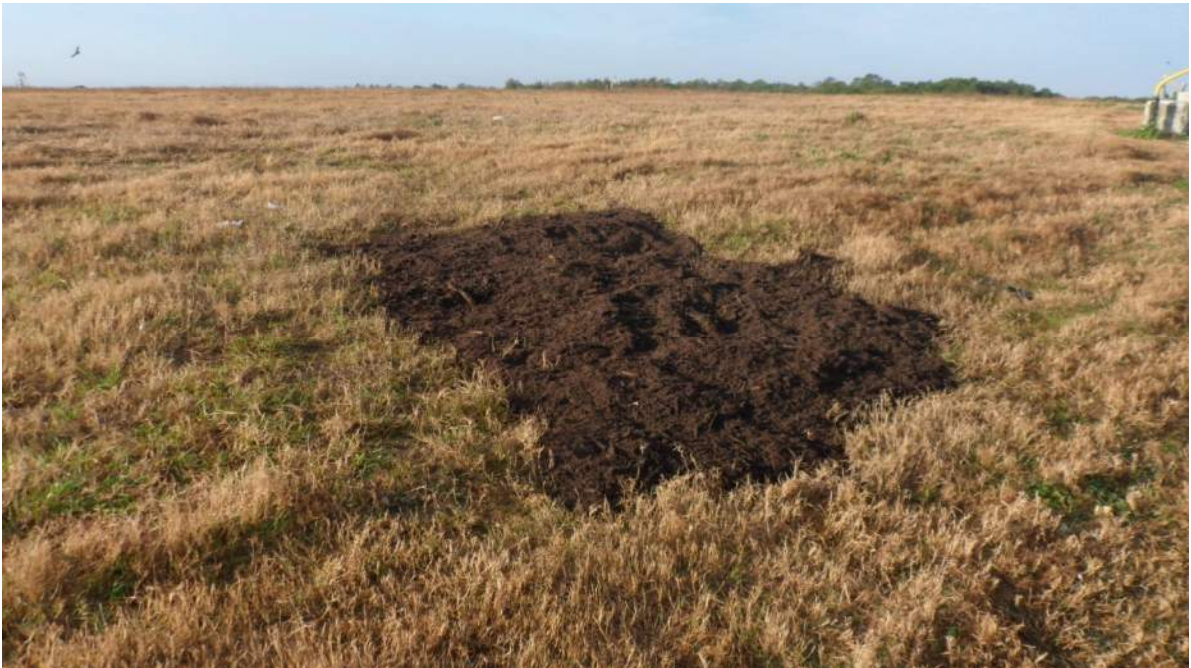
**Attachment 4**

Explanation: This is the second consecutive violation for this item observed during inspection. The intermediate cover located on the southeastern corner of Phase I was not adequate during the inspection. The facility provided the Department with photo documentation via email on December 18, 2020, that the southeastern corner of Phase I received adequate intermediate cover. In addition, a bare spot was observed on the top of Phase I near the northern side slope that leads down to Phase II.

**Response 2.19: Facility staff has repaired the bare spot on the north side slope of Phase I. Staff applied additional soil and cover to the area. Attachment 4 provides photographs.**

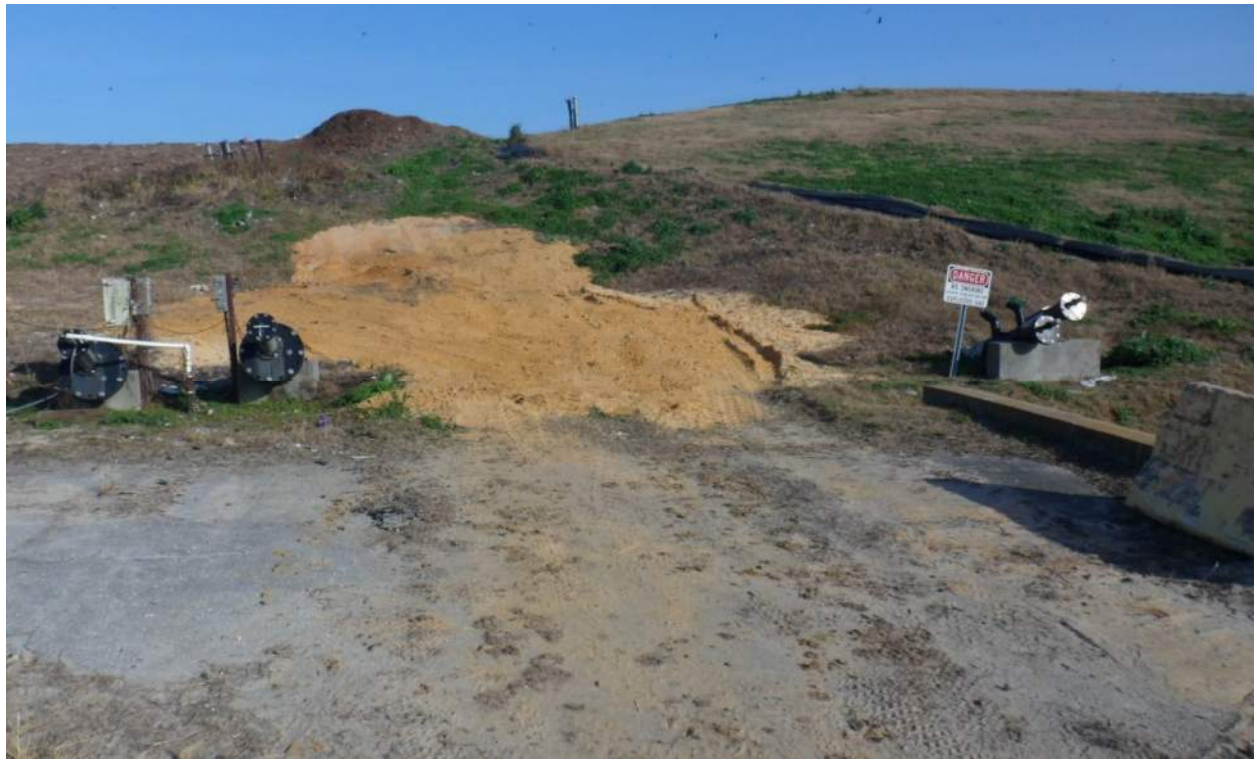
**Attachment 5**

A) Five leachate seeps in total were observed at the eastern, northern, and western sides of the landfill. The western leachate seep was observed in Phase II and potentially discharged into the stormwater system. The northern leachate seeps (two seeps) were discharging outside of the edge of disposal and into the perimeter stormwater swale. The eastern leachate seeps (two seeps) were also discharging outside of the edge of disposal and possibly into the stormwater management system. Per email correspondence dated December 1, 2020, the facility indicated that the recent installation of lateral gas wells may have created a conduit for water to infiltrate the landfill and to consequently cause these leachate seeps. Photo documentation was provided with this correspondence showing that the eastern and northern leachate seeps were repaired by placing cover on them.

**Response 2.28: The seep on the west side of the landfill was repaired. Attachment 5 provides photographs documenting the repair. The County will work with Jones Edmunds to evaluate the seeps at the site and identify methods to reduce the frequency of seeps at the site. FDEP noted that they require notification of leachate seeps within 24 hours of observation.**

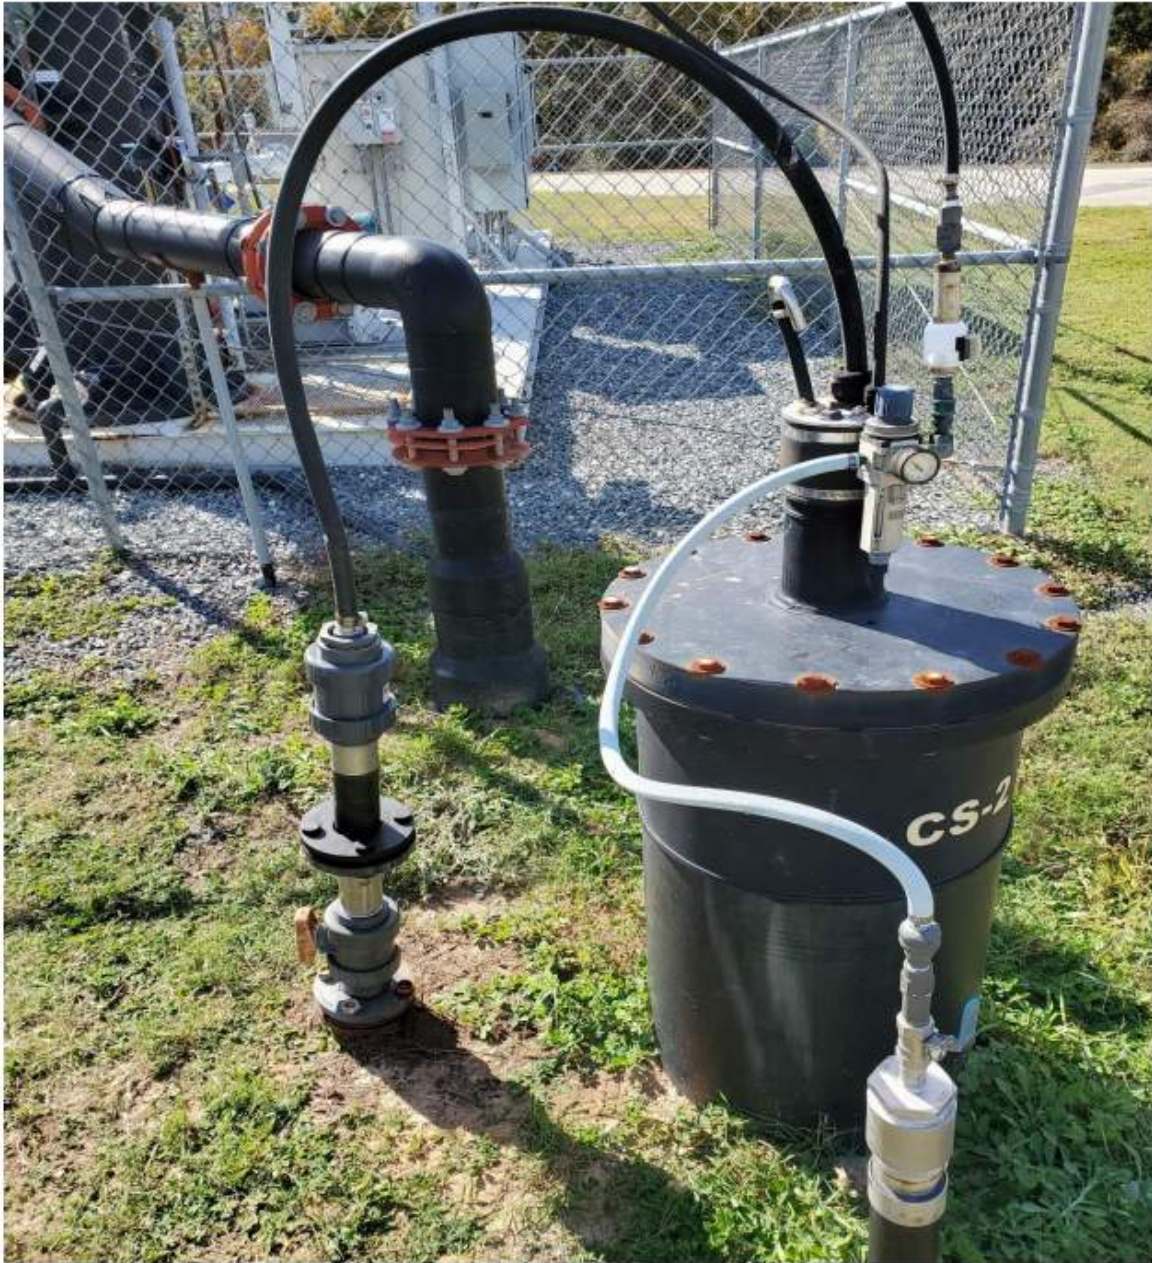
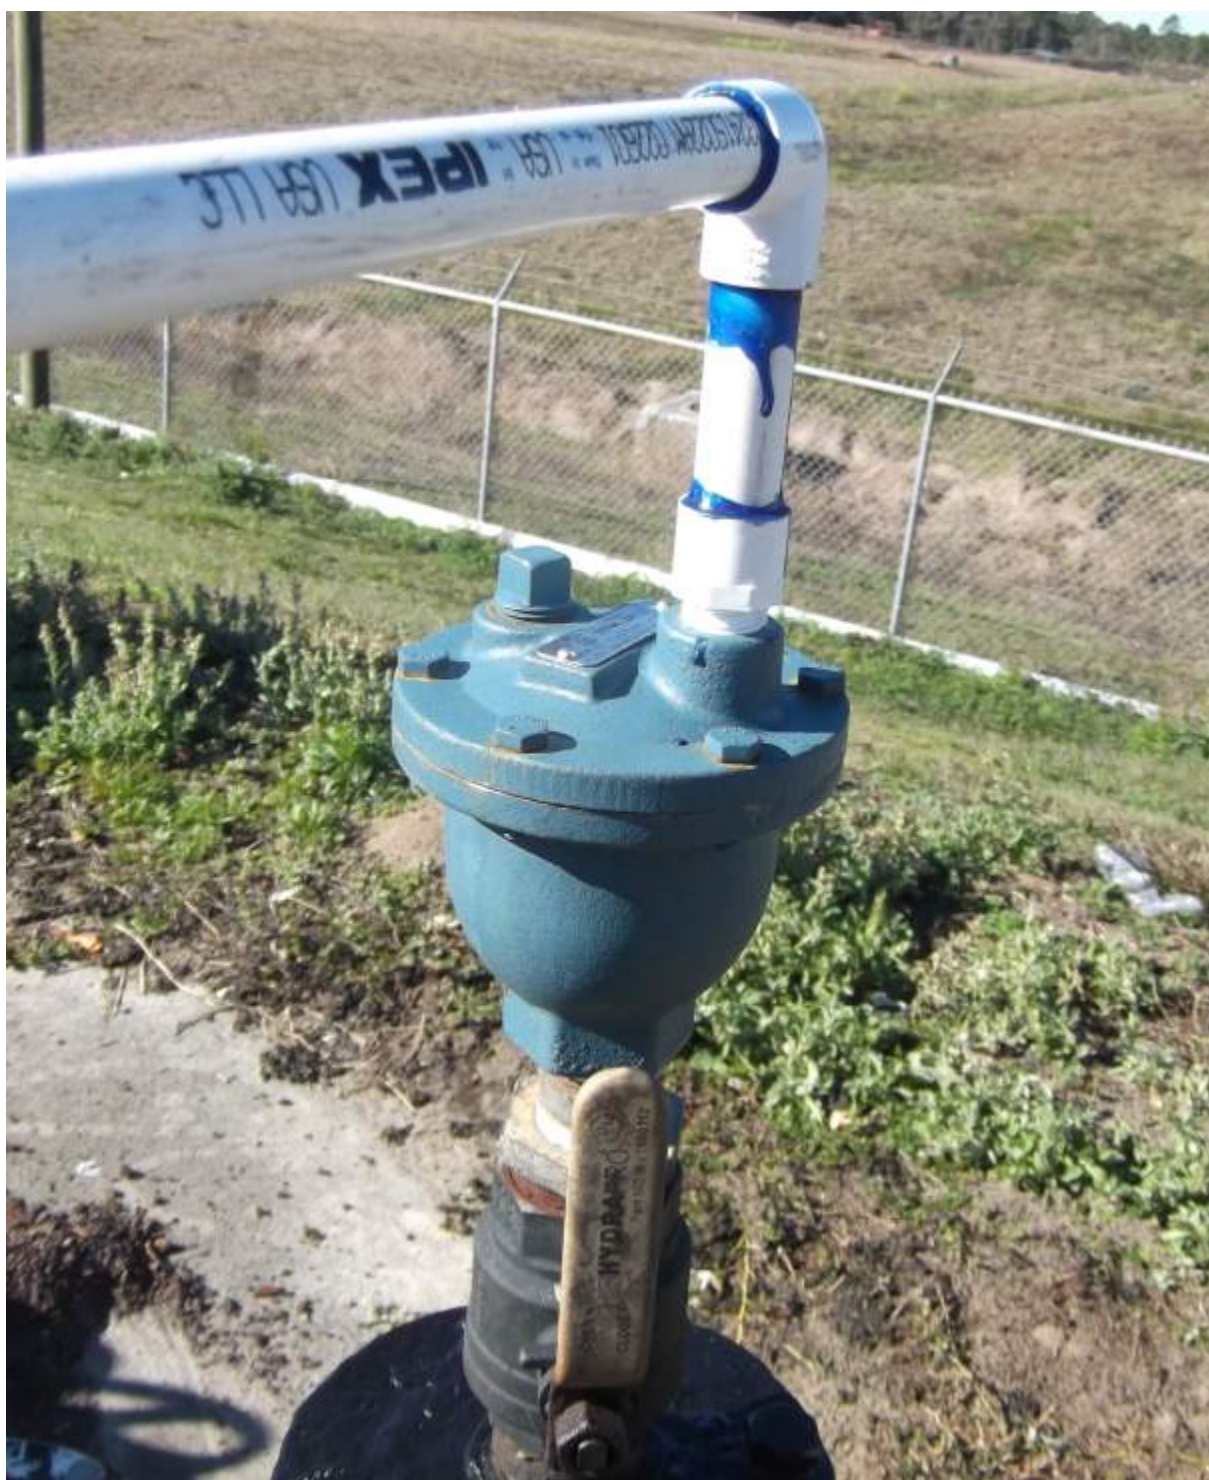
**Attachment 8**

D) At the time of the inspection, exterior portions of the flare condensate flange and the piping above the leachate lift station were corroded. The air relief valve at the main lift station discharged a heavy stream of leachate into the air during the inspection. Email correspondence dated December 11 and 18, 2020, from the facility shows that the flare condensate flange was replaced.

**D) The corroded flange has been replaced; Attachment 8 provides a photograph. The County is progressing with soliciting bids for replacing the corroded lift station piping. Piping has been installed on the air-release valve so that it does not evacuate leachate into the air, and the leachate will flow through the tubing back into the wet well.**
