Subject: FW: 01/19/2022 Inspection Follow-up, Pasco RRF, WACS No. 45799

Subject: 01/19/2022 Inspection Follow-up, Pasco RRF, WACS No. 45799

It was nice to see you all today. As a follow-up to our inspection of the Pasco County Resource Recovery Facility, please find summary of items discussed which require additional review/response:

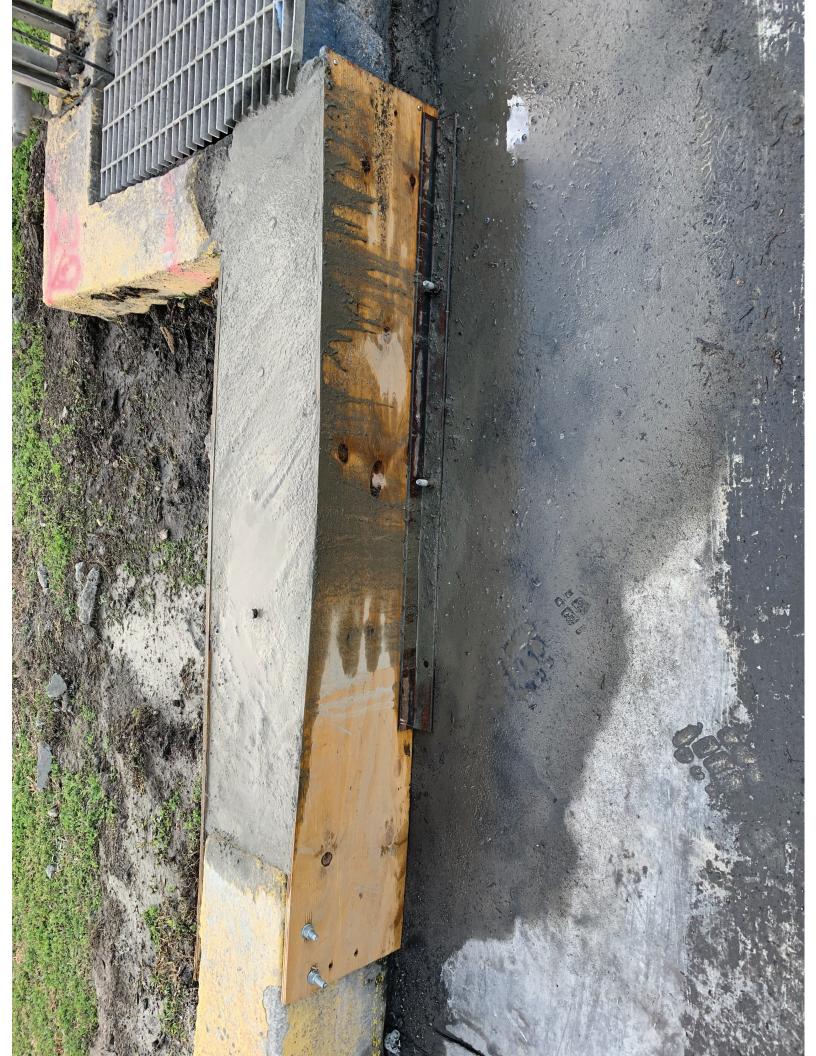
Attachments: IMG_1127.jpg

Please see the attached photo of the curb which was just poured.

- 4. Class IIII Last inspection logs available were dated week of 12/25. Please provide reports to date.
- 5. WTE Damage to containment curbing at entrance to ash building noted. Evidence of buildup of leachate/debris was noted on sump filter ("water line") indicating height of water in this area may be capable of breaching low areas in curbing, necessitating repair to curbing. Minor litter was observed on exit ramp and some track out in the ash driveway was noted. Covanta indicated a new sweeper is expected this week but that any areas noted are routinely cleaned manually by staff. Photo documentation of repairs and cleanup requested from Covanta w/in 1 week along with December scale records for processable waste.

The WTE ash containment curb has been formed and will be poured today weather permitting. Covanta is going to provide photos once complete
