EXECUTIVE SUMMARY OF GASOLINE LINE BREAK,
OCCURRED ON 02/21/2024

4699 INVESTMENT CORP
4699 NW 183 ST, OPA LOCKA, FL 33055

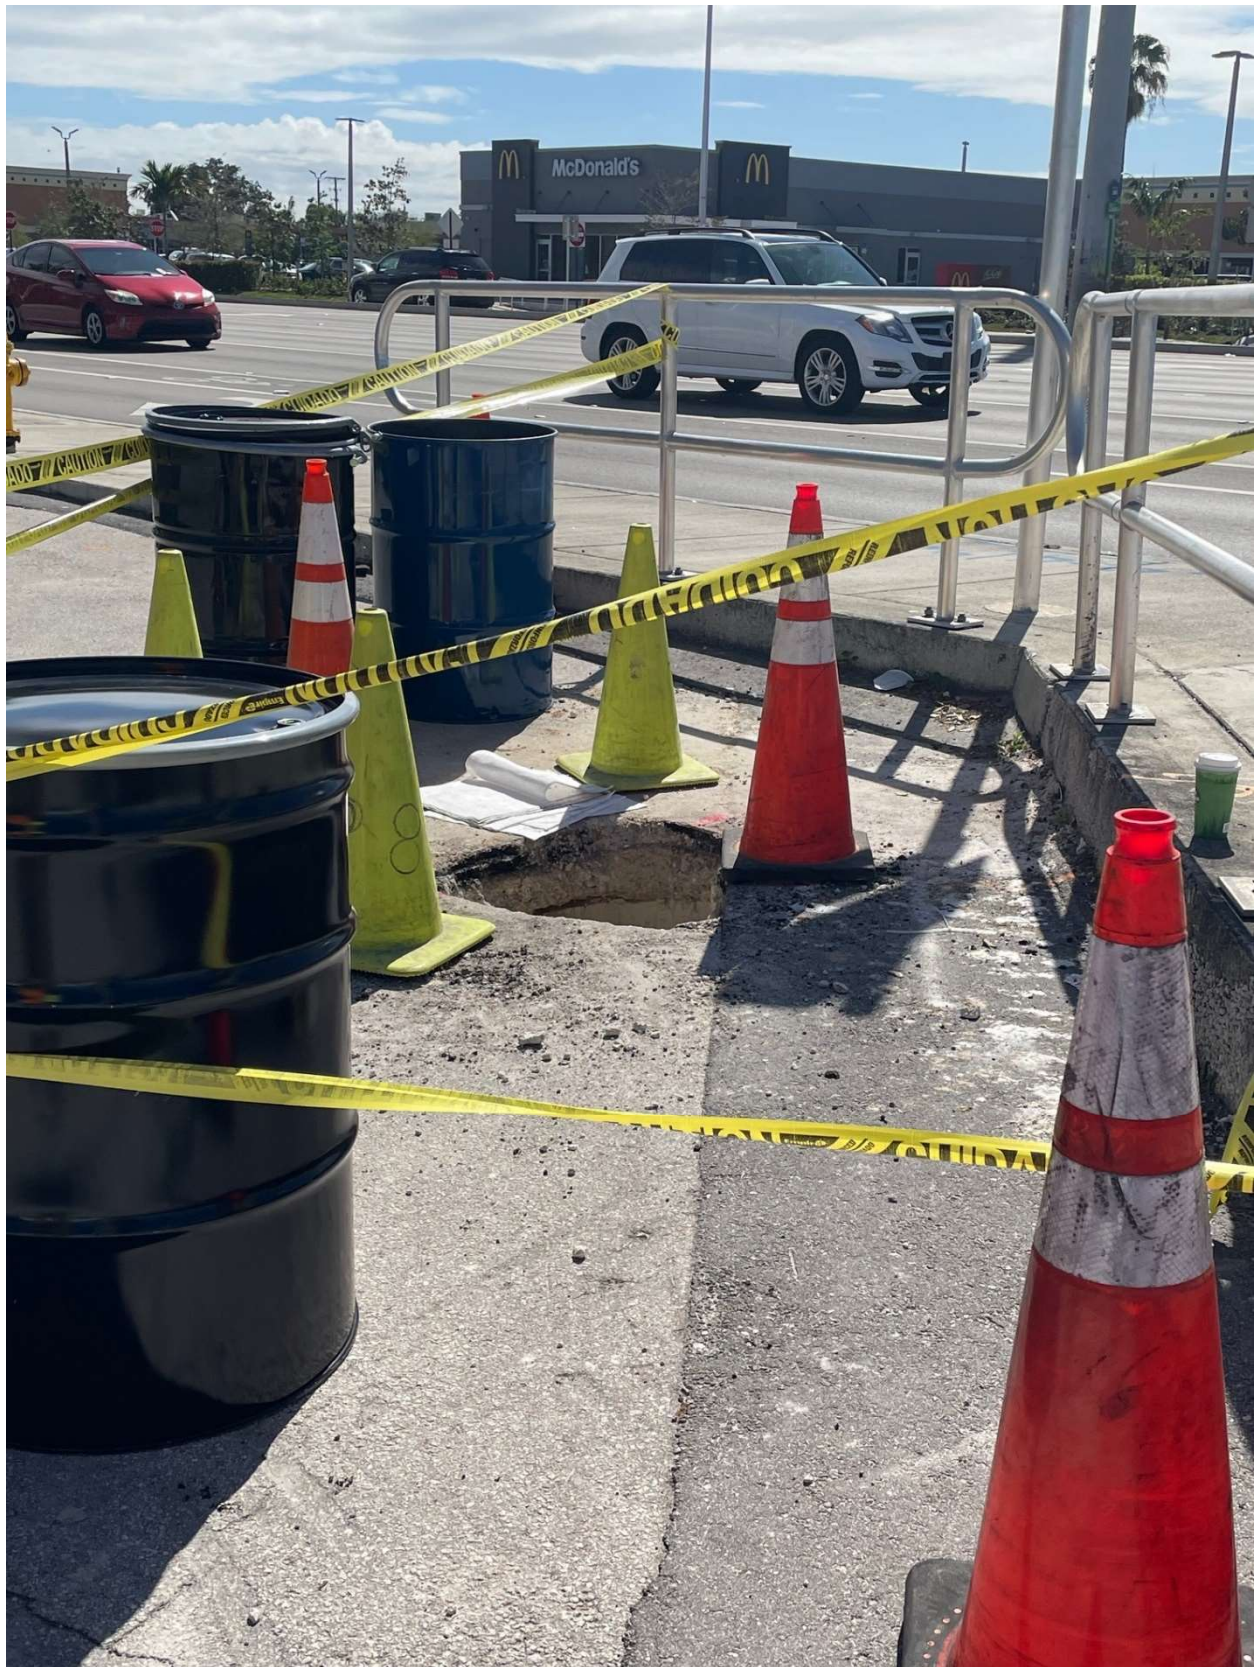
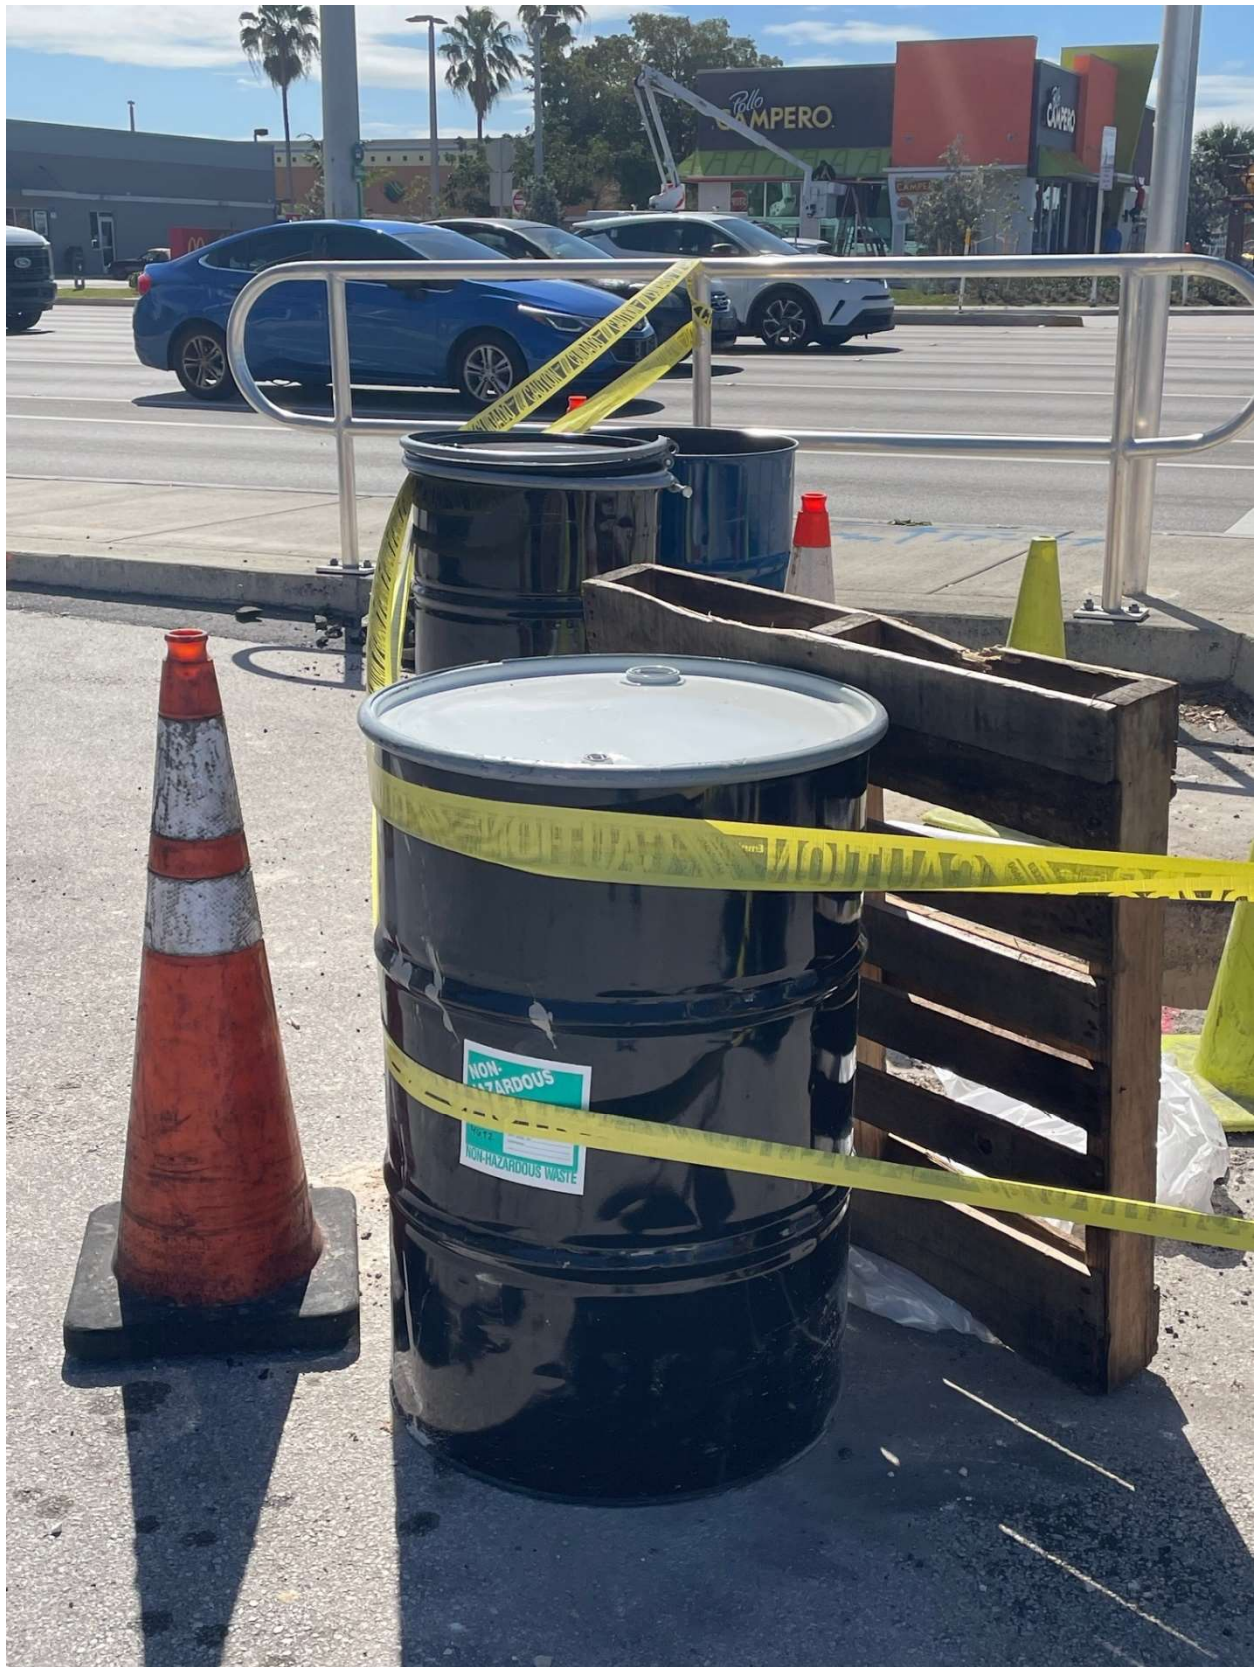
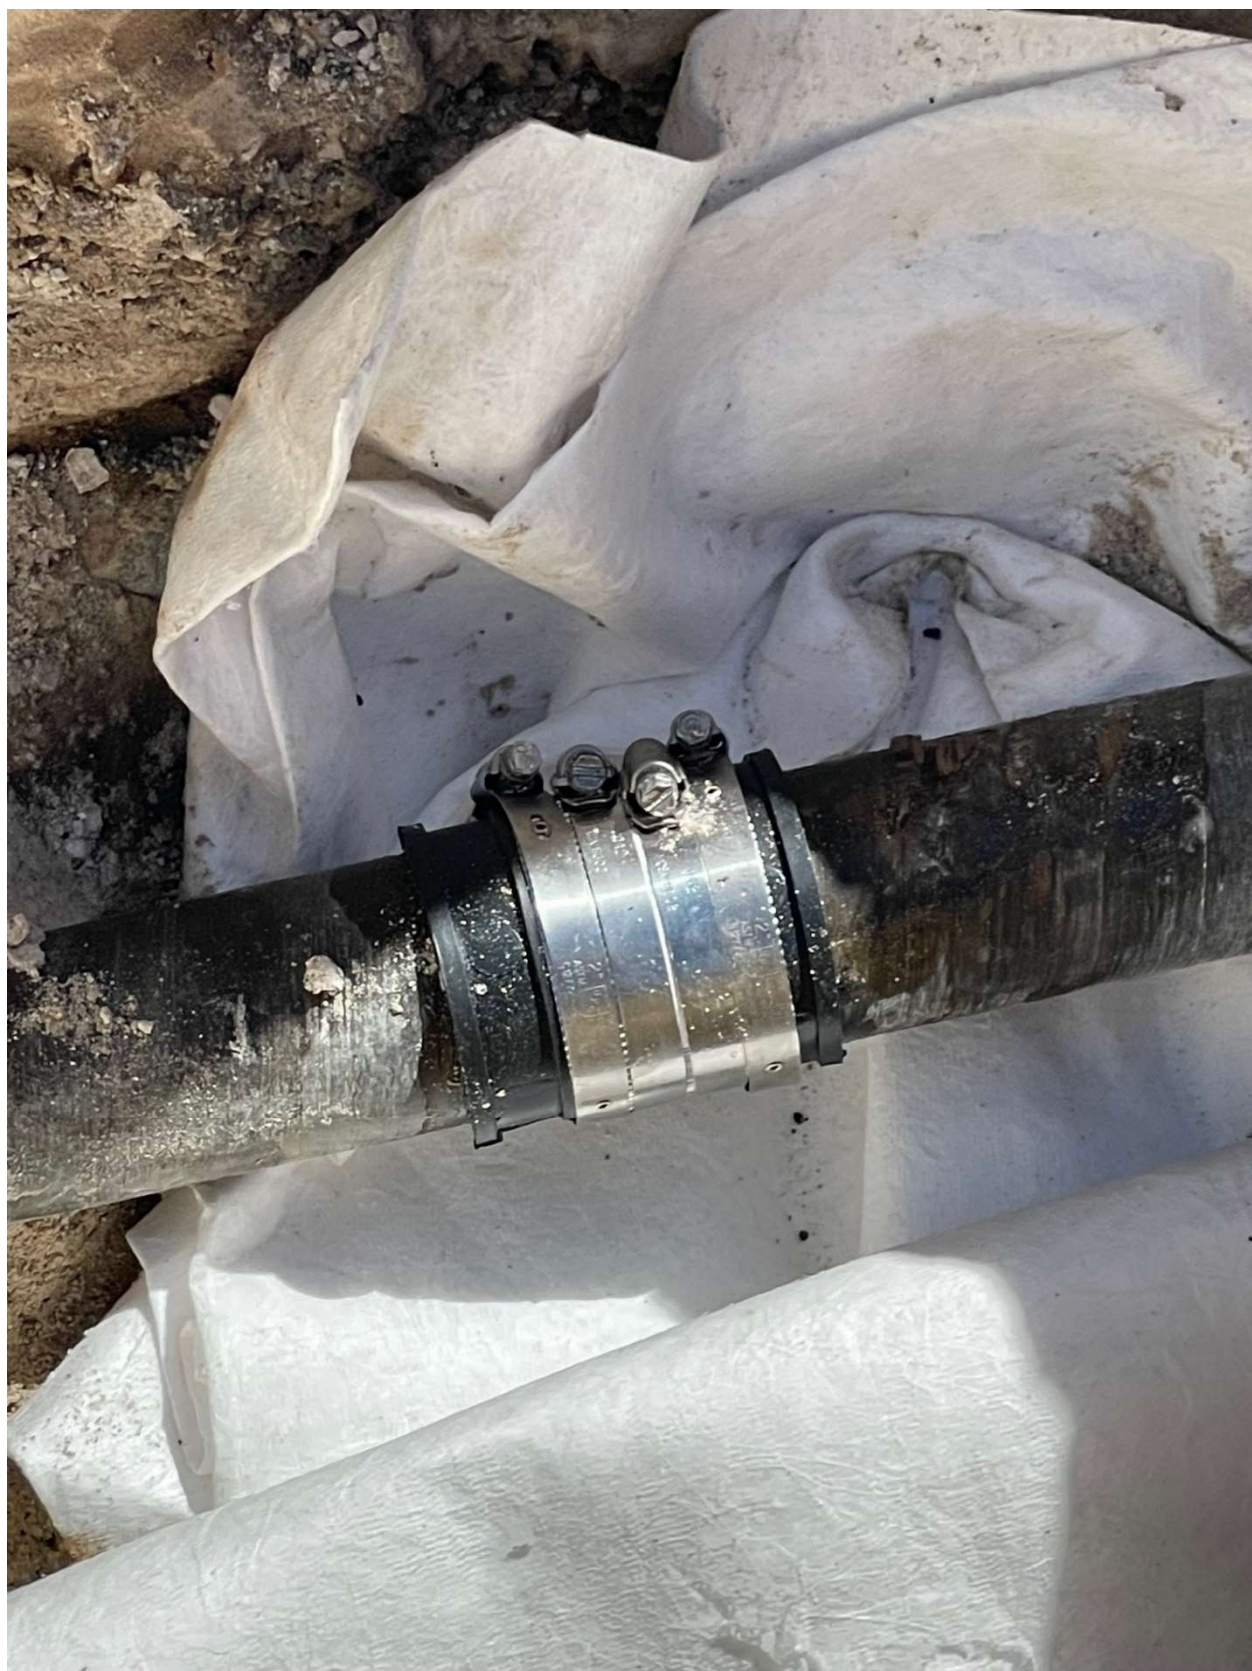
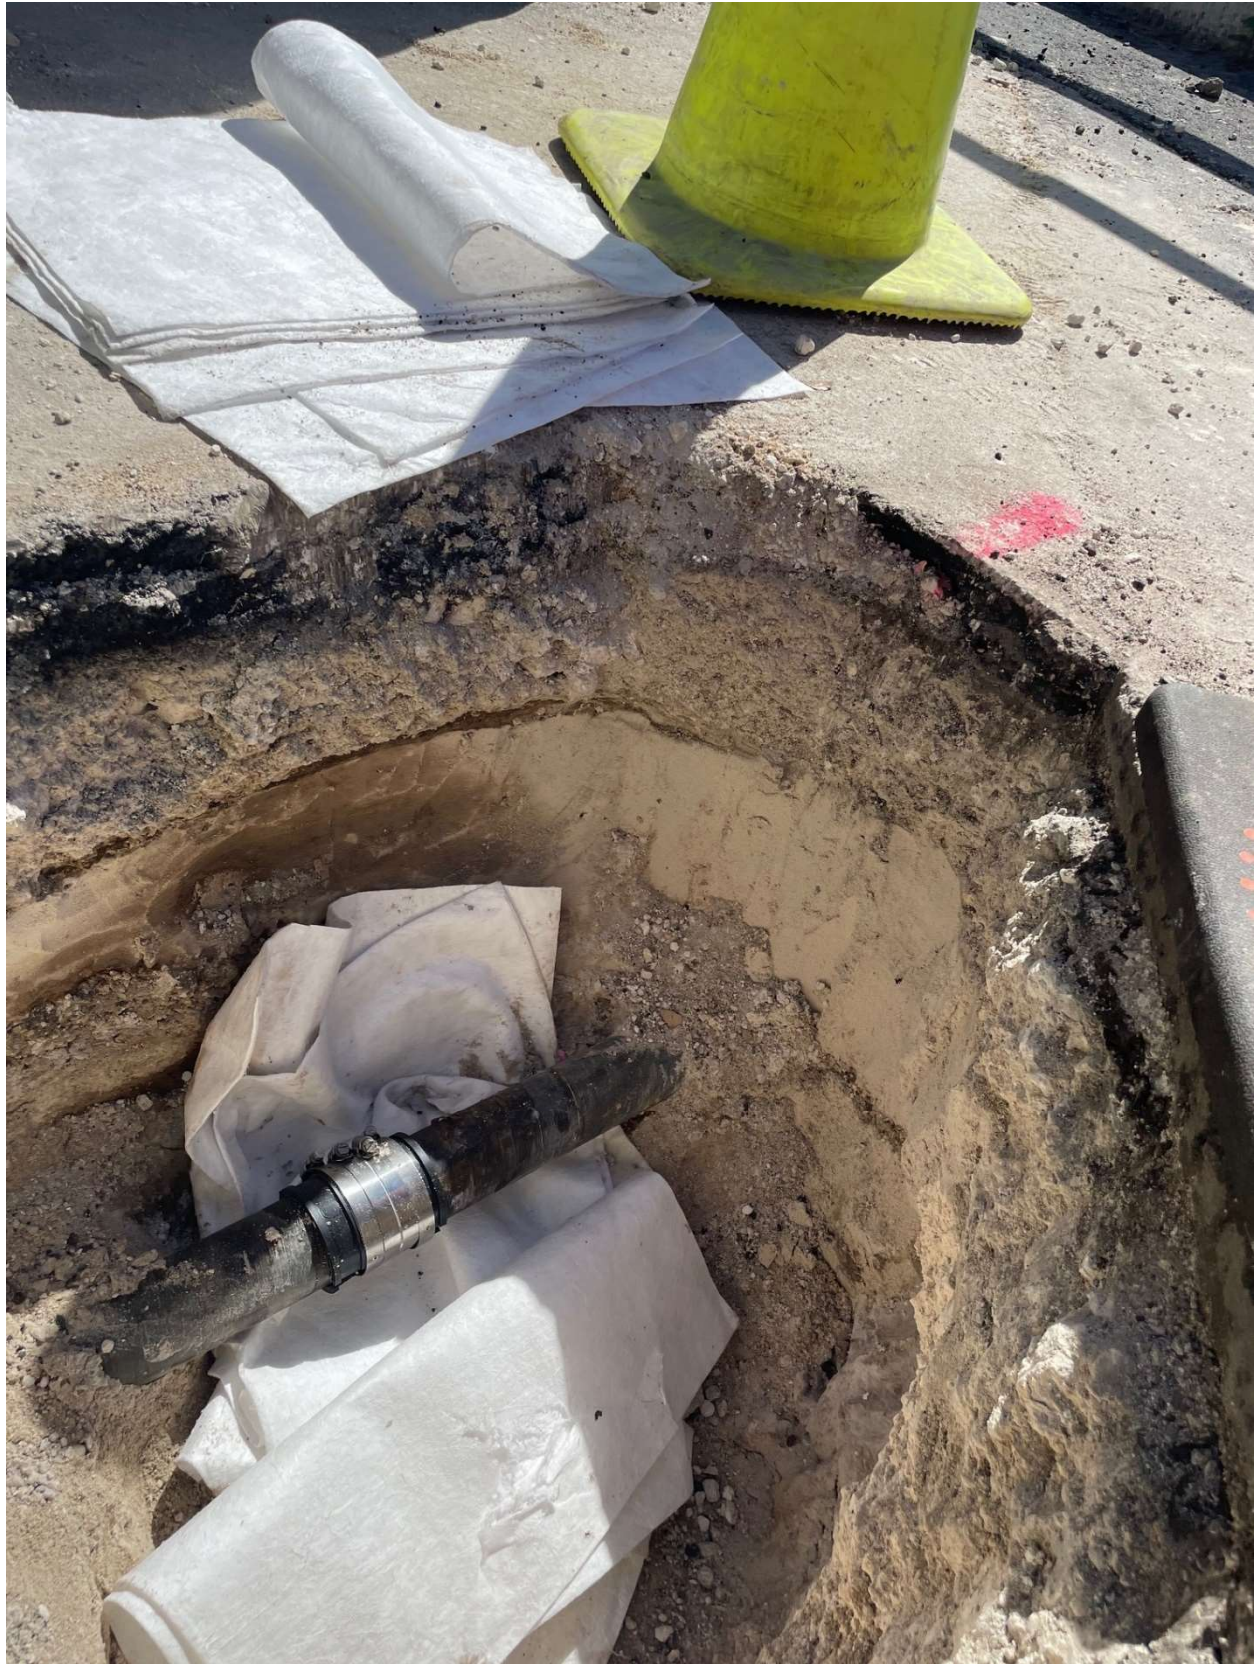
attempting to bore a hole for MW-15R in the late afternoon on 2/21/2024. Soil was excavated and drummed. The damaged pipe was temporarily capped (leaking stopped), and absorbent pads were placed at the bottom of the excavation to remove any remaining product. Tank contractor would perform final repair. OWL crew arrived on site to start the line repair work. Remedial action plan for the impacted area was carried out by UES, hired by GFA. As per phone conversation with DERM on 2/22/2024, three (3) drums were generated in total.

The below images show the line break zone surrounded by drums. Also attached, a site figure indicating the line break area, and the submitted DRF.

A Discharge Reporting Form (DRF) was prepared and submitted by the site owner, Henry Isquierdo, on 2/22/2024. The line was repaired, and the station was back in service on 2/23/2024.

On 2/29/2024, impacted soil was removed by the ATC. While onsite on 2/29/2024, Earth Systems verified the horizontal and vertical extent of the impacted soil using OVA. The north, east, south, and west sidewalls and base of the excavation were confirmed <1 ppm. Confirmation soil samples were collected from each side wall and at approximately 4’ from the base of the excavation for lab analysis of BTEX/M, PAH, and TRPH. ATC requested documentation for tank tightness testing and soil manifesting from the tank contractor.
