SITE INSPECTION REPORT

NAME OF SITE: Florida Crushed Stone Company

INSPECTION DATE: January 29, 2009

PERMIT #: PA 82-17N

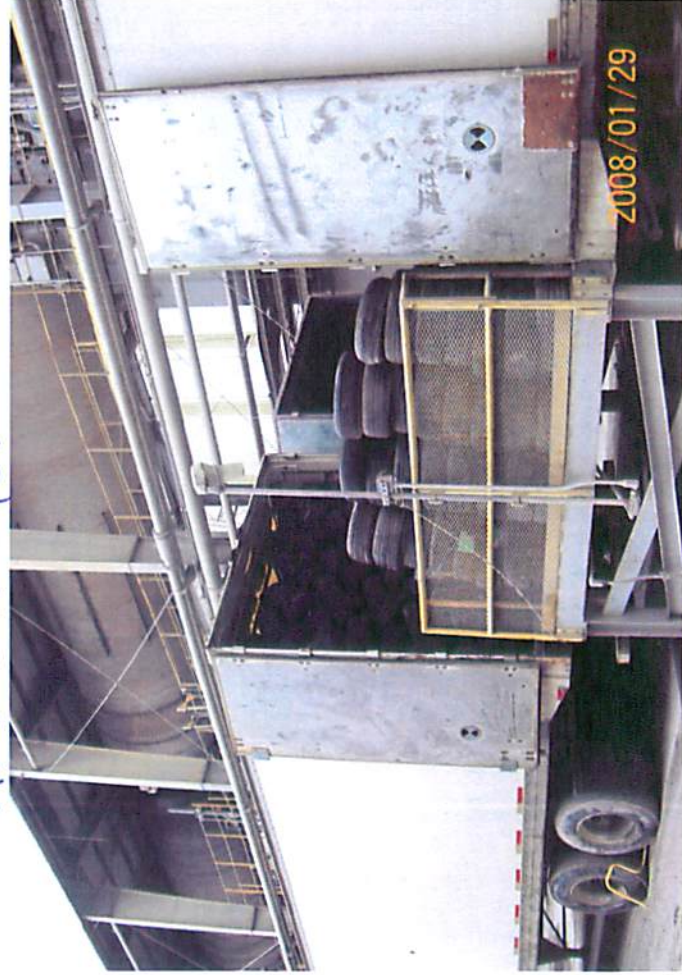
TIRE STORAGE

Department staff first observed the waste tire processing area. All tires were stored in two 100cy trailers or on the platform ready for loading onto the conveyor system. Adjacent to the tire conveyor system, a second kiln has been constructed for cement manufacturing. Facility staff indicated that they are planning on adding a tire processing system to kiln #2 in the near future. A modification of Conditions of Certification PA 82-17N and Facility Operations Plan should be submitted to the Department prior to construction in accordance with section XXXII.C of PA 82-17N to reflect changes in operation and increase capacity and financial assurance.

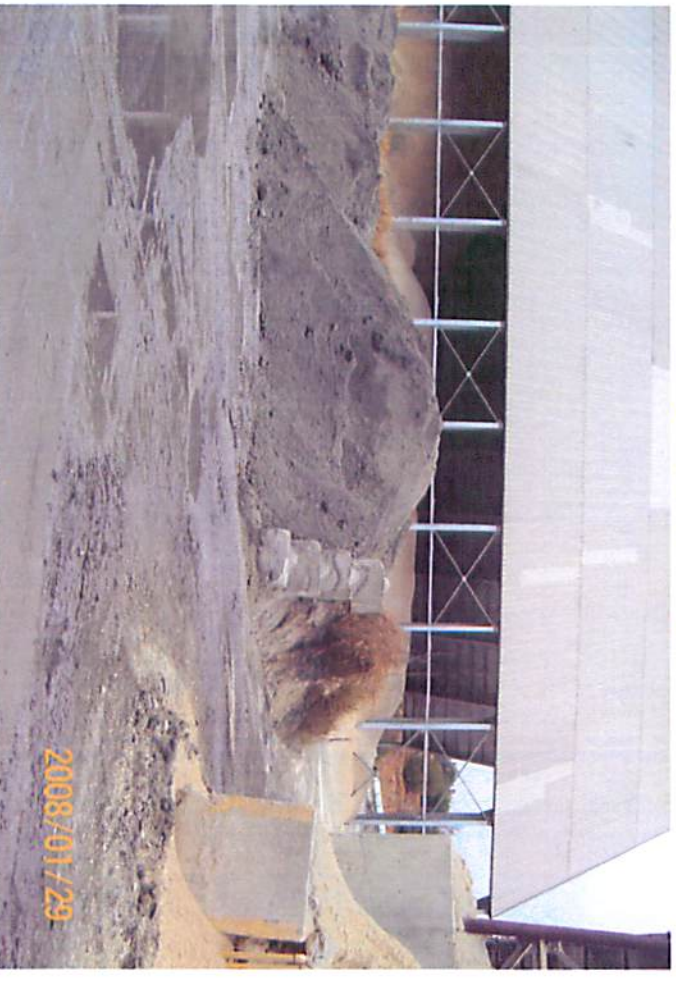
CPL BOTTOM ASH

(CPL) bottom ash. The CPL ash was stored in an uncovered bunker adjacent to the larger A-frame building (limerock storage), near the kilns. Facility staff indicated that this ash is used first in the cement manufacture process and is not stored in this location for extended periods of time. A second A-frame building has been constructed at the site and is used for solid waste/ash and industrial by-product storage. Millscale (high and low oil), Crystal River conditioned ash and TECO gypsum by-products were observed stored within the new building, under cover. The building did not appear to have any method of containment (besides cover) and could not be determined to have an impermeable surface for storage. Department staff traveled to the TECO Gannon Ash Pile #1 (east of the Plant) which appeared to be adequately tarped and weighted. The second TECO Gannon Ash Pile (#3, north of the Plant) also appeared adequately tarped, however, the slopes appeared very steep in some areas as the Facility is currently pulling ash from this pile. The pile should be adequately graded (at least 3H:1V) under the tarp to allow for adequate stormwater flow and provide for slope stability. A small pile of TECO gypsum was observed being stored at the south end of the large A-frame in the open (not under cover). Two piles of TECO slag were observed, one north of the large A-frame and the second south of the Plant, which did not have cover and appeared to be stored on the ground. A final small pile of ash was observed along the quarry road being stored on the ground, without cover. This pile was to be screened before being mixed for cement manufacture.

7. Within 90 days of the date of this report, please provide current analytical data for the TECO slag and gypsum, CPL bottom ash, Crystal River conditioned ash and millscale.
