Florida Department of Environmental Protection

Volusia County - SW
Tomoka Farms Road Landfill WACS # 27540
Class I - Permit # S064-0078767-016
Inspection Report Transmittal

Florida Department of
Environmental Protection
Inspection Checklist

Facility Name: TOMOKA FARMS ROAD LANDFILL

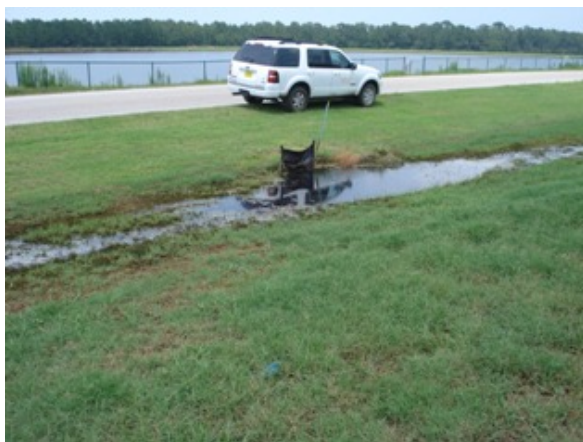
Area: North Side Slope
Rule: 62-701.500(10), 62-701.400(9)(c)
Question Number: 2.30
Explanation: It appears that leachate has mixed with storm water at the toe of the slope and is draining into the North Lake.
Corrective Action: Devise and submit a plan to the Department stating how the leachate seeps will be stopped or minimized and how it will be prevented from draining into the North Lake.

Ponding leachate

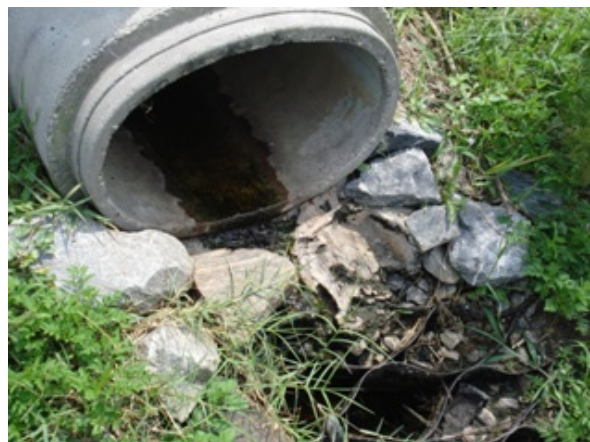
Liquid coming into North Lake

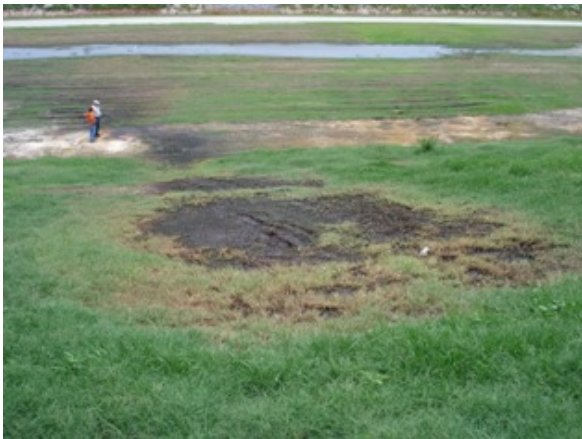
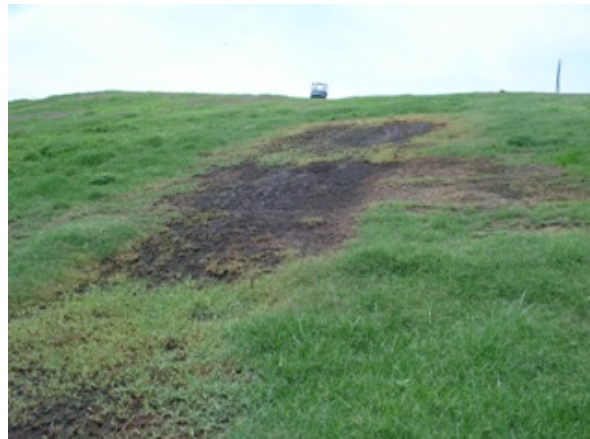
Area: South Side Slope
Rule: 62-701.500(10), 62-701.400(9)(c)
Question Number: 2.30
Explanation: Leachate is seeping from the landfill's side slope to the toe of the slope and continues to flow towards the south to an area outside of the lined landfill. There is a potential for leachate to mix with storm water. In a June 9, 2009 letter from the facility it is stated that an earth berm will be constructed to contain the leachate inside the lined landfill, this berm has not been constructed.
Corrective Action: First, construct the earth berm as stated in the June 9, 2009 letter. Second, devise and submit a plan to the Department stating how the leachate seeps will be stopped or minimized.

Looking S down the side slope

Looking N up the side slope

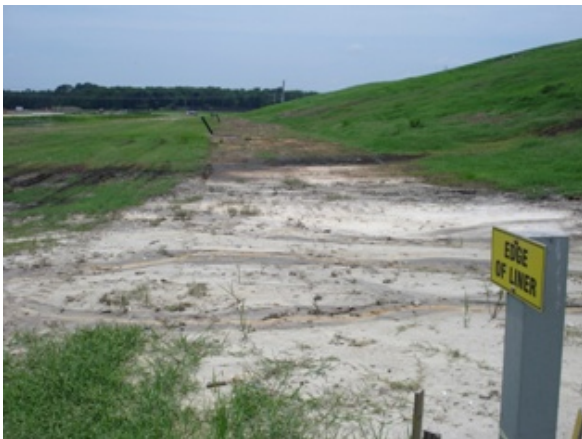
Leachate leaving lined LF

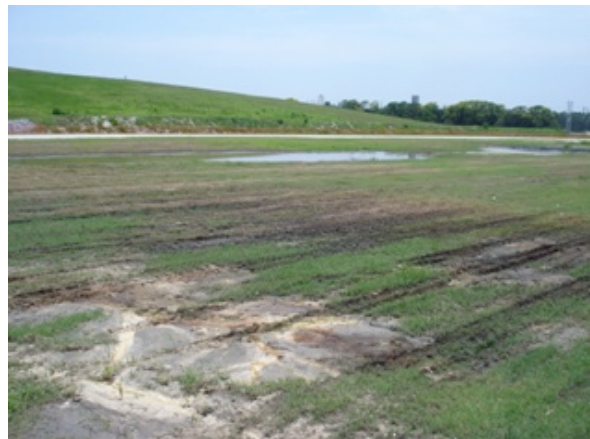
Leachate outside of lined LF

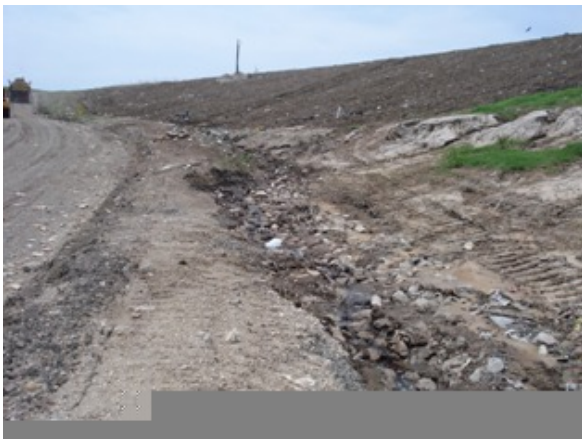
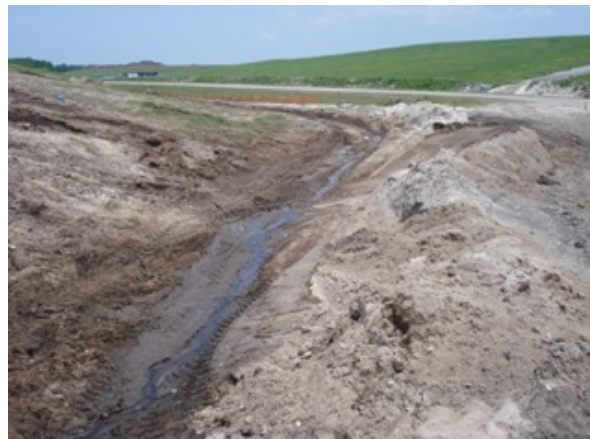
This area continues to seep leachate along the east side of the access road. The facility has built up a dirt berm to better contain the leachate at the toe of slope. Some of this dirt is discolored indicating that leachate has passed through the berm to the area outside the lined landfill and a pump is stationed outside of the lined landfill to transfer liquid back into the bermed area. At the time of inspection all leachate was contained within the area of the lined landfill.

Looking up the roadway to the N

Looking down the roadway to the S

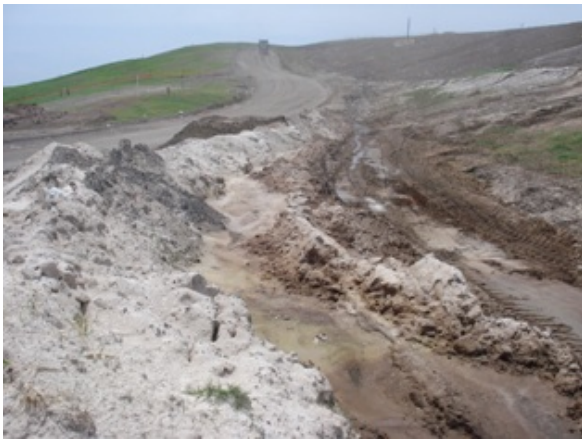
Built up dirt berm

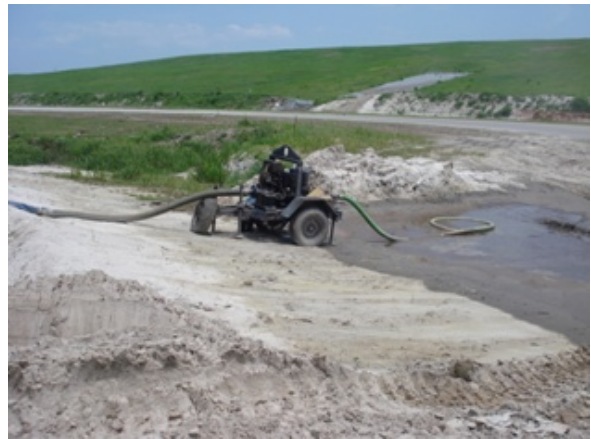
Pump to transfer leachate

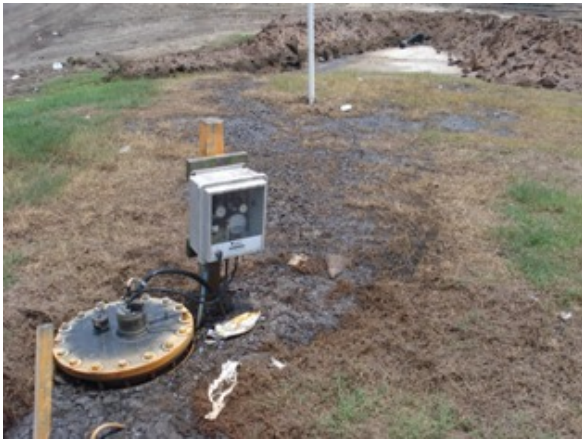
The facility submitted and installed a temporary fix of the leachate seepage on the west side of the access road. The fix was to collect the seeping leachate under ground and direct it into a leachate clean-out access point. At the time of inspection the area had leachate coming out of the ground and flowing south down the side slope. A "U" shaped berm was installed to keep the leachate inside the lined landfill; however, the dirt used for the berm is discolored indicating that leachate has passed through and around the berm to an area outside the lined landfill.

Leachate from area of temp. fix

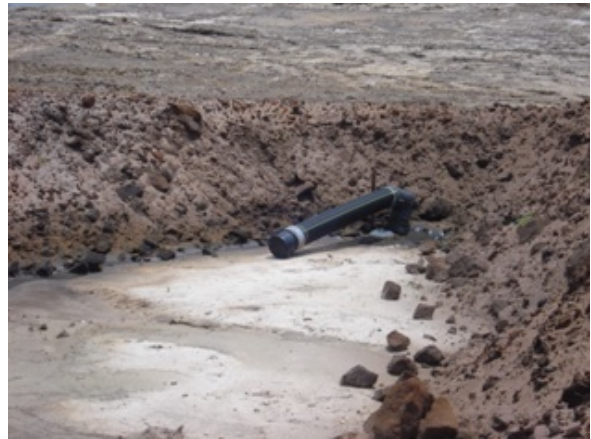
"U" Shaped dirt berm

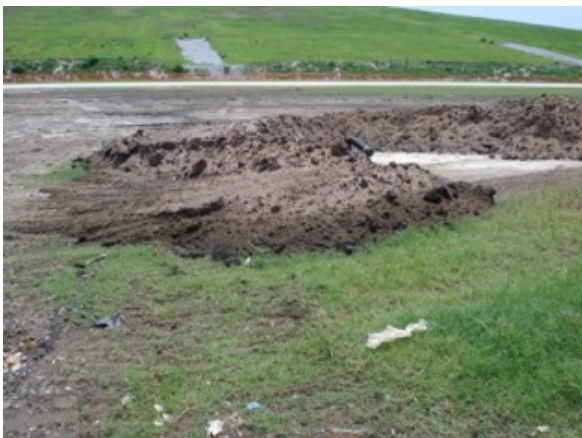
Discolored dirt outside of berm

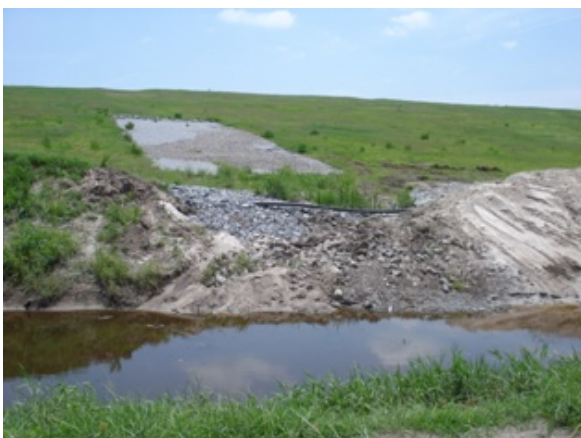
Explanation: Due to recent rains areas of the north side slope have eroded. The facility is in the process of correcting the erosion.

Area of erosion

Corrective Action: Continue to correct the eroded areas and submit photographs of the completed work.

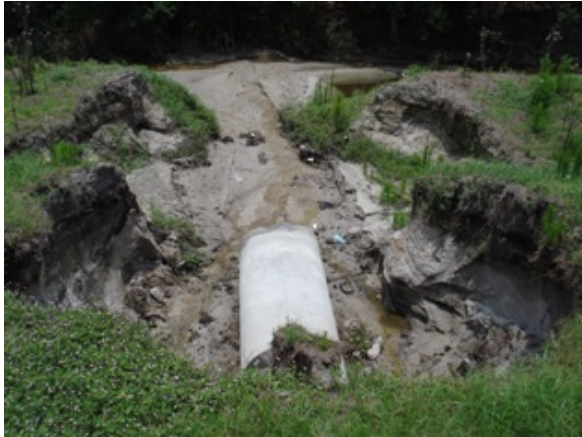
Explanation: Culvert 1 on the north side of the Class III landfill is not operating as designed due to dirt under the culvert being washed out. As a result, a portion of the concrete culvert pipe has broken apart. The portion of the culvert piping that remains in place runs under the landfill's perimeter road. The dirt under this piping and roadway appears to be eroding away too. This poses a potentially

dangerous situation for any traffic that drives over this roadway.

Corrective Action: Devise a plan and time-line for repairs to culvert piping and surrounding areas to be corrected and submit to the Department.

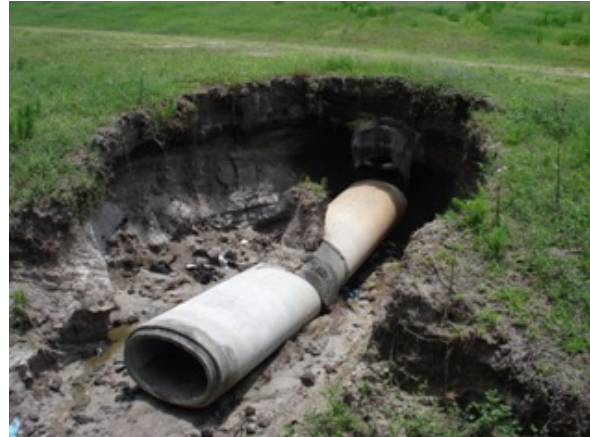
Culvert 1, note roadway

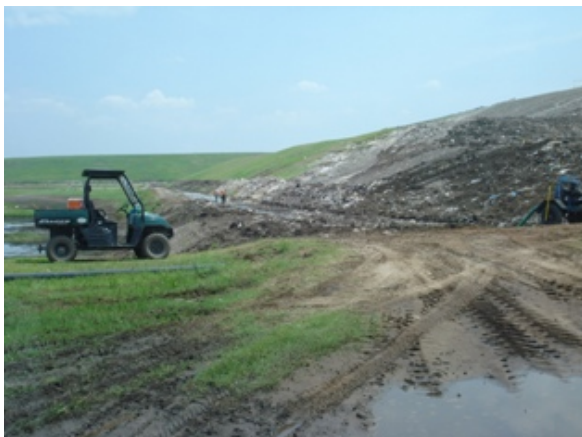
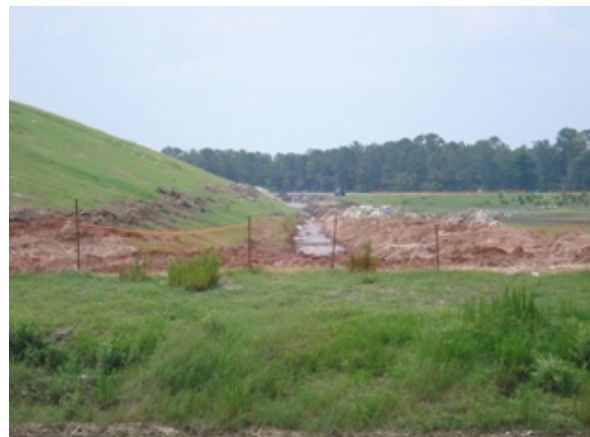
Excessive litter continues to be an issue on the east side of the North Cell Class I Landfill. At the time of inspection two workers were removing litter from the ponded leachate. The facility had a pump in place to transfer the ponded leachate into the leachate collection system.

Looking south down E side slope

Looking north down E side slope

Additional measures need to be taken to reduce the amount of litter collecting on this side of the landfill.

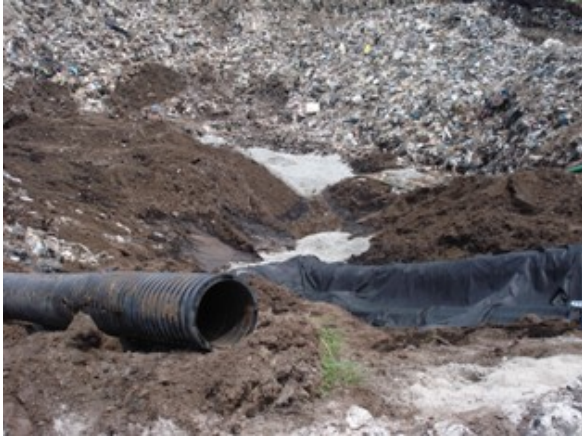
Joyce Belen with SCS was on-site to oversee the contractors working to fix the leachate collection line that was determined to be damaged when it was inspected by a camera fed into the line. The crew was working on the northwest corner of the North Cell and had dug down exposing the leachate line to be repaired and the bottom-liner.

NW corner leachate line repair

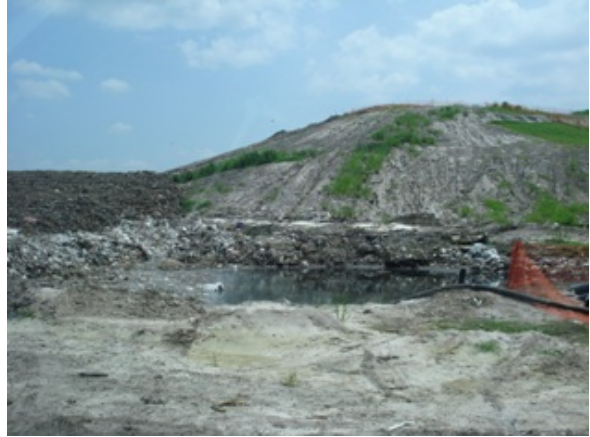
The same crew had previously been working on the northeast corner of the North Cell to repair a leachate pipe but due to heavy rain leachate filled the excavated area. The crew was planning to come back to the area once they completed the work on the northwest corner and the leachate was removed.

NE corner to be repaired

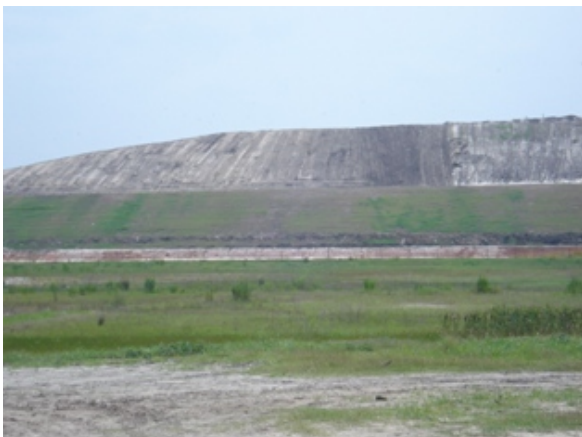
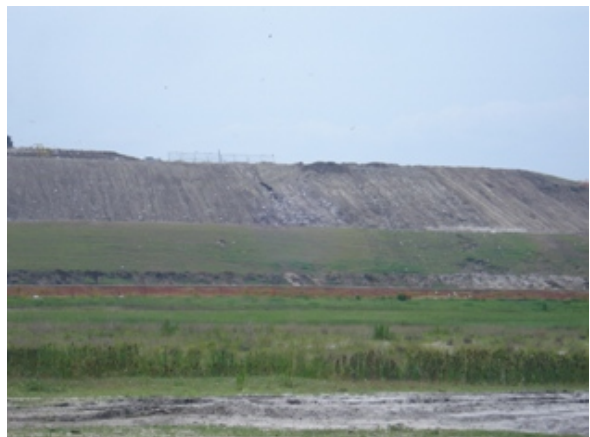
W side slope

Areas on the west side slope on the North Cell are also seeping leachate. It appears that the leachate is staying within the lined landfill. In the June 9, 2009 letter it states that an earth berm will be constructed to prevent leachate from leaving the lined landfill; this was not in place at the time of inspection.

The west side slope of the North Cell also showed signs of erosion. The facility had repaired previous areas of erosion but since that time new erosion had occurred.
