Florida Department of Environmental Protection

Volusia County - SW
Tomoka Farms Road Landfill WACS # 27540
Class I - Permit # S064-0078767-016
Inspection Report Transmittal

Florida Department of
Environmental Protection
Inspection Checklist

Facility Name: TOMOKA FARMS ROAD LANDFILL

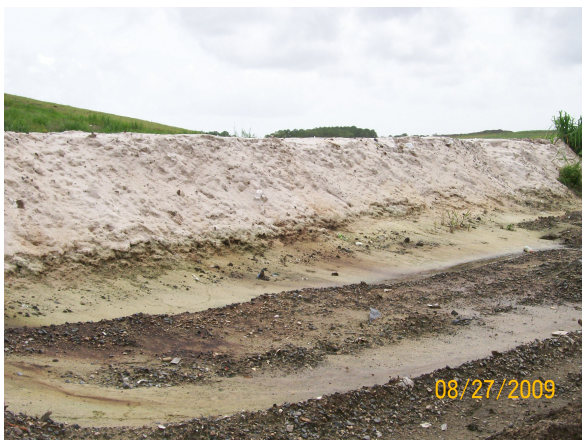
This area continues to seep leachate along the east side of the access road. The facility has built up a dirt berm to better contain the leachate at the toe of slope. Some of this dirt is discolored indicating that leachate has passed through the berm to the area outside the lined landfill and a pump is stationed outside of the lined landfill to transfer liquid back into the bermed area. At the time of inspection all leachate was contained within the area of the lined landfill.

Discolored dirt berm

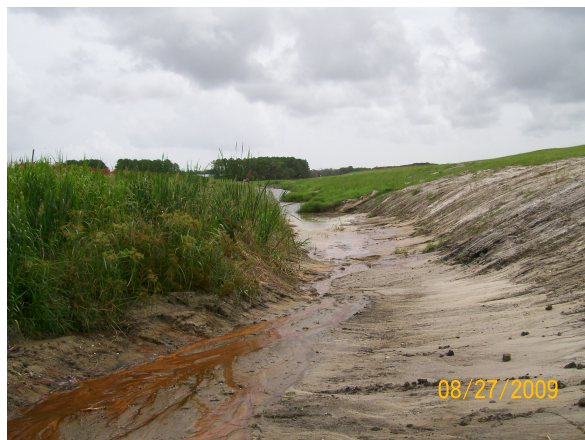
Area: South Side Slope
Rule: 62-701.500(10), 62-701.400(9)(c)
Question Number: 2.30
Explanation: Leachate appears to be flowing into the stormwater ditch near the haul road on the south side slopes.
Corrective Action: The facility has submitted the revised sequence of fill plan and has DEP approval for implementation.

Stormwater Canal

Seepage areas are still present on the south side. The leachate riser area near the haul road was still excavated and is being pumped out as noted before in the previous inspection. The dirt berm appears to still be discolored and leachate again appears to be flowing into a stormwater canal.

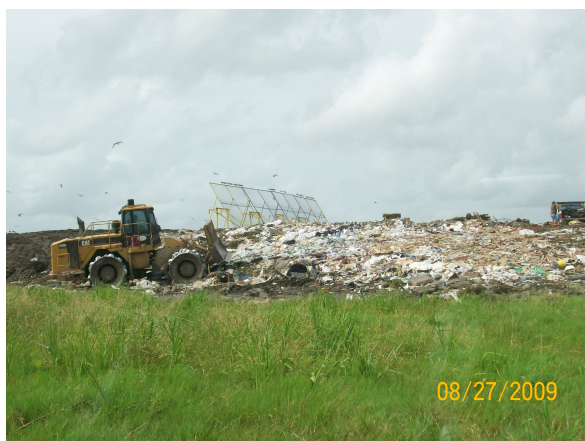
The landfill is in compliance. According to Ms. Stirk, the county is planning to expand the footprint to 25 feet of canal. Another layer of intermediate cover was added to the SW corner of the landfill.

Class III working face

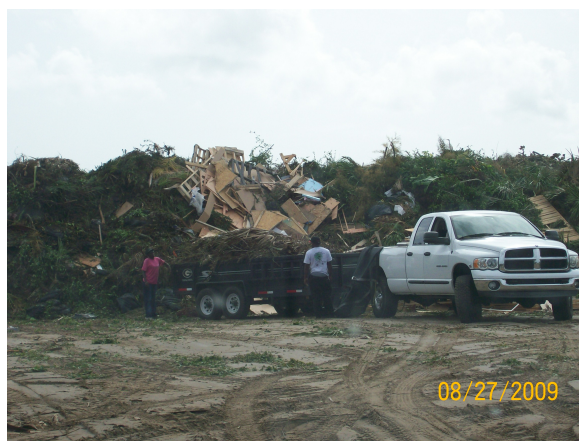
The area consists of piles of land clearing debris greater than 100 ft wide. Piles must have a fire

lane in between where no part of the yard trash pile shall be more than 50 ft from access of fire vehicles.

Yard Trash area

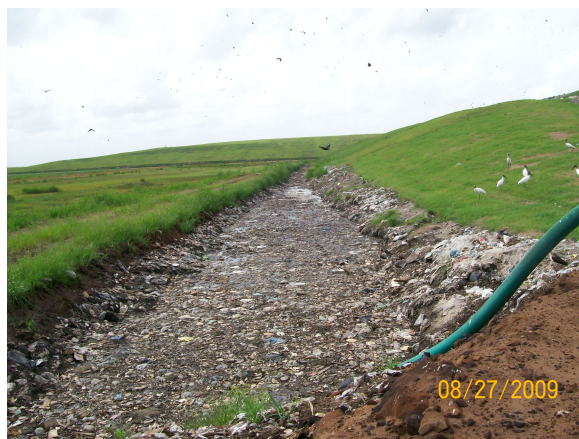
The recent side slope excavations and repair on the north slopes have helped the leachate seepage, although some seepage areas are still present on these slopes. 2 seepage areas near the toe of the slope were seen. There were also leachate seeps on the west side slopes. As before, the facility expects the new sequence of fill plan to alleviate these problems.

excavated toe on class I W. side

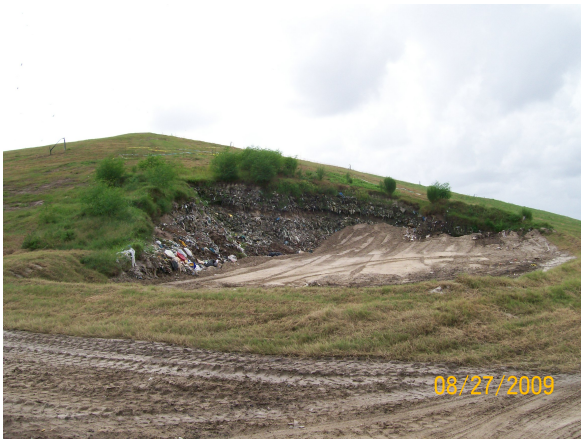
The edge of the Eastern cell is still excavated and excess leachate is being pumped. Once this area is dry enough, it will be filled again and covered. The NW corner is still excavated as part of the leachate riser repair. The piping was replaced in this area by HDPE and the area will be filled in preparation for the haul road in the coming months. As part of the new sequence of fill plan, the direction of the haul road in this area will be from the north to the south.

NW corner (leachate riser repair)

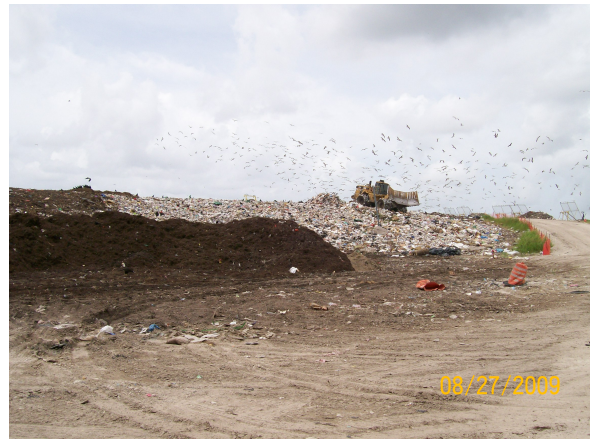
There was waste protruding from the cover (flagging) near the working face where waste is not being disposed. It is recommended that the facility place intermediate cover in this area. The 12 inches can be mixed with no greater than 50% of mulch material.

Class I working face
