Submittal DataCatalog **Solid Waste**Profile **Discovery_Compliance**County **CITRUS**Facility-Site ID **39859 - CITRUS CENTRAL SLF**Document Date **11-06-2009**Received Date **11-12-2009**Document_Type **MONITORING PLANS AND REPORTS RELATED**

Facility Type **CLASS I LANDFILL (100)**Document Subject **Inspection response 09/29/2009**☐ Double Sided☐ Oversized Pages

Re: Citrus County Central Landfill
Permit No. 21375-008-SO/01 and 126602-002-WT/02
Response to Site Inspection Comments received 10/15/2009

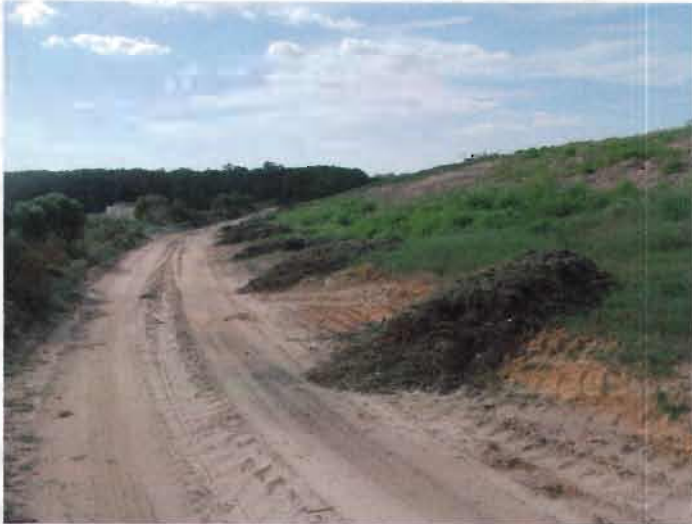
During the inspection, Department staff observed erosion with exposed waste along the Phase I access road. Water was observed flowing along the erosion over the exposed waste (leachate) and to the west. Erosional evidence appeared to indicate that any water in this area would have been directed back east along the toe of slope and been contained by a berm to direct stormwater to the E. The continuity of the lower berm could not be confirmed due to heavy vegetation.

Photo #1: Access Road looking east showing mulch stormwater diversions

We do agree with the observations noted with respect to the temporary access road, which was repaired immediately as noted in the October 2, 2009 email. Additionally, erosion control measures in the form of mulch diversion berms have been placed along the high side of the access road to slow the flow of runoff down the access road (See Photo #1). It should be noted that September was a very wet month with 6.4 inches of rainfall which made the access road nearly impassible for inspections and repairs very difficult. On October 6, 2009 the certified operators were re-educated with respect to our expectations for documenting stormwater related issues during daily inspections.

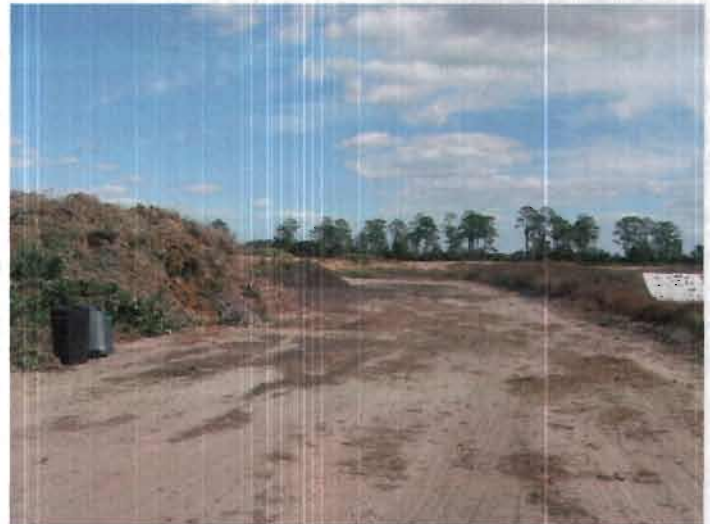
09/29/2009 - Minor ponding observed in the YT area. The grinder contractor will be at the site on October 5 and the pad will be re-graded at that time.

Photo #2: Yard Waste area re-graded

RESPONSE: The yard waste area has been re-graded to mitigate ponding. See Photo #2.

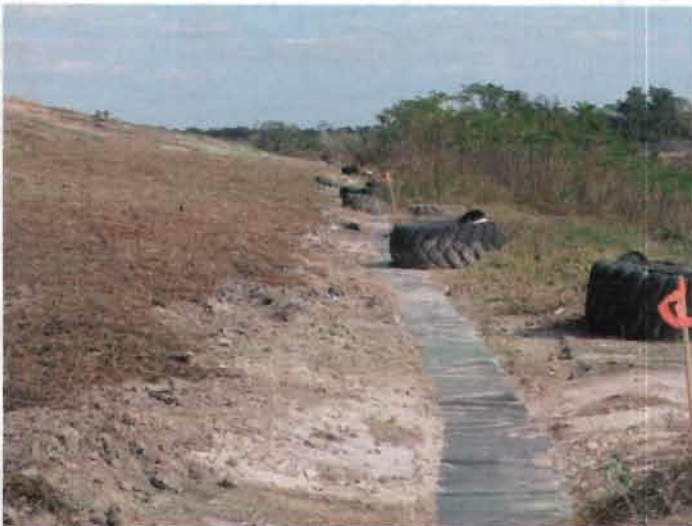
09/29/2009 - The cover on the lower terrace of the south slope of Phase I could not be effectively evaluated due to overgrowth of vegetation. Facility staff indicated that the slopes would be walked down as soon as they are dry enough and should be completed by Dec/Jan.

Photo #3: South slope of Phase I with vegetation removed

RESPONSE: The overgrowth of vegetation has been addressed ahead of schedule due to the cooperation of the weather. See Photo #3.

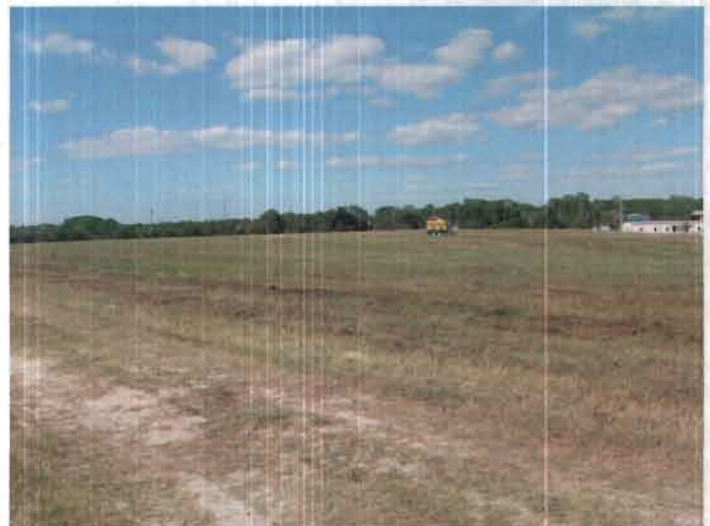
09/29/2009 - The 7 acre cell appeared very wet and vegetation was high. Facility plans to mow when the rainy season subsides.

Photo #4: 7-acre cell with vegetation mowed

RESPONSE: As stated above the pending 7 acre reclosure project will address the wet areas. The vegetation has been mowed. See Photo #4.
