Fla. Tire Recycling, Inc.  
Joe Lewis

Fla. Fire Recycling, Inc.

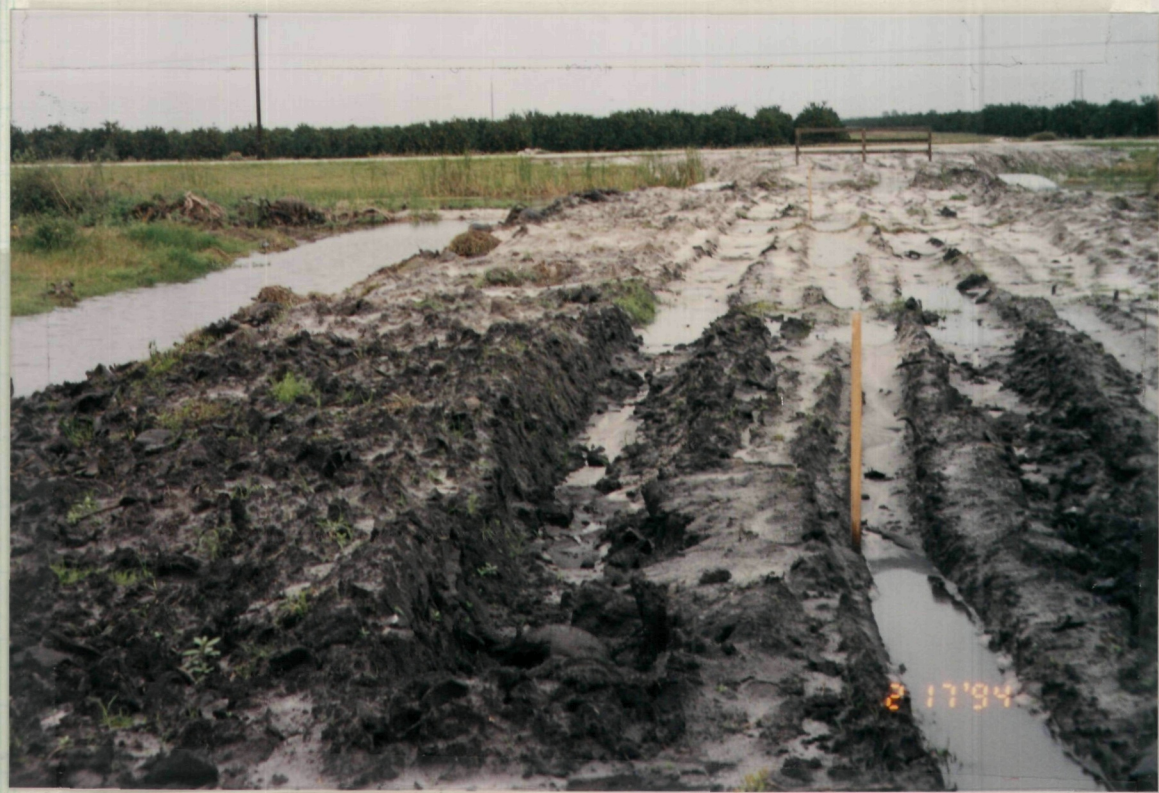
10.C.#2

Southern  
roadway  
looking  
east

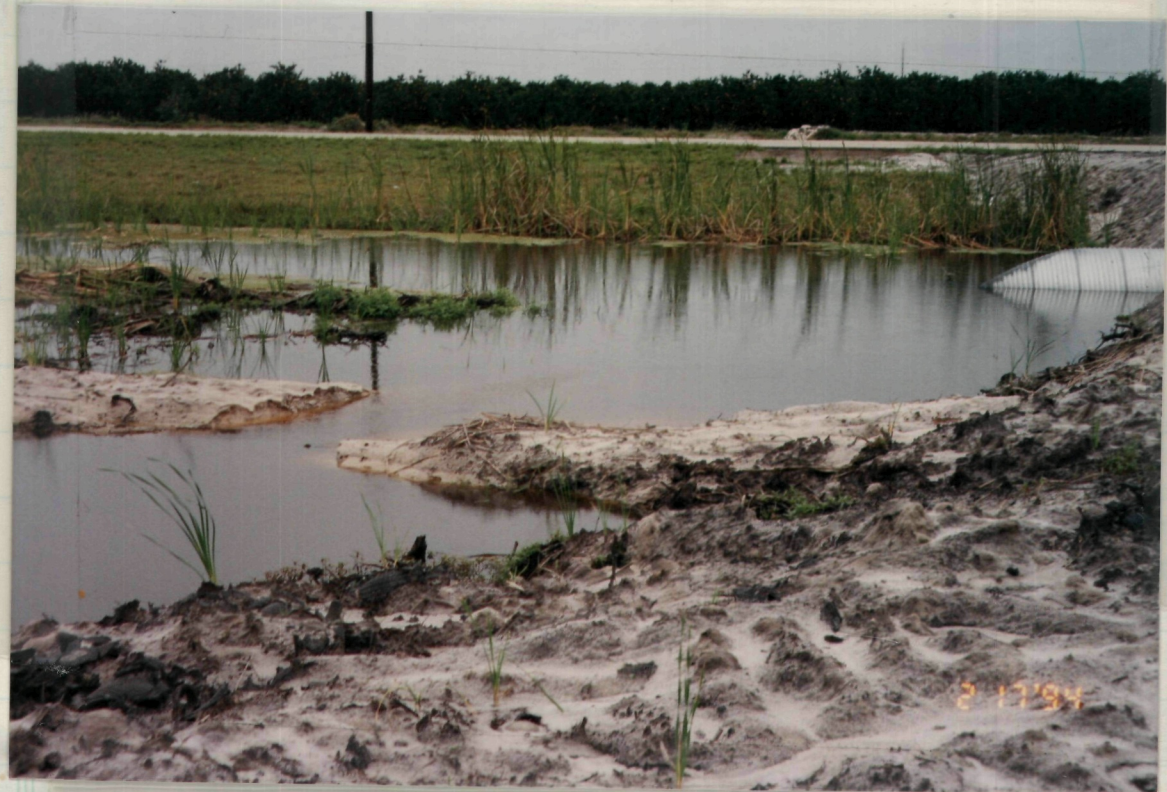
10A.#2

MSSW  
SE  
corner  
of  
property

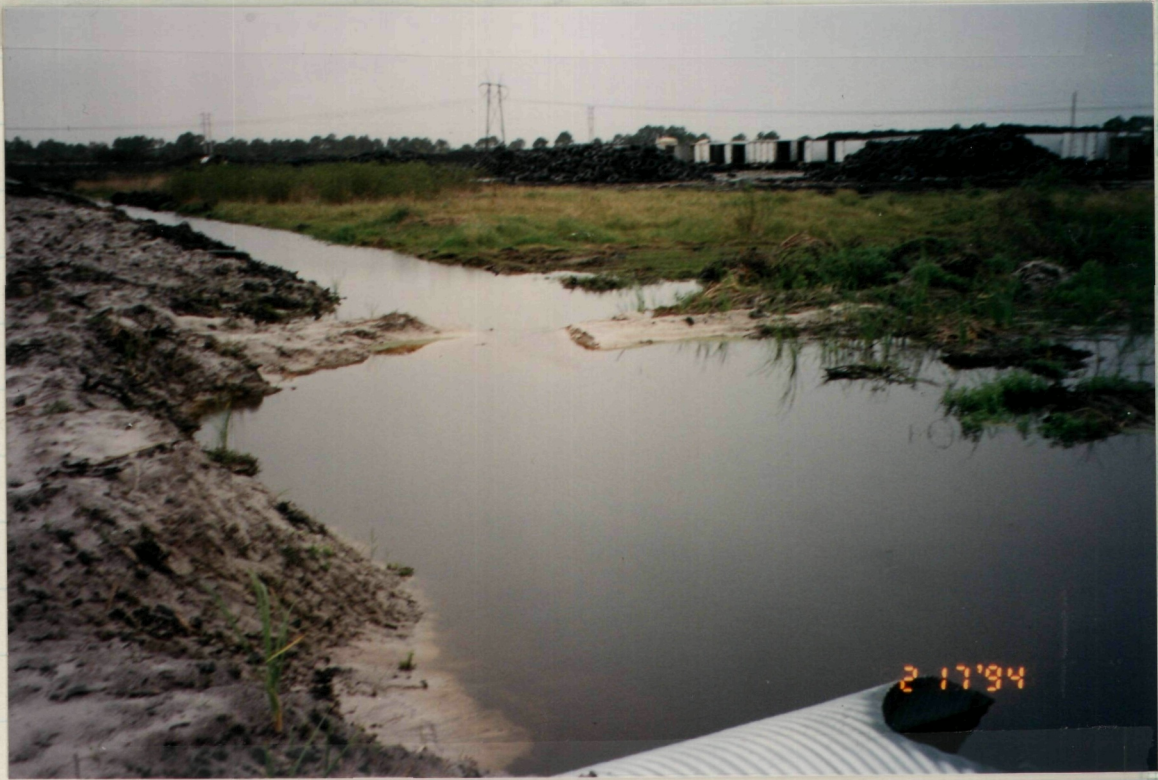
SE.  
corner  
10.A.#2  
MSSW

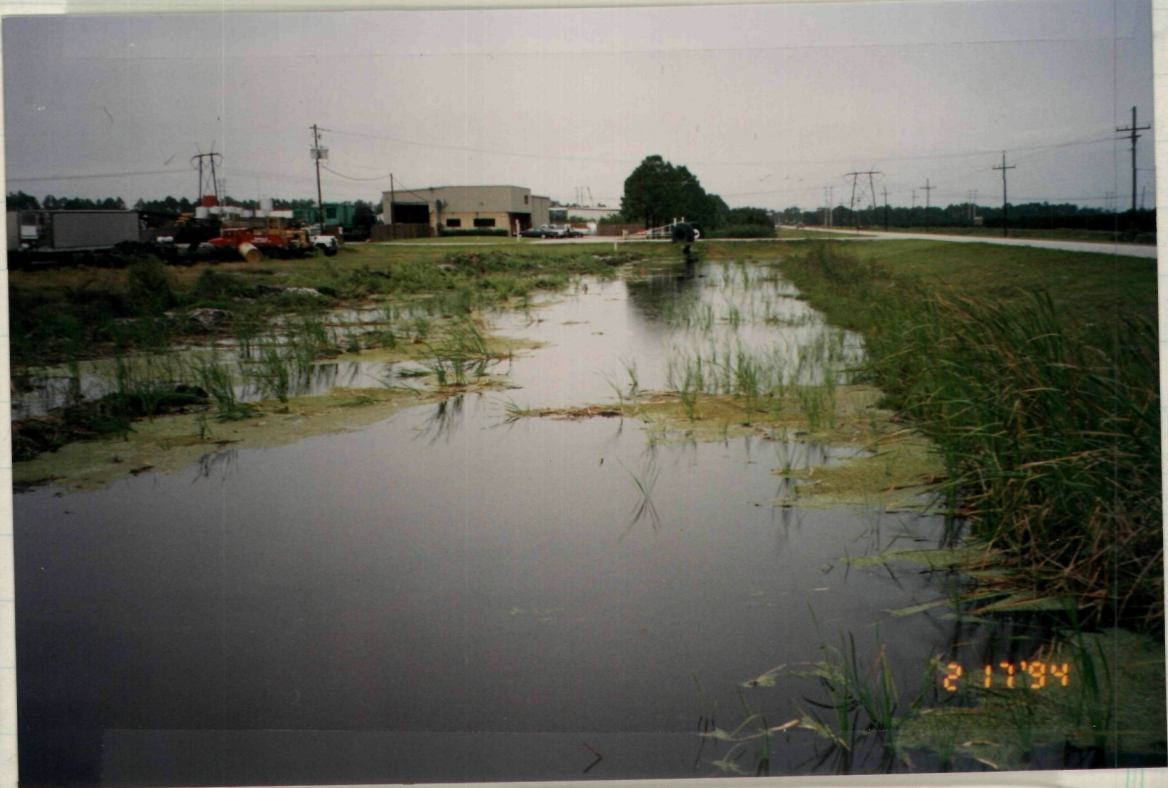
west  
side of  
Rangevine  
Road  
looking  
north

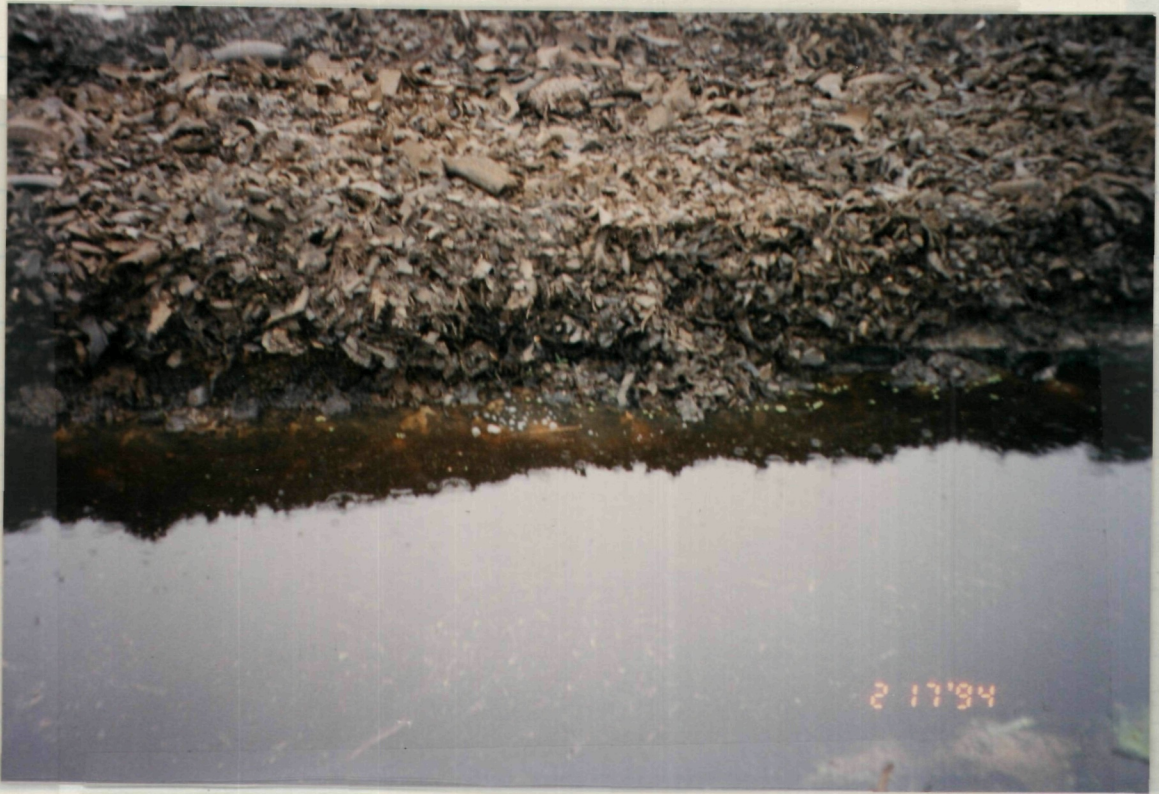
South canal  
- looking  
north at  
water  
sheet flow  
into canal

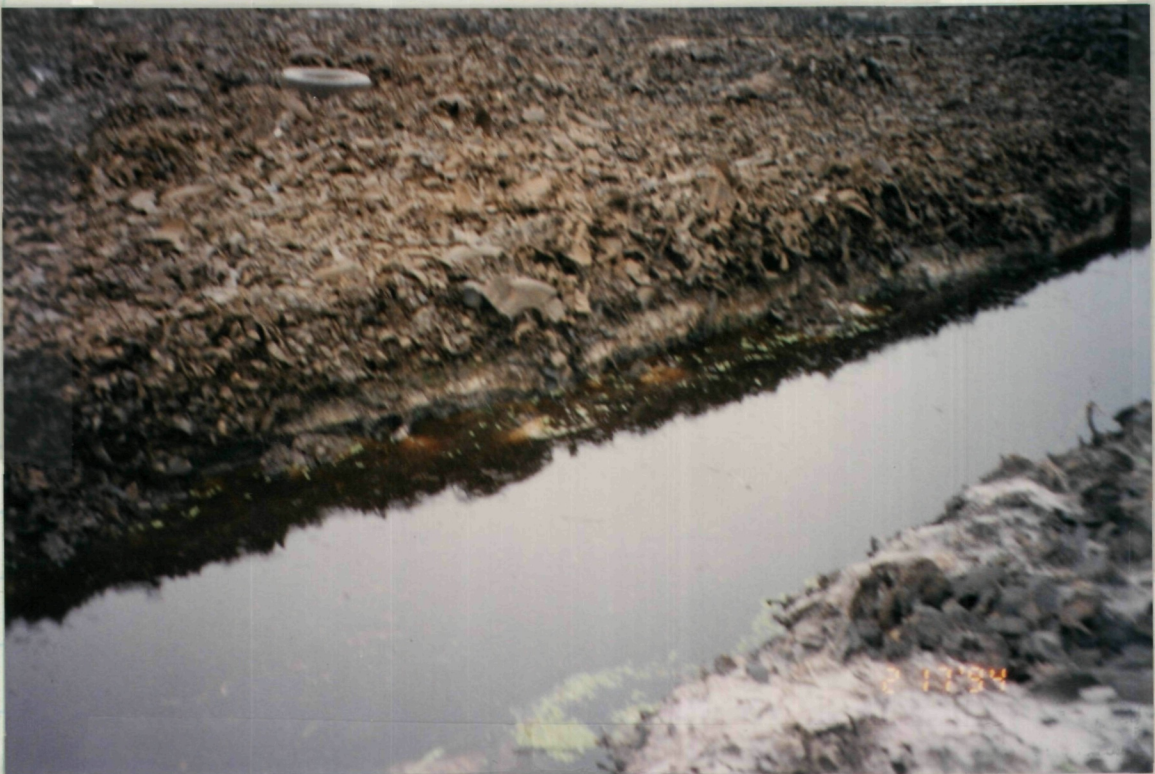
Same  
as above

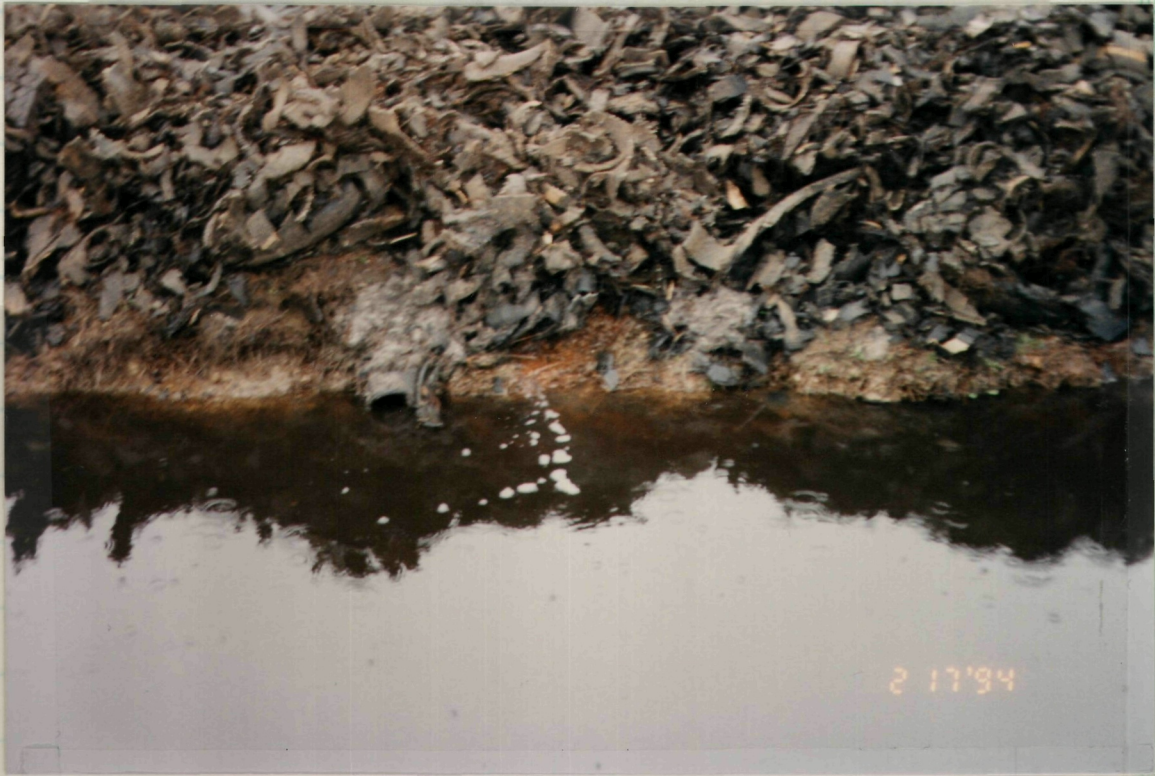
So. Canal  
- sheet flow  
of water  
into canal  
- looking  
north  
10D #1  
S.A.

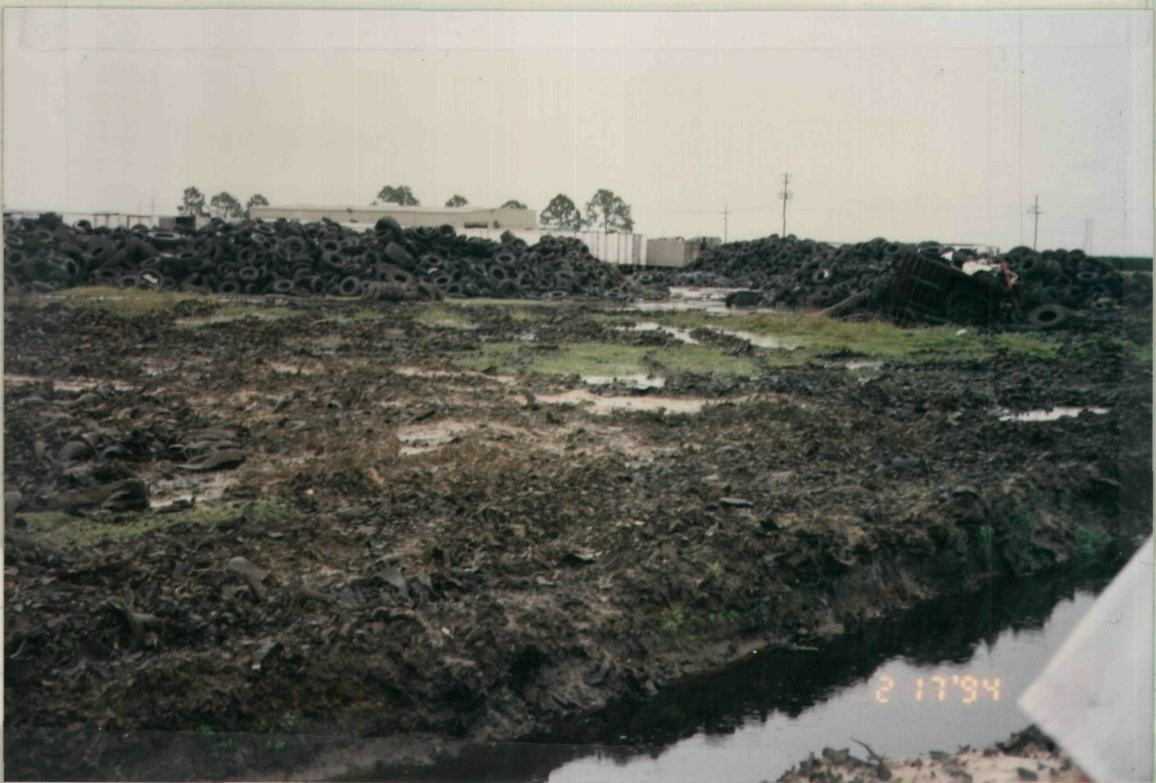
Pile 18-T  
from  
S.A.

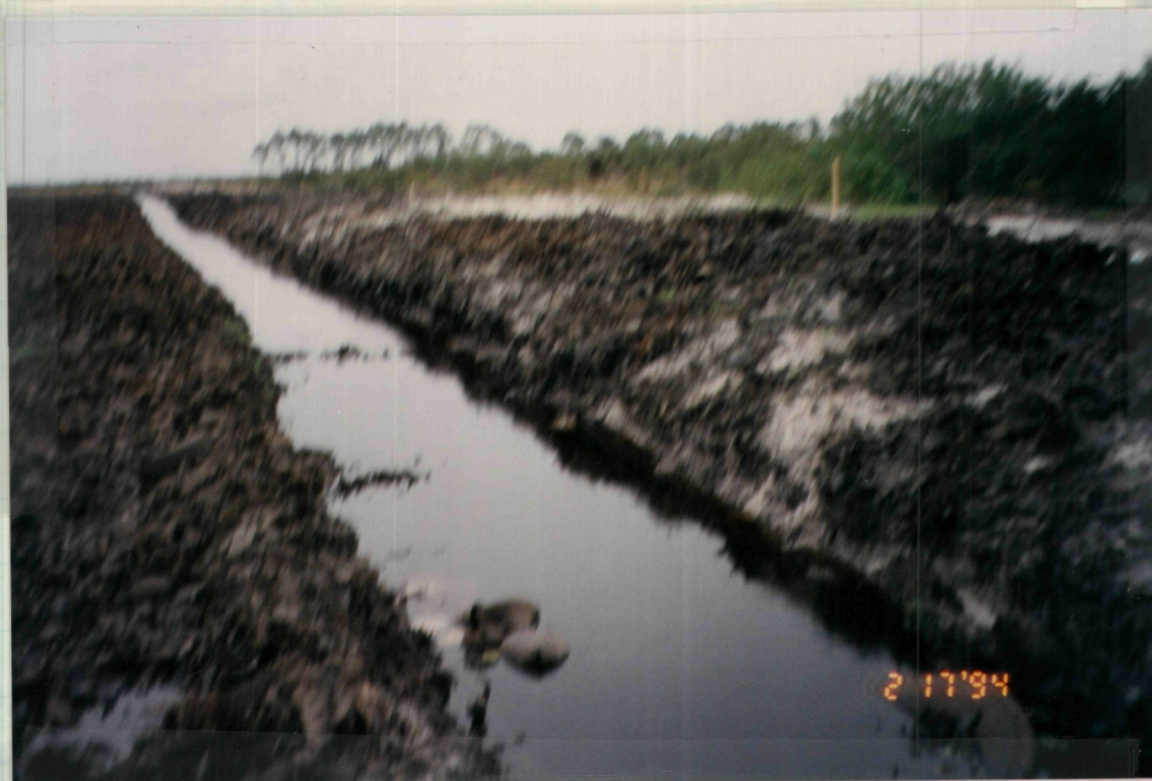
South  
canal  
looking east  
50' wide  
lane.  
10D #1.  
S.A.

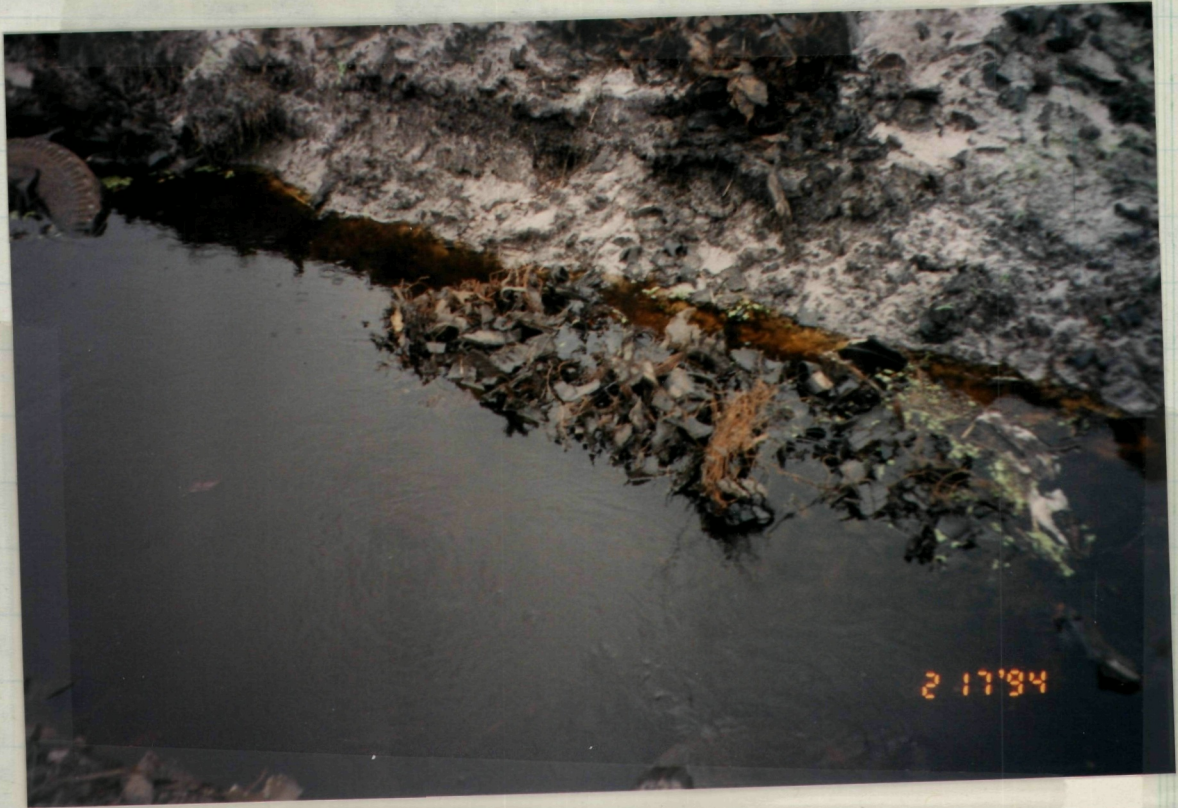
10D #1.  
S.A.

South  
Canal  
looking  
north

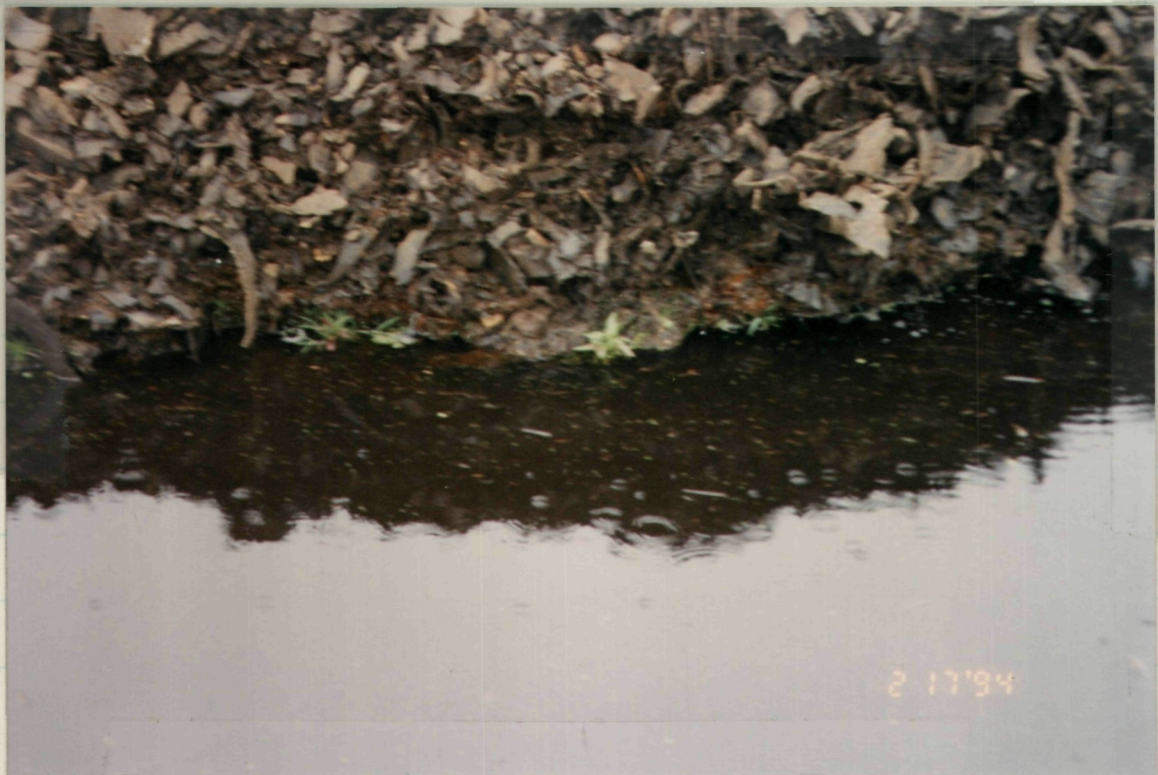
same  
as above

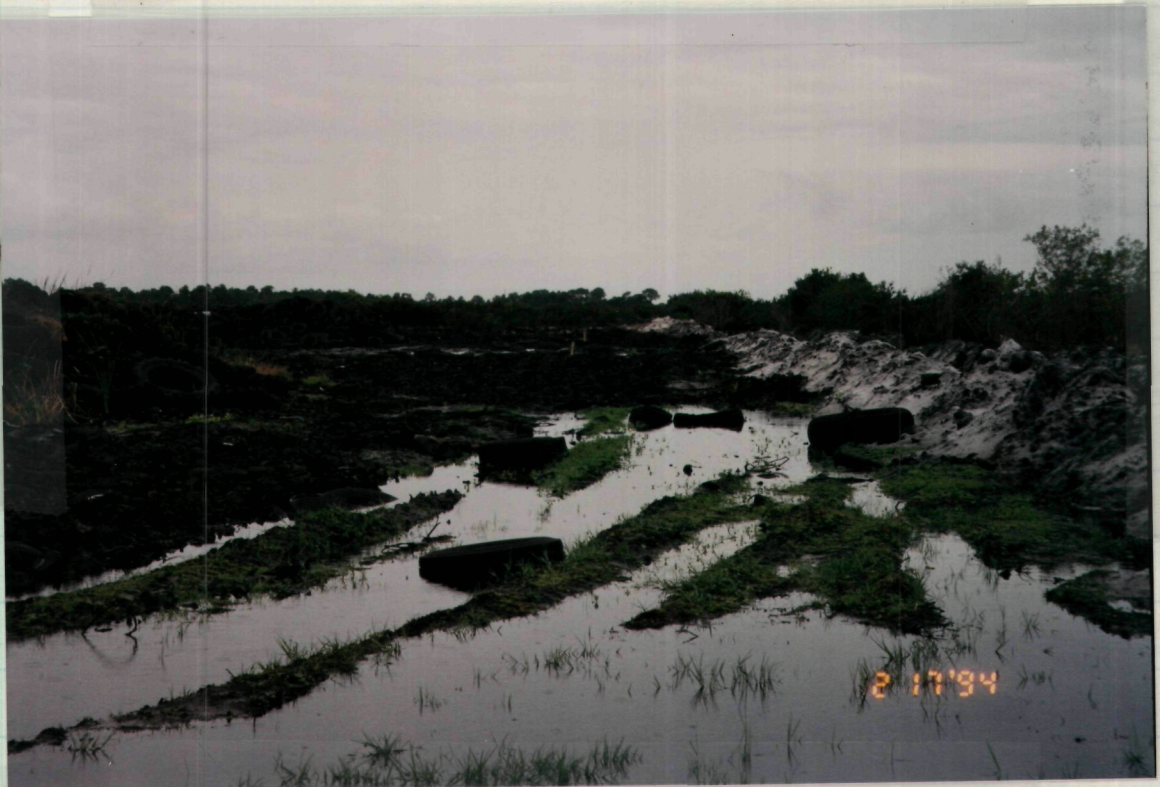
N.W.  
corner.  
Pile #15  
row  
#15 of S.A.

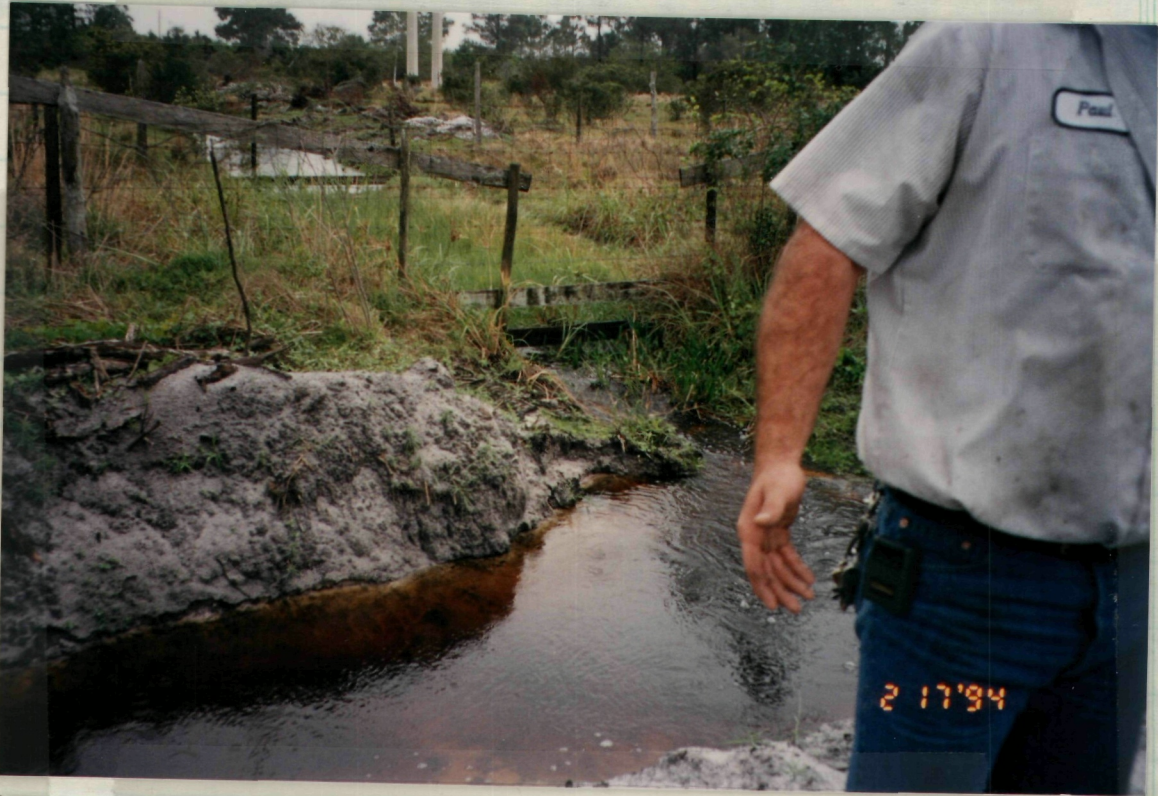
west boundary  
looking south  
10D. #1  
A.

westside  
of property  
- water  
flowing  
on site  
south to  
broken  
earth plug -

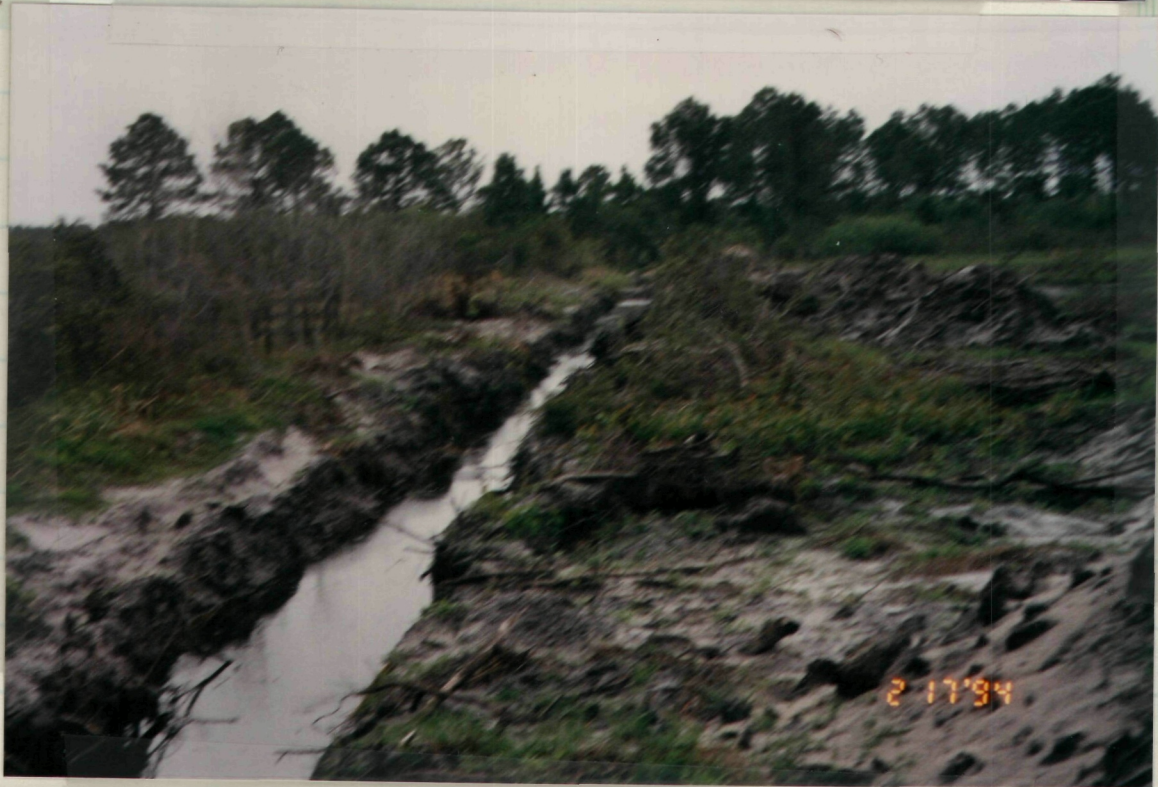
looking  
north  
along  
western  
boundary

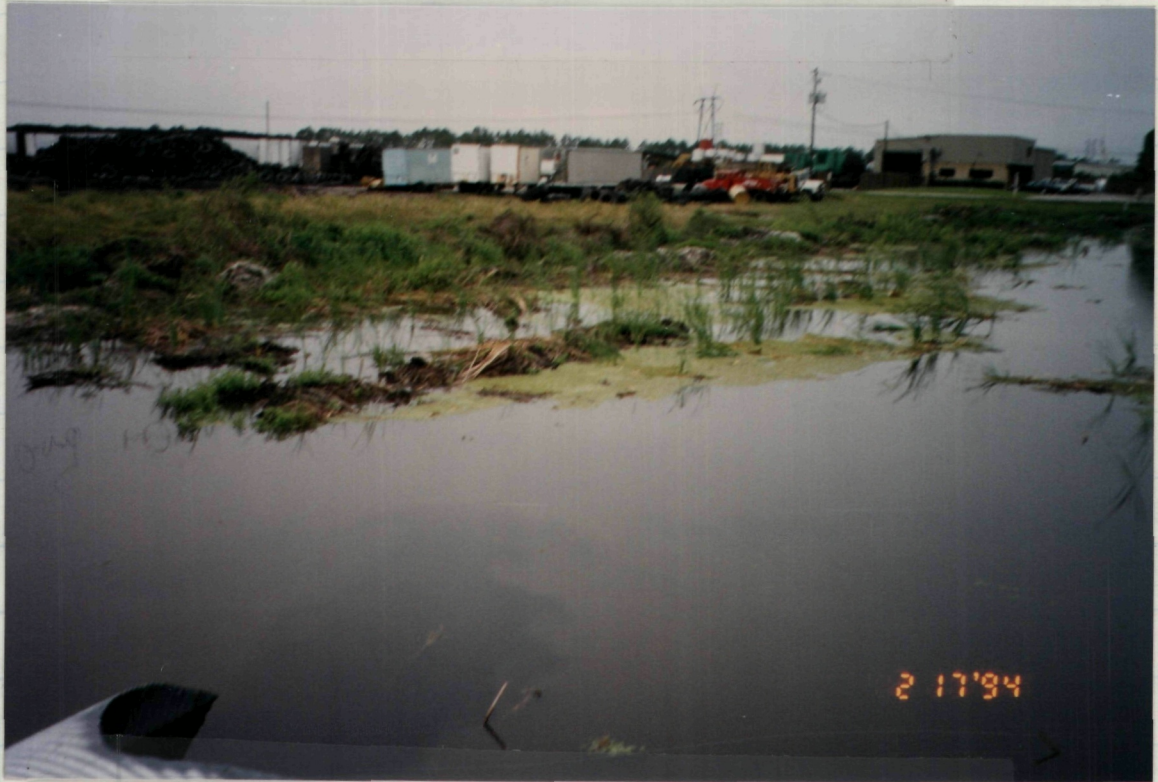
west side  
along  
Range Line  
Road  
looking  
north  
at new  
southern access roadway
