FIELD INSPECTION SUMMARY FORM

<p>FAC ID: 039300822 SITE NAME: Chaver Fowhand (MRKT Place) ADDRESS: 3101 N Highway 77 CITY: Panama City COUNTY: Bay SCORE: 56</p>	<p>DEP SITE MANAGER/ TEAM: Nik Hicks / LP17 CURRENT BUSINESS NAME: Auto Truck Parts FACILITY STATUS: <input type="radio"/> Active Fuel Dispensing <input type="radio"/> Active, Not Fuel Dispensing <input checked="" type="radio"/> Closed</p>
-------------------------------------------------------------------------------------------------------------------------------------------------------------------------------------------------------	------------------------------------------------------------------------------------------------------------------------------------------------------------------------------------------------------------------------------------------------------------------------------------------

Fac ID: 039300822

Site Name: Chaver Fowhand (MRKT Place)

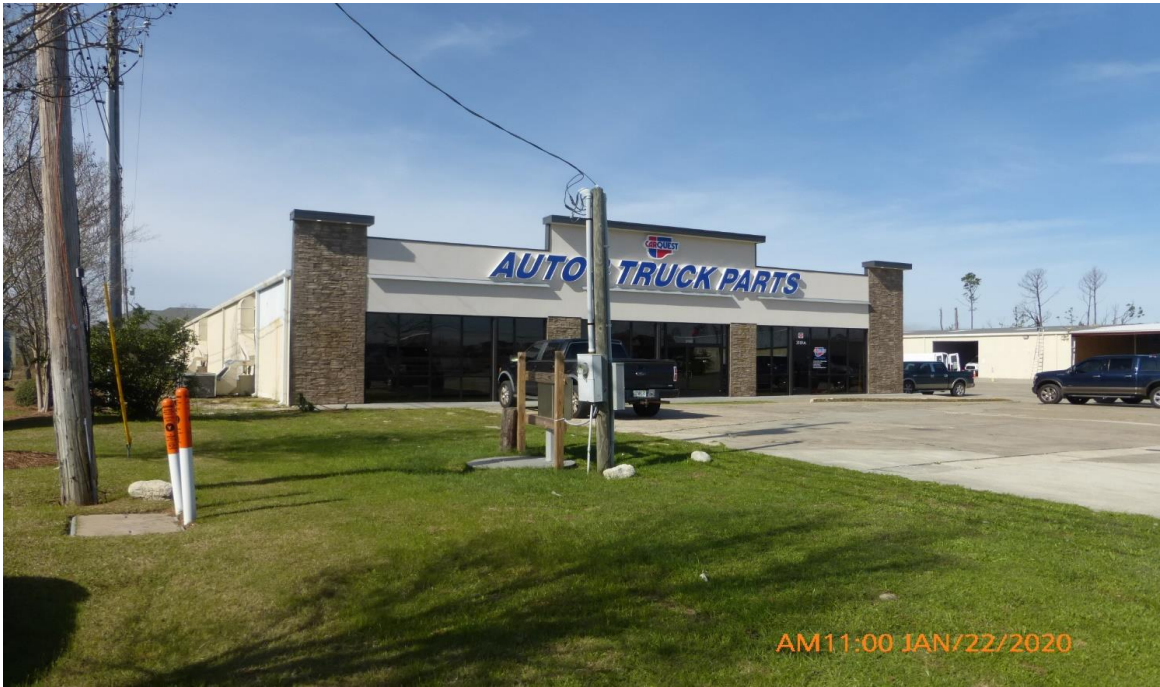
Facing north towards the store where the system compound was. New landscaping.

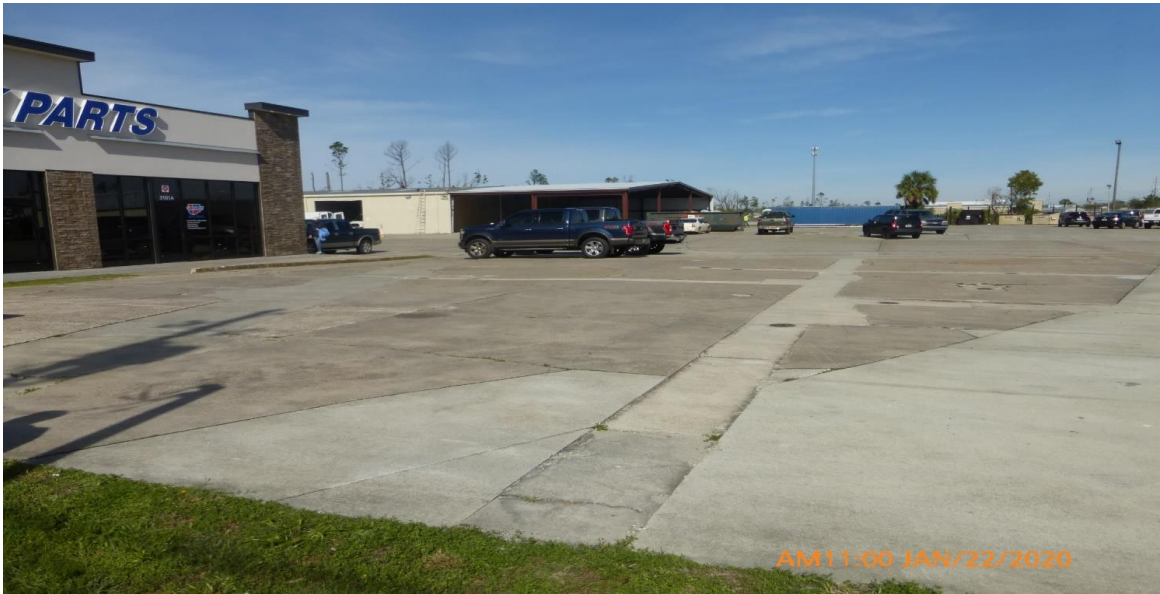
Facing northeast across the parking lot to be excavated.

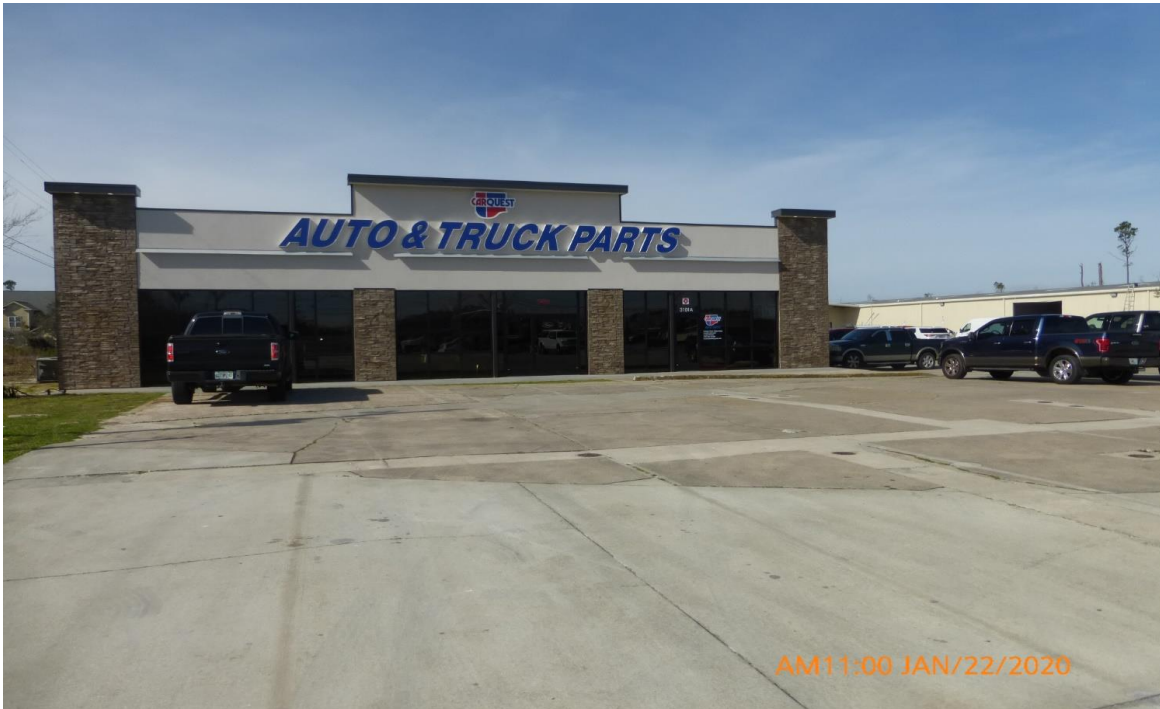
Facing north towards the store building. Area to be excavated.

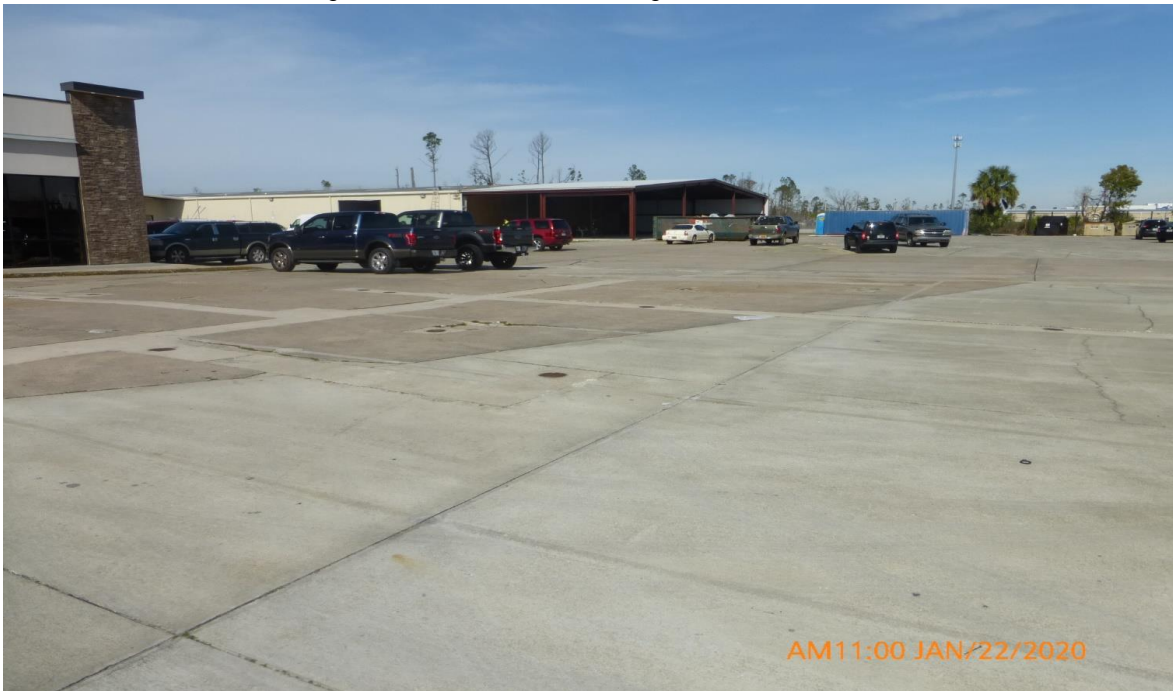
Monitoring well network and former trenches facing northeast.
