SUBJ: RCRA Inspection
Safety-Kleen Systems, Inc.
Tallahassee, Florida
EPA ID. No.: FLD 982 133 159

RCRA COMPLIANCE INSPECTION REPORT

Safety-Kleen Systems, Inc.
4426 Entrepot Boulevard
Tallahassee, Florida 32310

June 7, 2010

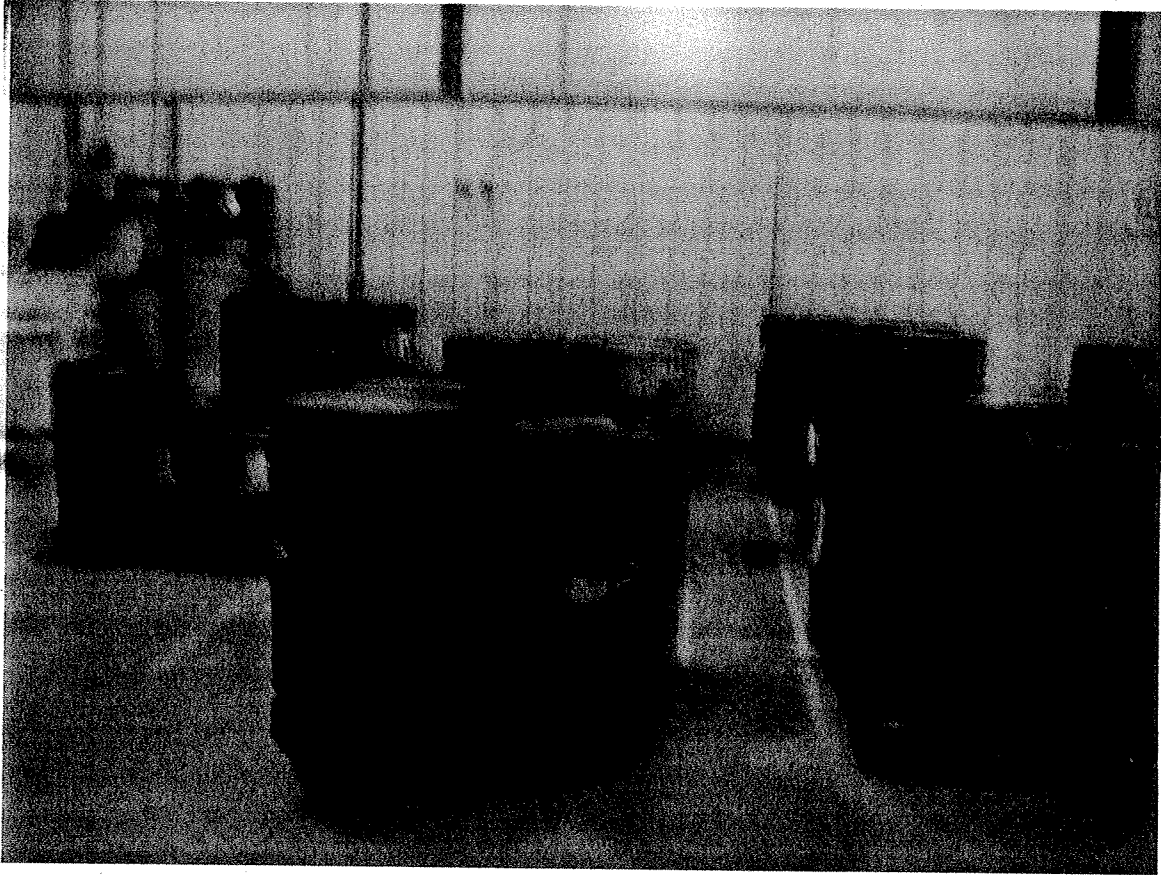
The containers observed in this area were on pallets and in three rows (See Photo 1). The first row consisted of three 55-gallon drums, two 15-gallon drums, and one 40-gallon drum. The second row consisted of six 55-gallon drums, seven 15-gallon drums, and three 5-gallon containers. The third row consisted of three 55-gallon drums, two 15-gallon drums and one 20-gallon drum. All of the drums and containers were closed and labeled with the words "Hazardous Waste" and accumulation start dates. Proper aisle space and spill equipment were observed for this area.

Photo 1 – Permitted Container Storage Area

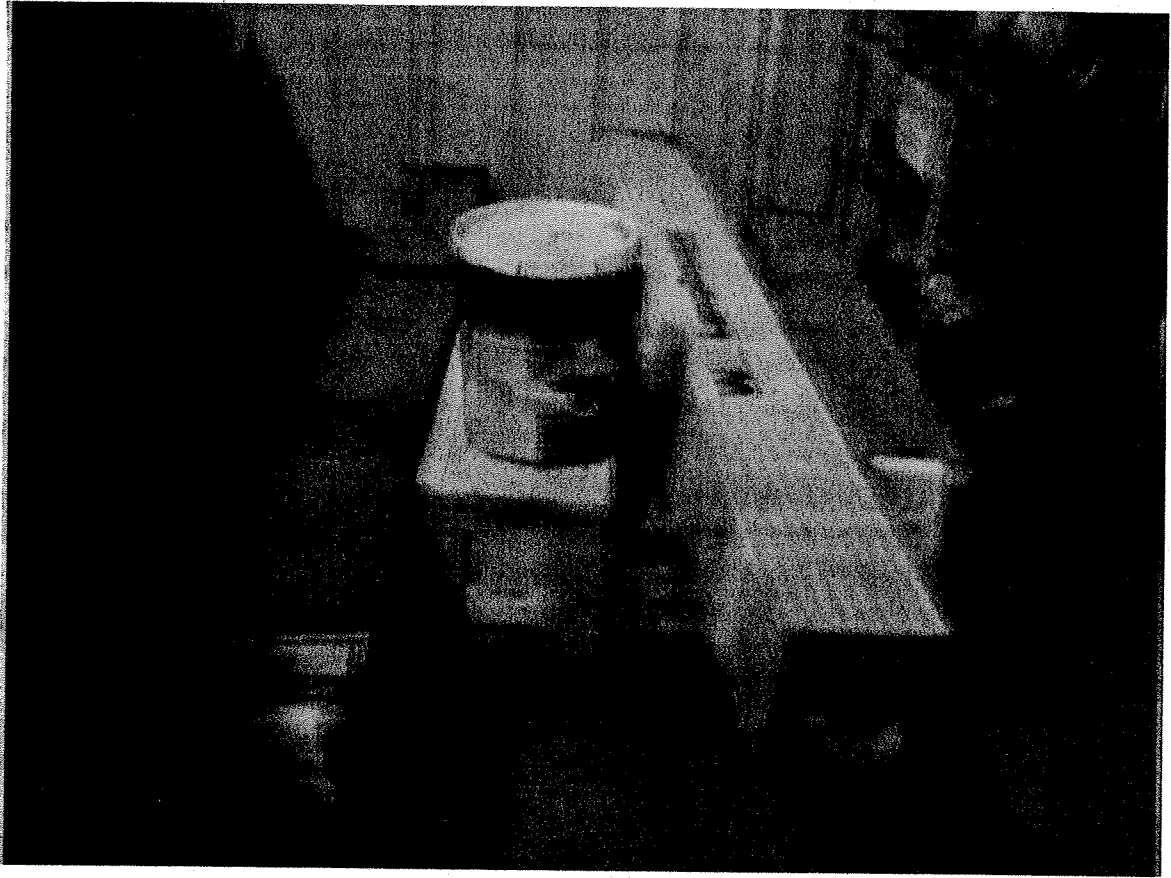
Universal wastes observed in this area included two boxes of eight foot tubes, four boxes of four foot tubes, and one five gallon container of batteries (See Photo 2). All of the containers were labeled with the correct universal waste language and marked with accumulation start dates.

Photo 2 – Universal Waste Storage Area

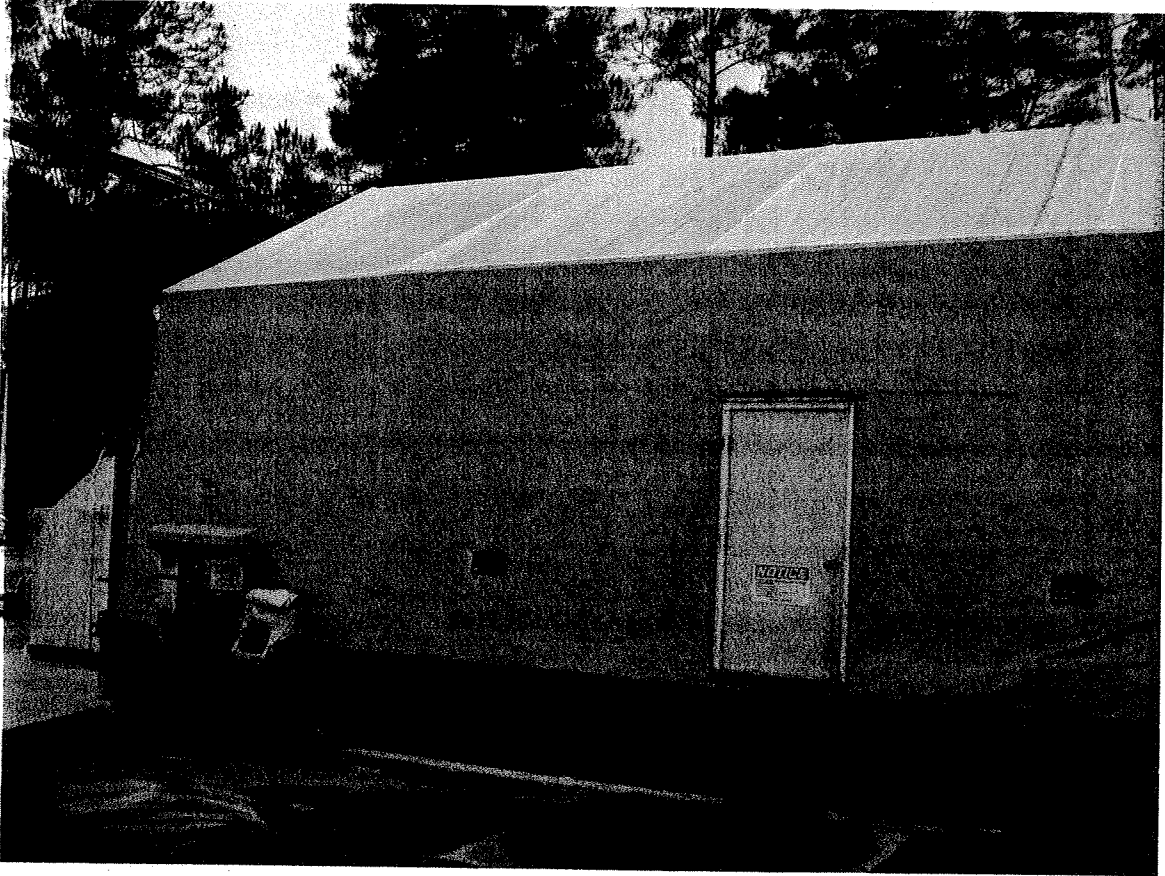
Photo 3 – Canvas covered tank farm.

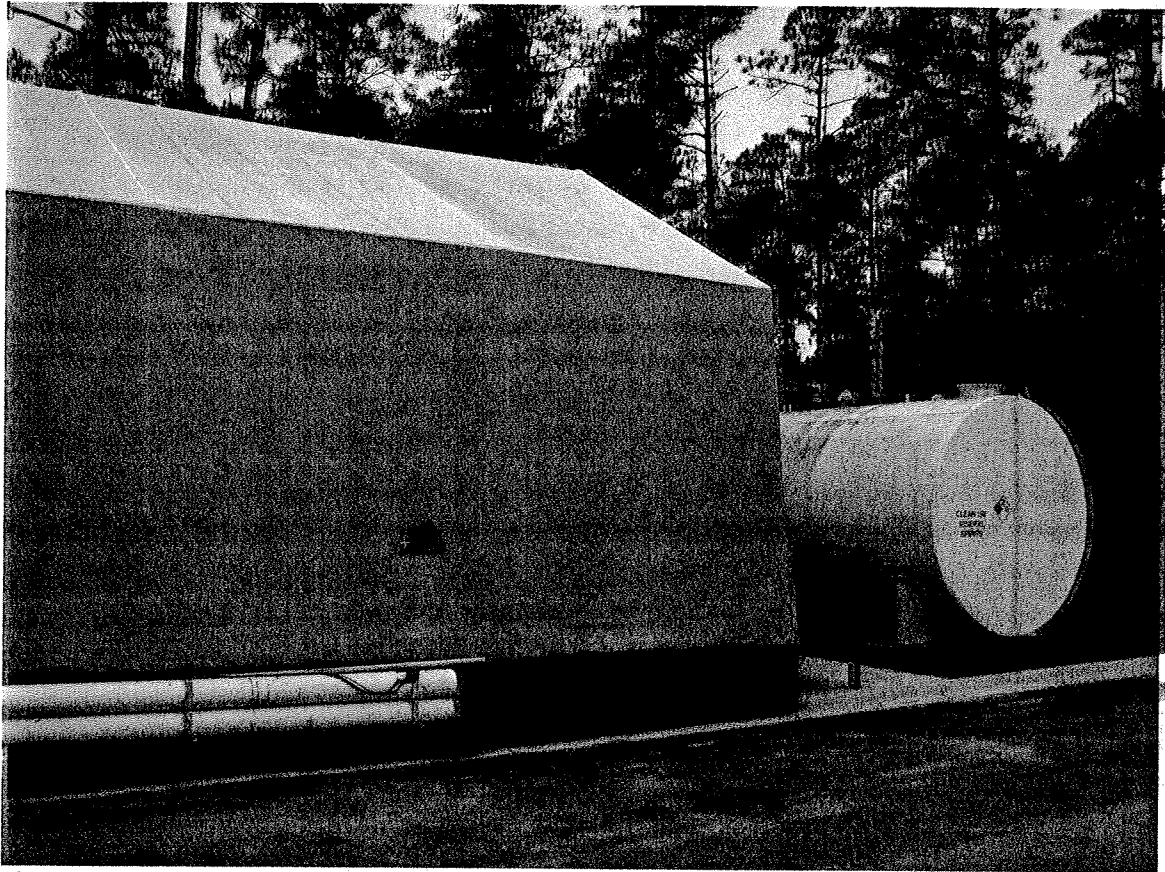
Photo 4 – Canvas covered tank farm.
