March 14, 2001

**SUBJECT: Report of Inspection of Tanks 1P-10P, 1SW, and Discharge Tank
 Water Recovery, Inc.
 Jacksonville, Florida
 LAW Project Number 40563-1-0225**

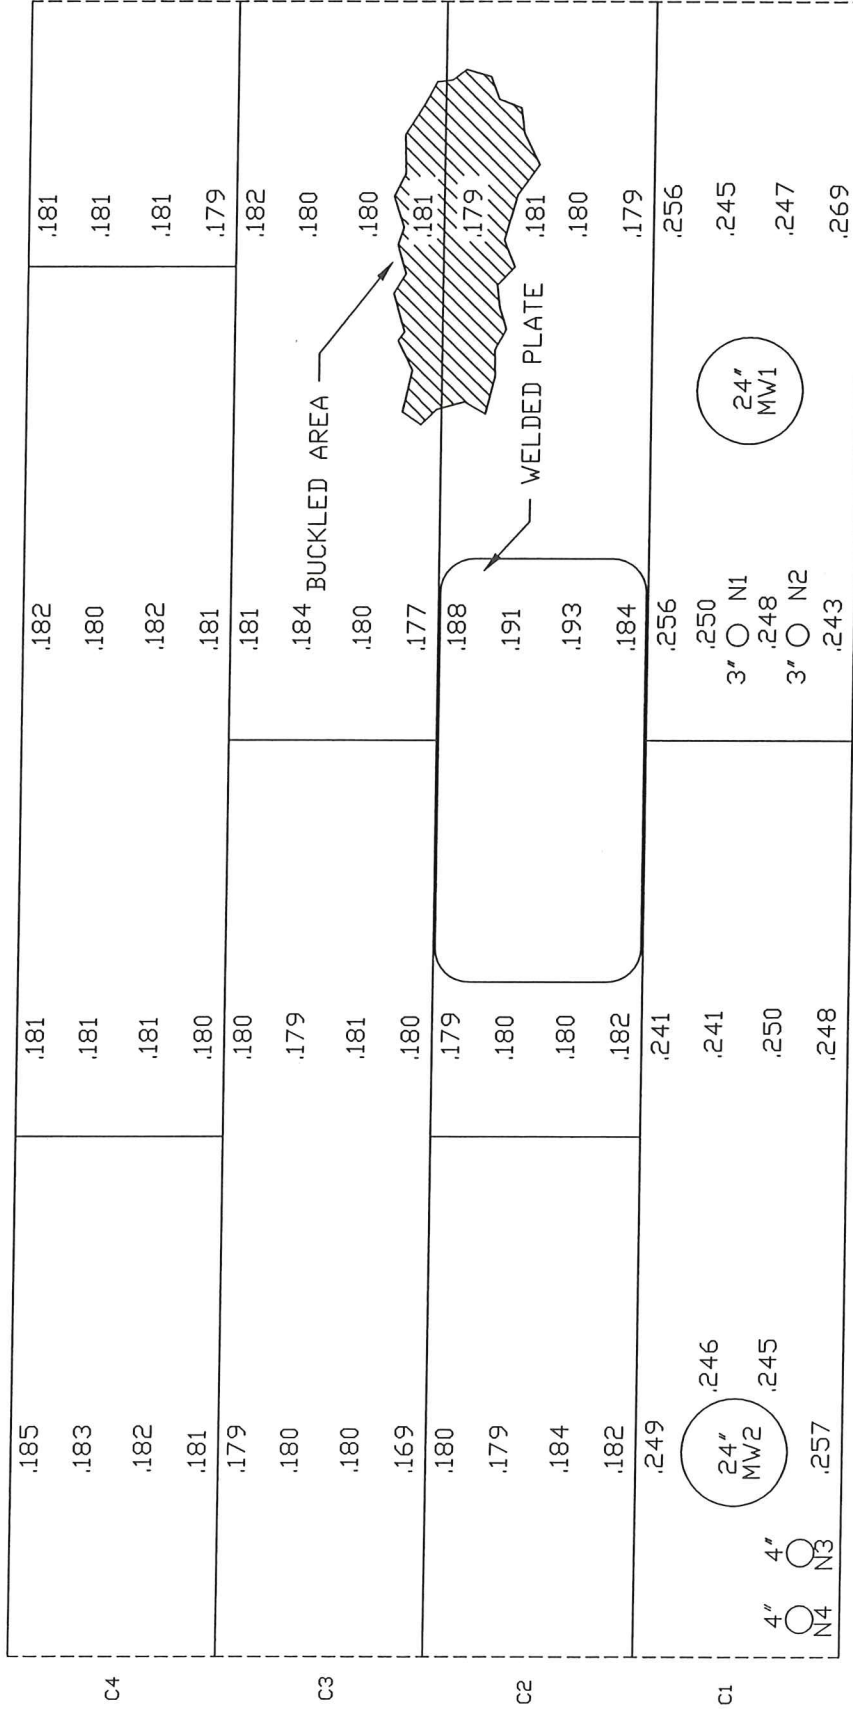
JOB NO.: 40563-1-0225 DWG. NO.: 0225-6P-01

showed some signs of deterioration. The tank was slightly buckled on the east side. The autogauge was also slightly damaged and the grounding strap was missing. All of the nozzles were not welded on the inside diameter of the tank. The tank has a baffle running northeast to southwest along the center. This baffle had a section that has been partially removed. All thickness readings recorded on this tank were above minimum thickness requirements per API-653 guidelines.

1. DRAWING NOT TO SCALE.
2. NOZZLES HAVE NO INSIDE DIAMETER WELDING.
3. SEE ATTACHED NOZZLE SHEET FOR NOZZLE UT READINGS.

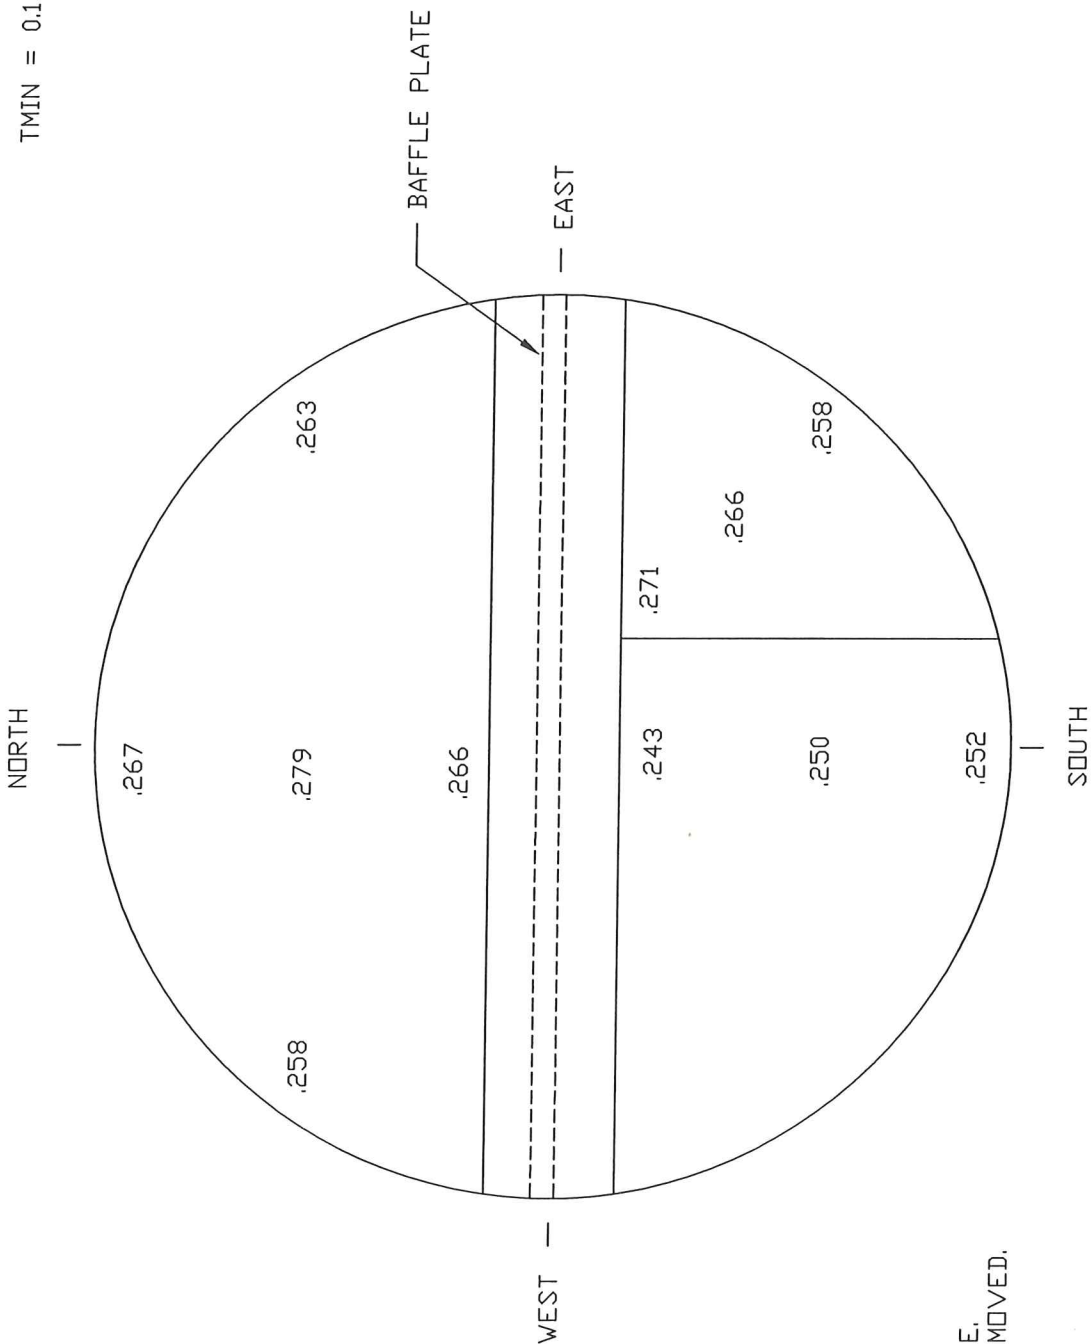
JOB NO.: 40563-1-0225 DWG. NO.: 0225-6P-02

1. DRAWING NOT TO SCALE.
2. BAFFLE PARTIALLY REMOVED.
