GE Inspection Services
9655 Florida Mining Blvd. West
Jacksonville, Florida 32257
(904) 292-1579

VESSEL GENERAL DATA									
NUMBER (EQUIPMENT NO., ETC.)			NAME (VESSEL TITLE)				DATE		
9P			USED OIL TANK				7/29/2010		
TYPE AND CONSTRUCTION CODE									
	PRESSURE VESSEL			ASME VIII			ASME X		
X	STORAGE TANK			API 620			UL 142		
	HEAT EXCHANGER		X	API 650			OTHER		
NAME PLATE DATA									
	PRESENT		X	ABSENT			OBSCURED		OTHER
MFR: METAL EQUIPMENT CO.				DESIGN PRESSURE: ATMOSPHERIC					
SERIAL NO.: N/A				DESIGN TEMP: N/A					
NAT. BD NO.: N/A				CONTENTS: OIL					
YEAR BUILT: N/A				SPECIFIC GRAVITY: 0.9					
DATA PLATE STAMPS									
	U		W		R		S		RT-1
									OTHER
SHELL			#1 HEAD (TOP)			#2 HEAD (BOTTOM)			
X	VERTICAL			ASME F&D / TORISPHERICAL			ASME F&D / TORISPHERICAL		
	HORIZONTAL			HEMISPHERICAL			HEMISPHERICAL		
	SKEWED			CONICAL			CONICAL		
	OTHER			ELLIPTICAL			ELLIPTICAL		
X	CYLINDRICAL			TORICONICAL			TORICONICAL		
	SPHERICAL			SEGMENTED DOME		X	FLAT		
	RECTANGULAR		X	FLAT			OTHER		
	OTHER			FLOATING ROOF

CUSTOMER: WATER RECOVERY INC., LLC
ADDRESS: JACKSONVILLE, FLORIDA
VESSEL TITLE: USED OIL TANK
EQUIPMENT NO.: 9P
DEPARTMENT: WATER / OIL SEPARATOR
SERVICE COMPON

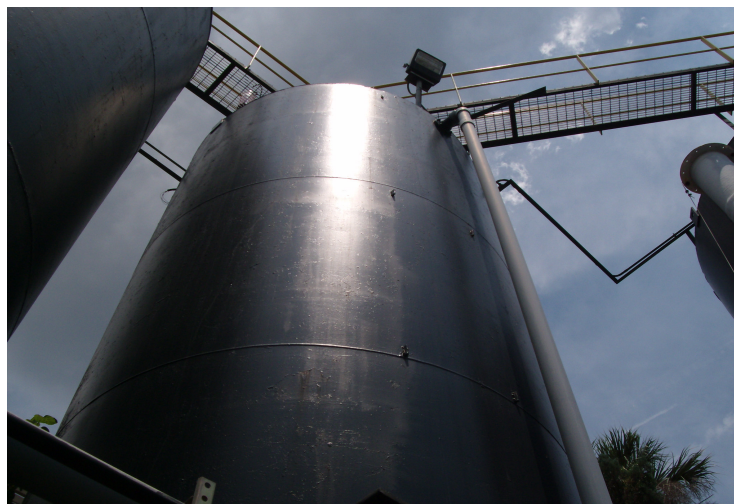
9P Tank - External Shell Photo

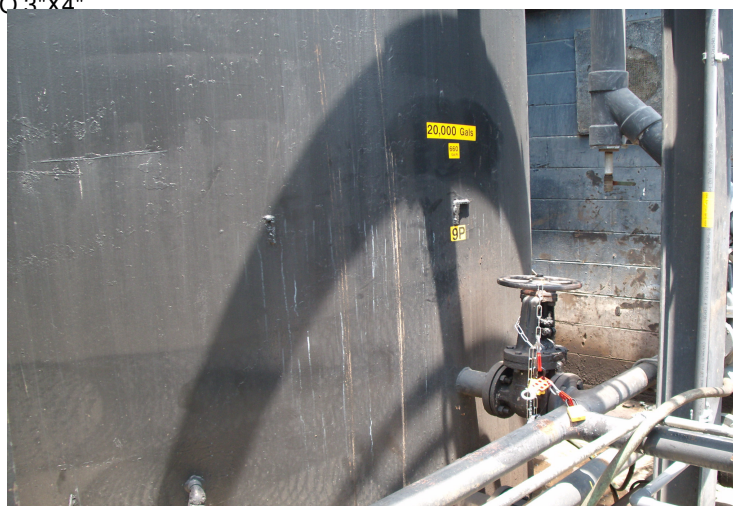
9P Tank - Additional External Shell Photo

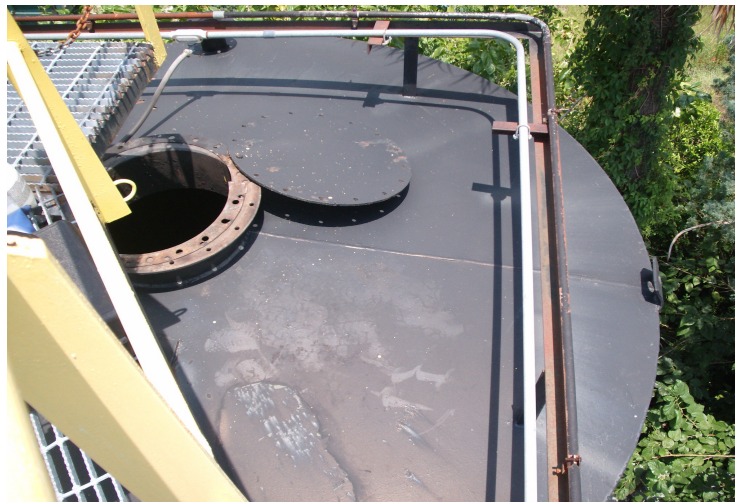
9P Tank - External Roof Photo

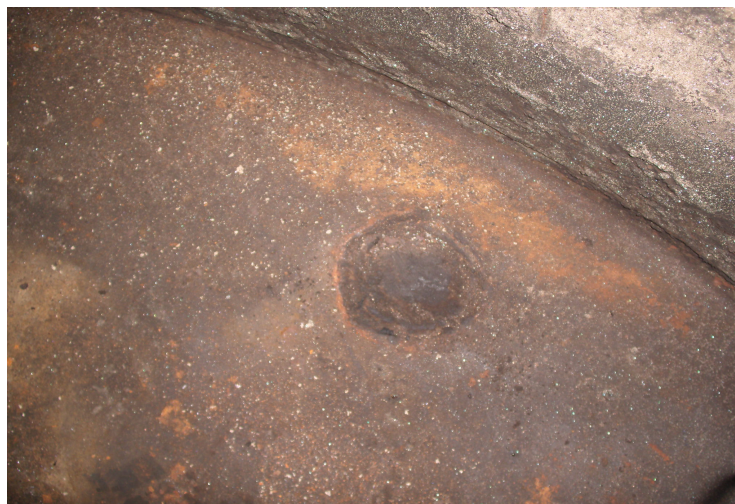
9P Tank - Internal Floor Patch Plate Photo
