## Section 7

**WATER RECOVERY, INC.**  
JACKSONVILLE, FL

**TANK 7P**  
**GENERAL ARRANGEMENT**

JOB NO.: 40563-1-0225 DWG. NO.: 0225-7P-01

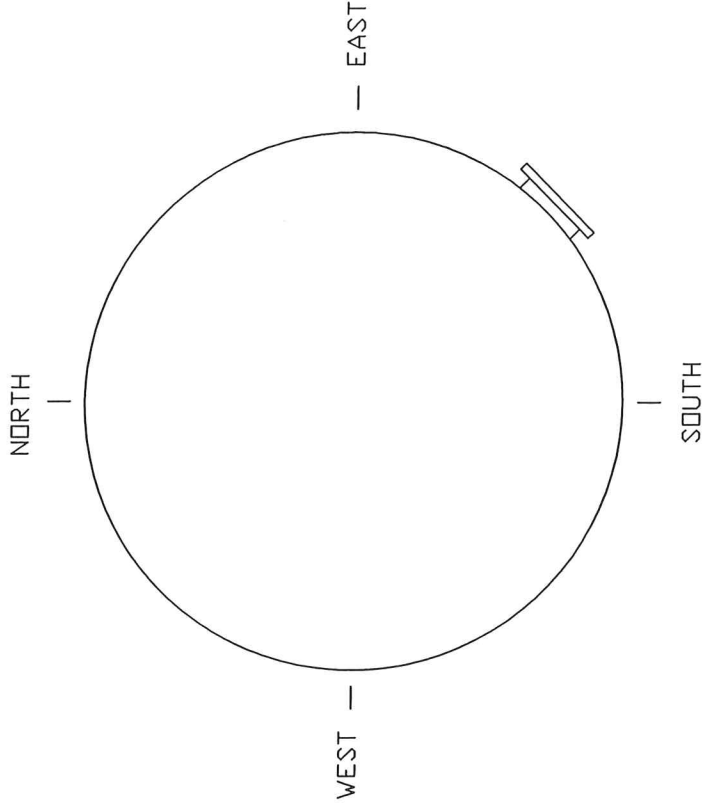
C4	.261	.265	.259	.265
	.264	.262	.260	.262
	.262	.257	.261	.257
	.260	.248	.254	.247
C3	.251	.260	.257	.254
	.258	.262	.263	.260
	.256	.256	.261	.256
	.248	.248	.248	.247
C2	.269	.260	.258	.259
	.264	.263	.264	.263
	.257	.260	.257	.260
	.248	.248	.245	.249
C1	.269	.266	.266	.267
	.274	.273	.279	.271
	.272	.274	.281	.274
	.270	.279	.283	.281

1. DRAWING NOT TO SCALE.
2. NOZZLES HAVE NO INSIDE DIAMETER WELDING.
3. SEE ATTACHED NOZZLE SHEET FOR NOZZLE UT READINGS.

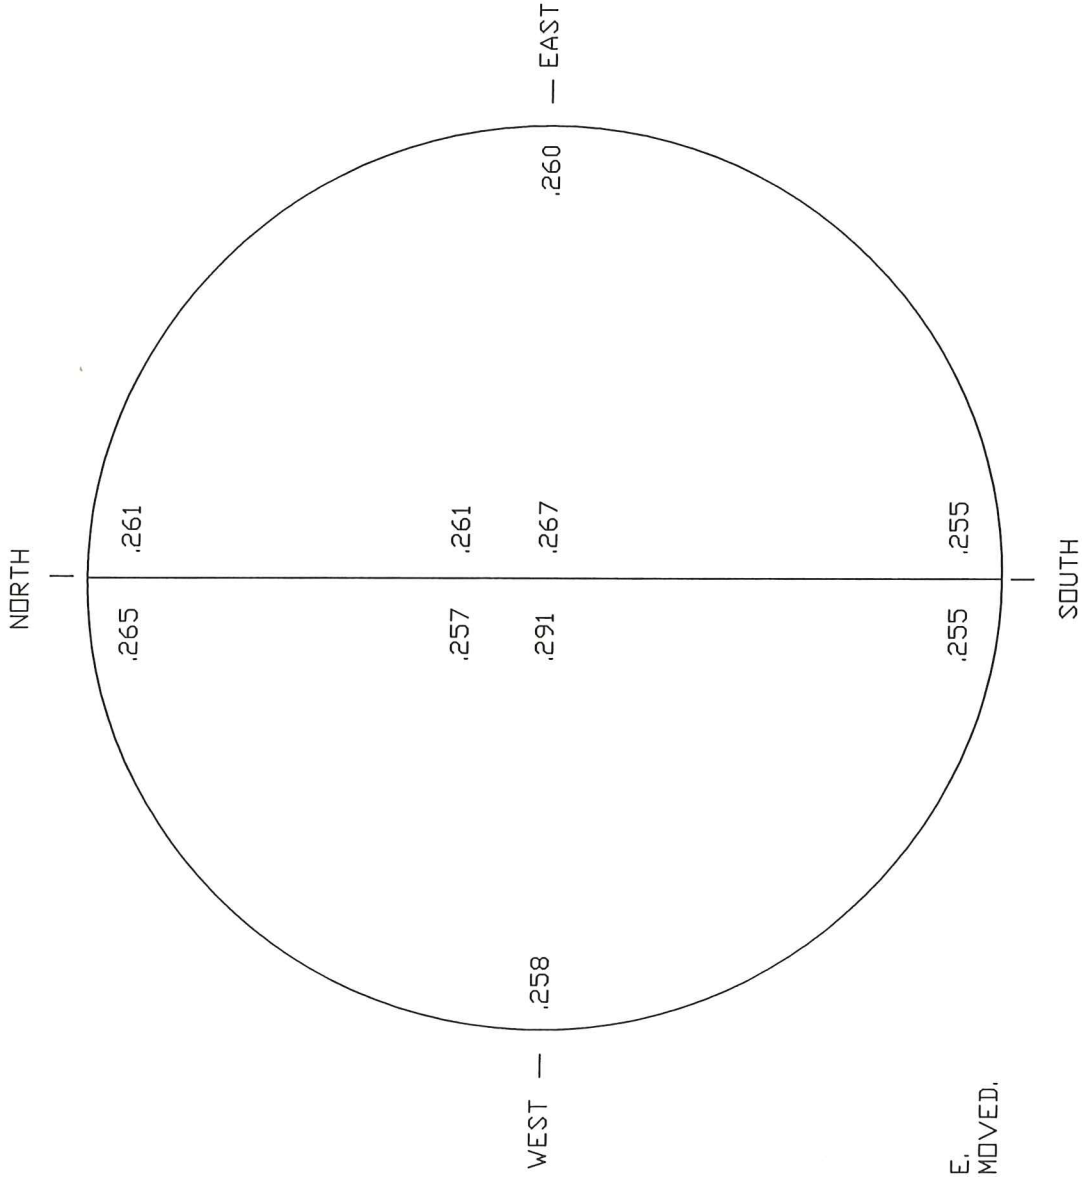
**TANK 7P**  
**ROOF LAYOUT AND UT DATA**

TMIN = 0.100 INCH

1. DRAWING NOT TO SCALE.
2. BAFFLE PARTIALLY REMOVED.

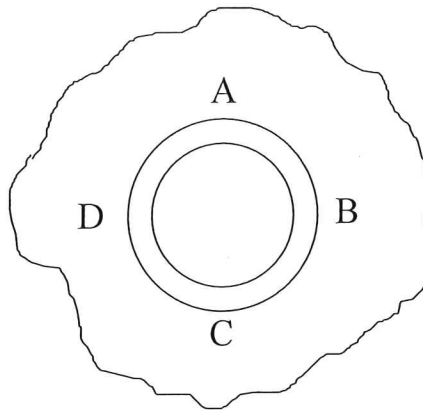
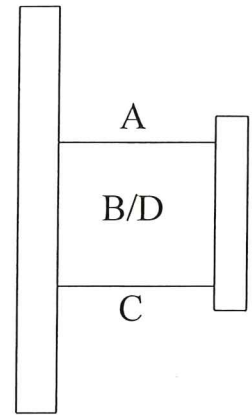
**TANK 7P**  
**MANWAY/NOZZLE UT READINGS**  
**WATER RECOVERY, INC.**

NOZZLES	SIZE	SHELL PLATE THICKNESS				NOZZLE PIPE THICKNESS				REPAD THICKNESS
		A	B	C	D	A	B	C	D	
N1	3'	NA	.280	NA	NA	NA	.198	NA	NA	NA
N2	3"	NA	.282	NA	NA	NA	.242	NA	NA	NA
N3	4"	NA	.279	NA	NA	NA	NA	NA	NA	.270
N4	4"	NA	.285	NA	NA	NA	NA	NA	NA	.320
MW	24"	.282	.278	NA	.285	.276	.267	.257	NA	NA

1. Readings are in inches.
2. NA = Not Applicable.
3. Repad on N3 did not have a weep hole.

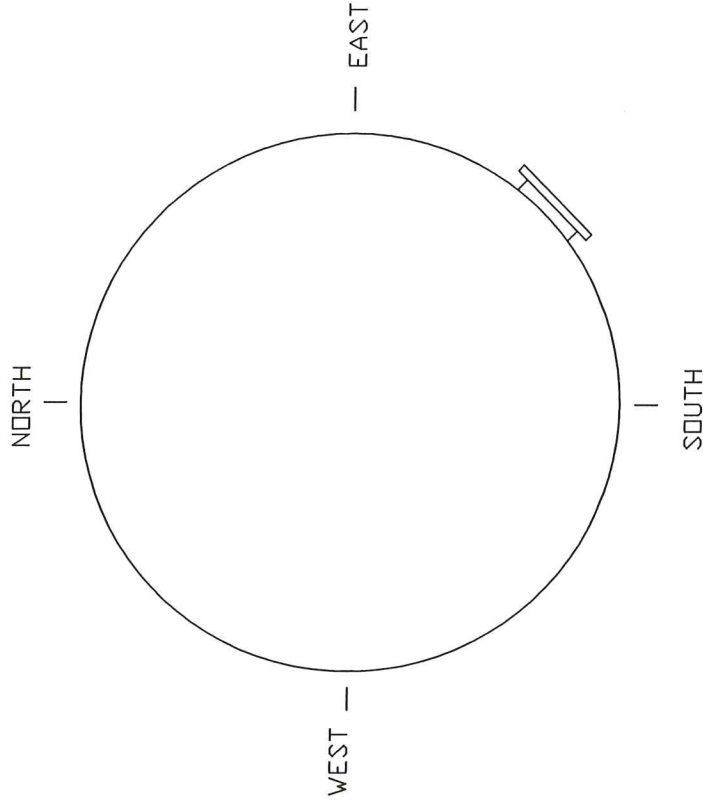
**TANK 8P**  
**GENERAL ARRANGEMENT**

C4	.261	.259	.254	.259
	.263	.268	.258	.268
	.260	.262	.254	.256
	.257	.253	.246	.252
C3	.261	.259	.254	.258
	.265	.266	.257	.266
	.269	.267	.256	.269
	.258	.261	.249	.259
C2	.265	.267	.259	.270
	.276	.277	.268	.276
	.271	.273	.267	.277
	.267	.264	.259	.265
C1	.258	.261	.254	.257
	.272	.262	.261	.254
	.253	.263	3" ON1	.258
	.270	.255	3" ON2	.257

1. DRAWING NOT TO SCALE.
2. NOZZLES HAVE NO INSIDE DIAMETER WELDING.
3. SEE ATTACHED NOZZLE SHEET FOR NOZZLE UT READINGS.

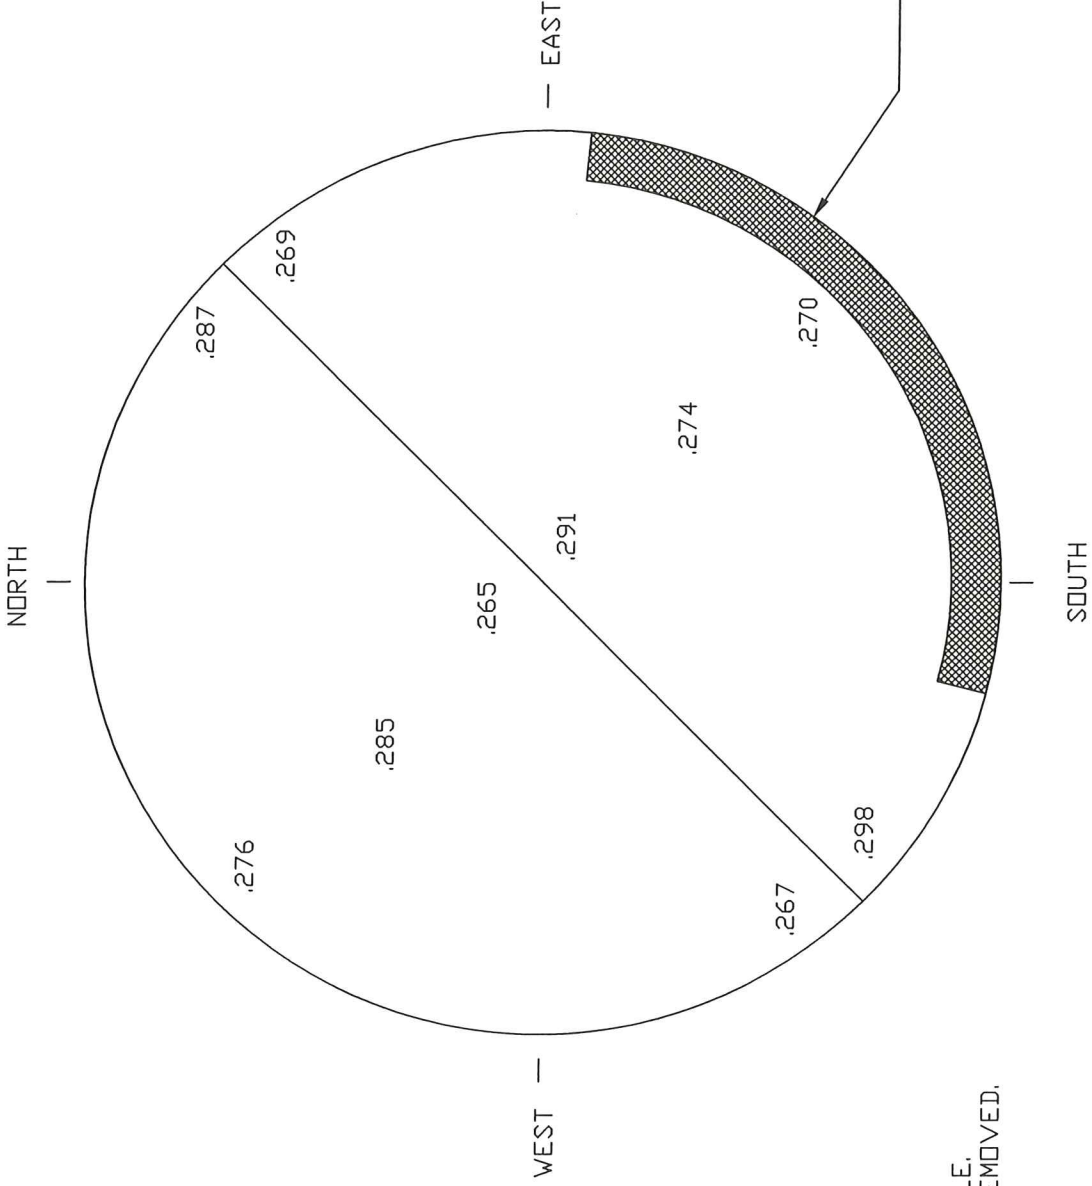
**TOP LAYOUT AND UT DATA**

TMIN = 0.125 INCH

1. DRAWING NOT TO SCALE.
2. BAFFLE PARTIALLY REMOVED.

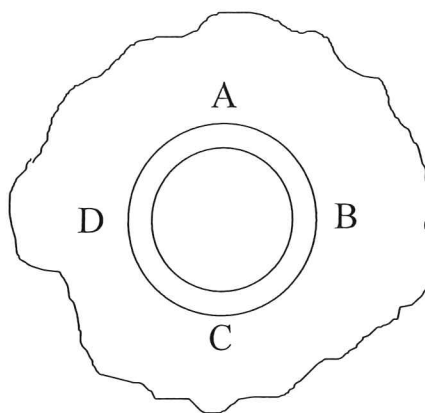
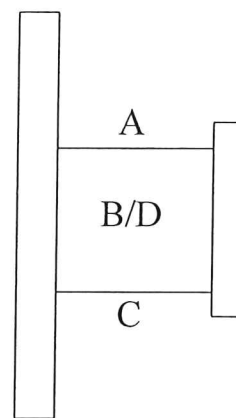
NOZZLES	SIZE	SHELL PLATE THICKNESS				NOZZLE PIPE THICKNESS				REPAD THICKNESS
		A	B	C	D	A	B	C	D	
N1	3'	NA	.267	NA	NA	NA	.209	NA	NA	NA
N2	3"	NA	.259	NA	NA	NA	.222	NA	NA	NA
N3	3"	NA	.272	NA	NA	NA	NA	NA	NA	.260
N4	1"	NA	.275	NA	NA	TC	TC	TC	TC	NA
N5	4"	NA	.293	NA	NA	NA	NA	NA	NA	.276
MW	20"	.271	.273	NA	.266	.276	.270	.263	NA	NA

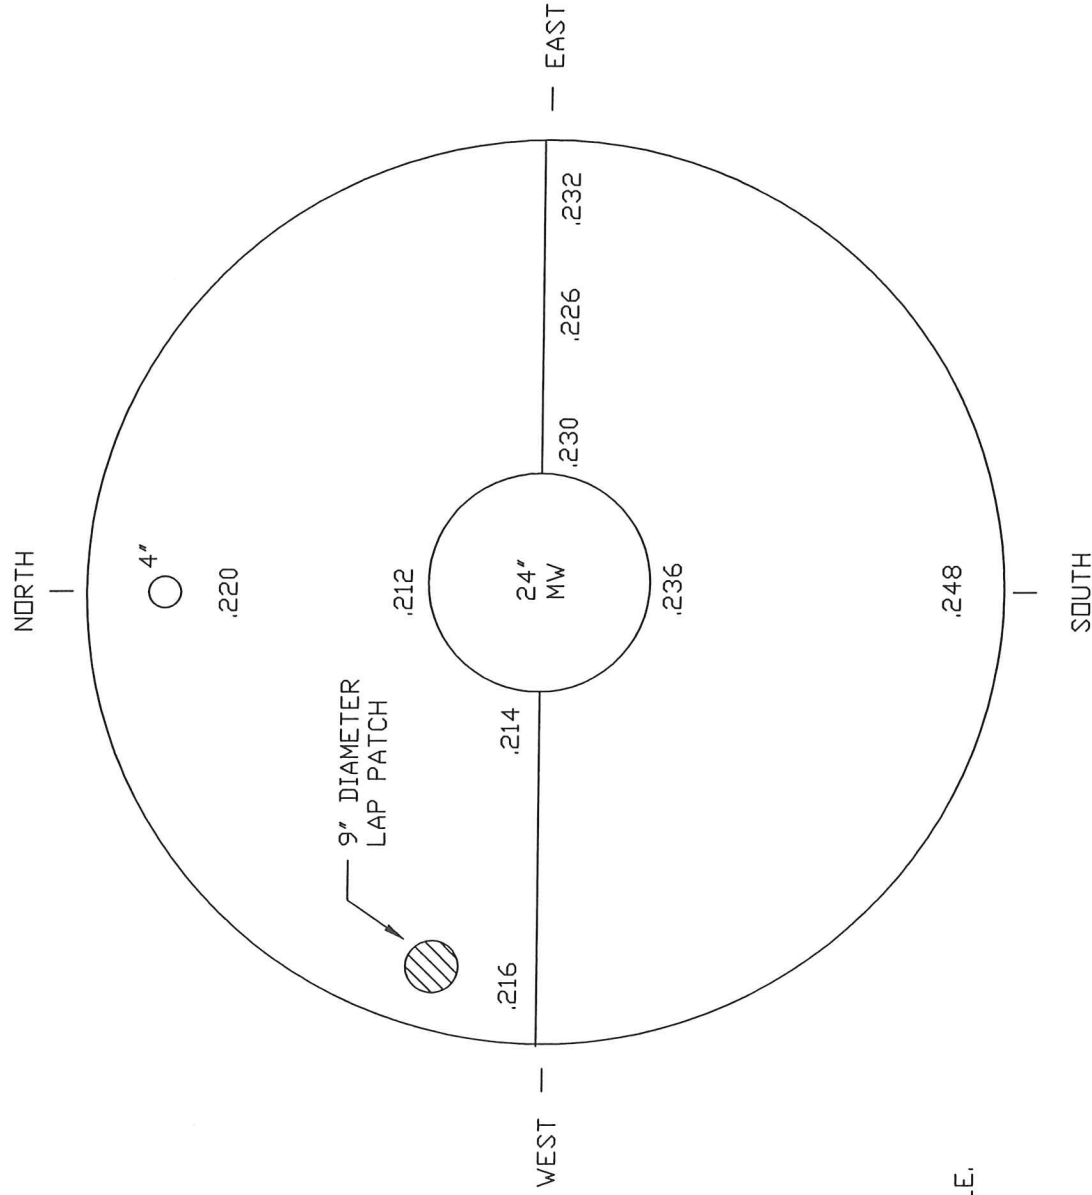
**TANK 9P**  
**SHELL LAYOUT AND UT DATA**

TMIN = 0.100 INCH

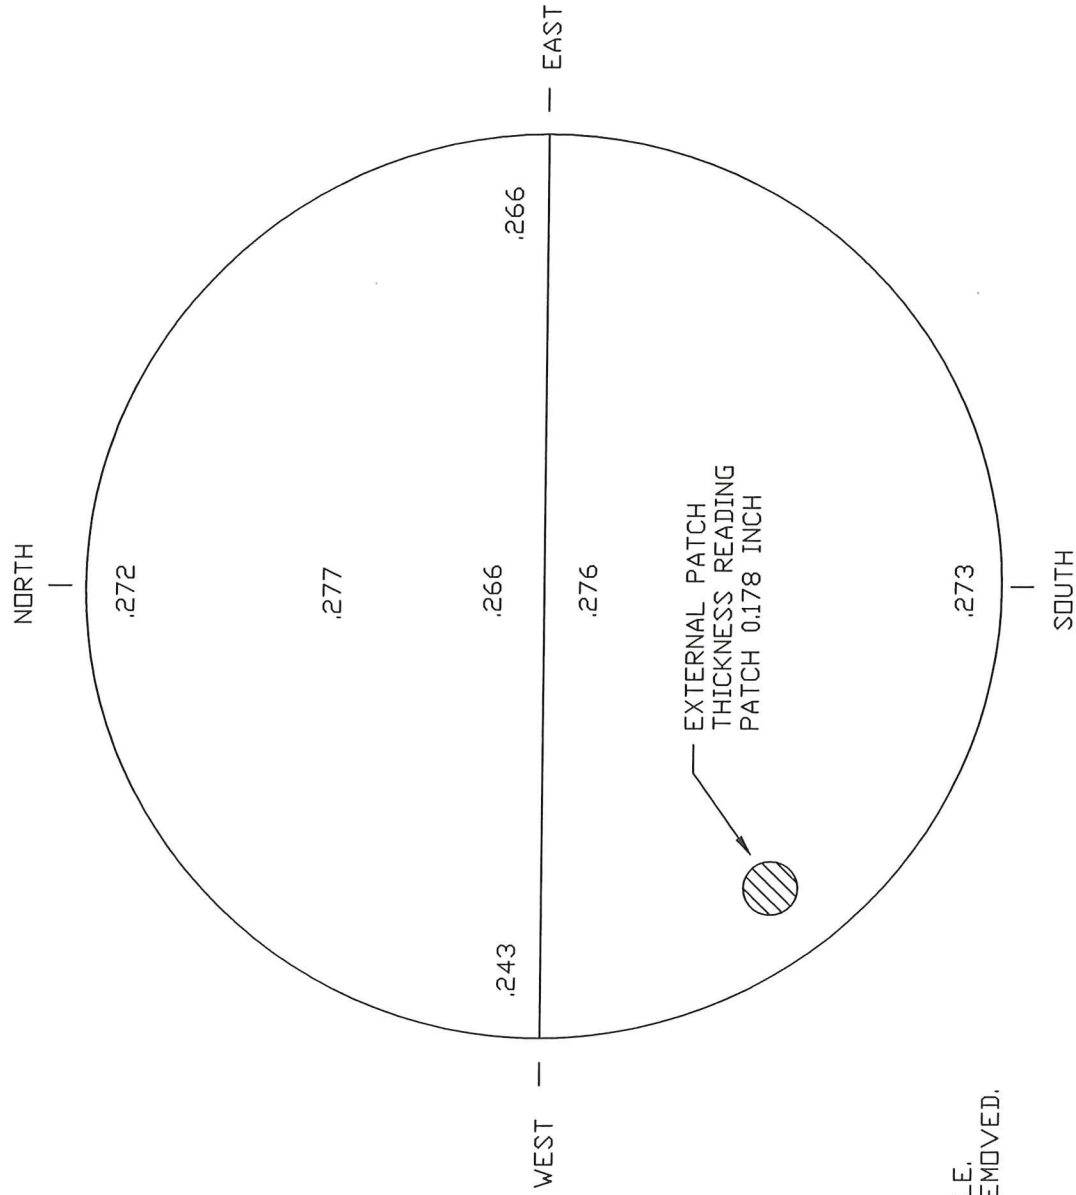
JOB NO.: 40563-1-0225 DWG. NO.: 0225-9P-02

TMIN = 0.125 INCH

1. DRAWING NOT TO SCALE.
2. BAFFLE PARTIALLY REMOVED.

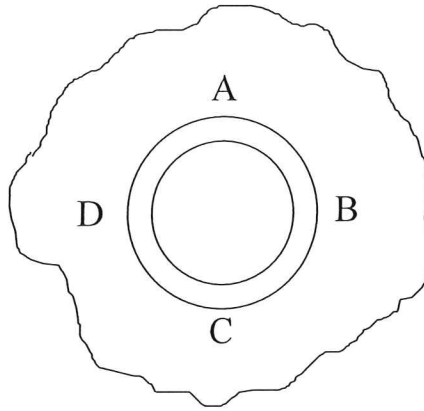
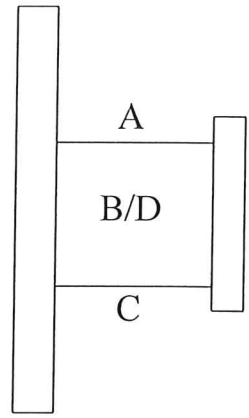
NOZZLES	SIZE	SHELL PLATE THICKNESS				NOZZLE PIPE THICKNESS				REPAD THICKNESS
		A	B	C	D	A	B	C	D	
N1	3'	NA	.276	NA	NA	NA	.217	NA	NA	NA
N2	3"	NA	.280	NA	NA	NA	.211	NA	NA	NA
N3	1"	NA	.294	NA	NA	TC	TC	TC	TC	NA
N4	1"	NA	.291	NA	NA	TC	TC	TC	TC	NA
N5	1"	NA	.302	NA	NA	TC	TC	TC	TC	NA
MW	20"	.289	.287	NA	.297	.262	.266	.265	NA	NA

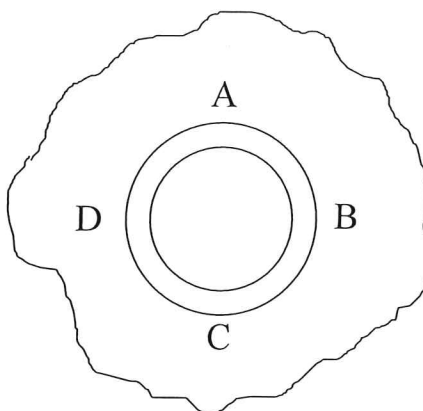
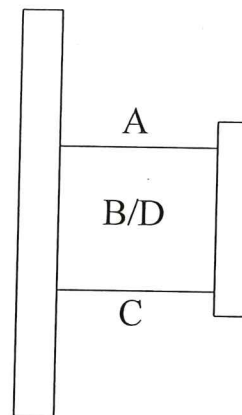
NOZZLES	SIZE	SHELL PLATE THICKNESS				NOZZLE PIPE THICKNESS				REPAD THICKNESS
		A	B	C	D	A	B	C	D	
N1	2'	NA	.296	NA	NA	NA	.162	NA	NA	NA
N2	4"	NA	.290	NA	NA	NA	.223	NA	NA	NA
N3	3"	NA	.291	NA	NA	NA	.204	NA	NA	NA
N4	3"	NA	.283	NA	NA	NA	.169	NA	NA	NA
N5	3"	NA	.277	NA	NA	NA	.205	NA	NA	NA
N6	3"	NA	.276	NA	NA	NA	.209	NA	NA	NA

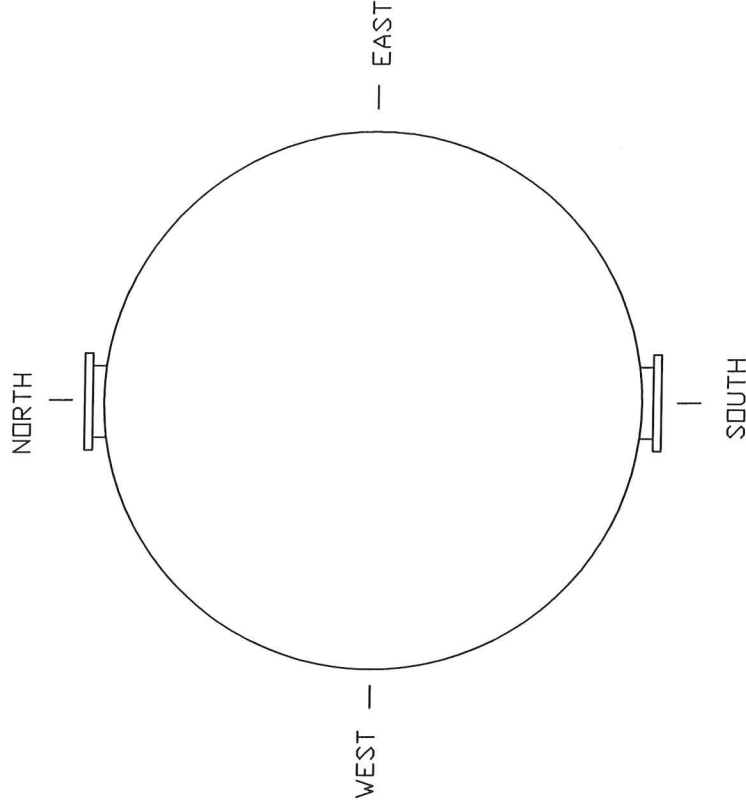
**DISCHARGE TANK**  
**SHELL LAYOUT AND UT DATA**

BOTTOM SECTION SCHEDULED  
TO BE REPLACED; NO THICKNESS  
READINGS TAKEN
