Re: September 12, 2006 Multimedia Inspection
Aqua Clean Industrial Wastewater pretreatment facility
3210 Whitten Road, Lakeland, Florida

SITE INSPECTION REPORT

NAME OF SITE: Aqua Clean Industrial Wastewater
processing facility
SITE ADDRESS: 3210 Whitten Road
CITY: Lakeland, FL

**RECONNAISSANCE INSPECTION
AQUA CLEAN ENVIRONMENTAL COMPANY, INC.
3210 WHITTEN ROAD
LAKELAND, FLORIDA 33811**

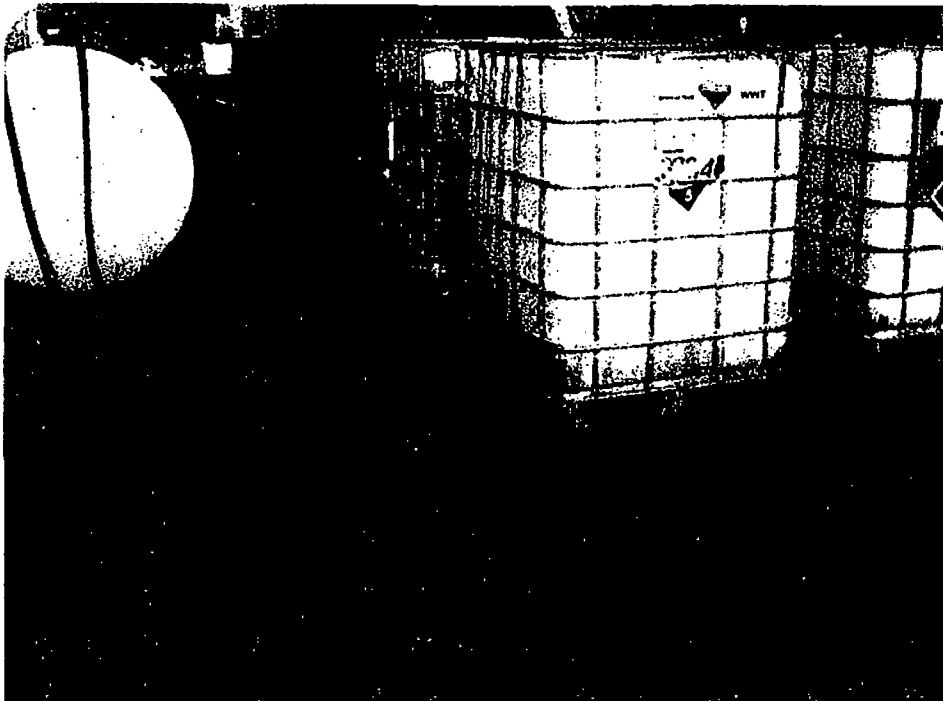
Mr. Miller accompanied us on the inspection. We walked in the south portion of the site to the "solidification" area (Photo #1). Drainage was observed discharging from the plant to the solidification area (Photo #2). It appears that this discharge was contained within the curbed paved area. Sludge from the wastewater pretreatment process is discharged to the solidification area where it is mixed with sawdust (Photo #3) and then loaded into trucks for offsite disposal. The current disposal facility is Omni Waste in Holopaw. At the time of the inspection, Aqua Clean had not been able to load all of the previous day's treated waste. The northern half of the pad was being used to solidify additional waste. The previous day's waste had been moved too close to the southern curb of the pad, and waste had spilled over the wall onto the pavement outside the pad. Solidified sludge and seepage was observed discharged outside the solidification area walls (Photos #5 and #6). Cracks were also observed in a couple of locations in the wall and seepage through the wall was observed. At the east of the solidification area, it appeared that the containment curb had been damaged and containment for the liquids within the area were not contained. Discharges to a low area (Photos #7 and #9) outside of the containment area were observed. This area appeared to have experienced discharges other than during the inspection since discolored soils were observed trending toward the stormwater pond (Photo #8), but liquids were observed adjacent to the solidification area (Photos #7, #9, #10, #11).

Photo #11: Area northeast of solidification area

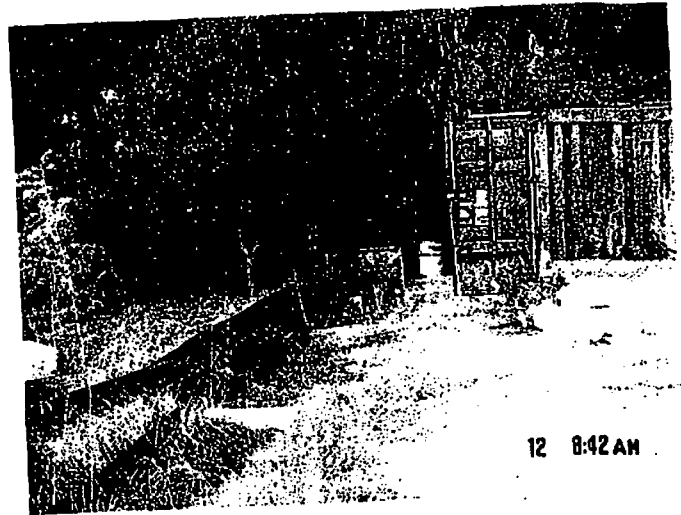
- A pallet with some broken bags of sodium sulfide were observed at the southeast corner of the facility, in proximity to the stormwater pond (see photos DSC03340, DSC03342, DSC03343 and DSC03344). This was mentioned to Mr. Miller during the inspection, and the pallet of bags was removed from the area before the inspection was concluded.

Photo DSC03342 8:42 am – view of bags of sodium sulfide located to the right of the stormwater pond discharge structure

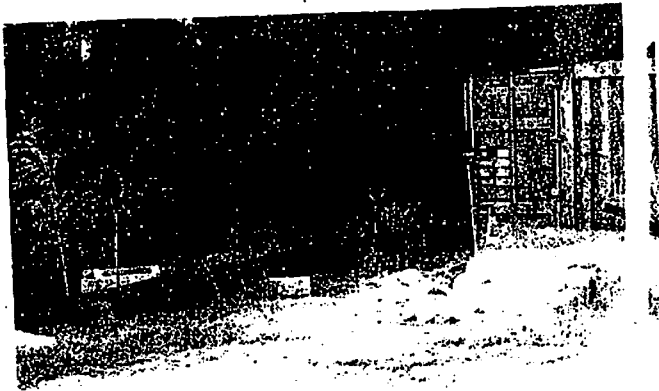
Photo DSC03343 8:43 am – view of bags of sodium sulfide located to the right of the stormwater pond discharge structure

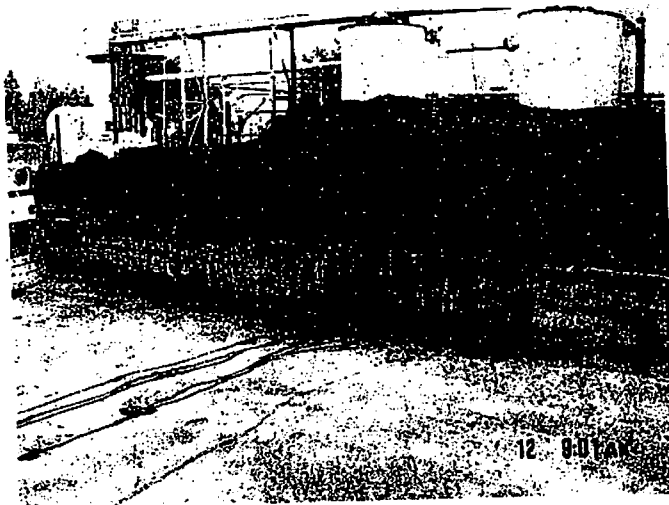
- A small discharge from the solids bulking area was observed onto the concrete area between the bulking area and the stormwater catch basin (see photos DSC03346 and DSC03347). Mr. Miller indicated that a truck driver had an accident that day and that had caused the solids in the bulking area to accumulate.

Photo DSC03346 9:01 am -- view solids bulking area, notice discharge from this area into concrete pad.

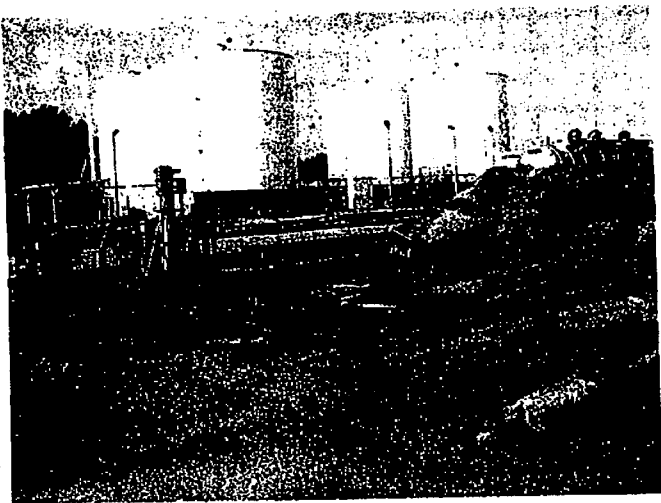
- There was also standing water on the east side of the solids bulking area that appeared to be in contact with the material from the bulking area (see photos DSC03348, DSC03349 and DSC03351). This issue was also addressed by the Solid Waste program, and has been corrected according to information provided during the October 17, 2006 meeting.

Photo DSC03349 9:04 am -- View of back area of the solids bulking area and the tank farm for the leachate.

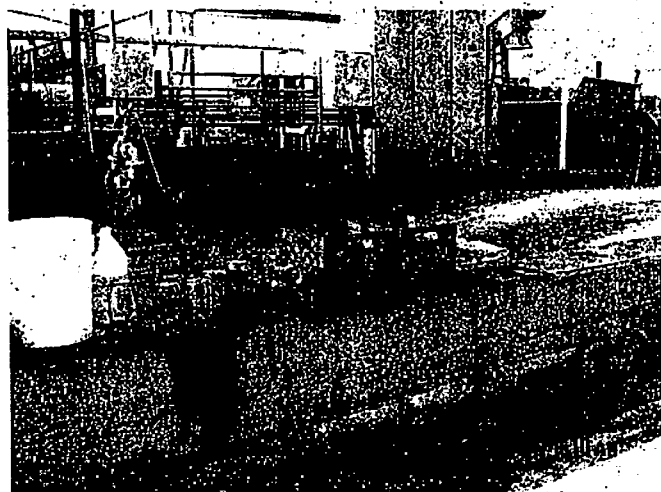
- It appeared that a cleaning area had been established on one side of the tanker was pad area. Bottles and cleaning products were observed in this area. The water from this washing activity was being collected by a section of the concrete pad liner, and not directed to the wash pad drain (see photos DSC03356 and DSC03357).

Photo DSC03357 9:10am – Cleaning area by the tanker wash pad area.
