INITIAL REMEDIAL ACTION REPORT
FOR THE
PERMA-FIX ENVIRONMENTAL SERVICES FACILITY
3670 S.W. 47TH AVENUE
DAVIE, FLORIDA
EAR LICENSE NO. 00429

AQUA TERRA, INC.
3250 CORPORATE WAY
MIRAMAR, FLORIDA 33025

PROJECT NO. AT-1239

DECEMBER 1996

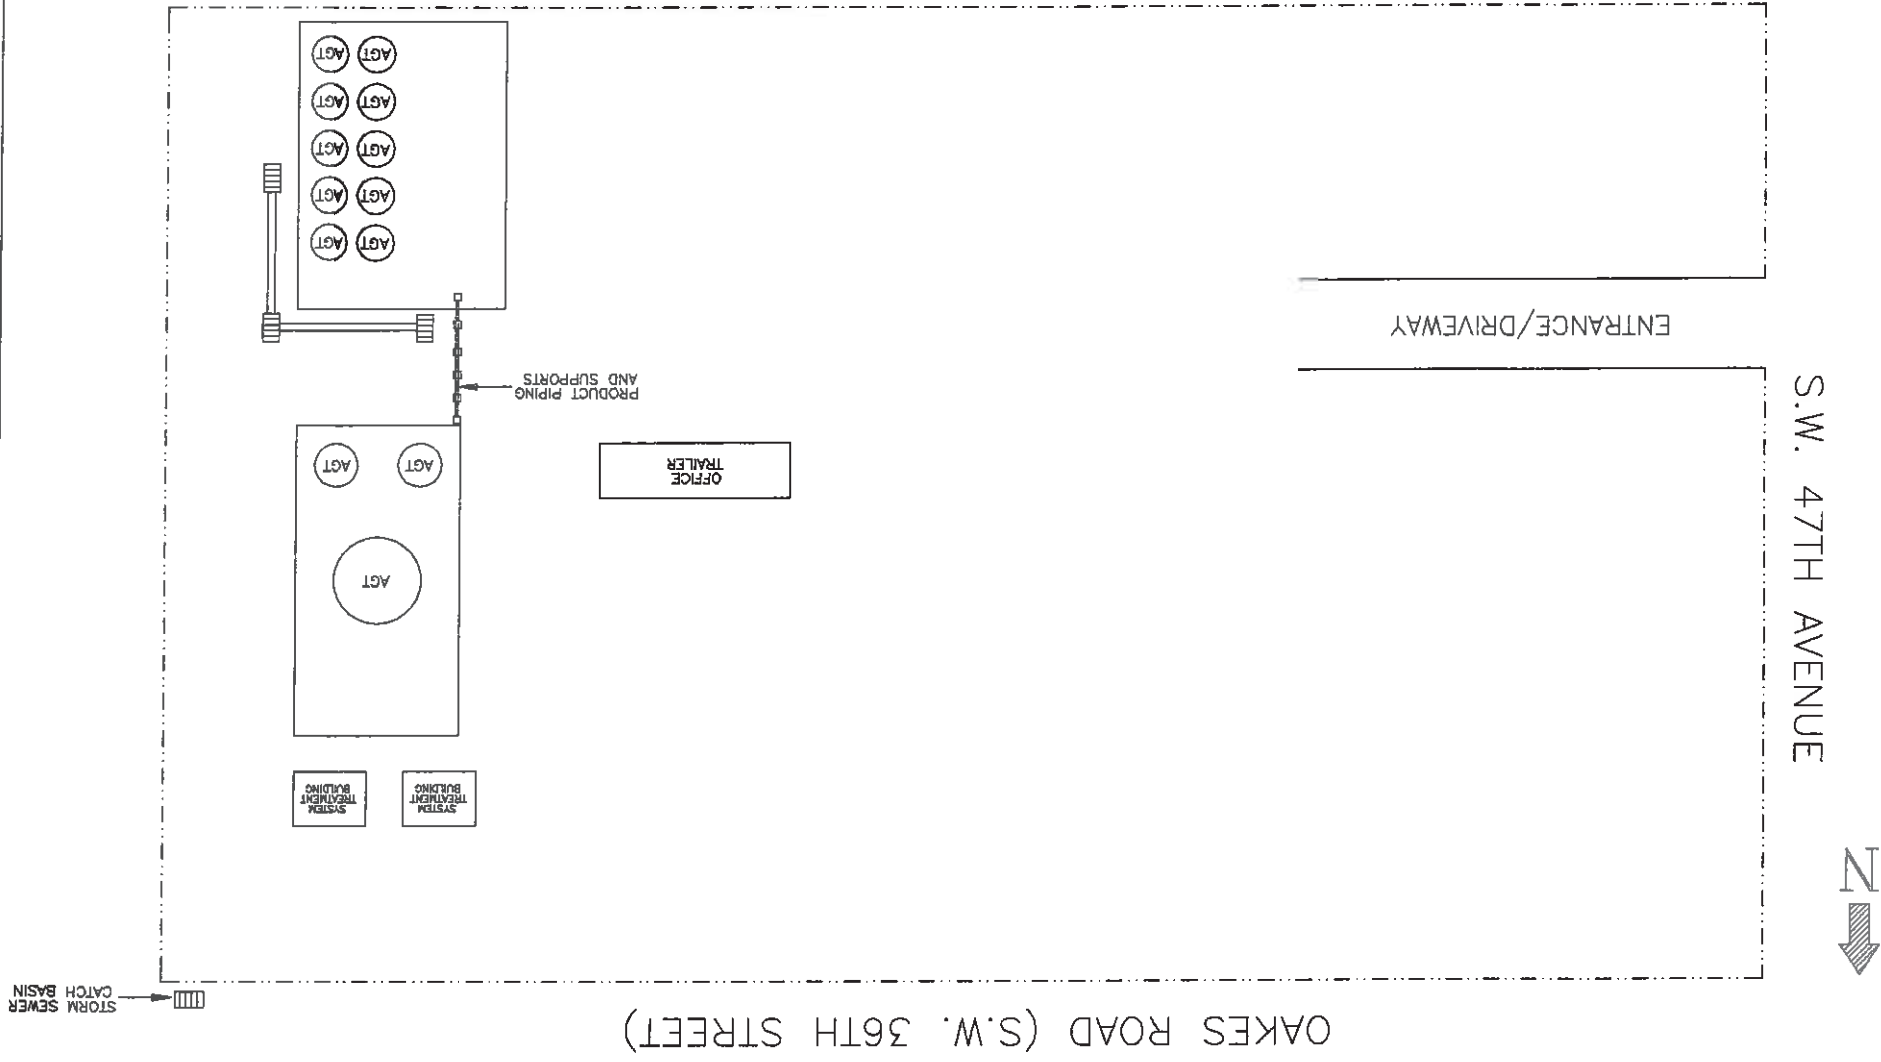
FIGURE 1: SITE MAP
PROJECT NAME: PERMA-FIX ENVIRONMENTAL SERVICES
ADDRESS: 3670 S.W. 47TH AVENUE, DAVIE, FLORIDA

The oil spill affected only the eastern portion of the subject site spanning from the south to north property boundaries. The oil which discharged outside of the containment walls migrated from the south to the north end of the subject site. Subsurface drainage at the subject site was limited to a French-Drain system located at the northeast corner of the southern above ground tank system and a storm sewer system located immediately north of the northern property boundary. A site map is included as Figure 1.

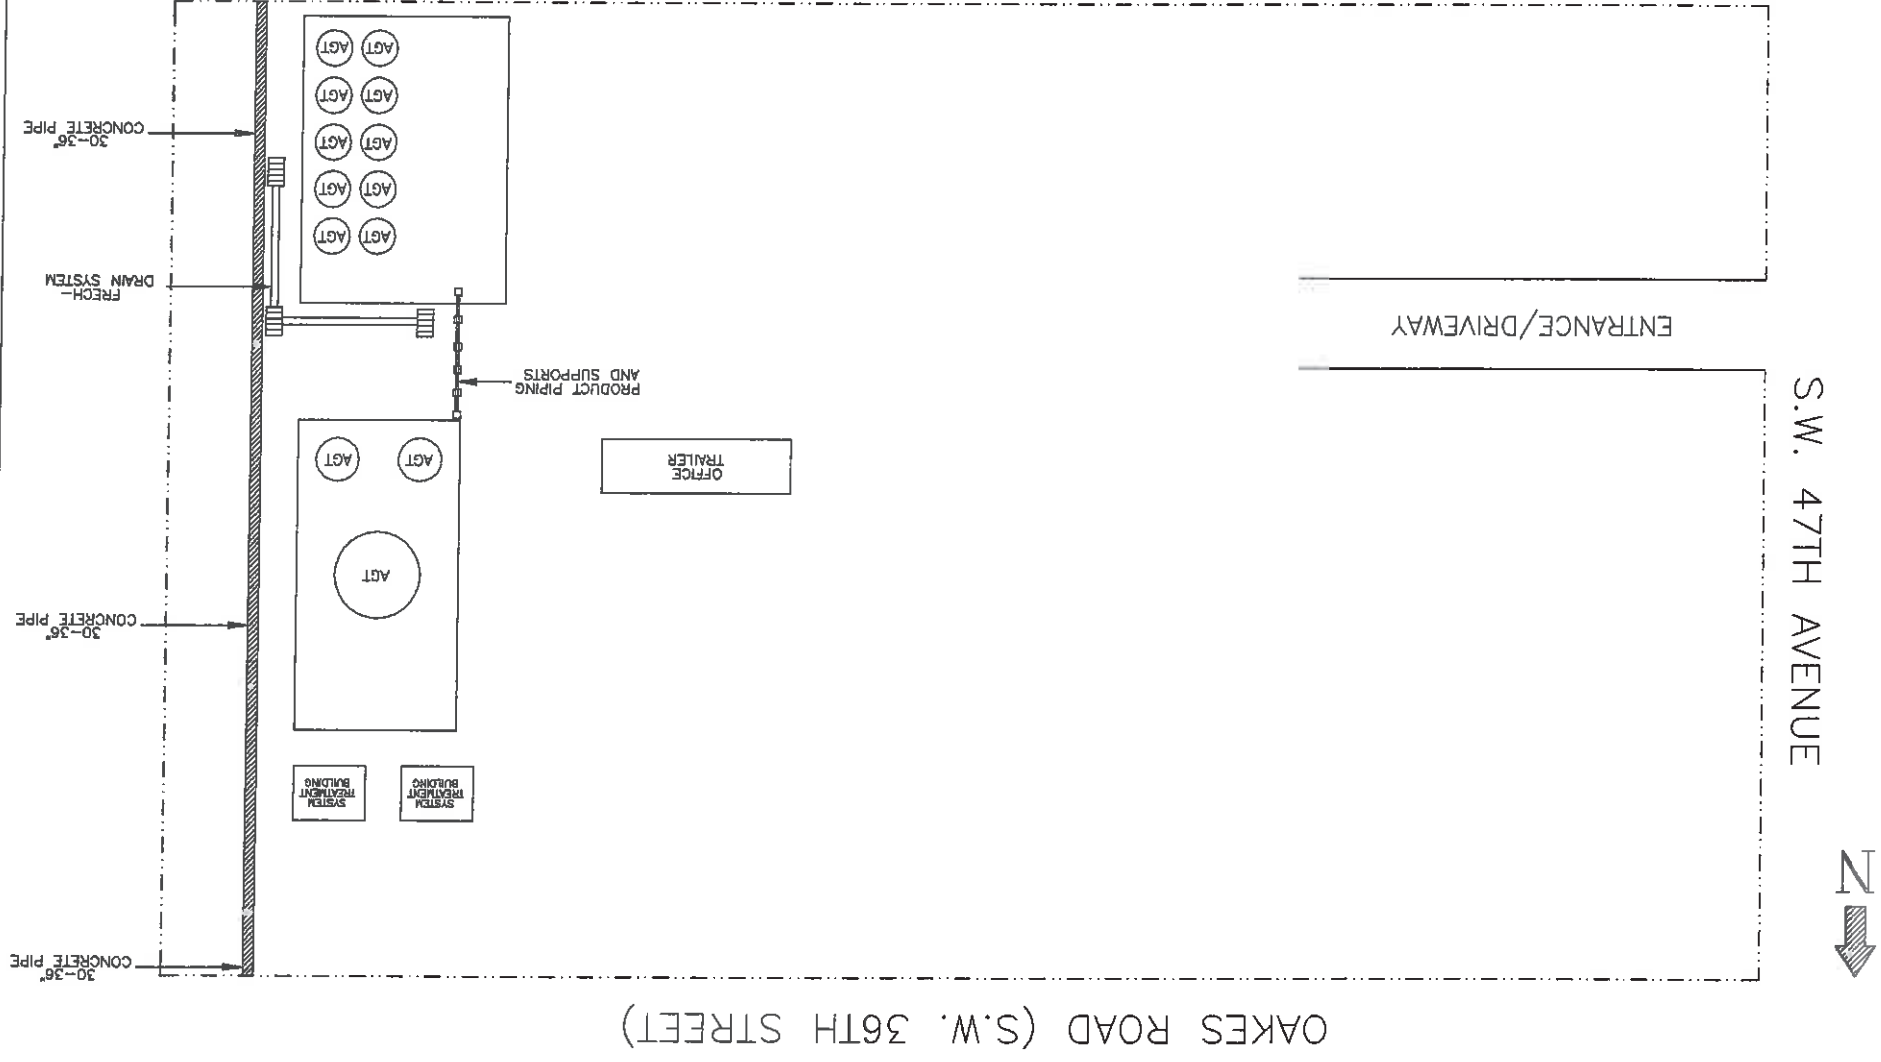
Since the pipe continued to discharge oil and approval was granted by DNRP to remove the pipe, the decision was made to remove and dispose of this pipe. The entire length of the pipe was excavated, pressure cleaned and removed from the southern to the northern property boundaries. After allowing all the oil to flow out of the remaining sections of pipe at each property boundary, both ends of the pipe at each property boundary were sealed with hydraulic cement to prevent any environmental concerns in the future. All oil entering the trench created by the removal of the pipe was recovered using a vacuum truck. After further investigation, it was determined that only one (1) eight foot section of concrete pipe remained at the northern property boundary (between Perma-Fix and Oakes Road). This pipe section was subsequently removed and disposed, leaving no pipe remaining on the north end of the property. Figure 2 depicts the location of the concrete pipe.

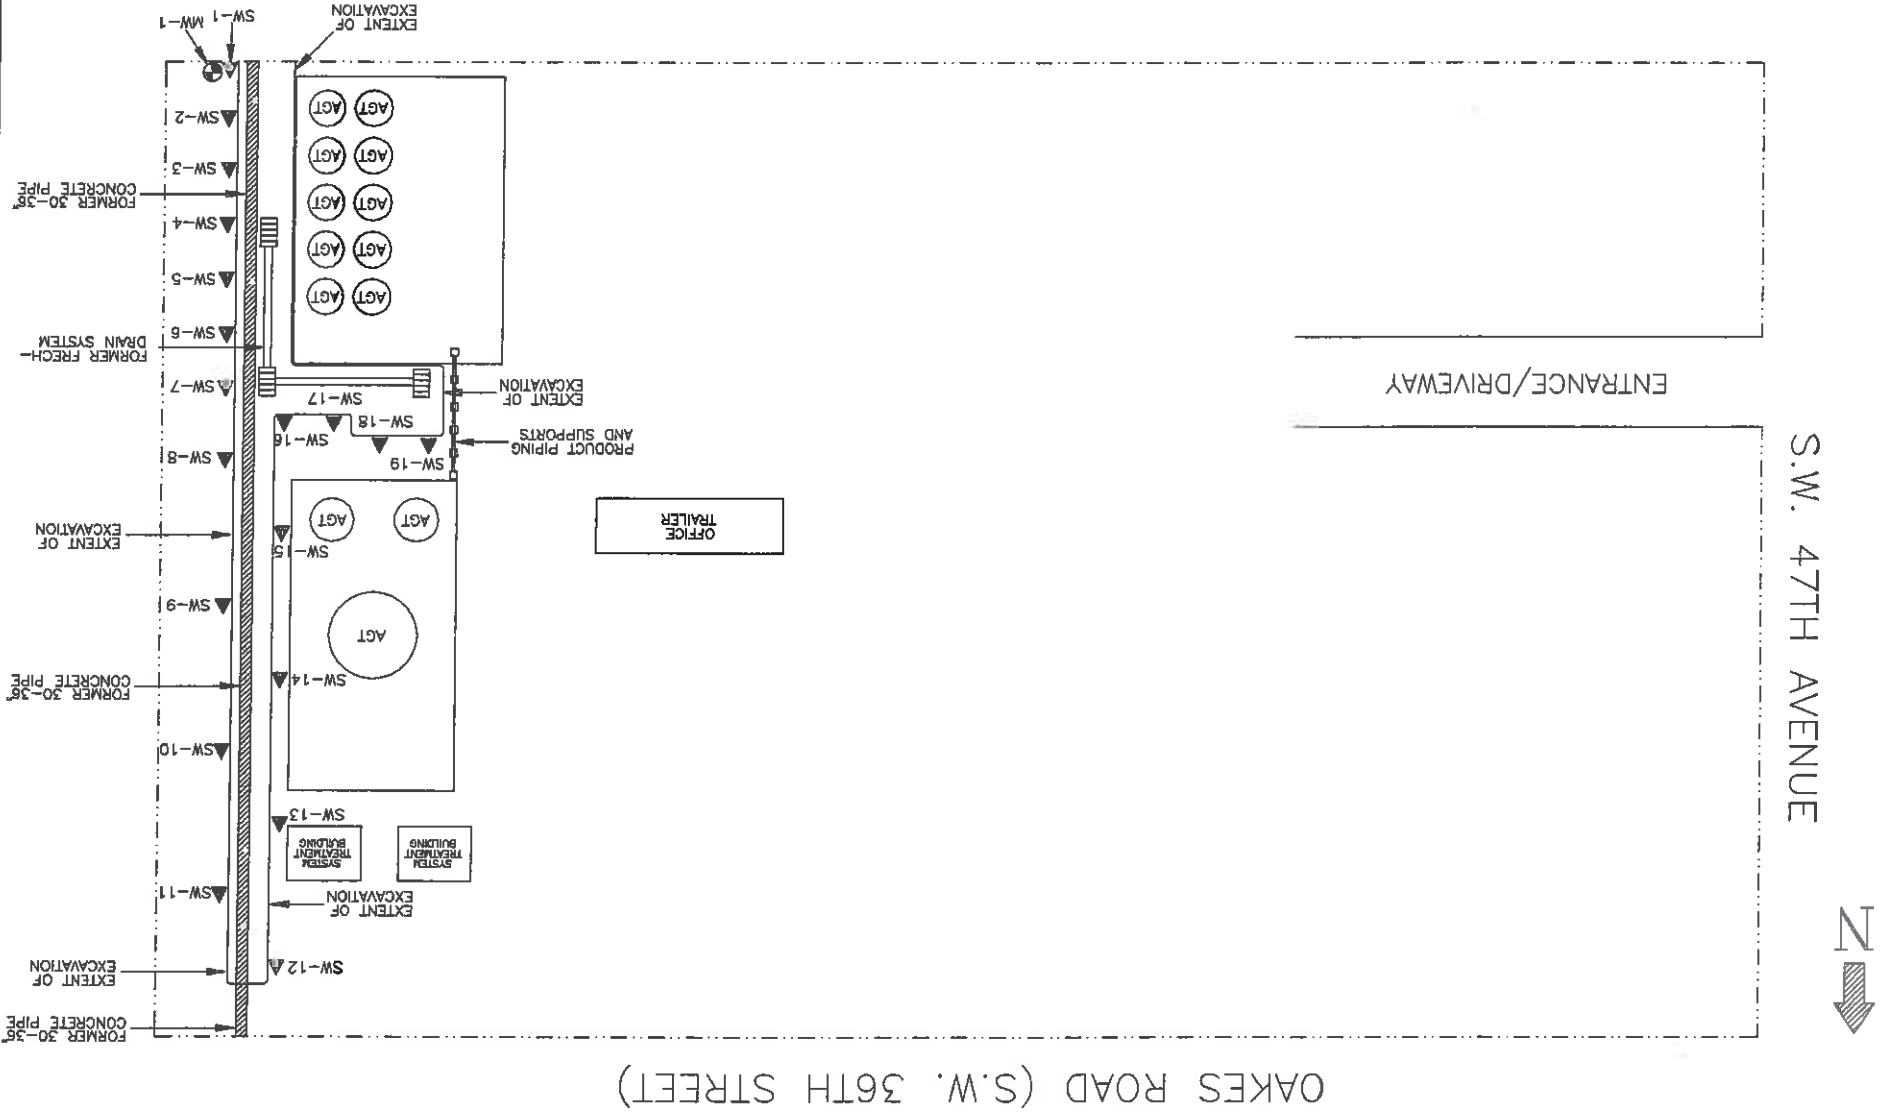
Following the removal of the French-Drain system and unidentifiable concrete pipe, Aqua Terra supervised the removal of impacted soil along the walls of the excavations. On October 29, 1996, Aqua Terra collected a total of fifty-seven (57) soil samples (SW-1 through SW-19) from the walls of the excavation areas at six inches, 18 inches and 30 inches below land surface at each sampling location. The samples were analyzed for Total Recoverable Petroleum Hydrocarbons (TRPH) by FL-PRO. The soil sampling locations are depicted in Figure 3. The analytical results indicated that 13 samples of the 57 samples collected exceeded the maximum allowable level of 50 parts per million (ppm). The exceedances are from particular intervals from soil samples SW-1, SW-5, SW-6, SW-8, SW-9, SW-12, SW-14 SW-16, SW-17 and SW-19. A summary of the soil analytical data from the walls of the initial excavation is provided as Table 1.

As a result of the exceedances at several locations along the excavation walls, the walls of the excavation areas were expanded in an effort to remove impacted soil. The walls were expanded in the locations of soil samples SW-5, SW-8, SW-9, SW-12, SW-16 and SW-17. From November 4, 1996 through November 6, 1996, Aqua Terra collected verification samples from the walls of the expanded areas from applicable intervals, designated soil samples SW-5A, SW-8A, SW-9A, SW-12A, SW-16A and SW-17A. The soil analytical results revealed that only soil sample SW-17A exceeded the maximum allowable level of 50 ppm. The locations of the soil sampling locations for the expanded excavation are depicted in Figure 4. A summary of the soil analytical data from the walls of the expanded excavation is provided as Table 2. The excavation area was eventually extended to the northern above ground tank system in the locations of SW-16A, SW-17A, SW-18 and SW-19.

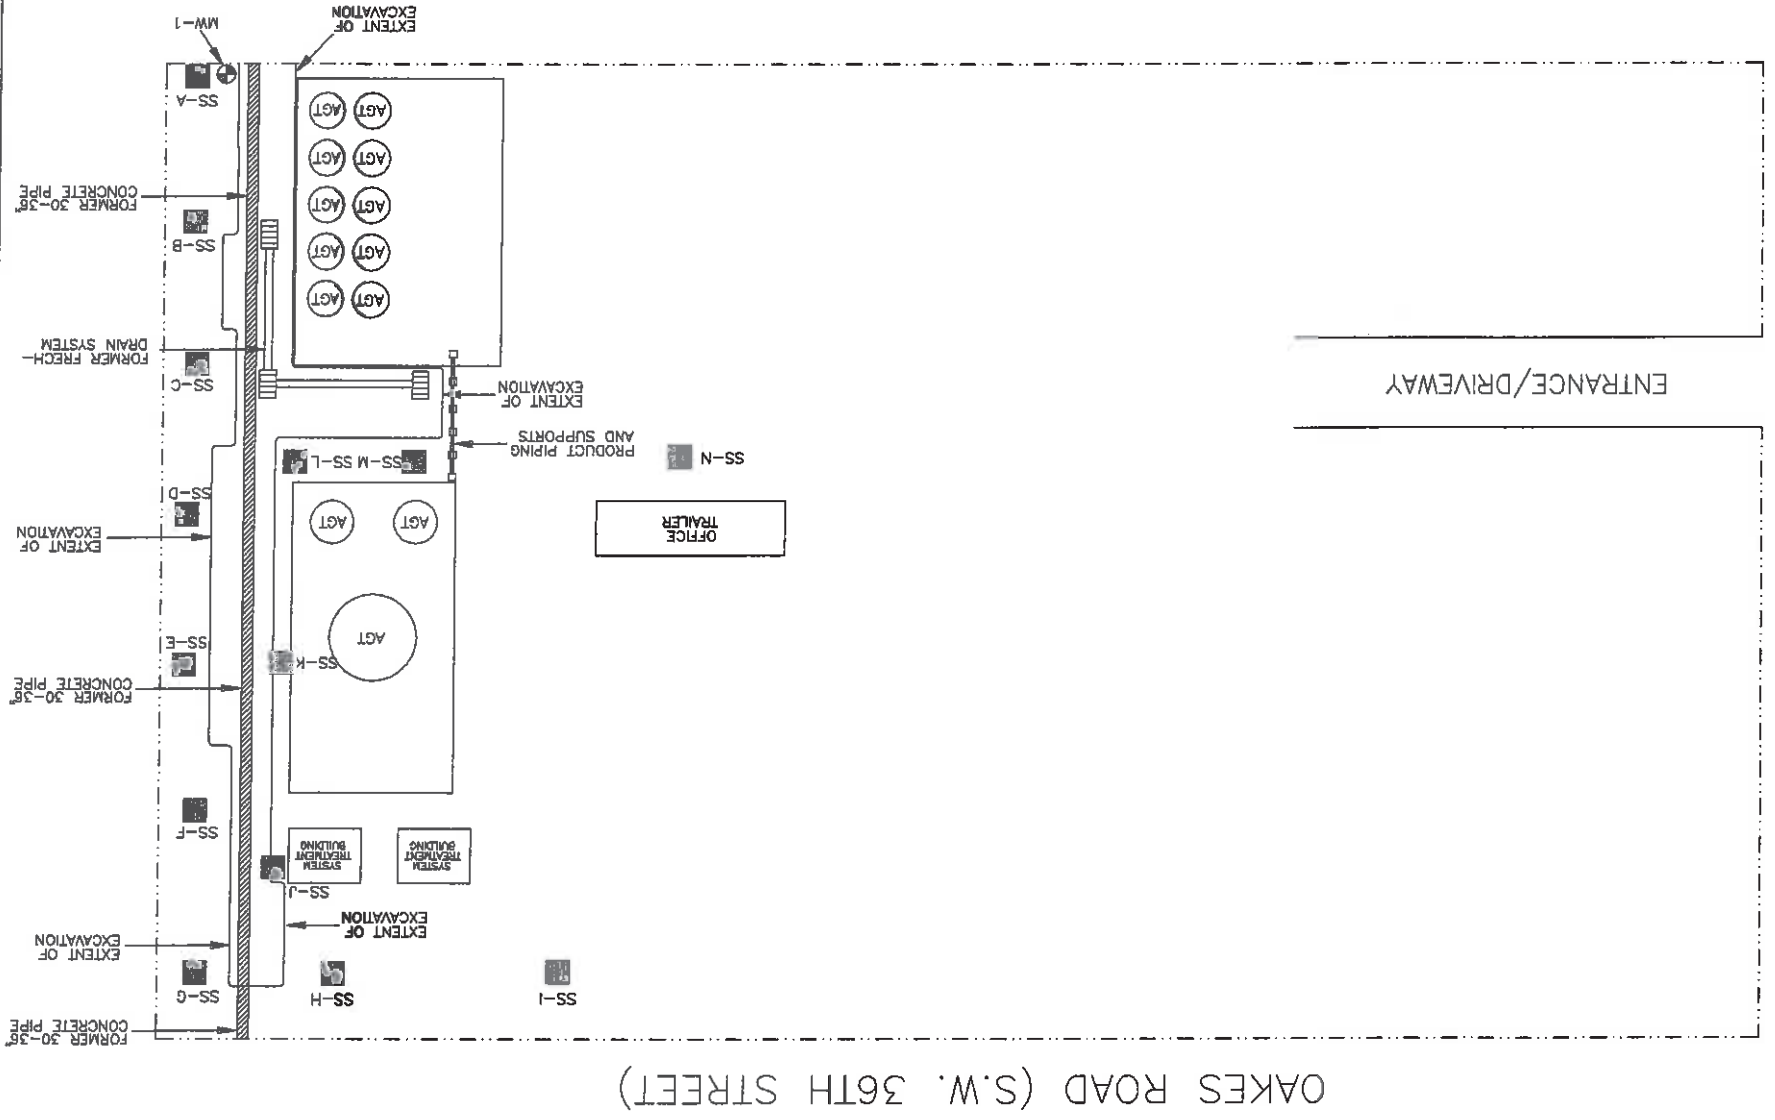
Exceedances revealed from soil sample locations SW-1, SW-6 and SW-14 were addressed by scraping approximately one foot of soil from these areas. Verification samples were collected from 14 ground surface areas, designated SS-A through SS-N. The surface soil samples were analyzed for Total Recoverable Petroleum

Hydrocarbons (TRPH) by FL-PRO as well. The soil surface sampling locations are depicted in Figure 5. The analytical results indicated that all samples were below detection limits. Copies of the soil verification analytical results and chain of custody forms are provided in Appendix B.

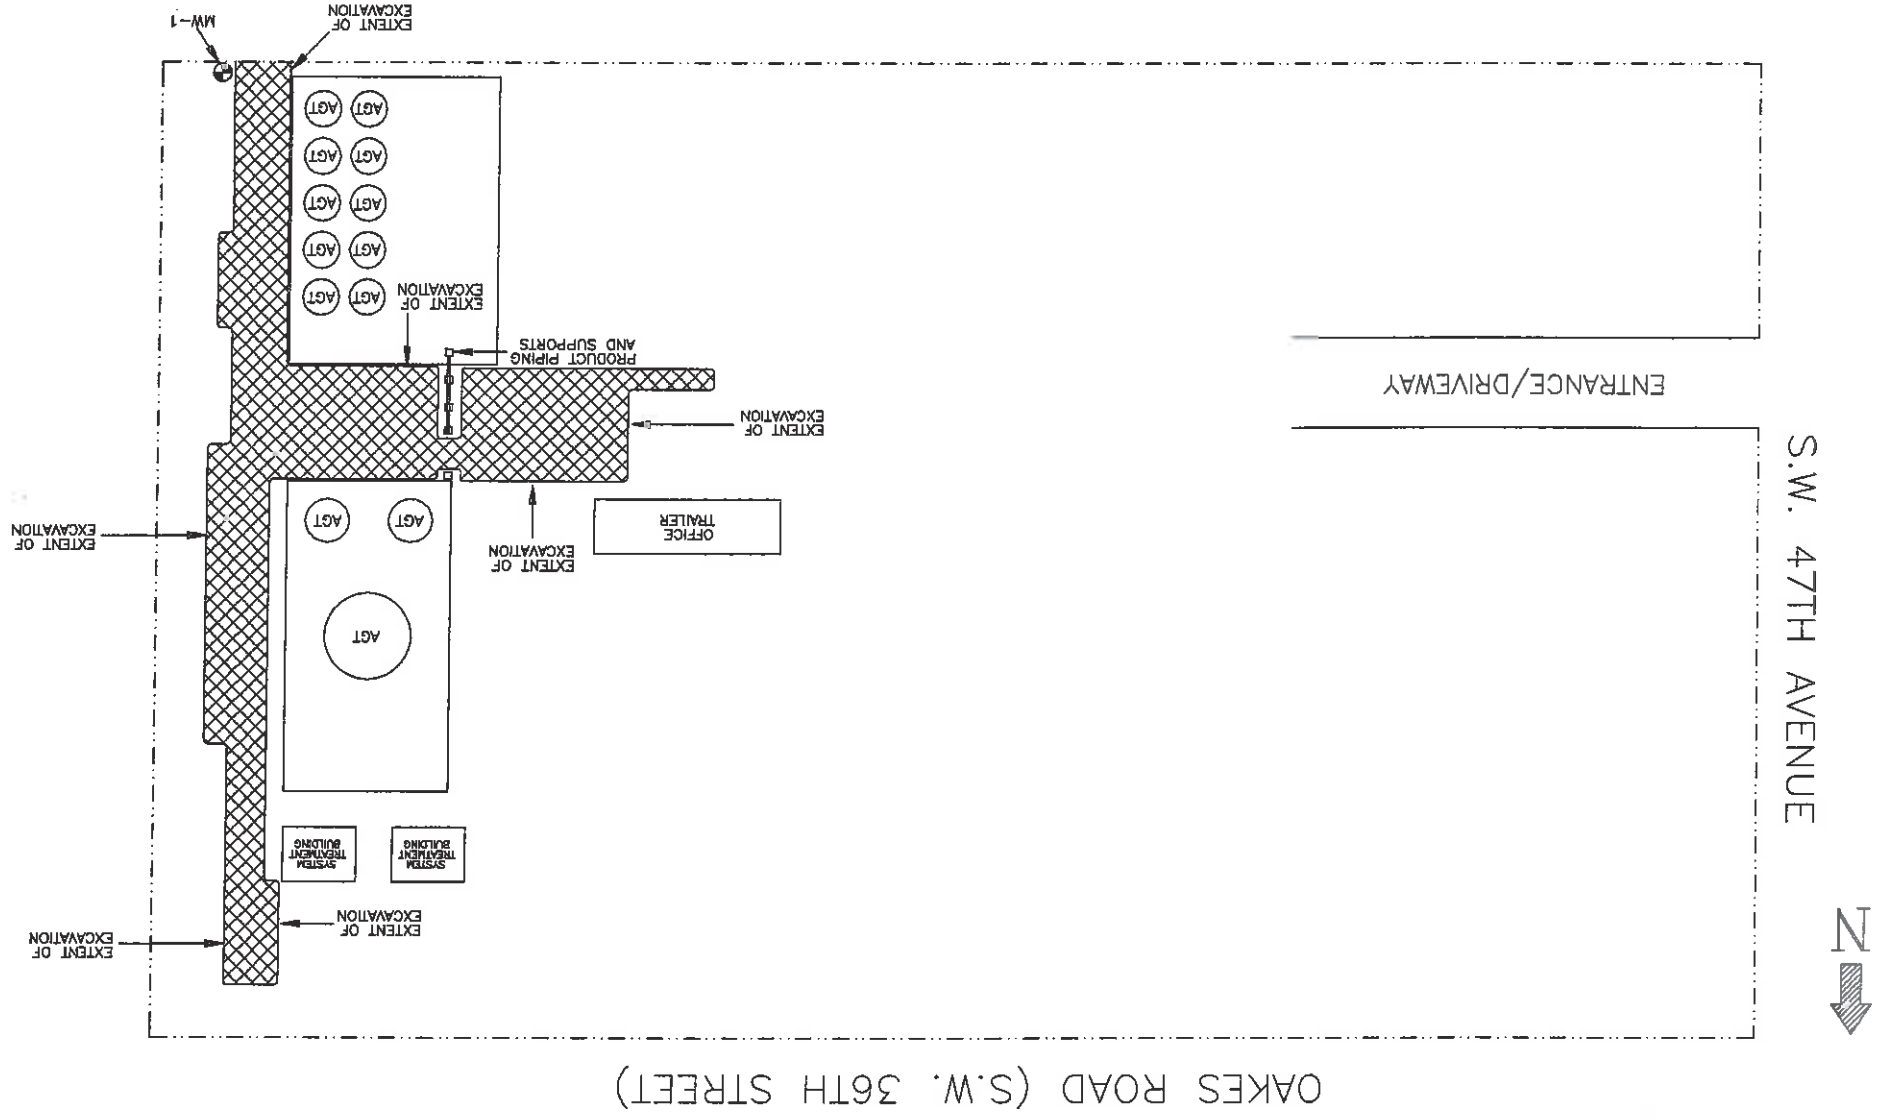
FIGURE 6: SITE MAP WITH MONITORING WELL AND FINAL EXCAVATION AREA
PROJECT NAME: PERMA-FIX ENVIRONMENTAL SERVICES
ADDRESS: 3670 S.W. 47TH AVENUE, DAVIE, FLORIDA

In an effort to be as thorough as possible, the excavation was eventually extended to the west of the tank farm systems, between the above ground piping supports and the office trailer. A site map depicting the extent of the final excavation is provided as Figure 6. Following the completion of the excavation activities, the excavated areas were backfilled to grade.
