Florida Department of Environmental Protection

Re: EQ Florida, Inc.
FLD981932494
Hillsborough County

**Florida Department of
Environmental Protection
Hazardous Waste Inspection Report**

Facility Name: US Ecology Tampa Inc
On-Site Inspection Start Date: 06/20/2018 **On-Site Inspection End Date:** 06/20/2018
ME ID#: 21659 **EPA ID#:** FLD981932494
Facility Street Address: 2002 N Orient Rd, Tampa, FL 33619-3356
Contact Mailing Address: 7202 E 8th Ave, Tampa, FL 33619-3380
County Name: Hillsborough **Contact Phone:** (813) 319-3423

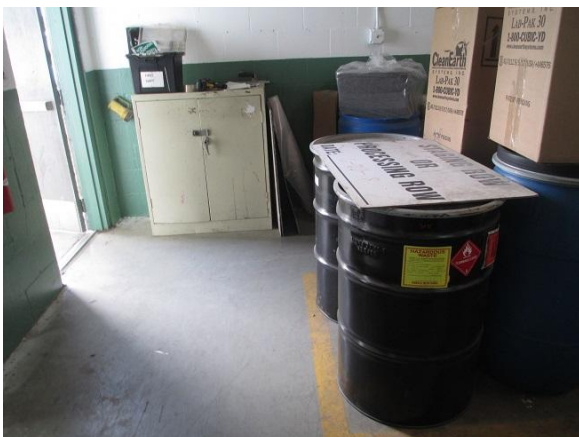
Rule: **264.176**

Explanation: Two containers of waste flammable materials were located in the staging area of the north bay of the container storage building. This was corrected during the inspection.

drums in north bay

Corrective Action: Ignitable or reactive waste must be located at least 50 feet from the property boundary.

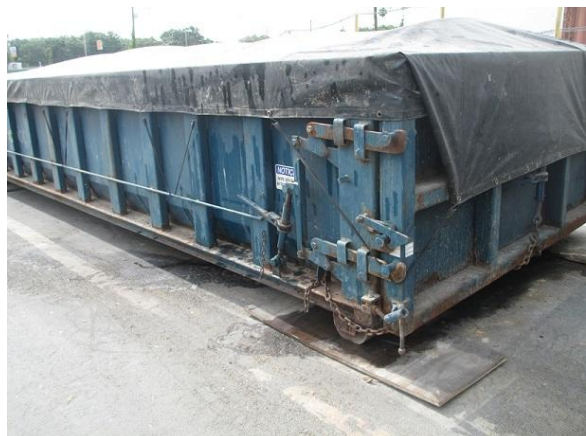
An issue was noted with one roll off that had just been loaded and was staged outside the treatment building. Free liquids were noted on the pavement under the roll off, and it was not clear whether the liquid was from a leaking rear gasket seal on the container or was condensate from the waste. When the roll off was opened, it was observed to be lined with plastic. The treatment process is exothermic, and liquids from the solidified waste can evaporate and condense on the tarp covering the roll-off. The pH of the liquid on the pavement was in the range of 12 to 13 when tested with pH paper. Based on some staining on the pavement, this has taken place in the past as well. After the inspection, EQ staff said that they would use a pop up containment under the treated waste to contain potential condensate drippage. The containment will be checked and cleaned as needed.

Rule: **264.31**

Explanation: High pH condensate was leaking onto the pavement under a roll-off of treated hazardous waste.

Condensate from roll off

Corrective Action: As a precaution, the facility will be staging bulk containers of treated hazardous waste within a pop-up containment.

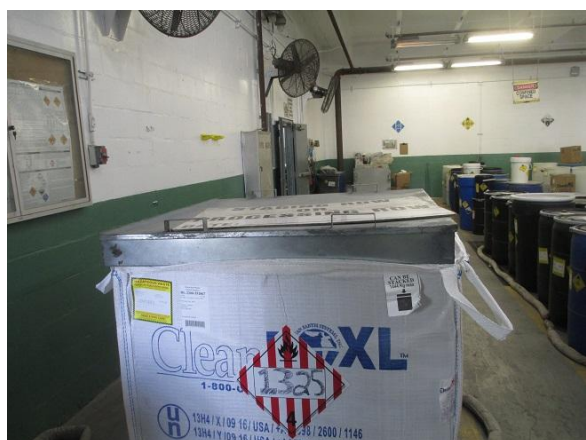
Rule: 264.1086(c)(5)

Explanation: A container with a capacity of more than 0.46 cubic meters was being used to manage waste makeup, including some ignitable material. The container was not yet closed in accordance with USDOT requirements, but was fitted with a cover meeting Subpart CC Level 1 container management standards. It was not clear whether any of the wastes had more than 500 ppm by weight of volatile organic compounds at the point of waste origination. A copy of the facility's procedure used to determine whether the container is subject to 40 CFR Subpart CC or whether the container is managing hazardous waste in light material service was not available.

Box with lid

Corrective Action: A written procedure for managing these containers was submitted showing that damaged small containers are supposed to be overpacked prior to placement in the larger container. As the inner containers are less than 0.26 cubic meters in size, they are not subject to Subpart CC.

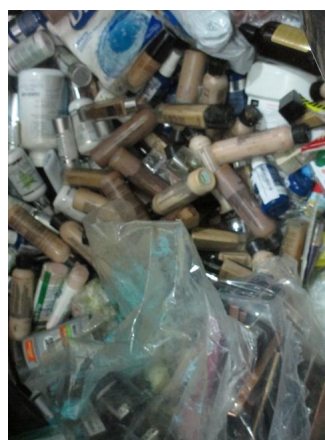
Box content
