SUBJ: RCRA Compliance Evaluation Inspection
EQ Florida, Inc.
Tampa, Florida 33619
EPA ID. No.: FLD 981 932 494

RCRA Inspection Report

EQ Florida, Inc.
7202 East 8th Avenue
Tampa, Florida 33619

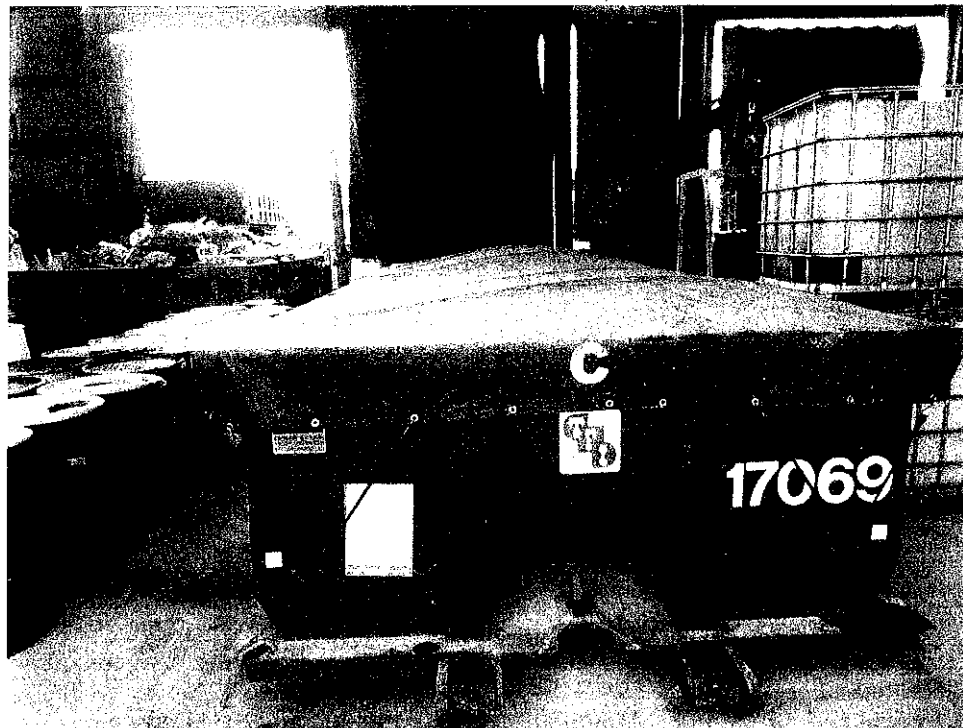
Photograph 2: Roll-off container in the Waste Processing Building. The container was holding a portion of treatment batch # 524. Photo taken by Javier García, on 6/20/2018, at 9:32 a.m. Equipment used: Samsung Camera (Model WB250F)-EPA Property Tag # S75951

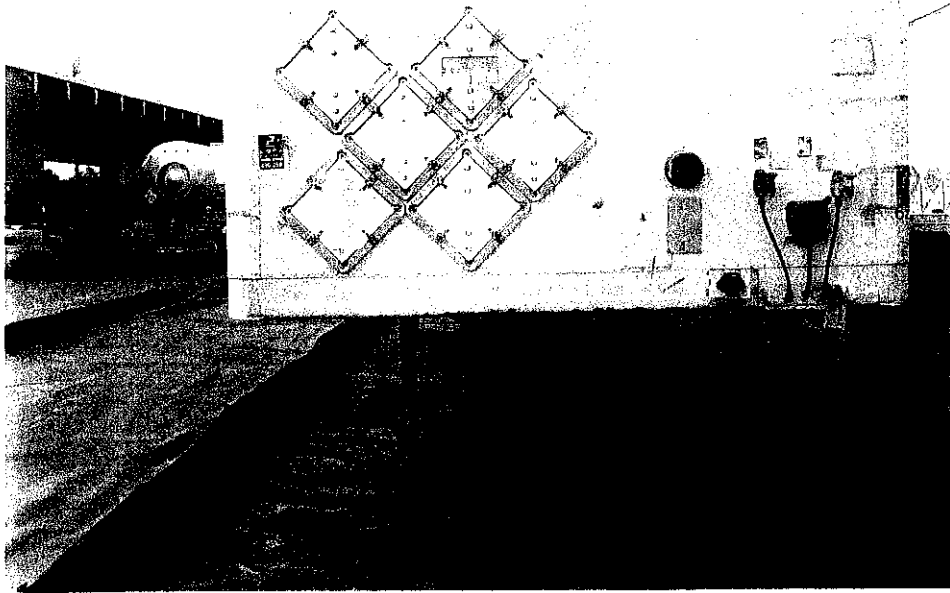
This area is designated in the permit as temporary storage of inbound loads awaiting receipt and unloading; and, for outbound loads waiting for completion of transportation paperwork. At the time of the inspection, the inspectors observed two trailers. One trailer contained inbound hazardous wastes and the other container contained an outbound load of universal wastes (Photos 4 and 5).

Photograph 5: Outbound trailer in the area designated in the permit as the "Transfer Lot." Photo taken by Javier García, on 6/20/2018, at 9:50 a.m. Equipment used: Samsung Camera (Model WB250F)-EPA Property Tag # S75951

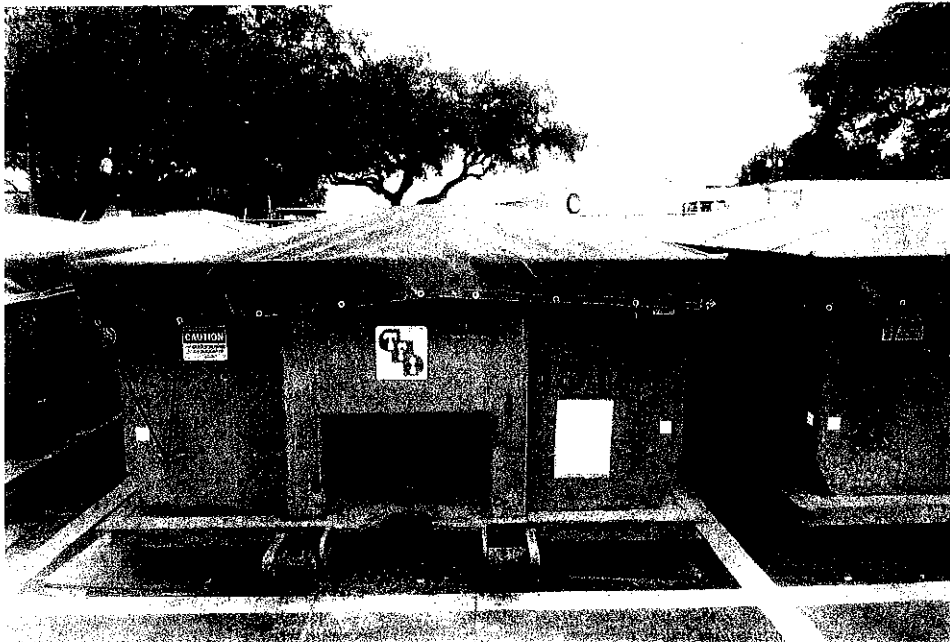
In the BCSAs, EQ stores treated hazardous wastes in roll-off containers. In the BCSA located along the northern property line, the inspectors observed six roll-off containers (Photos 6 and 7). In front of the WPB, the inspectors observed two roll-off containers which contained treated hazardous wastes (Batch #524). Underneath the containers, the inspectors observed condensate released from one of the container (Photos 8 and 9). The FDEP inspector measured the pH of the released condensate with litmus paper obtaining an approximate reading above 12 (Photo10). The treatment processing sheet for Batch #524 indicated that it did not contain K062 listed hazardous waste. Following the

Photograph 6: Partial view of the roll off containers stored in the Bulk Containers Storage Area Outbound along the northern property line. Photo taken by Javier García, on 6/20/2018, at 9:58 a.m. Equipment used: Samsung Camera (Model WB250F)-EPA Property Tag # S75951

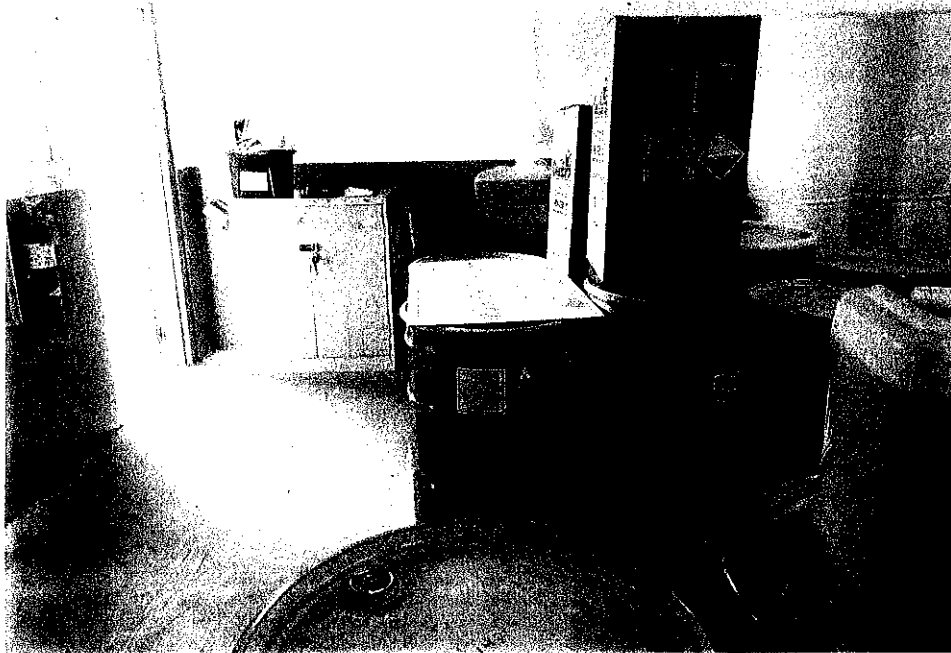
Permit Condition Part II.B.12 requires EQ to comply with the 15-meter (50-foot) setback rule concerning the locating of ignitable and reactive wastes in containers per 40 C.F.R. § 264.176.

Photograph 13: Two 55-gallon containers of flammable hazardous waste in the staging area of Bay 3, that within 50 ft. of the north property boundary Photo taken by Javier García, on 6/20/2018, at 12:16 p.m. Equipment used: Samsung Camera (Model WB250F)-EPA Property Tag # S75951

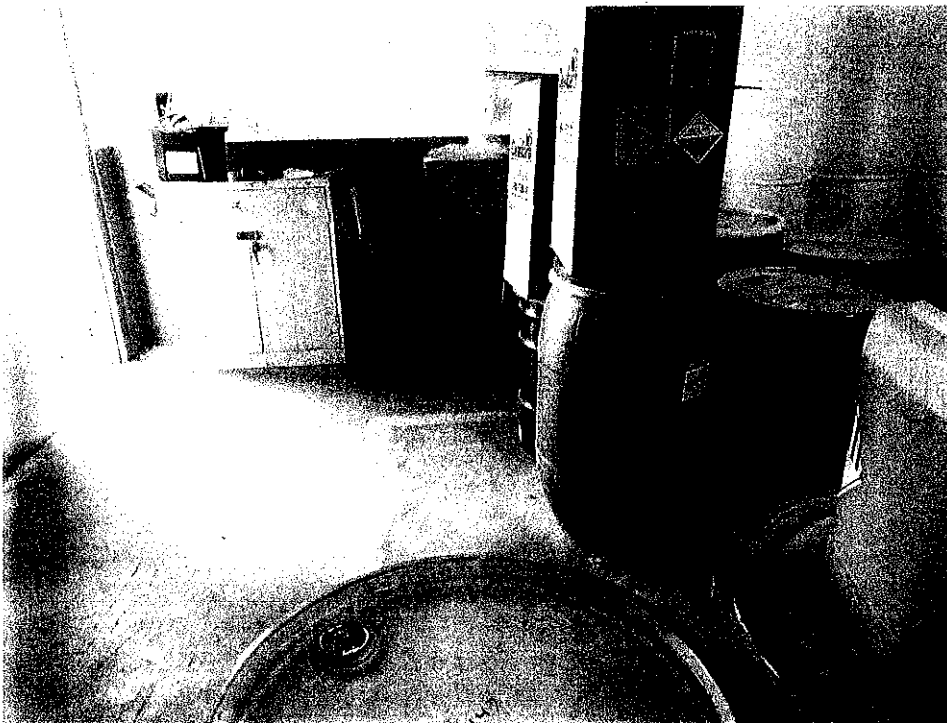
Photograph 14: Location where the two 55-gallon containers of flammable hazardous wastes shown in previous photograph were at. Photo taken by Javier García, on 6/20/2018, at 12:19 p.m. Equipment used: Samsung Camera (Model WB250F)-EPA Property Tag # S75951.
