**RE: Warning Letter WL18-171
North Florida Shipyards, Inc.
EPA/DEP ID: FLD 093 598 548
Duval County – Hazardous Waste**

**Florida Department of
Environmental Protection
Hazardous Waste Inspection Report**

SIC CODE: 3731 - Manufacturing - ship building and repairing

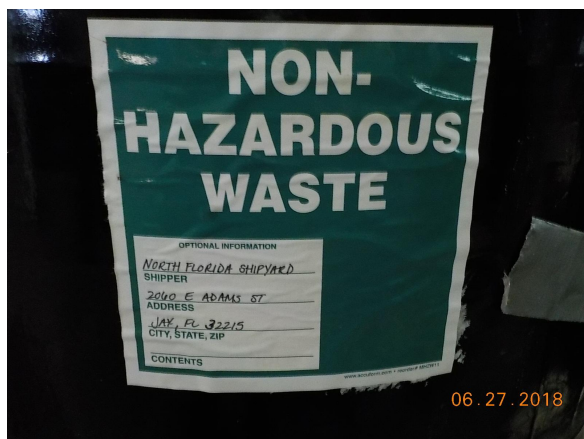
Photo 1

Non-hazardous waste is accumulated outside of the gated and locked HWAA. There were twenty-one 55-gallon drums of non-hazardous waste accumulating. These included four drums of non-hazardous oily water, three drums of used oil, seven drums of non-hazardous oily rags, one drum of non-hazardous AFFF rags, five drums of non-hazardous oily waste, and one drum of non-hazardous grit labeled "PENDING ANALYSIS 1/28/18." Two of the three drums of used oil were not labeled as "Used Oil" (Photo 1) [40 CFR 279.22(c)].

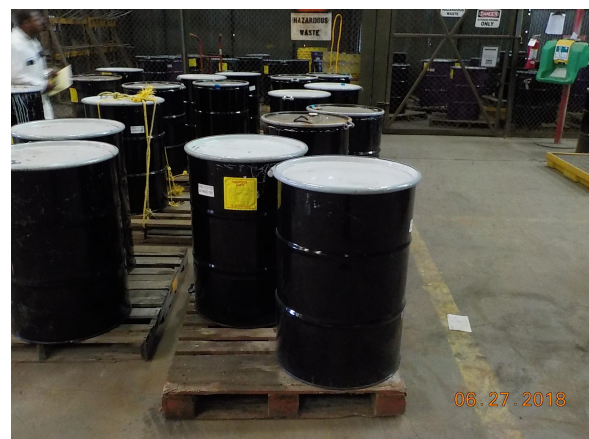
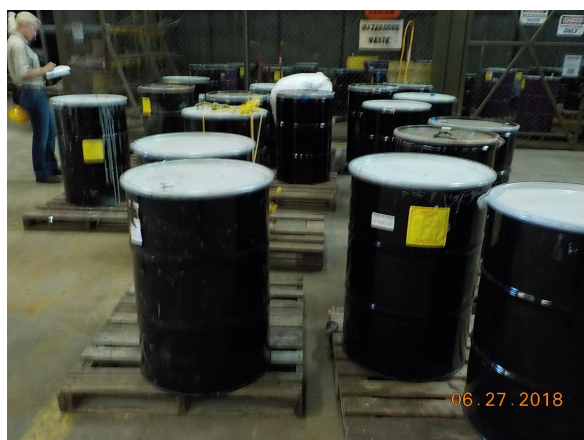
Photo 2

Outside of the gated and locked HWAA there were also eighteen 55-gallon drums of hazardous waste accumulating (Photos 2 and 3). These included three drums of solid paint hazardous waste, four drums of liquid paint hazardous waste, seven drums of solid hazardous waste and four drums of liquid hazardous waste. One drum of solid hazardous waste and one drum of liquid hazardous waste were not dated with the start date of accumulation (Photos 4 and 5) [40 CFR 262.17(a)(5)(i)(C)]. There was adequate aisle space for the inspection of each container of hazardous waste in this area.

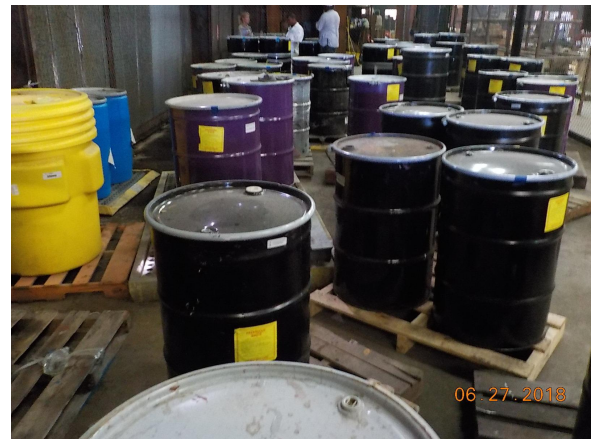
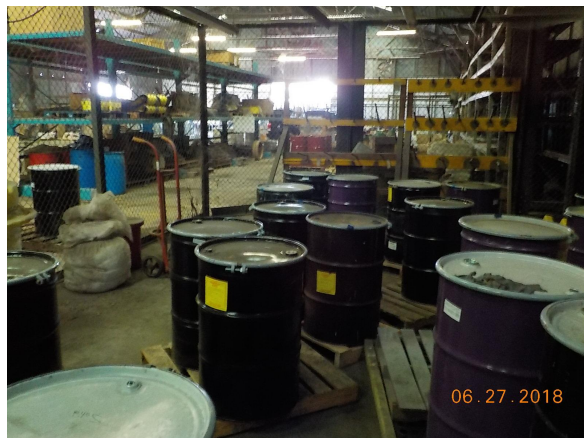
Photo 6

The HWAA was very crowded and there was not adequate aisle space for the inspection of each container of hazardous waste (Photos 6 and 7) [62-730.160(4), FAC]. Both drums of the hazardous waste crushed fluorescent bulbs, 15 drums of solid hazardous waste, 12 drums of liquid hazardous waste, the drum of hazardous waste fuel, one drum of unspecified hazardous waste and the overpack drum of acid hazardous waste had been accumulating for longer than 90 days (Photos 8 through 12) [40 CFR 262.17(a)]. The oldest drum to accumulate for longer than 90 days was one drum of liquid hazardous waste dated January 23, 2018. The second drum of unspecified hazardous waste was not labeled [40 CFR 262.17(a)(5)(i)(A)] and not dated with the start date of accumulation [40 CFR 262.17(a)(5)(i)(C)]. All of the other drums were labeled and dated.

Explanation: Shipping and Receiving Building:
There was inadequate aisle space for the inspection of each container inside of the HWAA.

Corrective Action: In order to return to compliance, the facility should ensure that there is adequate aisle space between containers of hazardous waste to allow for the inspection of the condition and labels of the individual containers. The aisle space should be sufficient space to allow unobstructed movement of personnel, fire-fighting equipment, spill control equipment and decontamination equipment to all areas of the facility in an emergency.

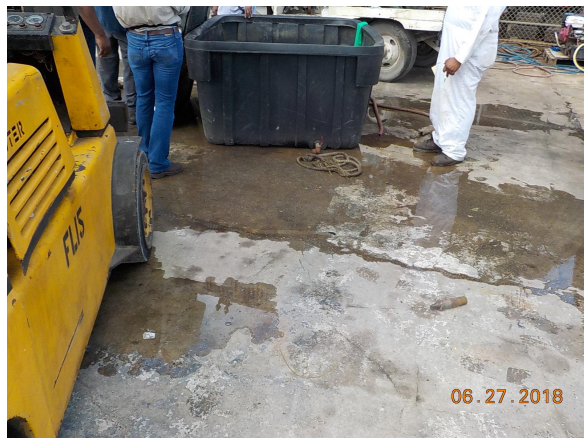
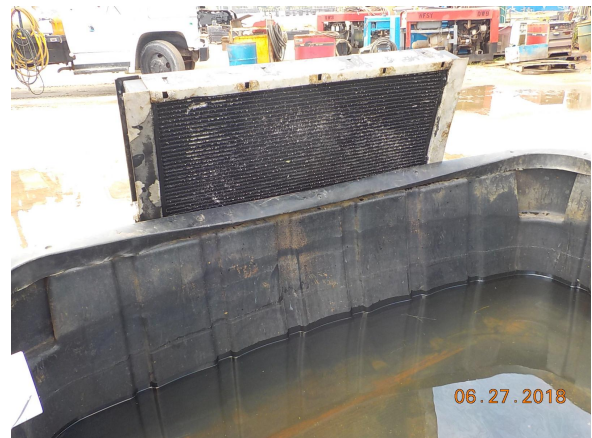
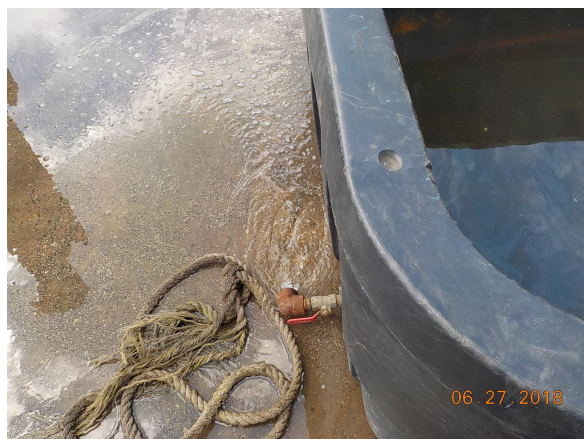
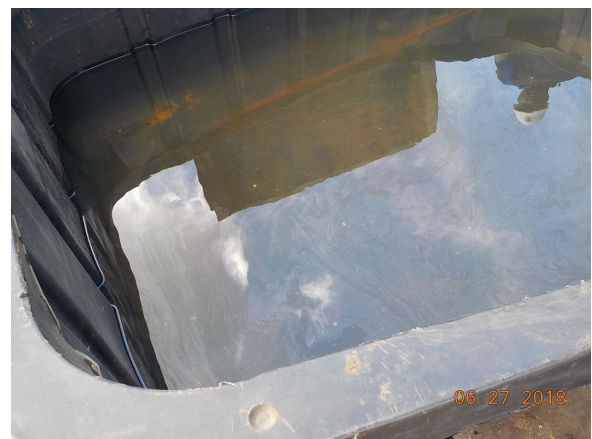
Photo 13

The Maintenance Shop has been relocated to the Old Blast House. In this service area, cranes, equipment and vehicles are maintained and repaired. The shop consists of a service area and a containment area. Outside of the shop, radiators are tested in a large tub of water. During the inspection, facility technicians were draining water from the large tub onto the ground. The tub contained water with what appeared to be an oily sheen on top. This is a release of used oil (Photos 13 through 16) [40 CFR 279.22(d)].

Explanation: Maintenance Shop/Old Blast House:
Oily water was released onto the concrete ground from a large tub that was used to leak-test radiators.

1. Stop and contain the release of used oil.
2. Clean up and properly manage the released used oil and remove any contaminated materials or soil for proper disposal.
3. If necessary to prevent future releases, repair or replace any equipment leaking used oil before returning the equipment to service.

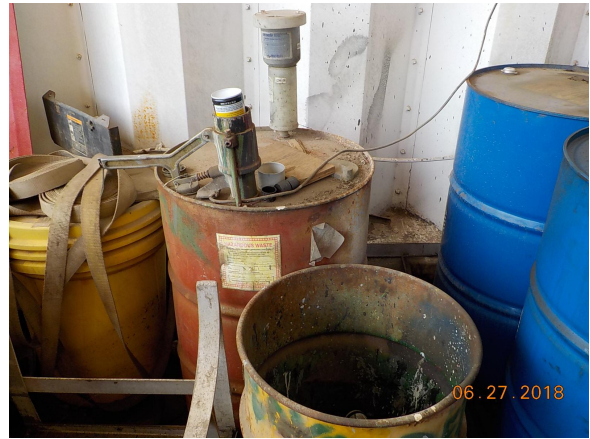
Photo 18

On the same spill pallet, there was one 55-gallon satellite drum of aerosol can liquid hazardous waste accumulating. This drum was properly labeled, but the drum's can puncturing device was open (Photo 18) [40 CFR 262.15(a)(4)].

Explanation: Maintenance Shop/Old Blast House:
One satellite drum of aerosol can liquid hazardous waste was not closed.

Corrective Action: Maintenance Shop/Old Blasting House, Machine Shop:
In order to return to compliance, the facility should keep all containers of hazardous waste closed, except when adding or removing waste.

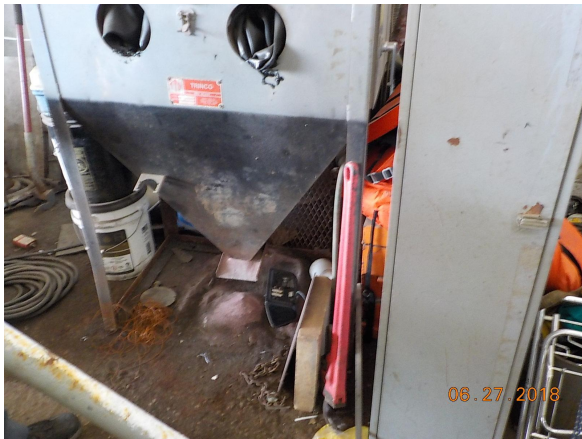
Photo 19

The shop has one self-contained glove box blasting unit that uses silica blast media. There was spent blast media on the shop floor underneath the unit (Photo 19). The facility did not have analytical data for the spent blast media at the time of the inspection. Subsequent to the inspection, the facility had a Toxicity Characteristic Leaching Procedure (TCLP) analysis performed on the spent blast media and determined it was non-hazardous.

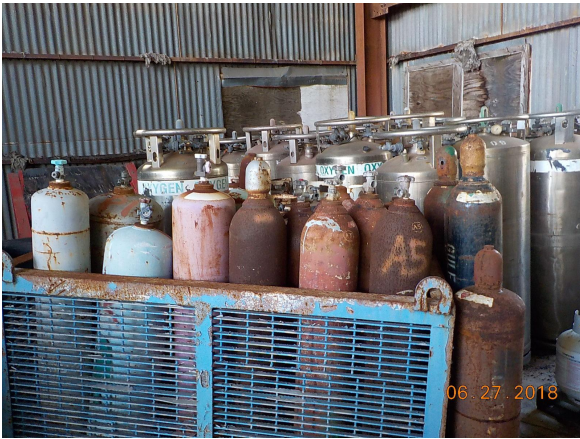
Photo 23

Tools used in the Fabrication Shop and throughout the facility are stored here. No hazardous waste is generated in this area; however, numerous compressed gas cylinders were observed (Photo 23). According to facility personnel, these cylinders are not usable and have been in this area for a very long time. Because these cylinders are a waste, and have been here for an extended amount of time, a hazardous waste determination should have been made on the compressed gas cylinders and the cylinders managed appropriately [40 CFR 262.11].

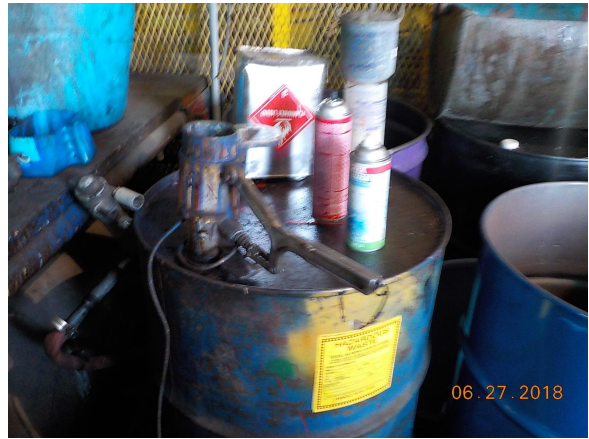
Photo 24

There was one 55-gallon satellite drum of aerosol can liquid hazardous waste accumulating in the shop. The drum was properly labeled, but the can puncturing device was open (Photo 24) [40 CFR 262.15(a)(4)]. Spent aerosol cans from the Paint Shop are being managed here. The facility is reminded that satellite containers of hazardous waste should be managed in areas at or near the point of generation. Spent aerosol cans from other shops should not be managed in this shop.

Machine Shop:
One satellite drum of aerosol can liquid hazardous waste was not closed.

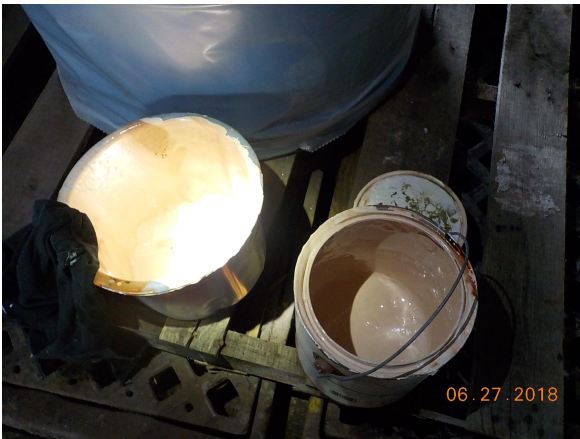
Photo 25

Adjacent to the drums were two small containers of liquid paint hazardous waste that had been intentionally left open in order for the waste paint to evaporate (Photo 25) [40 CFR 262.20(a)].

Paint Shop:
There were two small non-empty containers of liquid paint hazardous waste left open to intentionally evaporate.

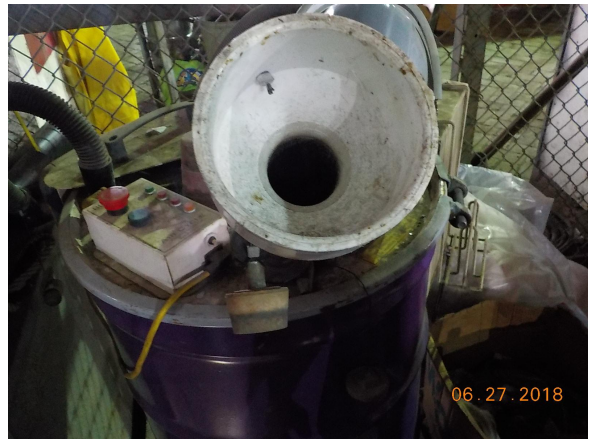
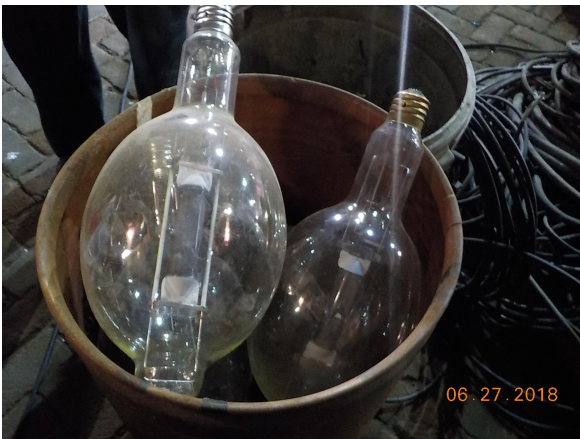
Photo 26

Spent fluorescent bulbs are accumulated in this area before they are crushed. There was one drum-top bulb crusher device attached to a 55-gallon satellite drum of hazardous waste in this area. The drum was open (Photo 26) [40 CFR 262.15(a)(4)] and not labeled [40 CFR 262.15(a)(5)]. Near the drum-top bulb crusher, there was one 30-gallon drum of large spent universal waste bulbs accumulating. The drum was open, [40 CFR 273.13(d)(1)], not labeled [40 CFR 273.14(e)] and not dated (Photo 27) [40 CFR 273.15(c)].

One satellite drum of hazardous waste crushed fluorescent bulbs was not closed.

Electrical Shop:
One satellite drum of hazardous waste crushed fluorescent bulbs was not labeled with the words "Hazardous Waste."

Corrective Action: In order to return to compliance, the facility should label all satellite containers of hazardous waste with the words "Hazardous Waste" and an indication of the hazards of the contents (i.e., ignitable, corrosive, reactive, toxic); hazard communication consistent with the Department of Transportation requirements at 49 CFR part 172 subpart E (labeling) or subpart F (placarding); a hazard statement or pictogram consistent with the Occupational Safety and Health Administration Hazard Communication Standard at 29 CFR 1910.1200; or a chemical hazard label consistent with the National Fire Protection Association code 704.

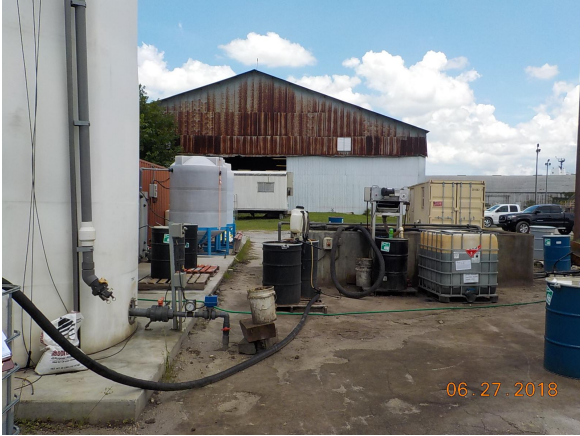
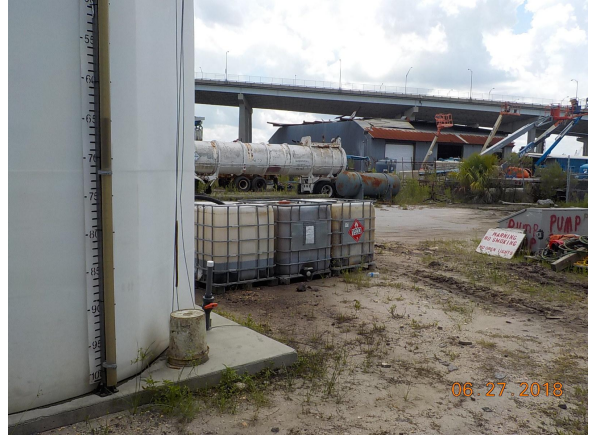
Photo 29

There were five 55-gallon drums and four poly totes of used oil that were not located within secondary containment (Photos 29 and 30) [62-710.401(6), FAC]. One of the totes was open [62-710.401(6), FAC]. There were also three 55-gallon drums of paint chips in this area. The facility did not have an analysis for the paint chips at the time of the inspection and, as a result, did not make a hazardous waste determination on this waste stream [40 CFR 262.11]. Subsequent to the inspection, the facility had a TCLP analysis performed on each of the three drums of paint chips and determined that one of the drums was hazardous for lead. The facility is managing the drum as oily waste contaminated with lead. The facility should properly manage and dispose of this drum as a D008 hazardous waste.
