#### FLORIDA DEPARTMENT OF Environmental Protection

SUBJECT: Department of Environmental Protection v. PACEM Defense, LLC

RE: Warning Letter WL21-201 (Significant Non-Complier)
PACEM Defense – AMTEC Less Lethal
EPA/DEP ID: FLR000201186
Taylor County – Hazardous Waste

#### **Hazardous Waste Inspection Report**

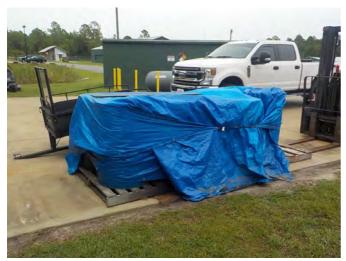
Photo 21

Immediately outside the open bay area, on the concrete driveway, were eight 55-gallon drums on wooden pallets underneath a tarp (Photos 21 and 22). Five 55-gallon drums were labeled used oil. The used oil containers were closed and properly labeled but did not have adequate secondary containment [62-710.401(6), FAC]. Adjacent to and underneath a pallet of used oil drums there was a small area of stained concrete and soil observed (See Photo 22). This is an Area of Concern. There was water on top of the tarp that dripped onto the concrete and ground when the tarp was pulled off the drums, but this staining did not appear to be the result of that action. The facility should determine if this staining is the result of a used oil release, and if so, clean-up and properly manage the contaminated materials. Two of the 55-gallon drums in this area were labeled oily water, and one 55-gallon drum was labeled hazardous waste flash powder (Photo 23). The 55-gallon drum of hazardous waste was closed and properly labeled "Hazardous Waste" but did not include an indication of the hazards of the contents [40 CFR 262.16(b)(6)(i)(B)]. Because this drum was not being used as a satellite accumulation container in this location, the container should have been managed as an HWAA. The area had the required equipment, but the facility was not performing weekly hazardous waste container inspections and did not have documentation of the weekly inspections [40 CFR 262.16(b)(2)(iv), 62-730.160(3), FAC].

- 4. Maintenance Building Inspectors observed an area of stained concrete and soil underneath several 55-gallon drums of used oil located outside the Maintenance Building. The facility should determine if this staining is the result of a used oil release and if so, should take the following actions: (1) Stop the release; (2) Contain the released used oil; (3) Clean up and properly manage the released used oil and other materials; and (4) If necessary, repair or replace any leaking used oil storage containers prior to returning them to service.

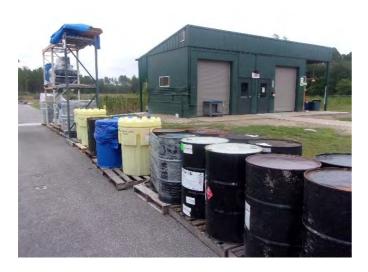
Photo 29

Adjacent to Annex #1 is an outdoor HWAA. Product drums and empty drums are also stored in this area. There were six hazardous waste accumulation containers located in the area (Photos 29-31). Three of the containers were 85-gallon overpack drums of waste OCBA, one of the containers was an 85-gallon overpack drum of OCBA spill clean-up waste, and two of the containers were 55-gallon drums of waste milano. All the accumulation containers were closed. The four waste OCBA containers were properly labeled with the words "Hazardous Waste" but were not marked with an indication of the hazards of the contents [40 CFR 262.16(b)(6)(i)(B)]. The two containers of waste milano were not properly labeled "Hazardous Waste" and were not marked with an indication of the hazards of the contents [40 CFR 262.16(b)(6)(i)(A), 40 CFR 262.16(b)(6)(i)(B)]. All hazardous waste accumulation containers had been accumulating for less than 180-days. The facility was not conducting weekly inspections of the HWAA and was not maintaining documentation of the inspections [40 CFR 262.16(b)(2)(iv), 62-730.160(3), FAC]. The HWAA did not have all the required equipment since there was no spill kit [40 CFR 262.16(b)(8)(ii)(C)].
