SUBJ: RCRA Compliance Evaluation Inspection
EQ Florida, Inc.
Tampa, Florida 33619
EPA ID. No.: FLD 981 932 494

RCRA Inspection Report

RCRA Compliance Evaluation Inspection
June 20, 2018 - Photographs
EQ Florida, Inc.
Tampa, Florida 33619
EPA ID. No.: FLD 981 932 494

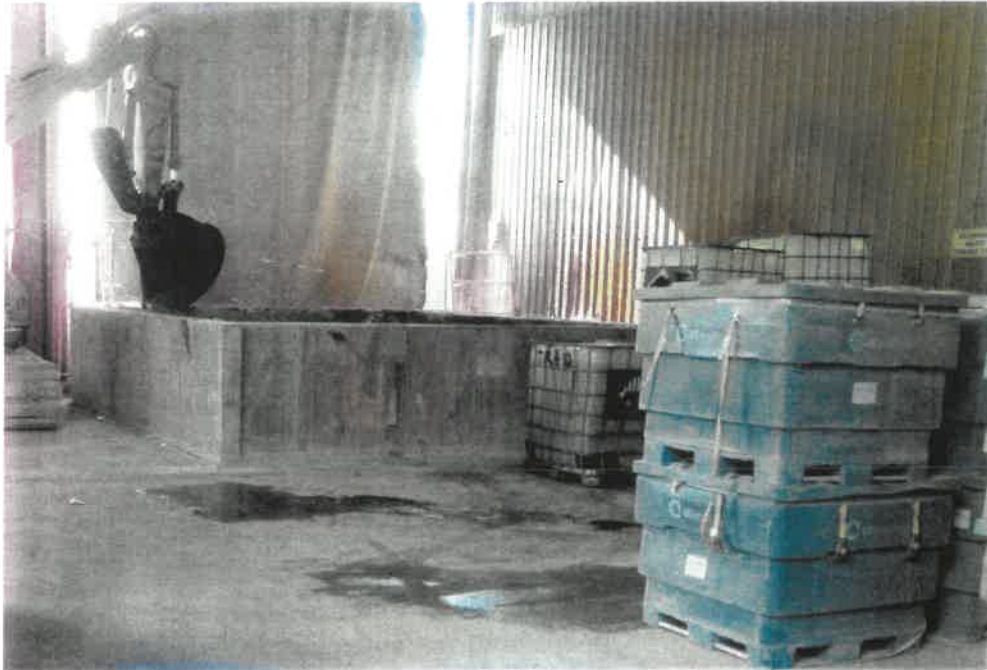
At the time of the inspection, EQ was treating hazardous wastes (Batch # 525) in the hazardous waste treatment tank (Photo 1). Near the treatment tank, the inspectors observed a roll-off container that contained a portion of treatment Batch # 524 and several hazardous waste containers (Photo 2). In the cabinet where EQ stores explosives wastes, the inspectors observed six hazardous waste containers (Photo 3). All containers were within the areas established in the permit, labeled, dated, closed and appeared to be in good condition.

Photograph 1: View of the hazardous waste treatment tank while in operation. Photo taken by Javier García, on 6/20/2018, at 9:31 a.m. Equipment used: Samsung Camera (Model WB250F)-EPA Property Tag # S75951

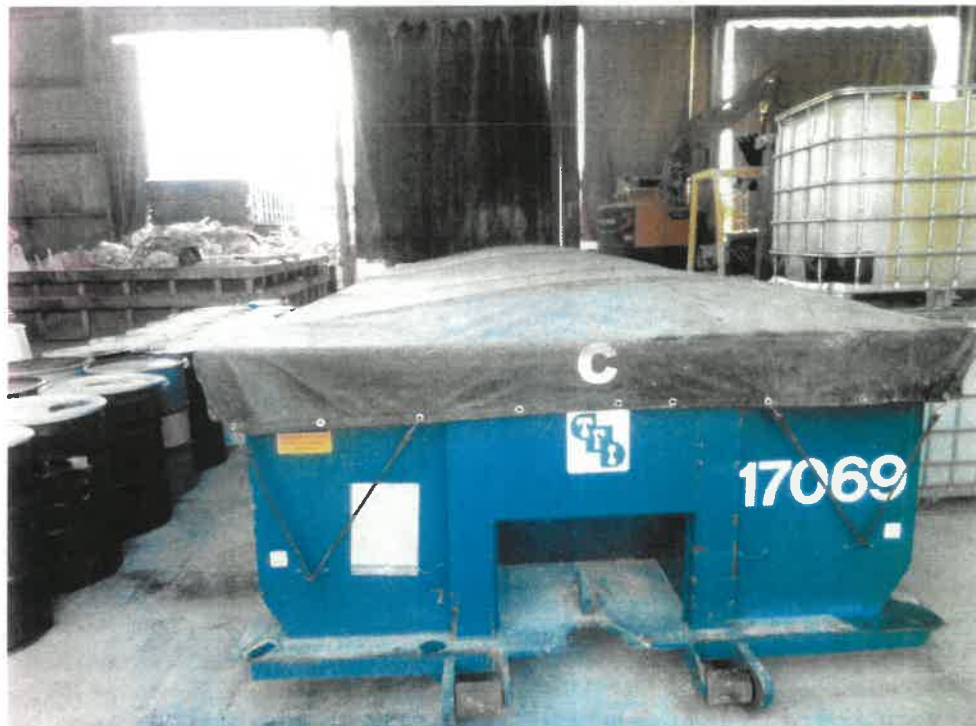
Photograph 2: Roll-off container in the Waste Processing Building. The container was holding a portion of treatment batch # 524. Photo taken by Javier García, on 6/20/2018, at 9:32 a.m. Equipment used: Samsung Camera (Model WB250F)-EPA Property Tag # S75951

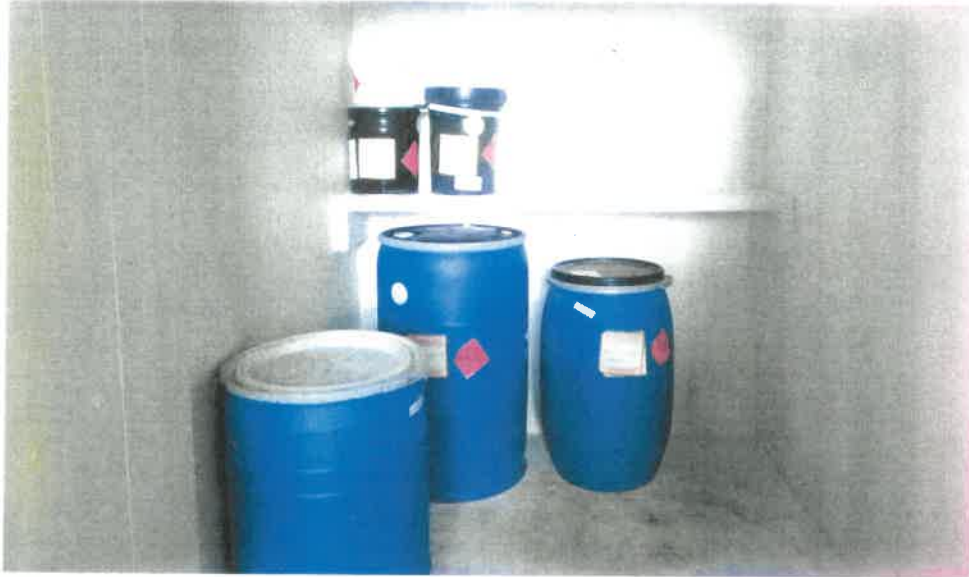
Photograph 3: Containers inside the cabinet for explosive/reactive wastes. The cabinet in the Waste Processing Building. Photo taken by Javier García, on 6/20/2018, at 9:43 a.m. Equipment used: Samsung Camera (Model WB250F)-EPA Property Tag # S75951

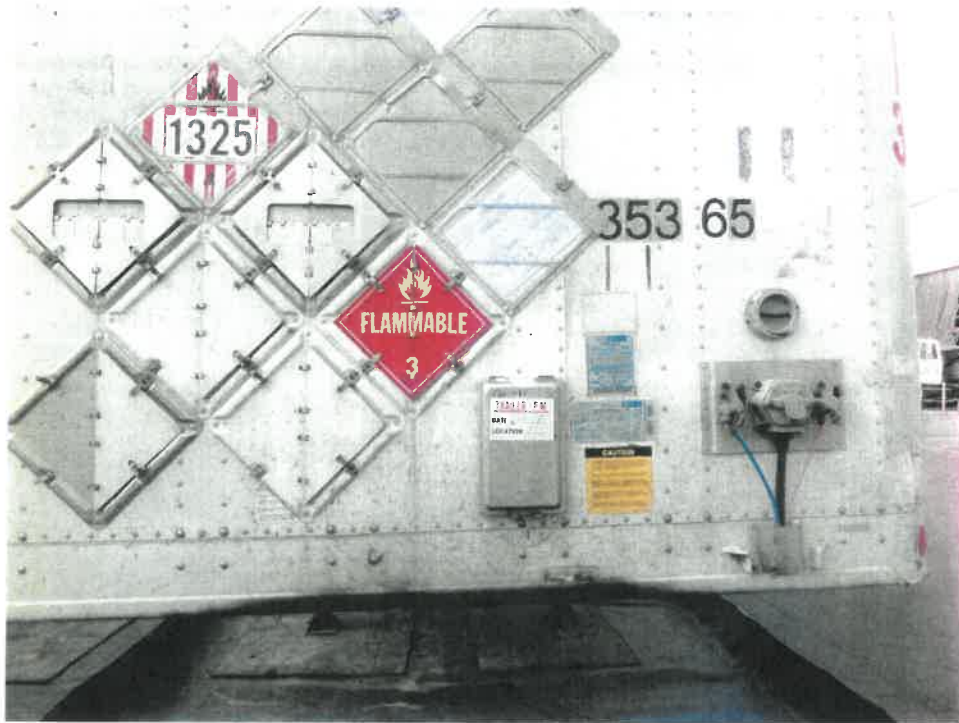
This area is designated in the permit as temporary storage of inbound loads awaiting receipt and unloading; and, for outbound loads waiting for completion of transportation paperwork. At the time of the inspection, the inspectors observed two trailers. One trailer contained inbound hazardous wastes and the other container contained an outbound load of universal wastes (Photos 4 and 5).

Photograph 4: Inbound trailer in the area designated in the permit as the "Transfer Lot." Photo taken by Javier García, on 6/20/2018, at 9:49 a.m. Equipment used: Samsung Camera (Model WB250F)-EPA Property Tag # S75951

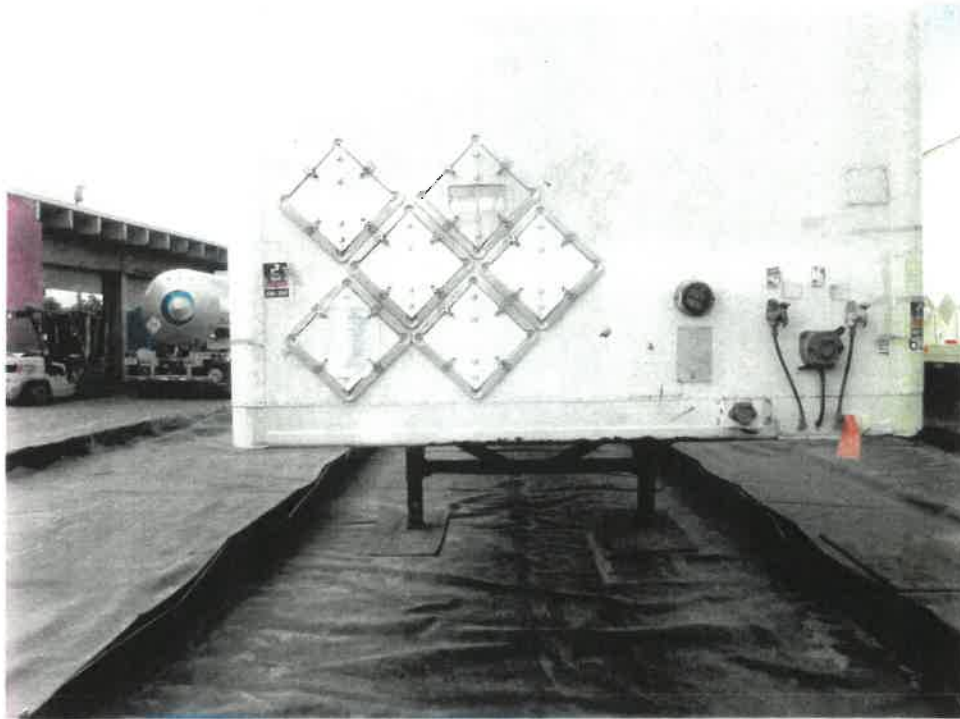
Photograph 5: Outbound trailer in the area designated in the permit as the "Transfer Lot." Photo taken by Javier García, on 6/20/2018, at 9:50 a.m. Equipment used: Samsung Camera (Model WB250F)-EPA Property Tag # S75951

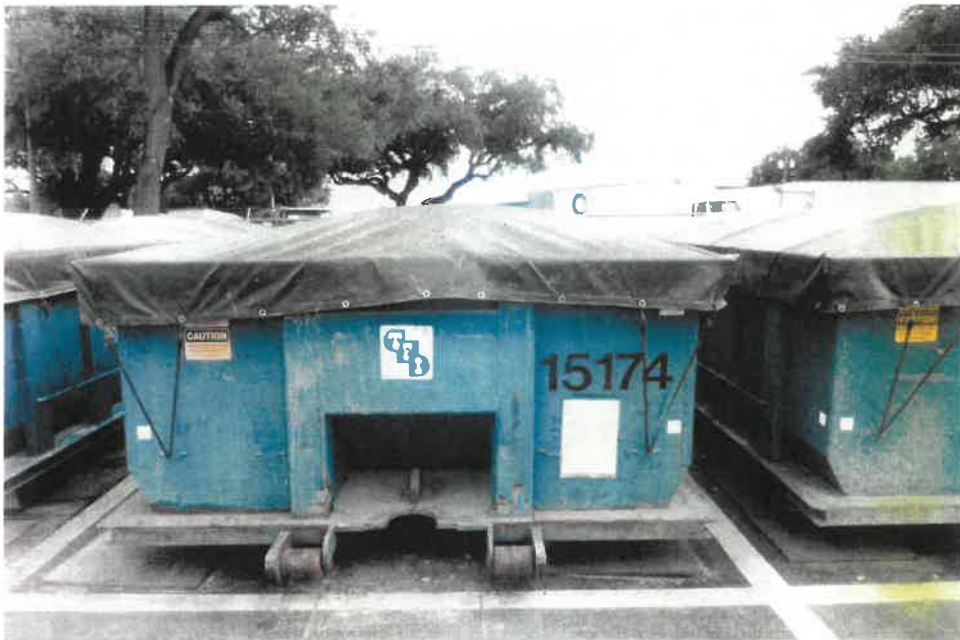
In the BCSAs, EQ stores treated hazardous wastes in roll-off containers. In the BCSA located along the northern property line, the inspectors observed six roll-off containers (Photos 6 and 7). In front of the WPB, the inspectors observed two roll-off containers which contained treated hazardous wastes (Batch #524). Underneath the containers, the inspectors observed condensate released from one of the container (Photos 8 and 9). The FDEP inspector measured the pH of the released condensate with litmus paper obtaining an approximate reading above 12 (Photo10). The treatment processing sheet for Batch #524 indicated that it did not contain K062 listed hazardous waste. Following the

Photograph 6: Partial view of the roll off containers stored in the Bulk Containers Storage Area Outbound along the northern property line. Photo taken by Javier García, on 6/20/2018, at 9:58 a.m. Equipment used: Samsung Camera (Model WB250F)-EPA Property Tag # S75951

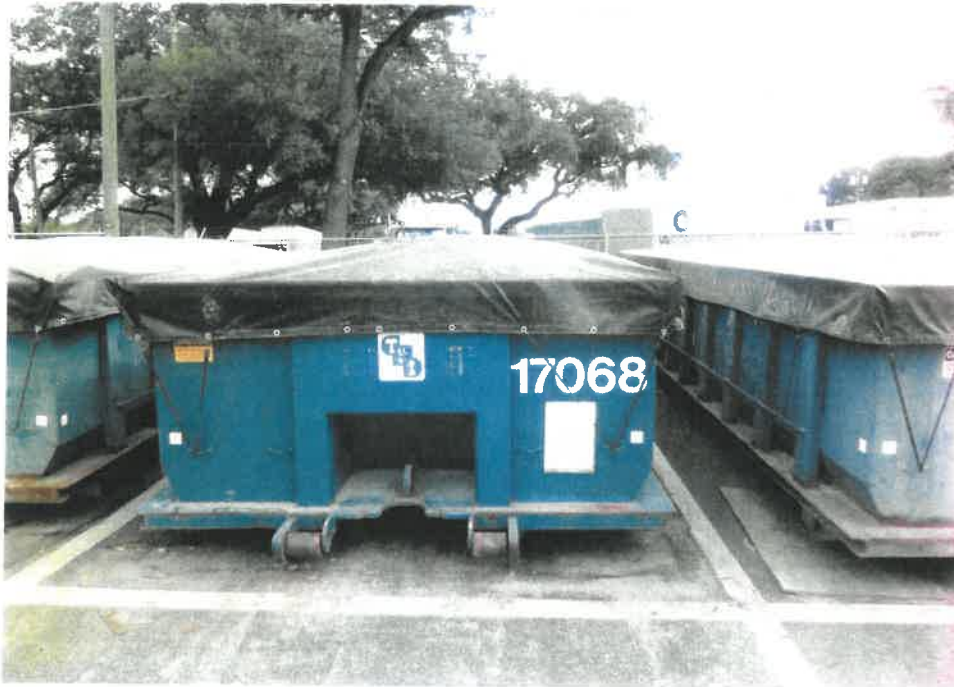
Photograph 7: Partial view of the roll off containers stored in the Bulk Containers Storage Area Outbound along the northern property line. Photo taken by Javier García, on 6/20/2018, at 9:58 a.m. Equipment used: Samsung Camera (Model WB250F)-EPA Property Tag # S75951

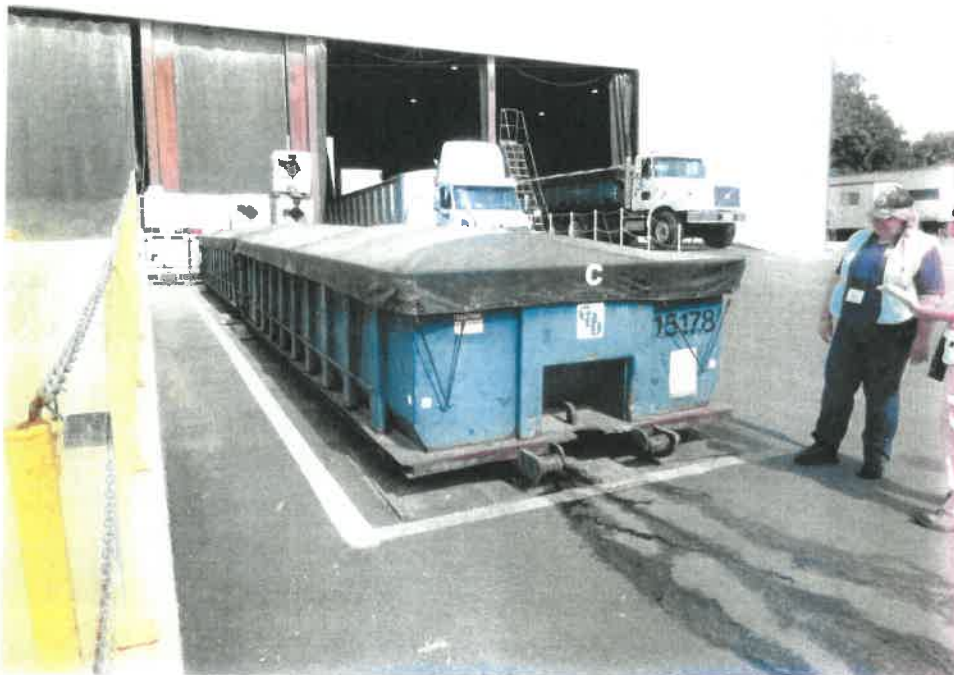
Permit Condition Part II.A.10, requires EQ to maintain and operate the facility to minimize the possibility of fire, explosion or any unplanned sudden or non-sudden release of hazardous waste or hazardous waste constituents to air, soil, or surface water which could threaten human health or the environment.

Photograph 8: View of the condensate released from one roll off container in the Bulk Containers Storage Area in front of the WPB. Photo taken by Javier García, on 6/20/2018, at 10:09 a.m. Equipment used: Samsung Camera (Model WB250F)-EPA Property Tag # S75951

inspection, Mr. Dean indicated that the facility would store the roll-off containers on a pop up containment structure to contain potential condensate drippage, which would be cleaned as needed.

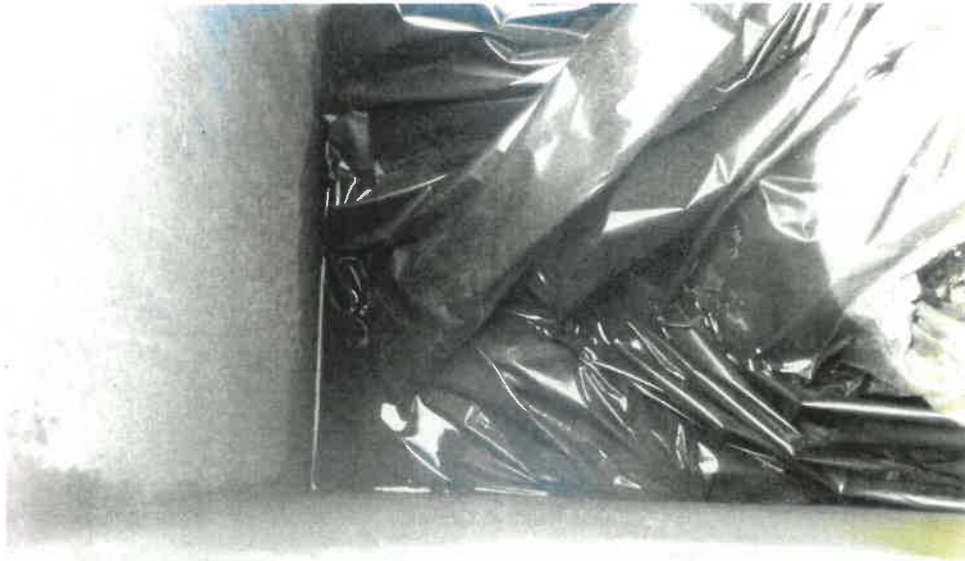
Photograph 9: View of the condensate in the roll off container that was leaking (see picture above). Photo taken by Javier García, on 6/20/2018, at 10:15 a.m. Equipment used: Samsung Camera (Model WB250F)-EPA Property Tag # S75951

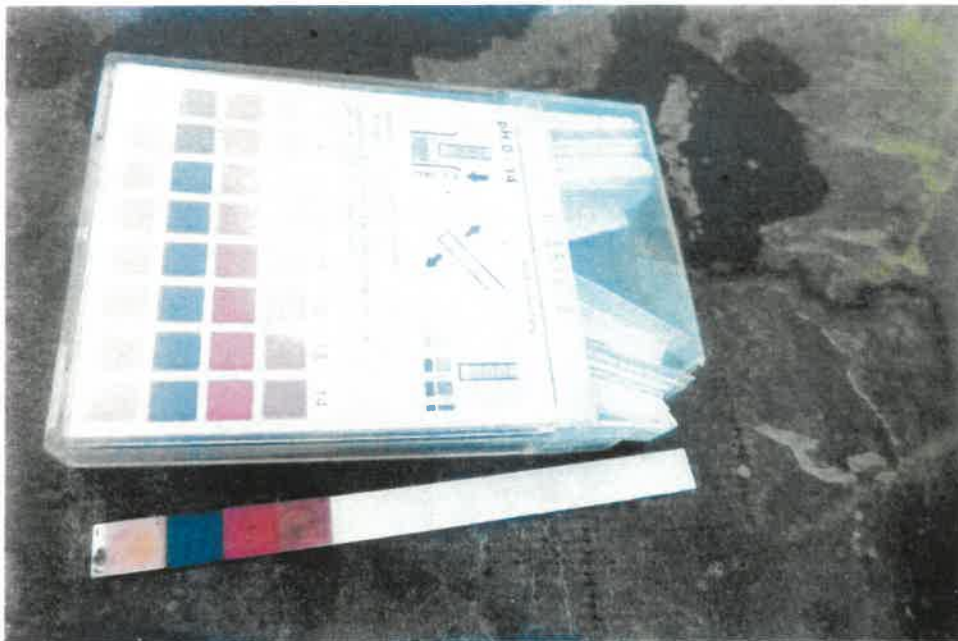
Photograph 10: View of the litmus paper the FDEP inspector used to measure the pH of the condensate released from a roll off container in front of the WPB. Photo taken by Javier García, on 6/20/2018, at 10:54 a.m. Equipment used: Samsung Camera (Model WB250F)-EPA Property Tag # S75951

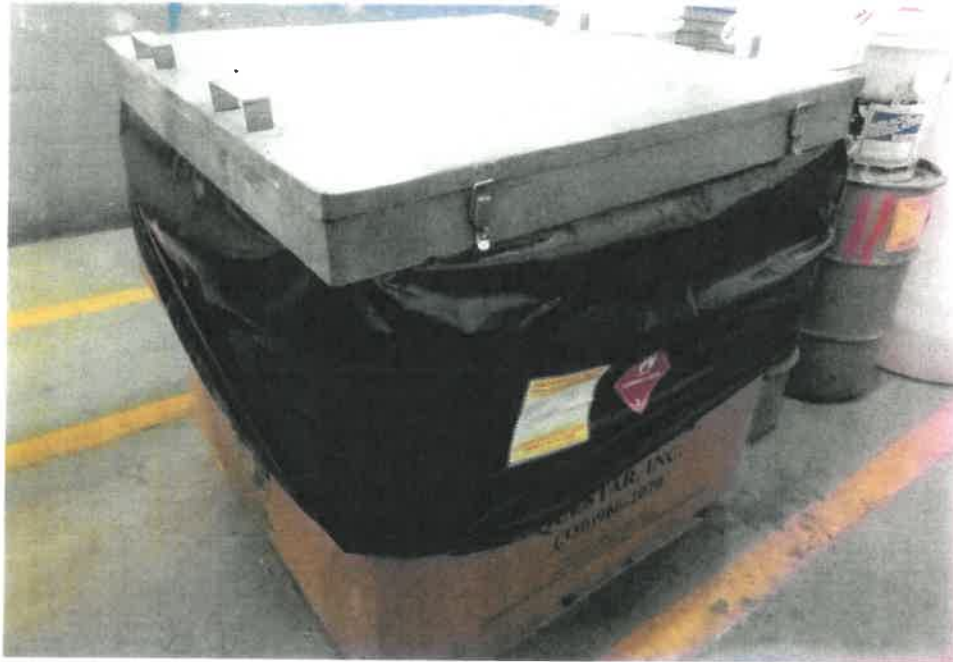
In Bay 2, the inspectors observed a 1-cubic yard container that was being used for the consolidation of ignitable damaged goods (i.e. cosmetic and perfume containers) that contained volatile organic constituents above 500 ppm. The 1-cubic yard container, or outer packaging [as referred to in the regulations promulgated by the Department of Transportation (DOT)] had a polypropylene liner and was covered with a removable metal lid, (Photo 11). No absorbent material was observed inside the outer package (Photo 12)

Following the inspection, Mr. Dean indicated that the UN rating for the outer container was 11G/X/0518/USA/+AA8369/1882/99, and that EQ does not consider the consolidation package to be a lab pack, as defined in 49 C.F.R. § 173.12(b). Nevertheless, in the manifest for this container, EQ described the waste load as "Waste Flammable Liquids, n.o.s. (Damaged Goods), 3, PG II, (D001). DOT allows the use of this description provided the container meets the lab packs packaging requirements in 49 C.F.R. § 173.12(b), including the requirement to surround inner packagings containing liquid with a chemically compatible absorbent material in sufficient quantity to absorb the total liquid contents.

Permit Condition Part II.A.1 requires EQ comply with those sections of 40 CFR Part 124 specified in Subsection 62-730.200(3), F.A.C., 40 CFR Parts 260 through 268, and 40 CFR Part 270 as adopted in Chapter 62-730, F.A.C., until all hazardous waste permitting operations have ceased and the facility has been closed and released from post closure care requirements and all facility-wide corrective action requirements. 40 C.F.R. § 264.1086(c)(1) requires owners or operators storing hazardous wastes in containers subject to Level 1 air emission standards to meet the applicable DOT regulations on packaging hazardous materials for transportation as specified in paragraph (f) of this section.

Following the inspection, the EPA reviewed the manifest for the “damage goods” hazardous waste load observed in Bay 2 of the CSB. In the manifest, EQ described the waste load as “Waste Flammable Liquids, n.o.s. (Damaged Goods) , 3, PG II, (D001). DOT allows the use of this description provided the container meets the lab packs packaging requirements in 49 C.F.R. § 173.12(b). In the manifest, EQ declared that it shipped two boxes of damage goods with a total weight of 1,717 pounds. Pursuant to 49 C.F.R. § 173.12(b)(2(ii), the gross weight of each completed combination package may not exceed 205 kilograms (452 pounds).

Photograph 11: One cubic yard container in Bay 2 of the container storage building in used for consolidation of damaged goods (cosmetics) that contained volatile organic constituents. Photo taken by Javier García, on 6/20/2018, at 11:37 a.m. Equipment used: Samsung Camera (Model WB250F)-EPA Property Tag # S75951

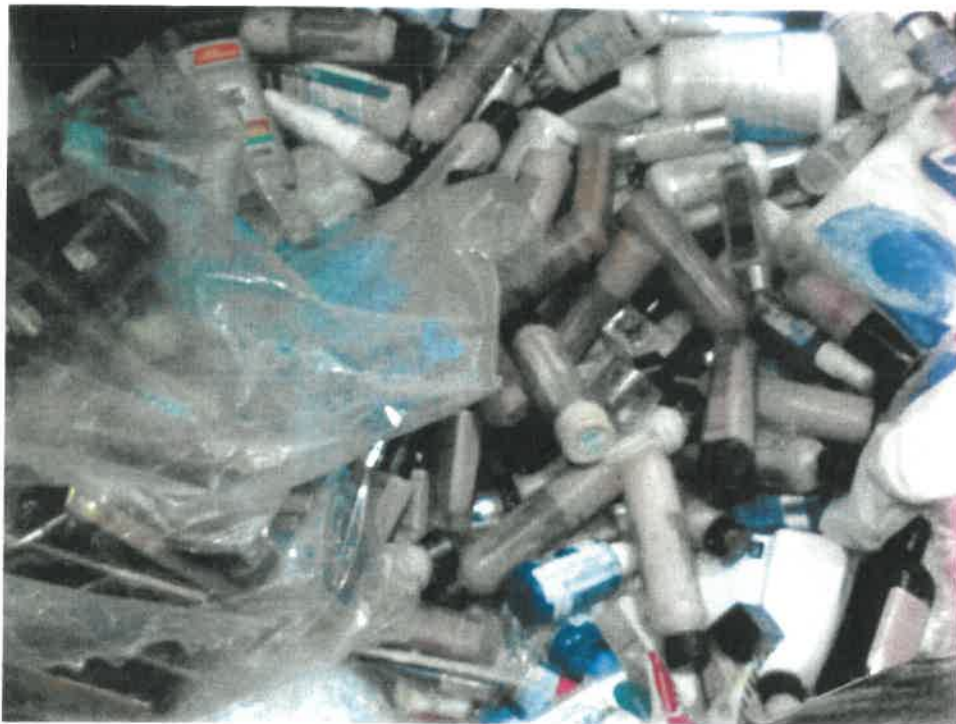
Photograph 12: View of the “damaged goods” in the one cubic yard container in Bay 2 of the container storage building. According to Mr. Dean, ziplock type bags contained bottles which integrity may had been compromised. Photo taken by Elizabeth Knauss (FDEP), on 6/20/2018.

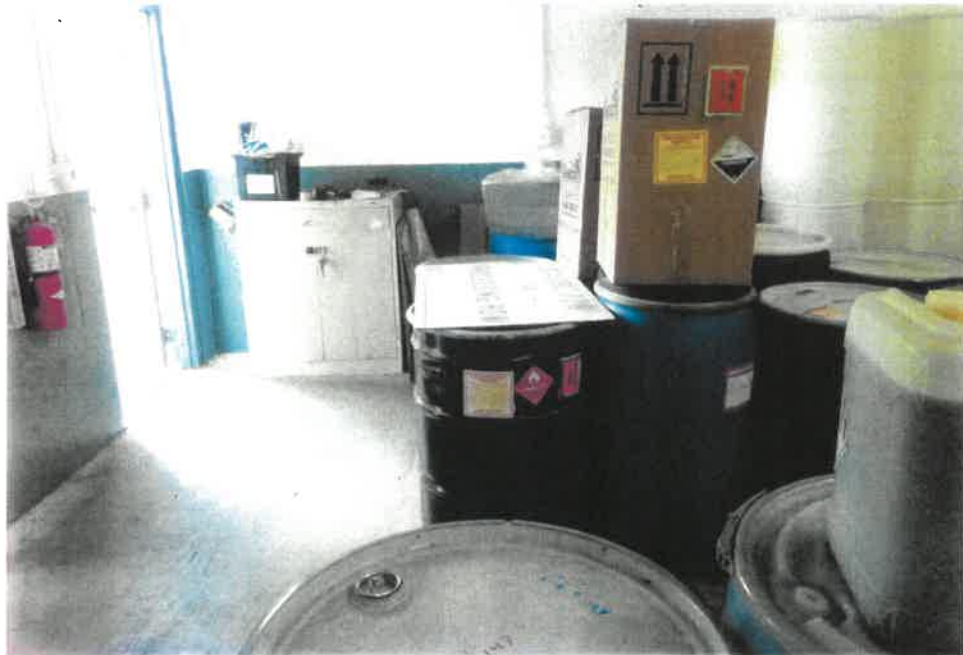
In the staging area of Bay 3, the inspectors observed two 55-gallon containers of flammable hazardous waste that were within 50 feet of the north property boundary (Photo 13). Mr. Cruz indicated that the containers were received on June 14, 2018. An EQ employee moved the containers to an approved location while the inspectors were in the bay (Photo 14).

Permit Condition Part II.B.12 requires EQ to comply with the 15-meter (50-foot) setback rule concerning the locating of ignitable and reactive wastes in containers per 40 C.F.R. § 264.176.

Photograph 13: Two 55-gallon containers of flammable hazardous waste in the staging area of Bay 3, that within 50 ft. of the north property boundary Photo taken by Javier García, on 6/20/2018, at 12:16 p.m. Equipment used: Samsung Camera (Model WB250F)-EPA Property Tag # S75951

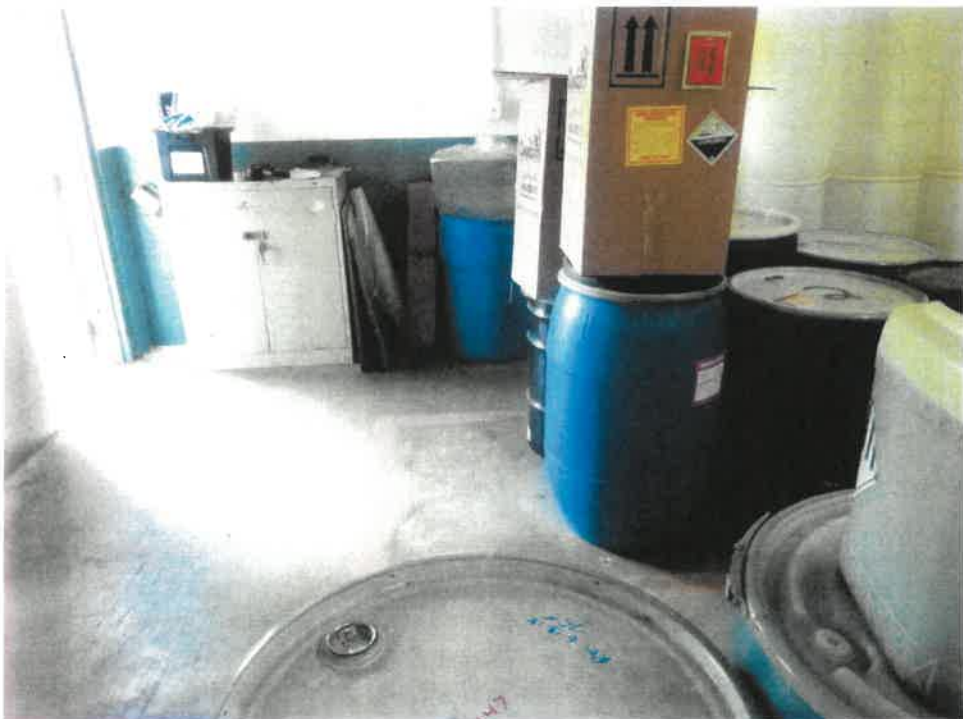
Photograph 14: Location where the two 55-gallon containers of flammable hazardous wastes shown in previous photograph were at. Photo taken by Javier García, on 6/20/2018, at 12:19 p.m. Equipment used: Samsung Camera (Model WB250F)-EPA Property Tag # S75951.
