Re: Warning Letter # WL25-33HW52SWD  
Hagan Holding Company dba HOWCO Environmental Services  
Facility ID No. FLD152764767  
Pinellas County

## Site Report

**Address:**  
**File #:**  
**Project Name:** Hagan Holding Company dba HOWCO Environmental Services (FLD152764767)  
Operating Permit Numbers: 33721-006-HO; 33721-007-SO  
**Inspection Date:** February 11, 2025  
**Inspectors:** Coral Evans.

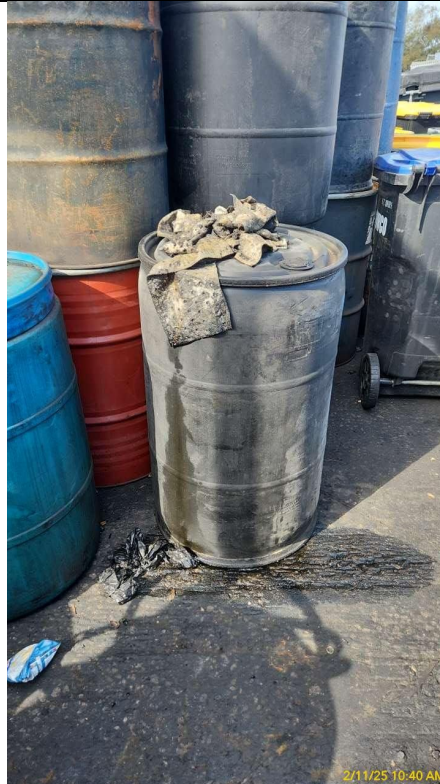
<b>Image #:</b>	1
<b>Photo Description:</b>	Unlabeled leaking defective drum and absorbents exposed to environment
<b>Photo Location:</b>	27°45'40.5"N 82°41'33.9"W

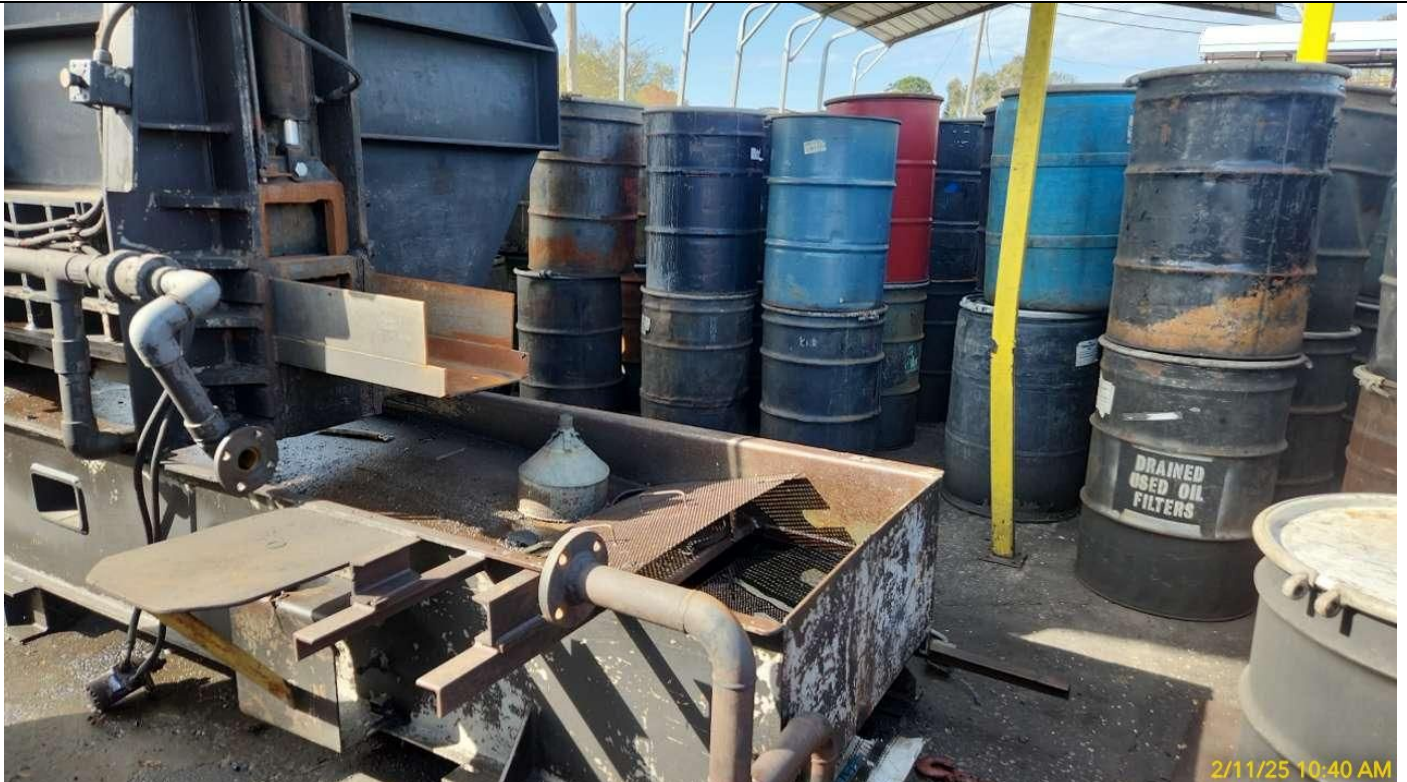
<b>Image #:</b>	2
<b>Photo Description:</b>	Unlabeled 55-gallon drums, aisle space not present
<b>Photo Location:</b>	27°45'40.4"N 82°41'33.9"W

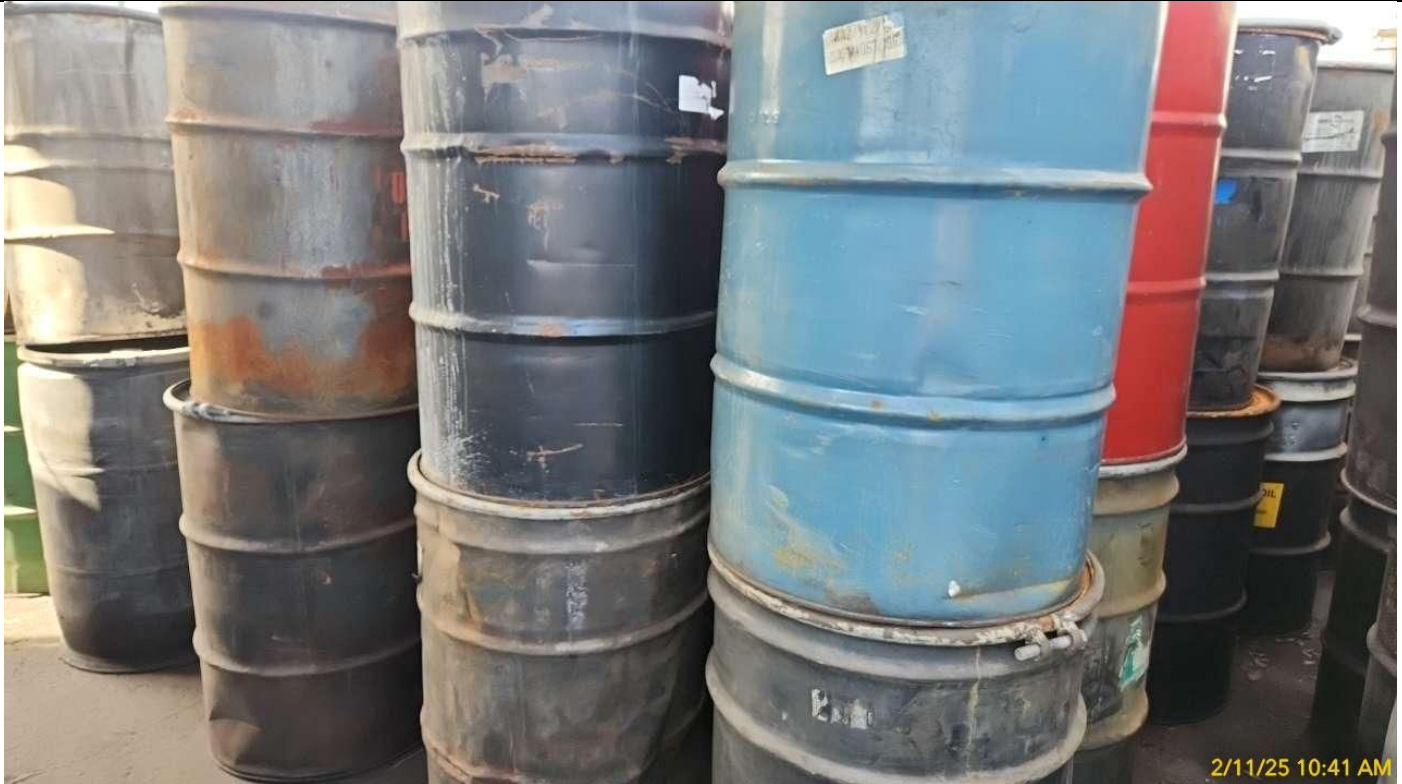
Image #:	3
Photo Description:	Unlabeled 55-gallon drums, aisle space not present
Photo Location:	27°45'40.5"N 82°41'34.1"W

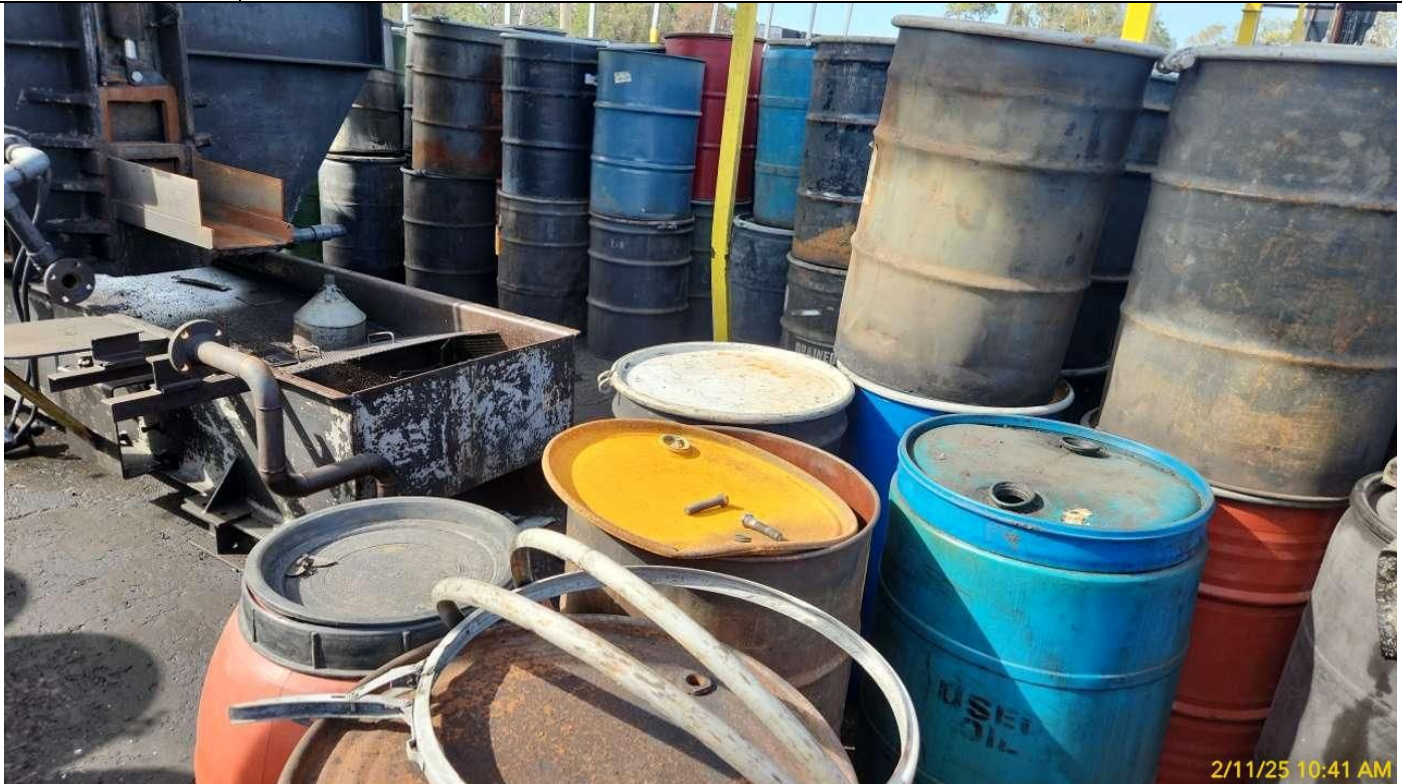
Image #:	4
Photo Description:	Unlabeled 55-gallon drums (some open and defective), aisle space not present
Photo Location:	27°45'40.5"N 82°41'34.0"W

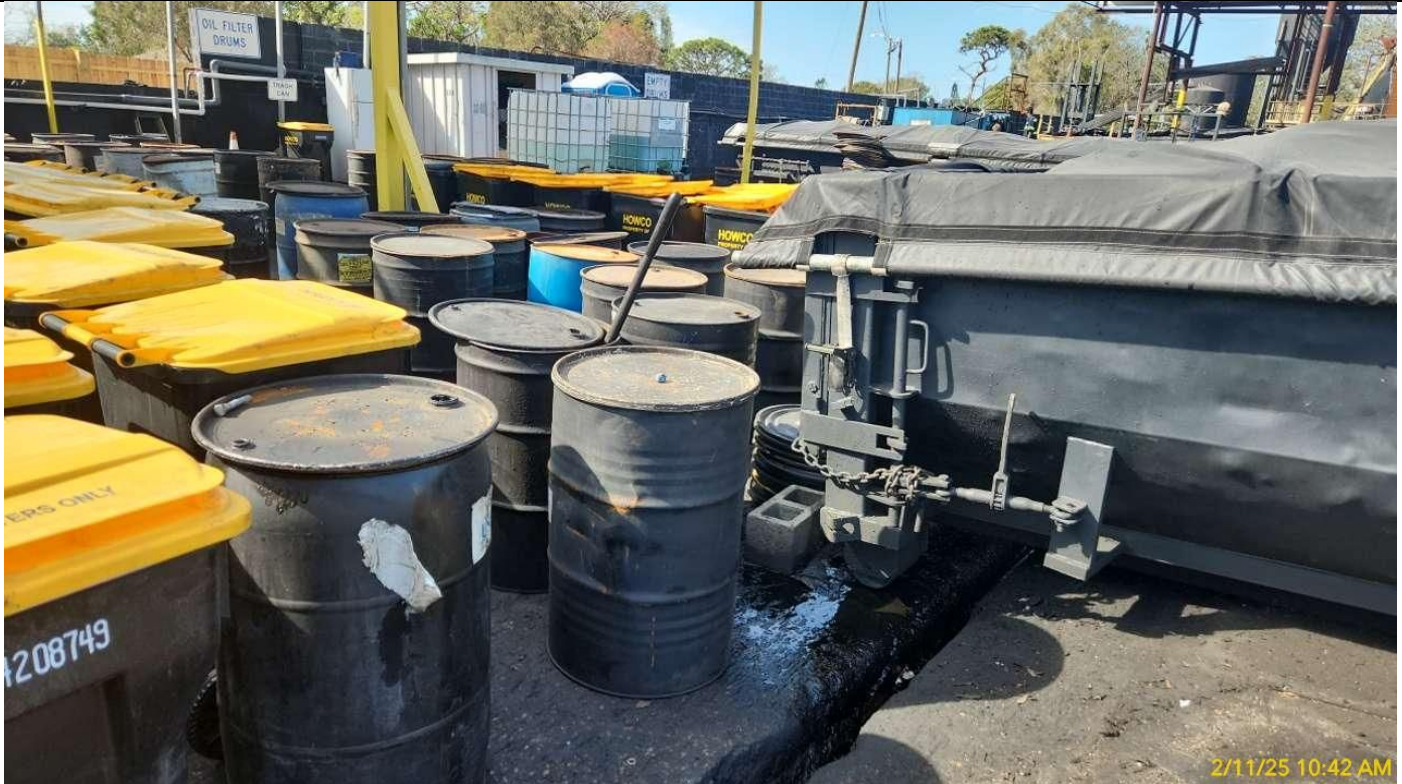
<b>Image #:</b>	7
<b>Photo Description:</b>	Adequate aisle space not present, drums open and leaking, some unlabeled containers present
<b>Photo Location:</b>	27°45'40.6"N 82°41'34.3"W

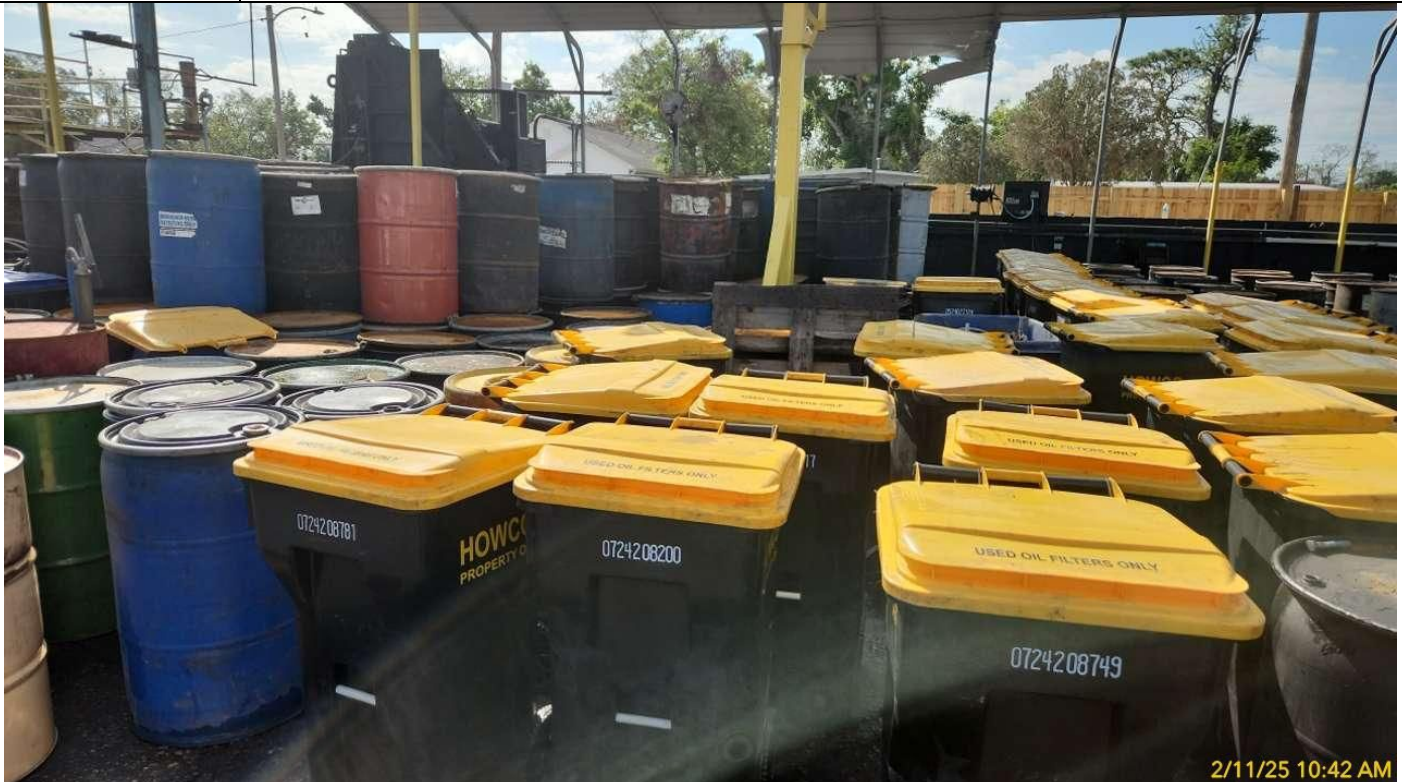
<b>Image #:</b>	8
<b>Photo Description:</b>	Adequate aisle space not present, numerous unlabeled containers some open
<b>Photo Location:</b>	27°45'40.6"N 82°41'34.3"W

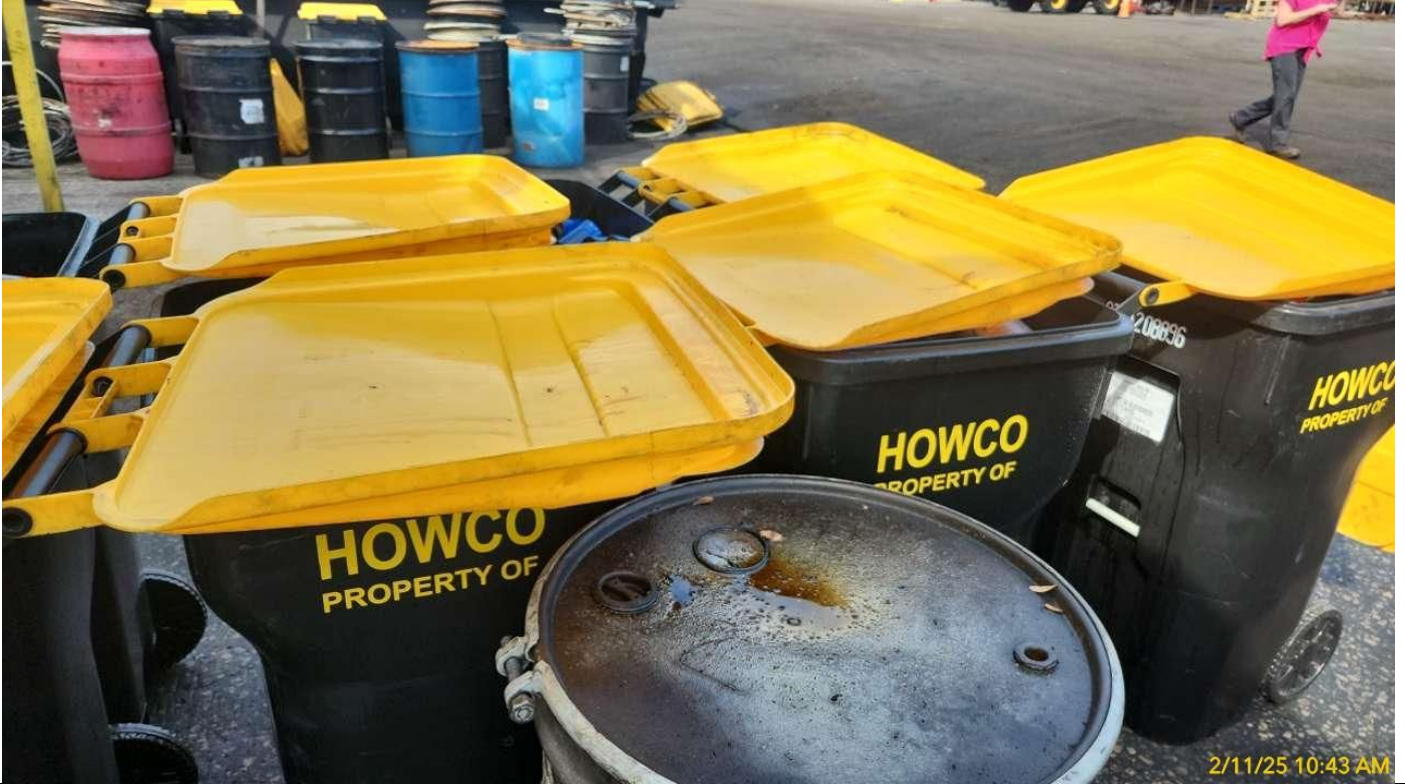
Image #:	11
Photo Description:	Open containers of used oil filters
Photo Location:	27°45'40.4"N 82°41'34.5"W

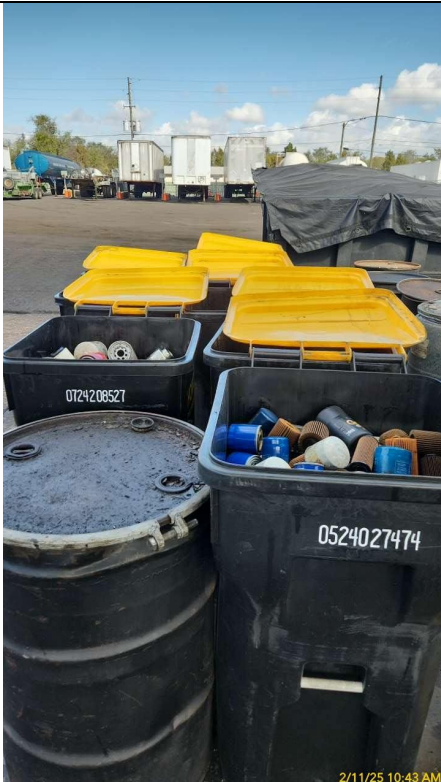
Image #:	12
Photo Description:	Open containers of used oil filters
Photo Location:	27°45'40.4"N 82°41'34.5"W

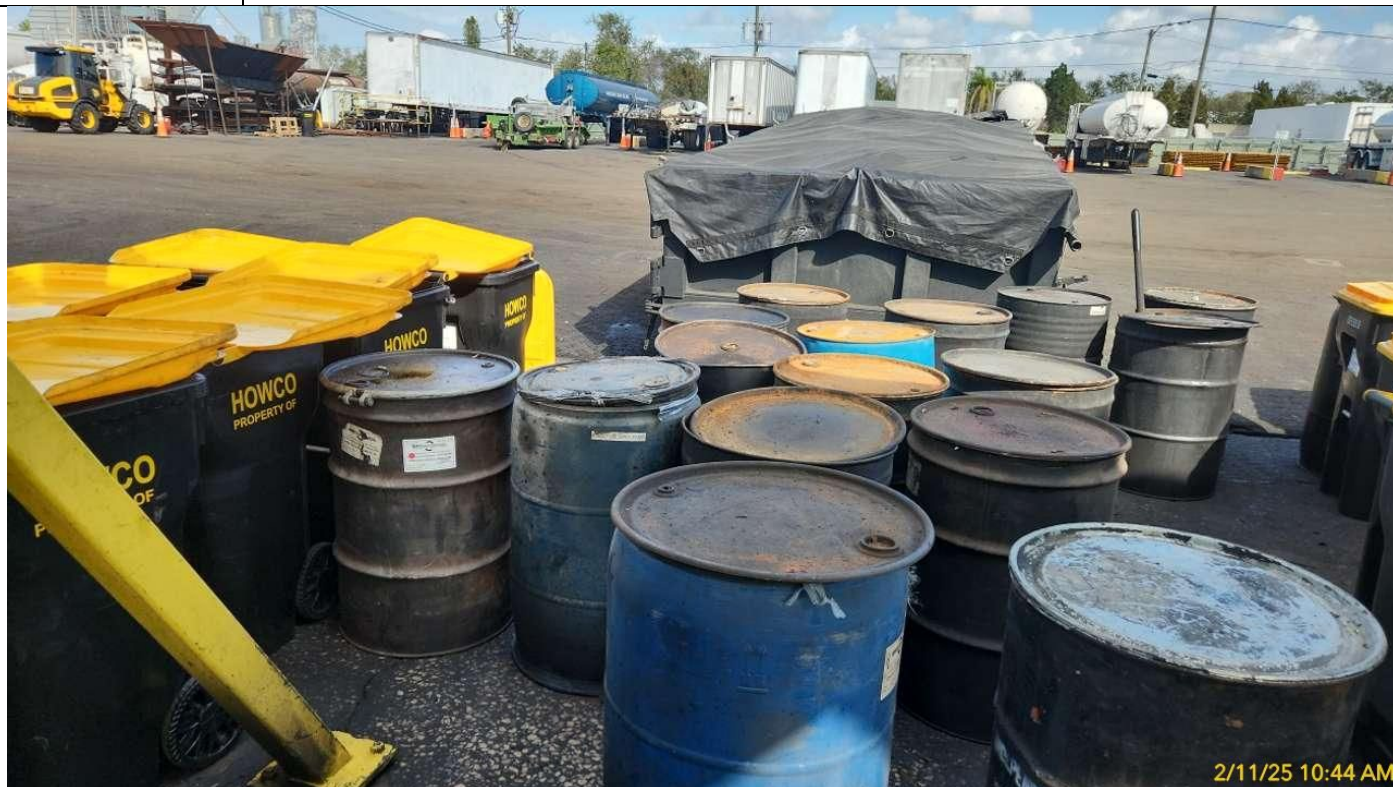
<b>Image #:</b>	13
<b>Photo Description:</b>	Adequate aisle space not present, containers observed open, and numerous drums unlabeled
<b>Photo Location:</b>	27°45'40.5"N 82°41'34.4"W

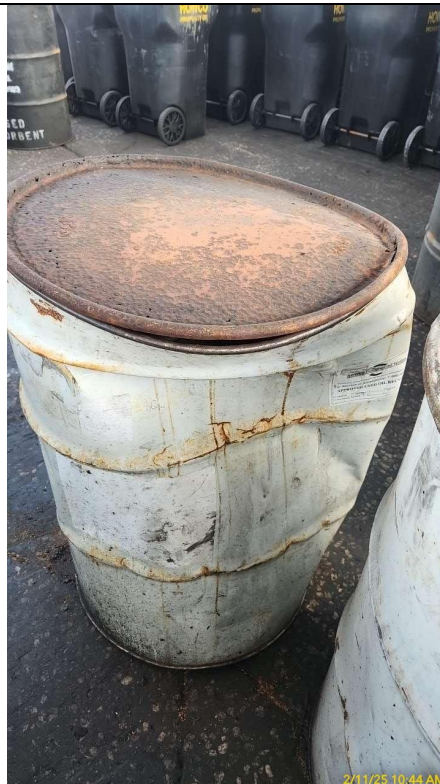
<b>Image #:</b>	14
<b>Photo Description:</b>	Unlabeled 55-gallon drum (open and defective)
<b>Photo Location:</b>	27°45'40.5"N 82°41'34.4"W

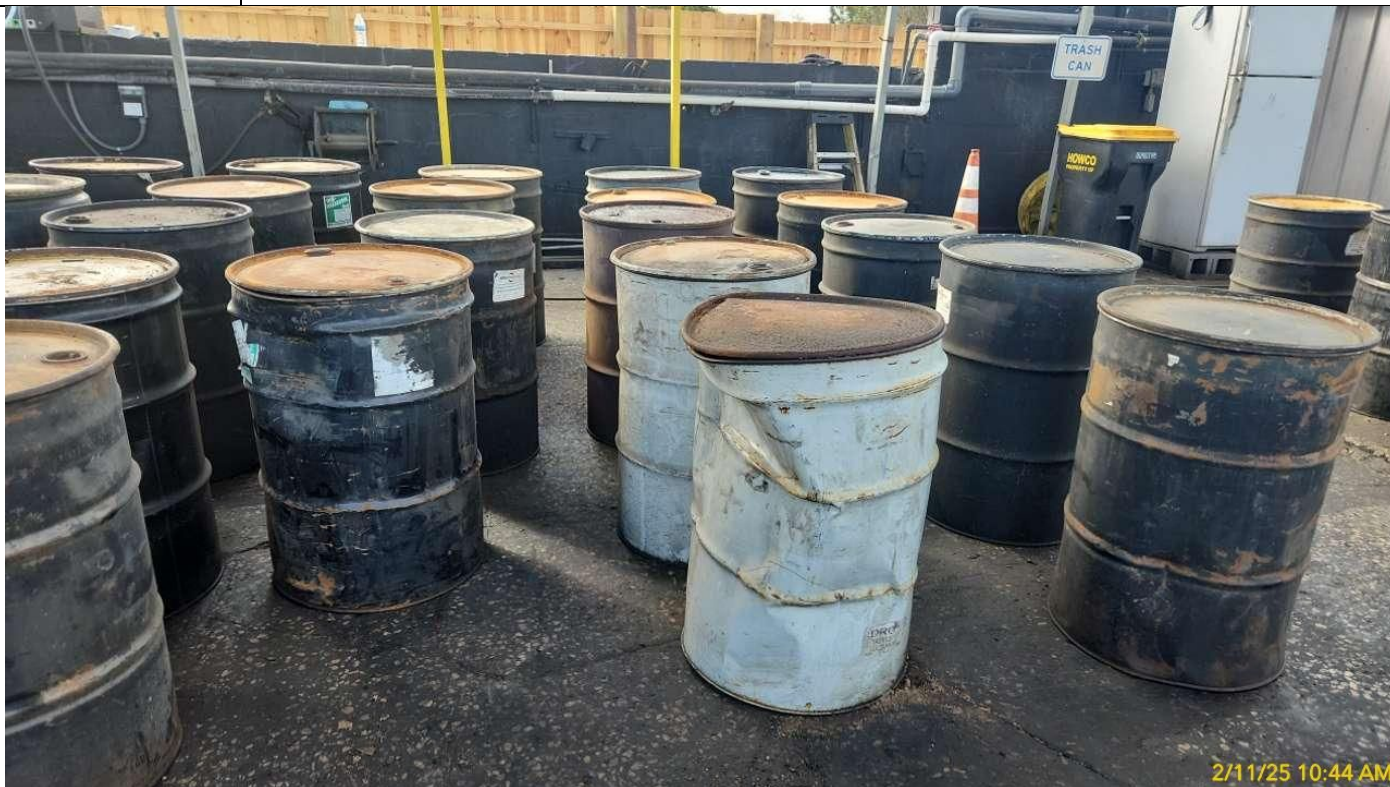
<b>Image #:</b>	15
<b>Photo Description:</b>	Unlabeled 55-gallon drums (some open and defective)
<b>Photo Location:</b>	27°45'40.5"N 82°41'34.4"W

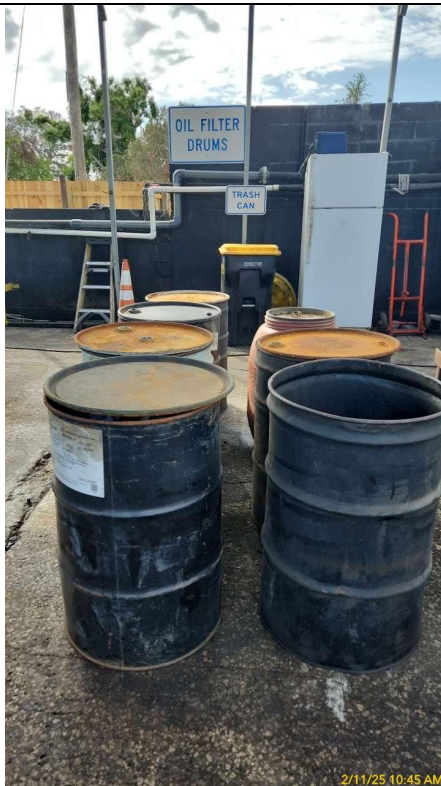
<b>Image #:</b>	16
<b>Photo Description:</b>	Unlabeled, open drums
<b>Photo Location:</b>	27°45'40.4"N 82°41'34.6"W

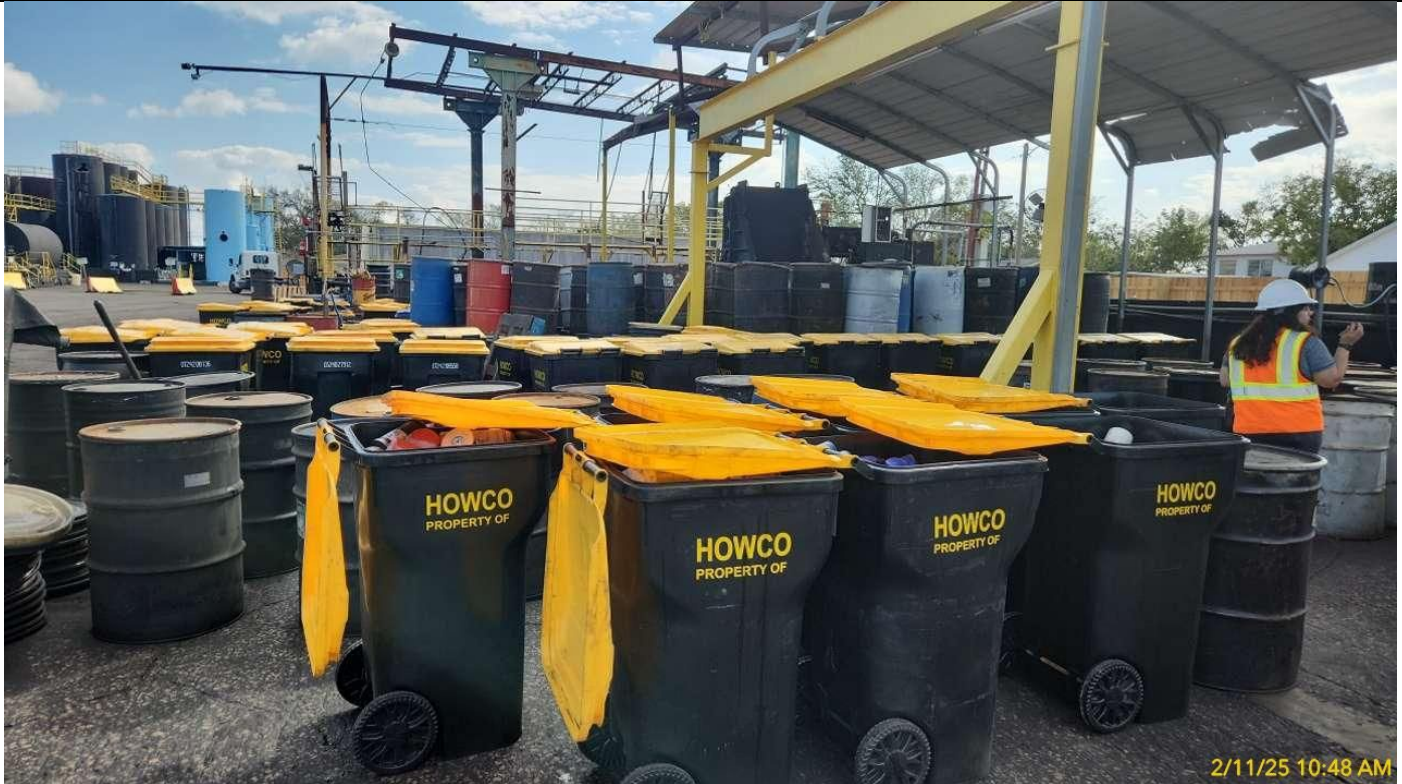
<b>Image #:</b>	17
<b>Photo Description:</b>	Adequate aisle space not present, containers observed open, and numerous drums unlabeled
<b>Photo Location:</b>	27°45'40.6"N 82°41'34.5"W

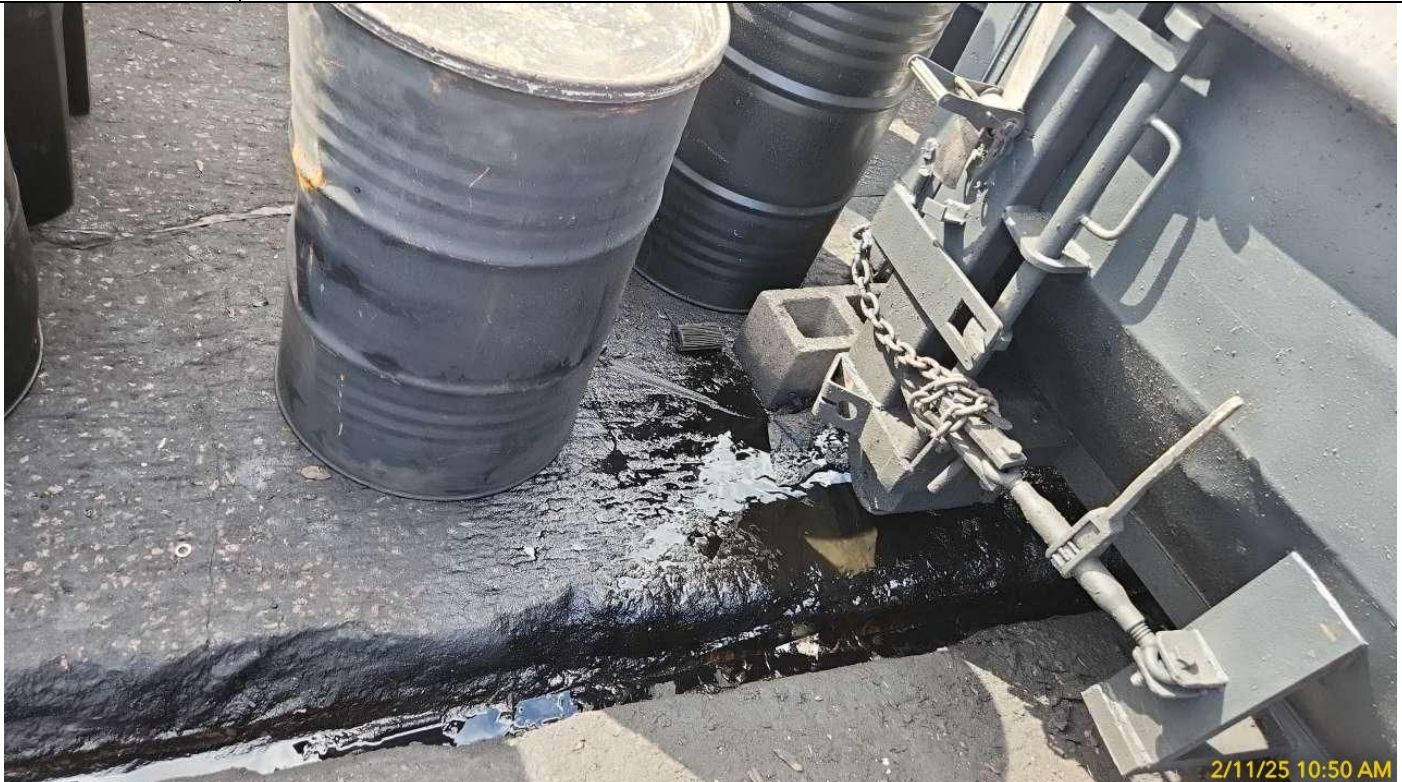
<b>Image #:</b>	18
<b>Photo Description:</b>	Leaking roll-off of used oil filters
<b>Photo Location:</b>	27°45'40.8"N 82°41'34.4"W

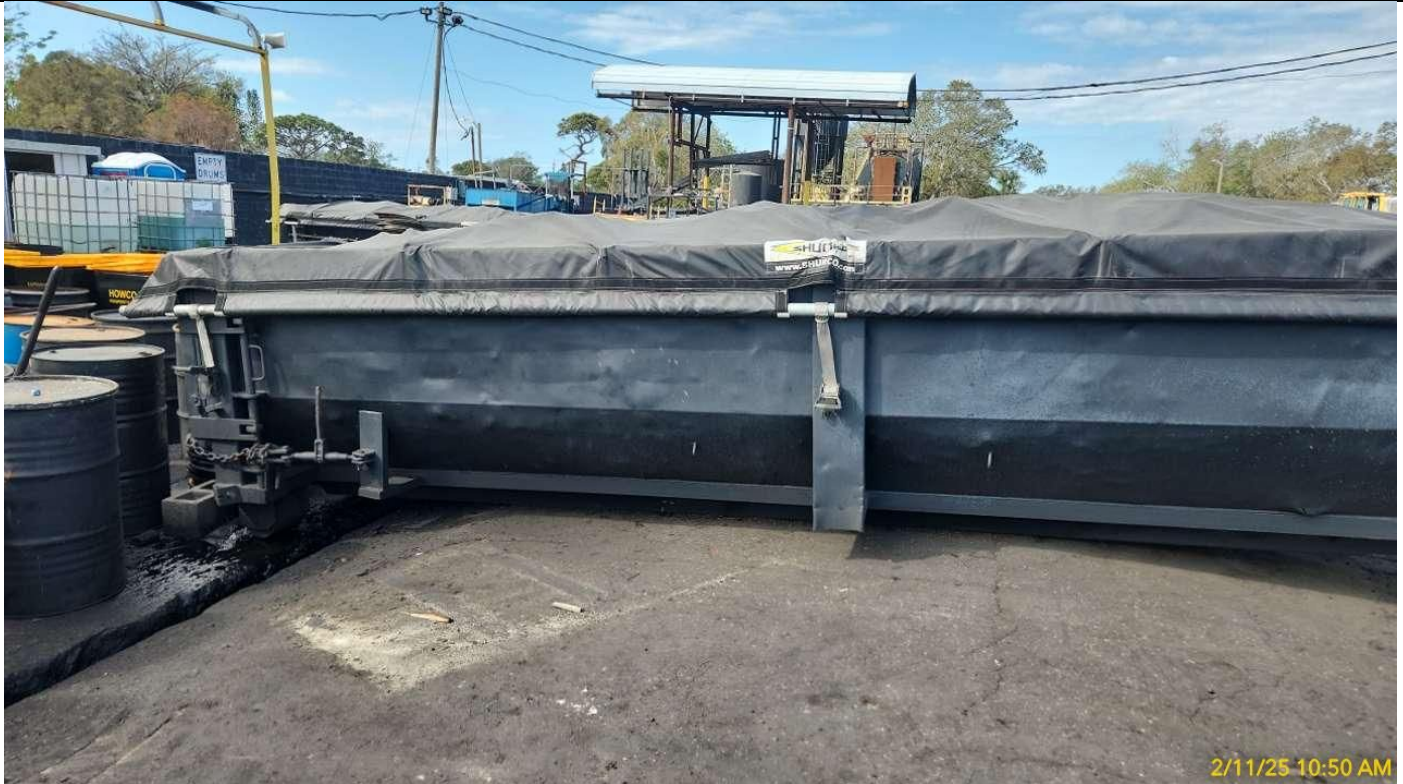
<b>Image #:</b>	19
<b>Photo Description:</b>	Leaking roll-off of used oil filters
<b>Photo Location:</b>	27°45'40.6"N 82°41'34.2"W

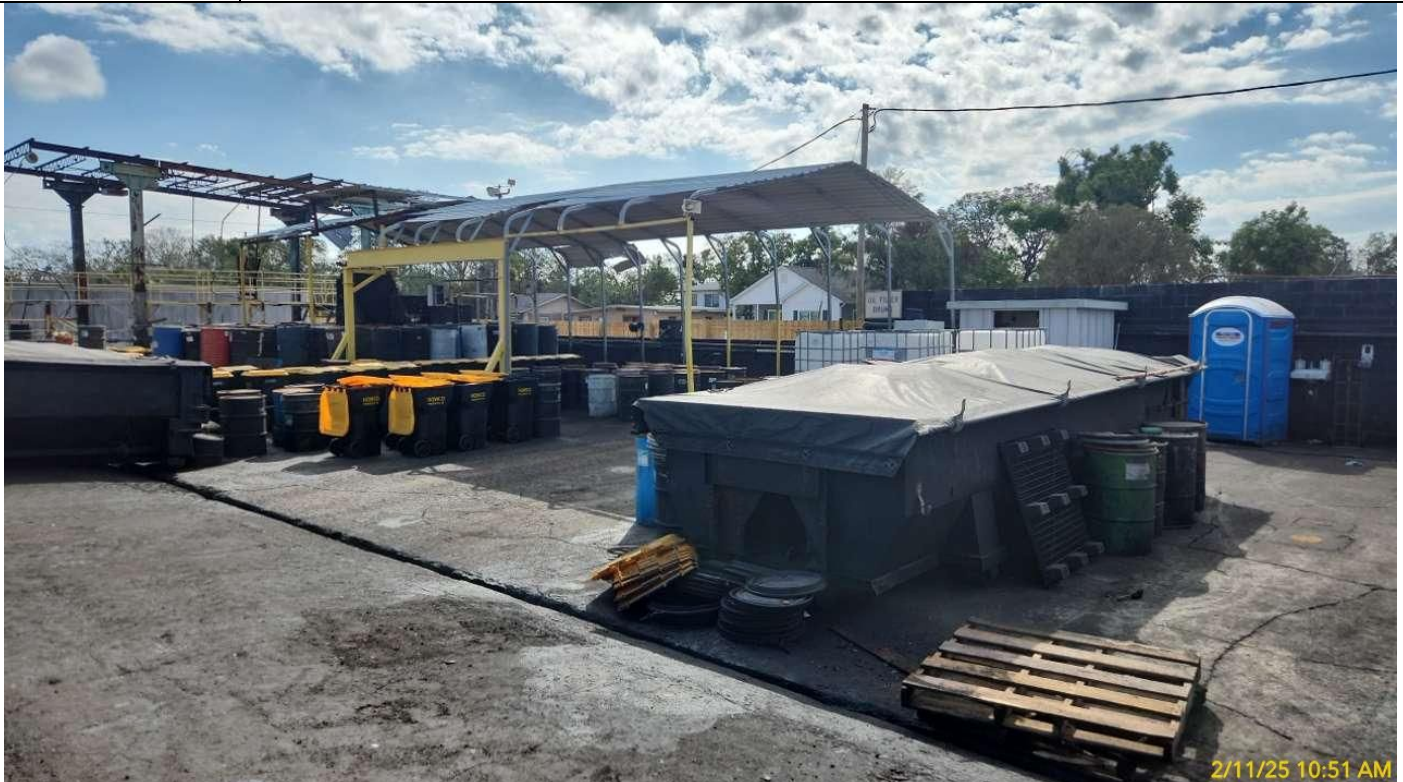
<b>Image #:</b>	20
<b>Photo Description:</b>	Adequate aisle space not present, containers observed open, and numerous drums unlabeled
<b>Photo Location:</b>	27°45'40.7"N 82°41'34.6"W

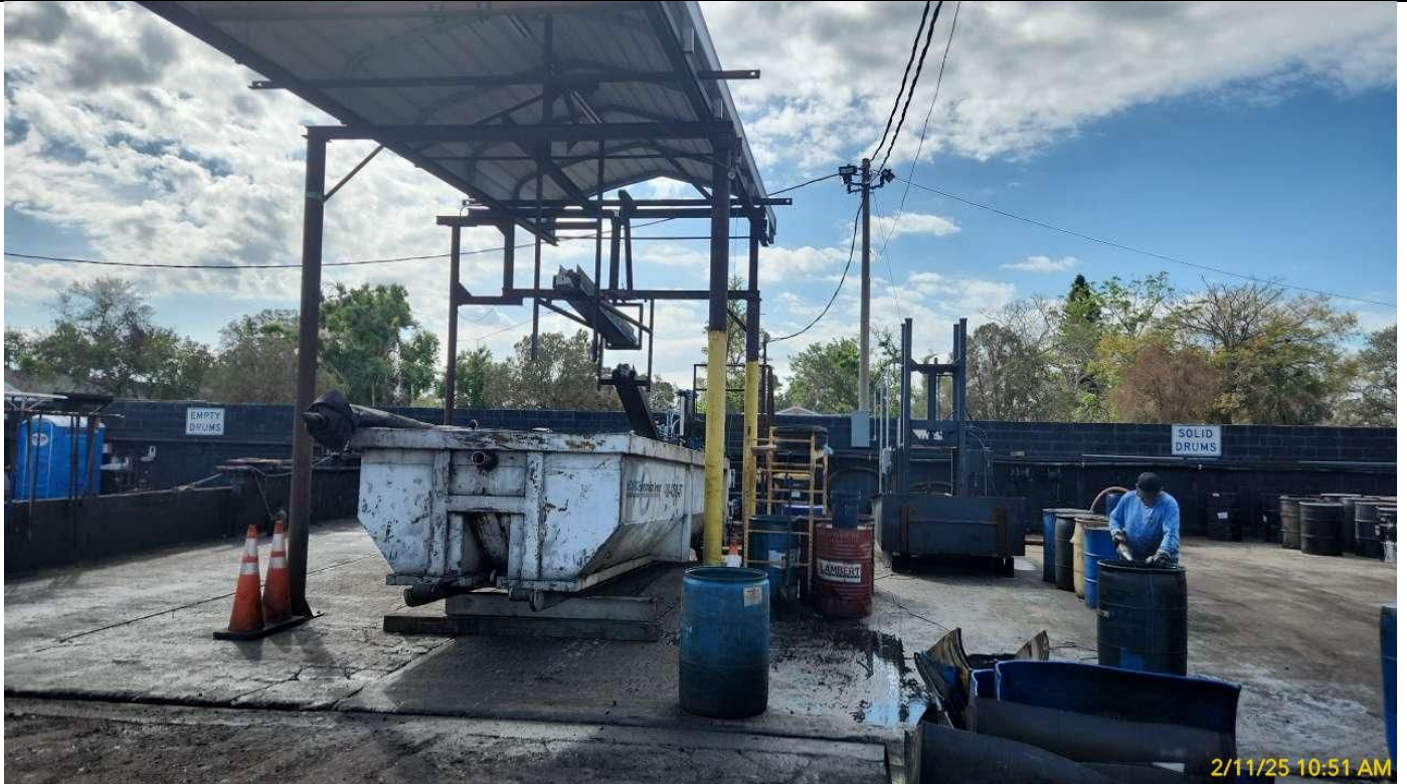
<b>Image #:</b>	21
<b>Photo Description:</b>	Used oil filter crusher and drum disposal area (cracks observed in containment area)
<b>Photo Location:</b>	27°45'40.7"N 82°41'35.4"W

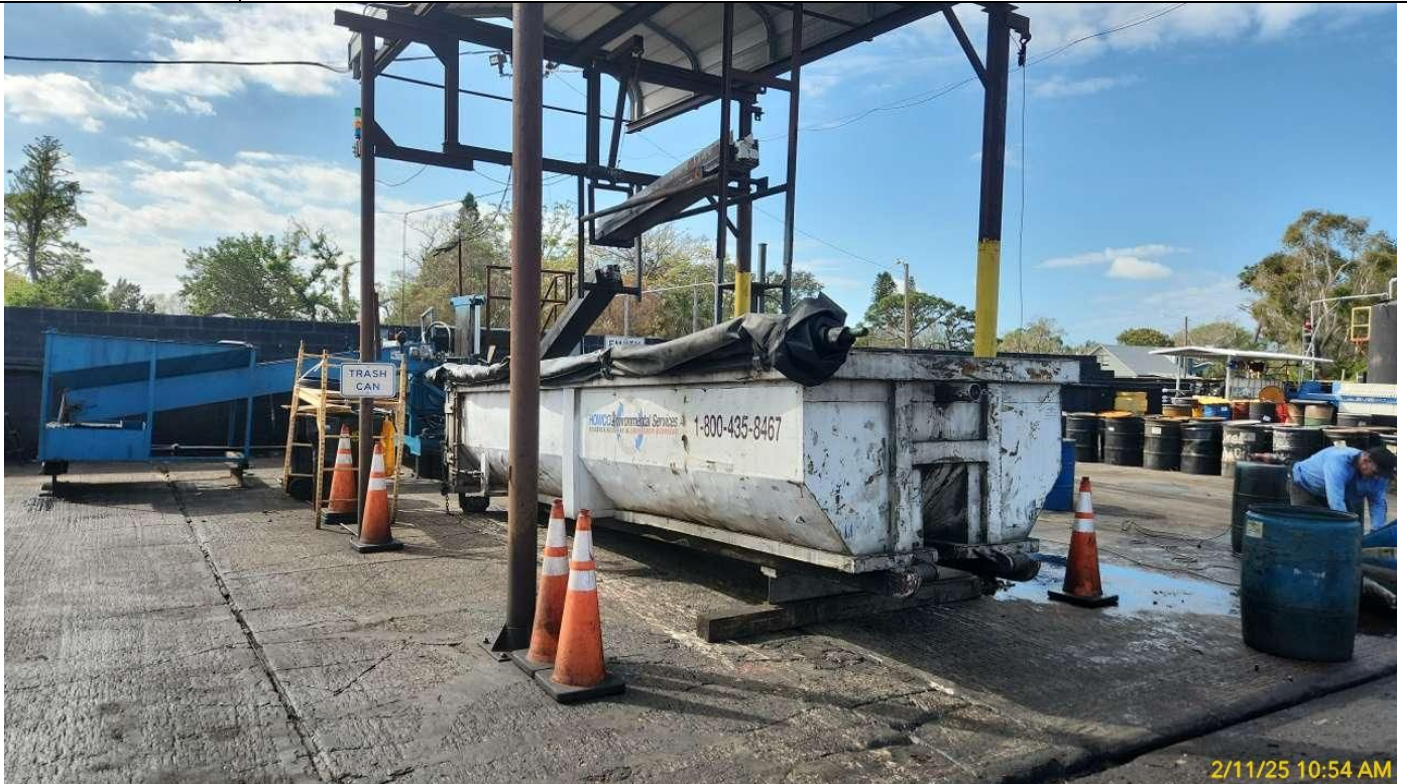
<b>Image #:</b>	22
<b>Photo Description:</b>	Used oil filter crusher and drum disposal area (cracks observed in containment area)
<b>Photo Location:</b>	27°45'40.6"N 82°41'35.0"W

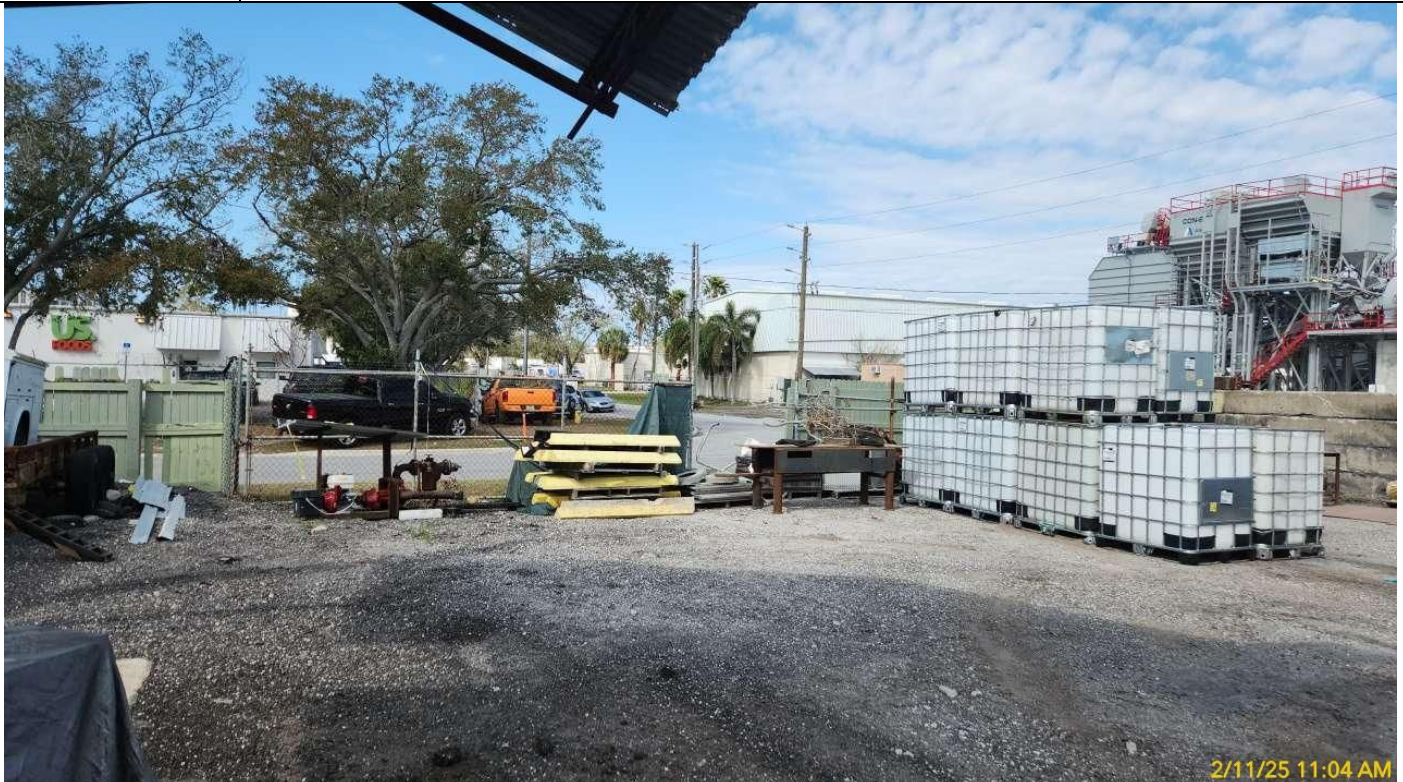
<b>Image #:</b>	26
<b>Photo Description:</b>	Fence down from storm in bone yard/storage lot
<b>Photo Location:</b>	27°45'41.3"N 82°41'36.2"W

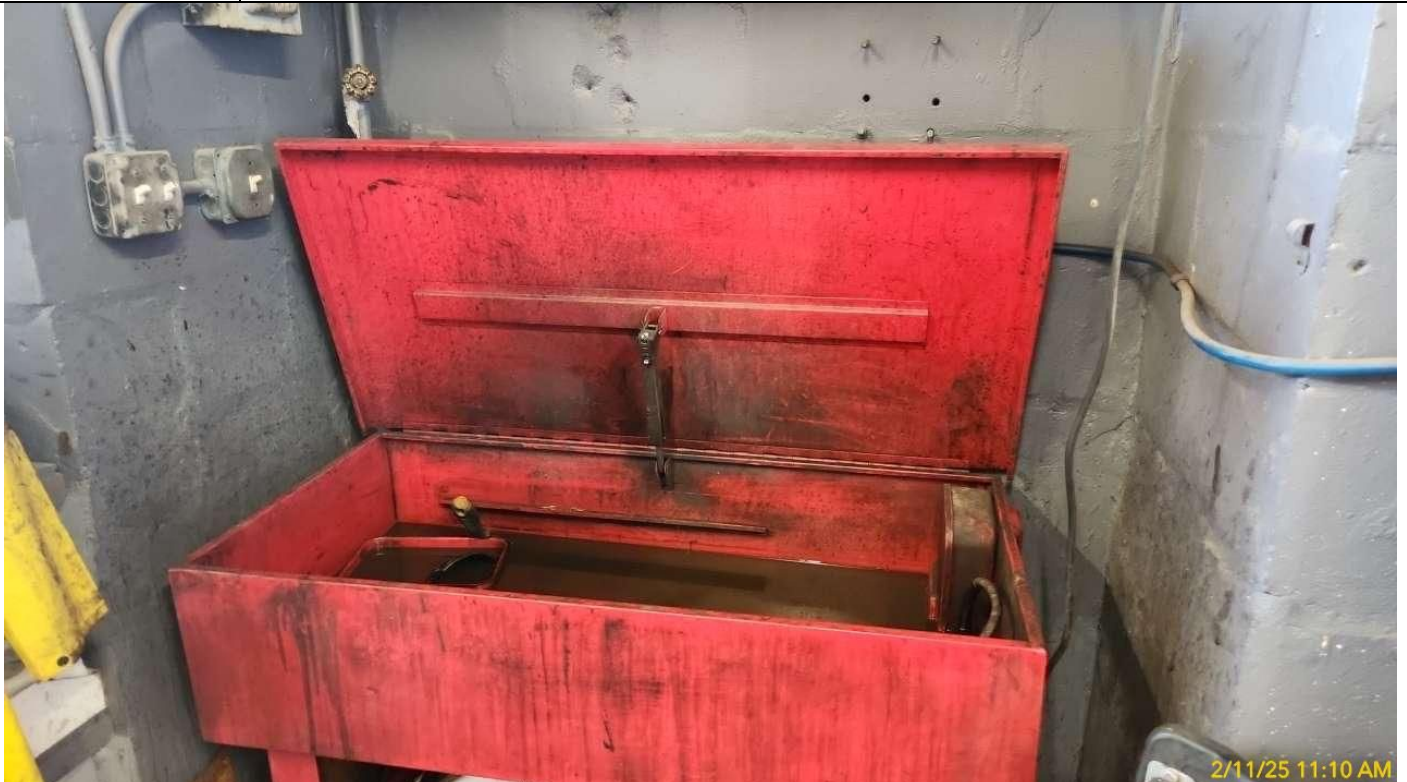
Image #:	28
Photo Description:	Open parts washer
Photo Location:	27°45'43.5"N 82°41'31.8"W

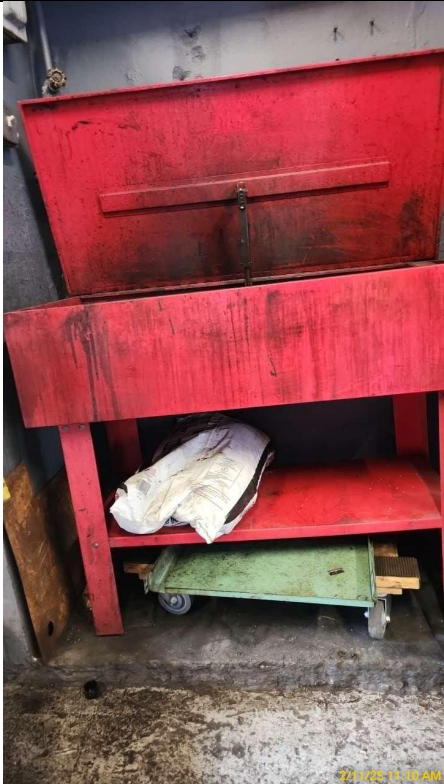
Image #:	29
Photo Description:	Open parts washer
Photo Location:	27°45'43.6"N 82°41'31.8"W

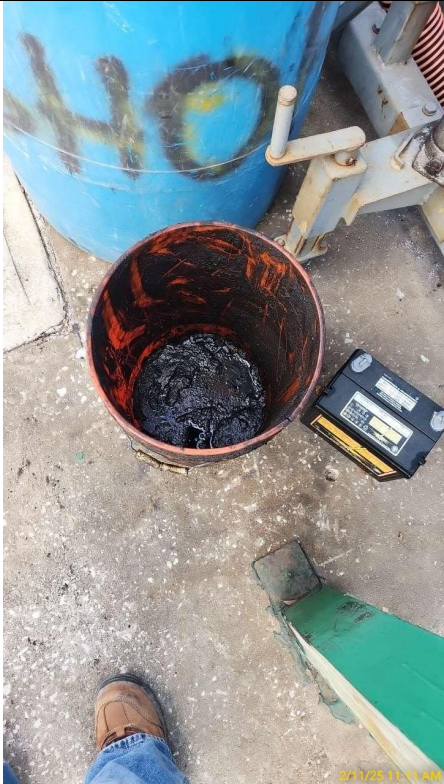
Image #:	30
Photo Description:	Unlabeled 5-gallon bucket of used oil and a spent lead acid battery
Photo Location:	27°45'43.2"N 82°41'31.9"W

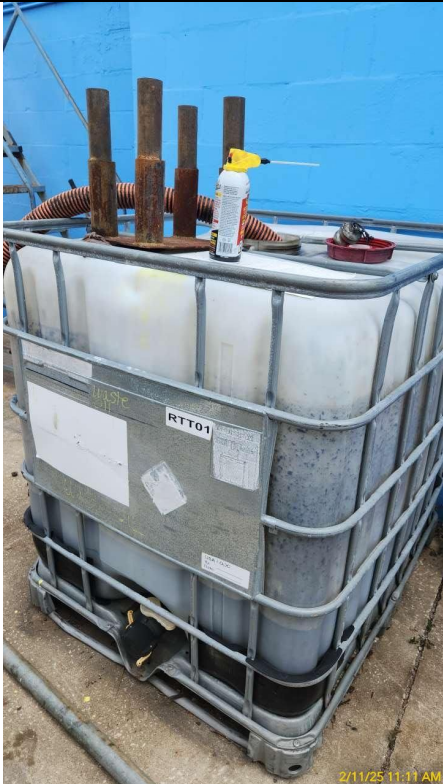
Image #:	32
Photo Description:	Unlabeled 250-gallon tote of used oil not provided with secondary containment
Photo Location:	27°45'43.5"N 82°41'32.0"W

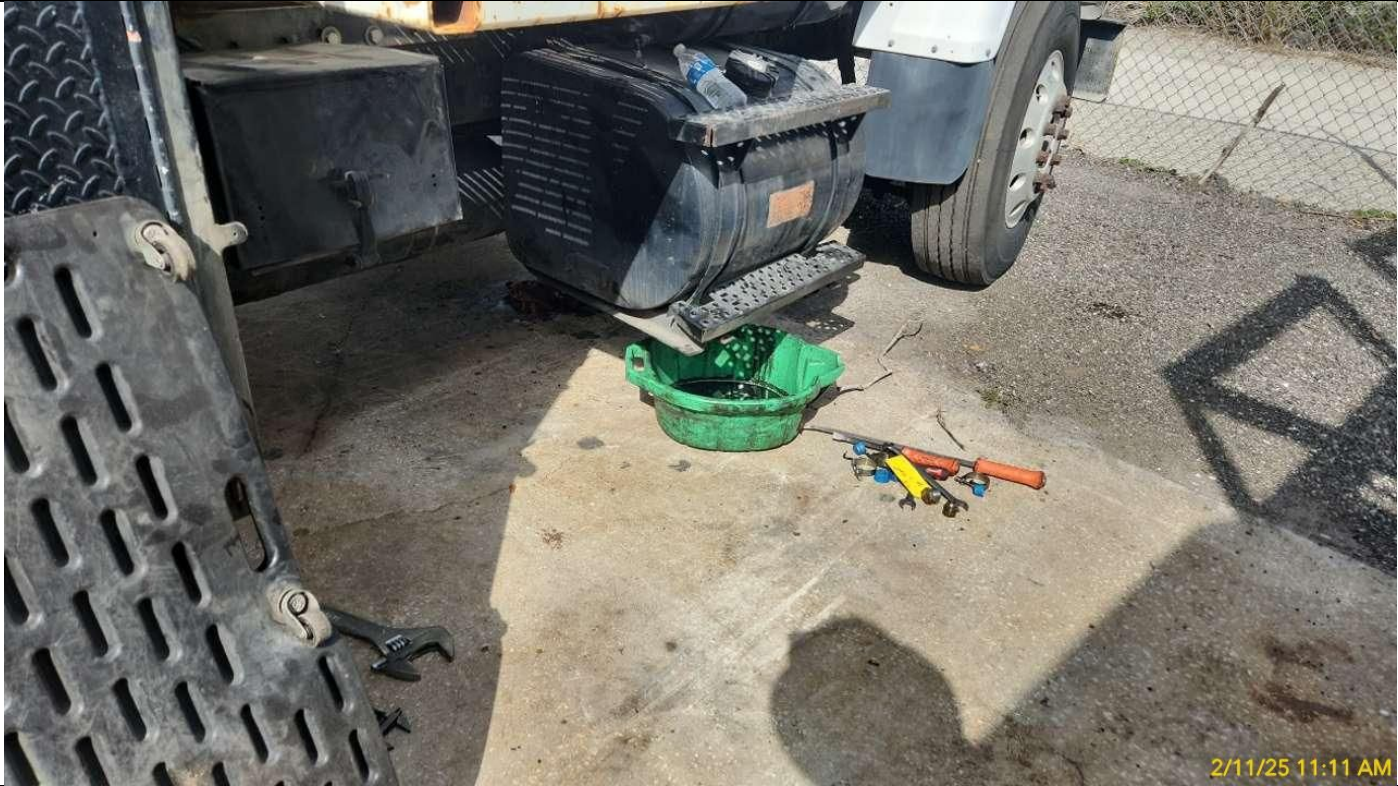
Image #:	33
Photo Description:	Unlabeled used oil drain pan
Photo Location:	27°45'43.5"N 82°41'32.2"W

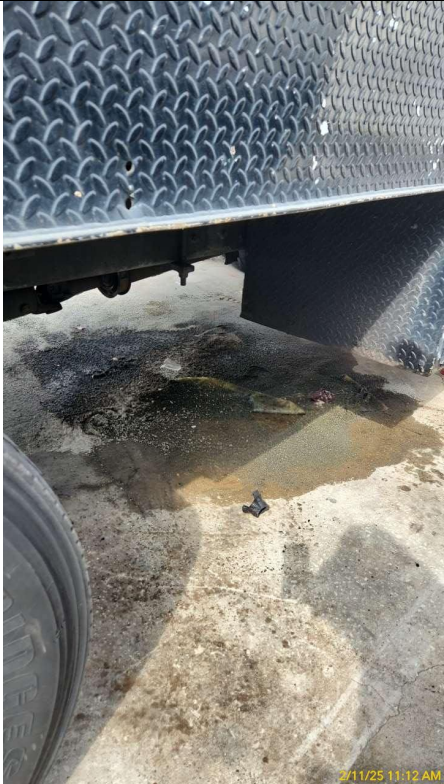
Image #:	34
Photo Description:	Spill observed addressed with absorbents
Photo Location:	27°45'43.5"N 82°41'32.2"W

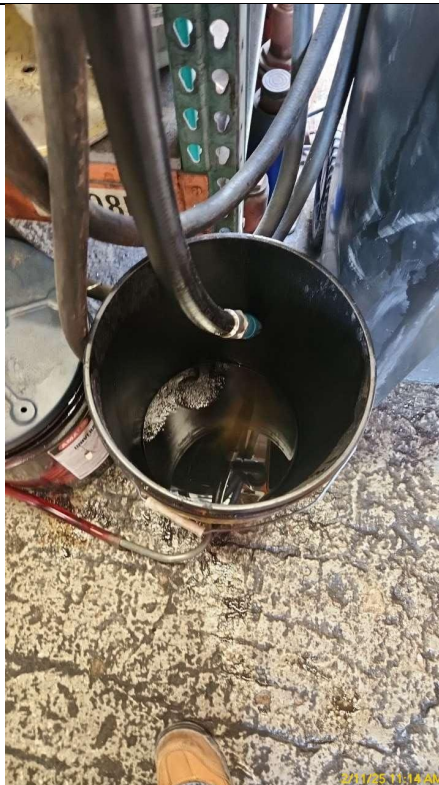
<b>Image #:</b>	35
<b>Photo Description:</b>	Unlabeled 5-gallon bucket
<b>Photo Location:</b>	27°45'43.4"N 82°41'32.3"W
