Re: Warning Letter # WL25-33HW52SWD  
Hagan Holding Company dba HOWCO Environmental Services  
Facility ID No. FLD152764767  
Pinellas County

## Site Report

**Address:**  
**File #:**  
**Project Name:** Hagan Holding Company dba HOWCO Environmental Services (FLD152764767)  
Operating Permit Numbers: 33721-006-HO; 33721-007-SO  
**Inspection Date:** February 11, 2025  
**Inspectors:** Coral Evans.

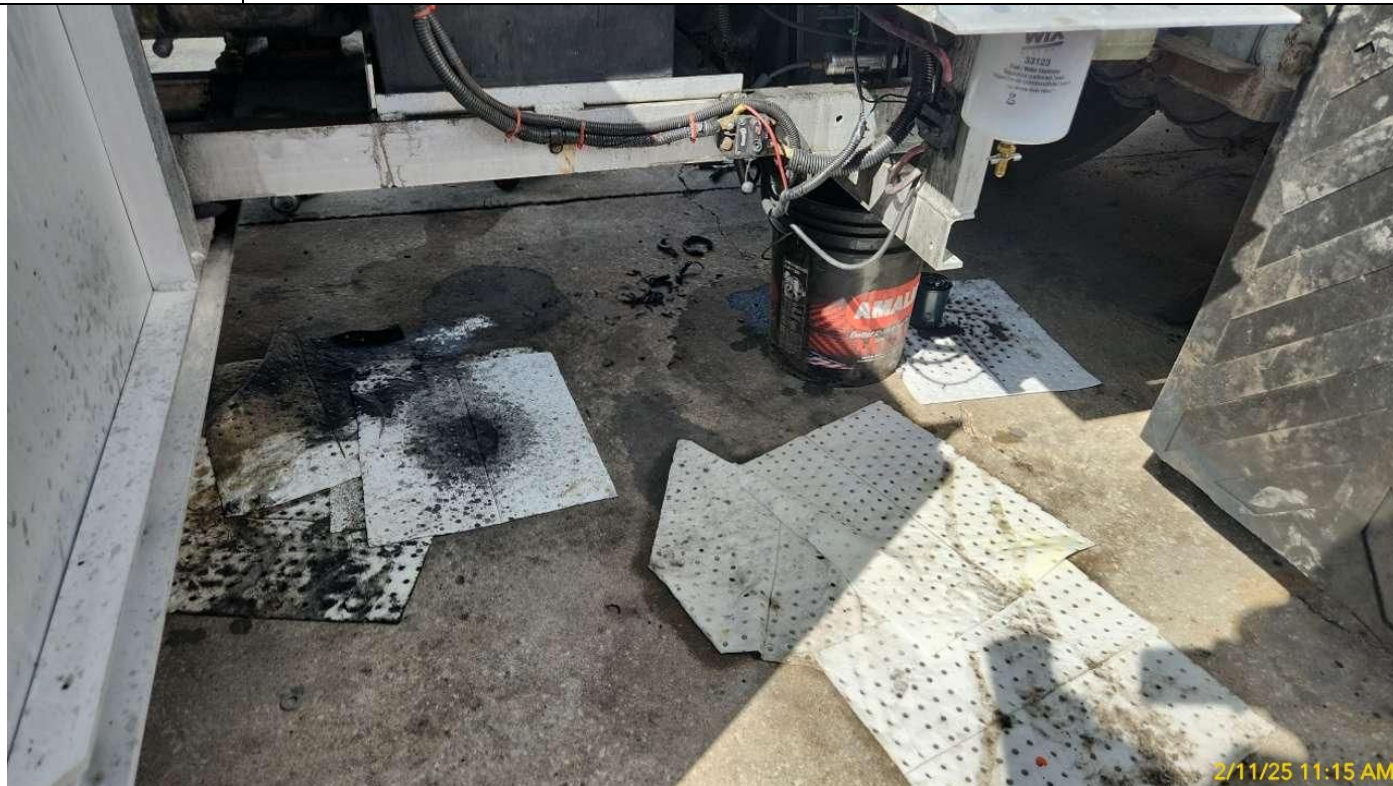
<b>Image #:</b>	36
<b>Photo Description:</b>	Spill observed addressed with absorbents, unlabeled 5-gallon bucket
<b>Photo Location:</b>	27°45'43.6"N 82°41'32.1"W

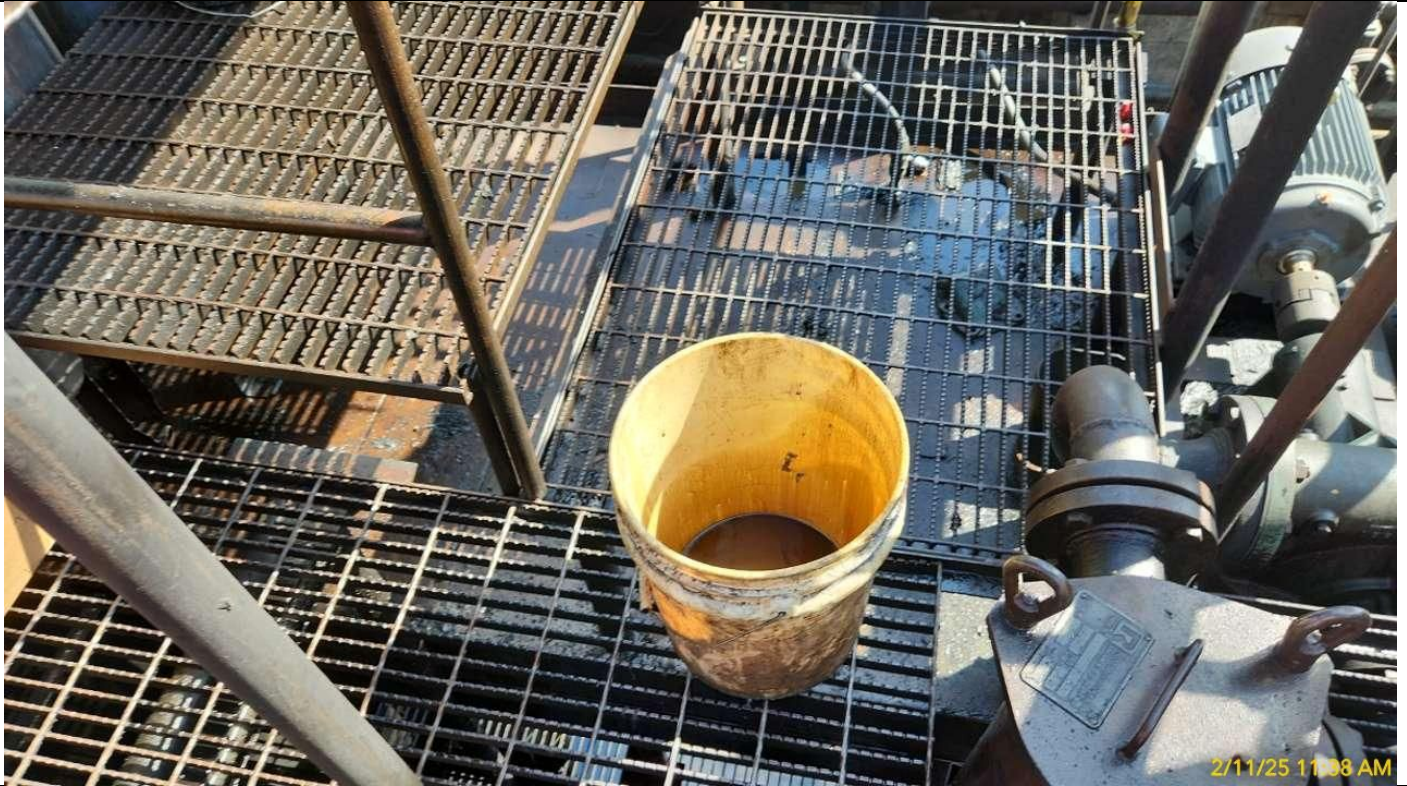
Image #:	41
Photo Description:	Unlabeled 5-gallon bucket
Photo Location:	27°45'41.4"N 82°41'31.8"W

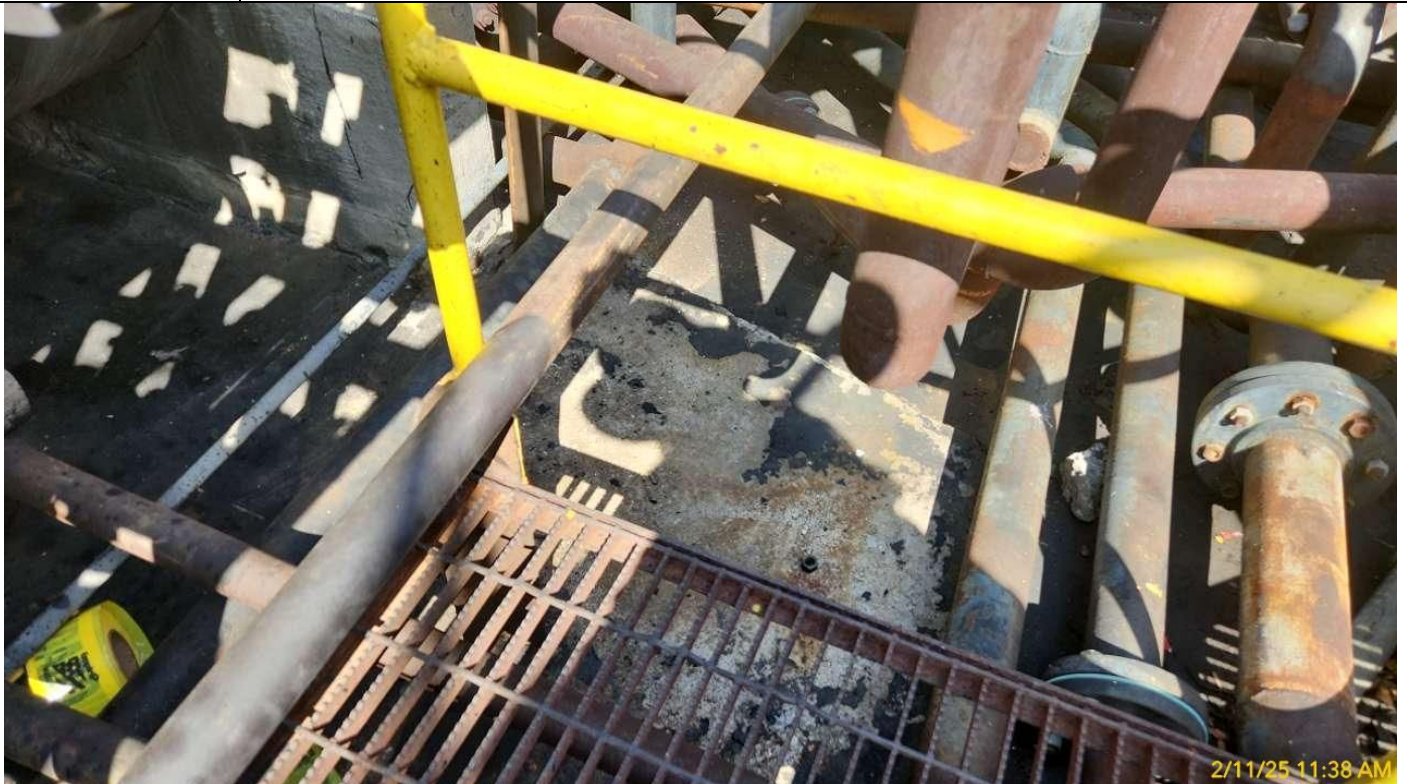
Image #:	42
Photo Description:	Exposed concrete in the secondary containment area of the used oil processing plant
Photo Location:	27°45'41.3"N 82°41'32.0"W

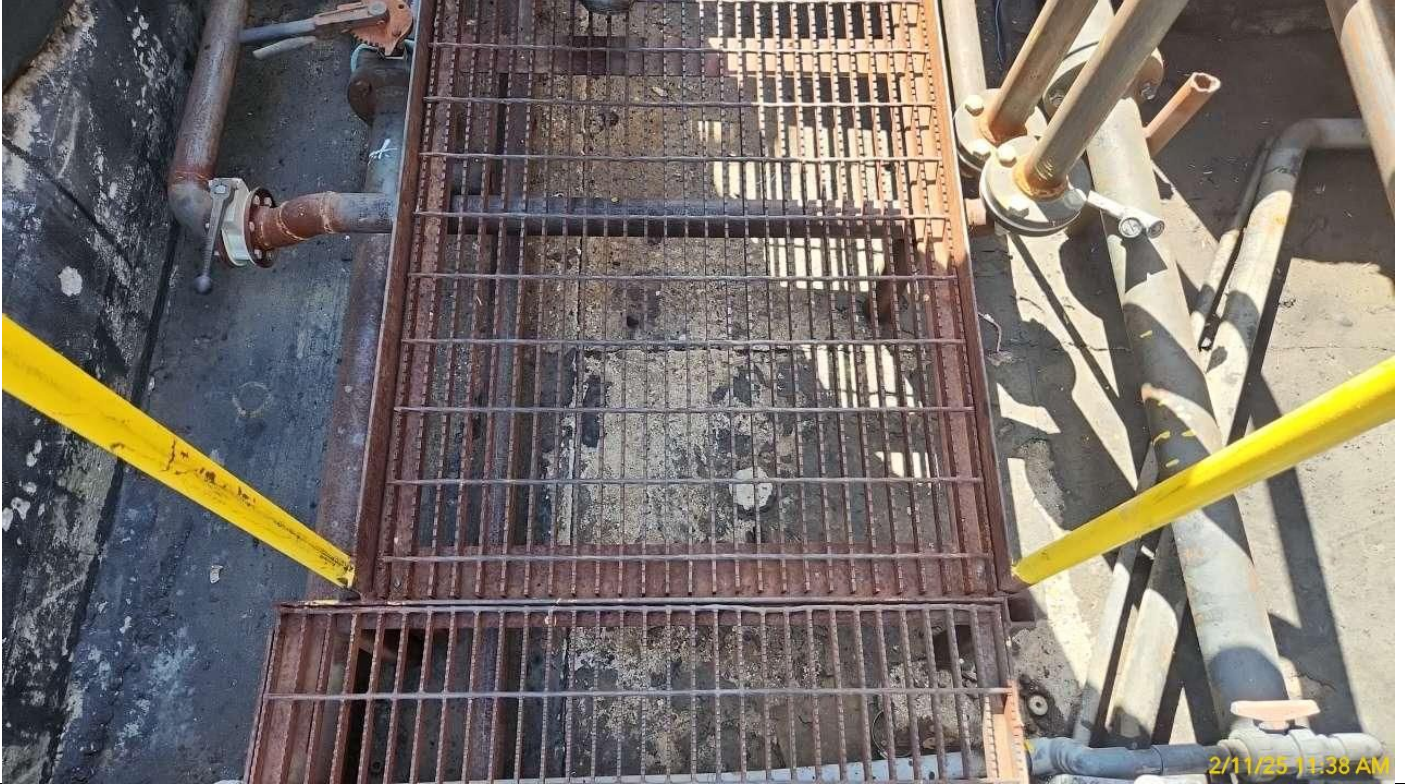
<b>Image #:</b>	43
<b>Photo Description:</b>	Exposed concrete in the secondary containment area of the used oil processing plant
<b>Photo Location:</b>	27°45'41.3"N 82°41'32.0"W

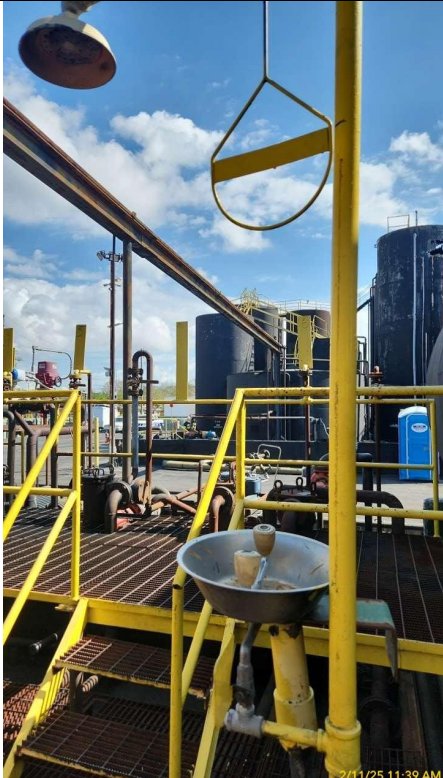
<b>Image #:</b>	44
<b>Photo Description:</b>	Eye wash station not properly functioning in the used oil processing plant
<b>Photo Location:</b>	27°45'41.3"N 82°41'32.0"W

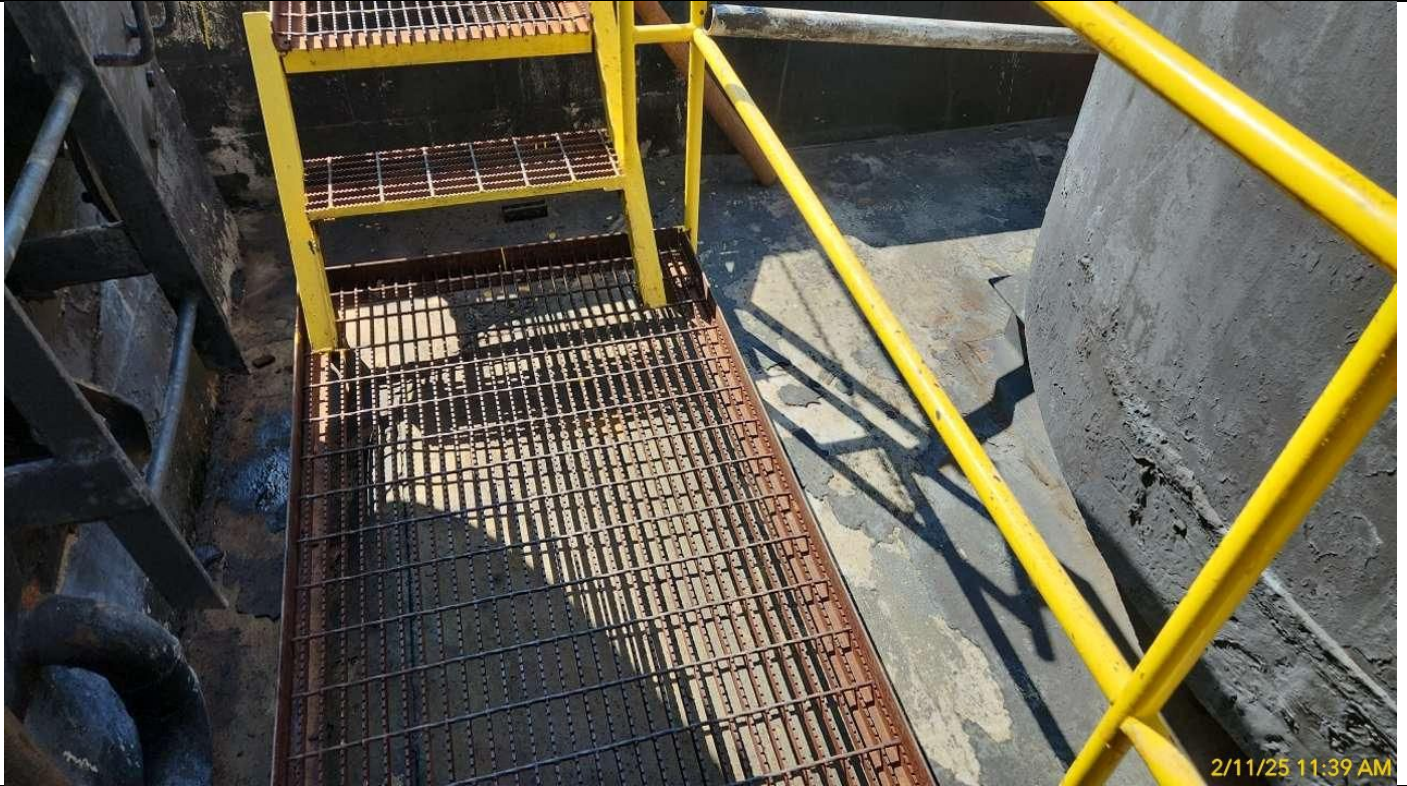
Image #:	47
Photo Description:	Exposed concrete in the secondary containment area of the used oil processing plant
Photo Location:	27°45'41.1"N 82°41'32.0"W

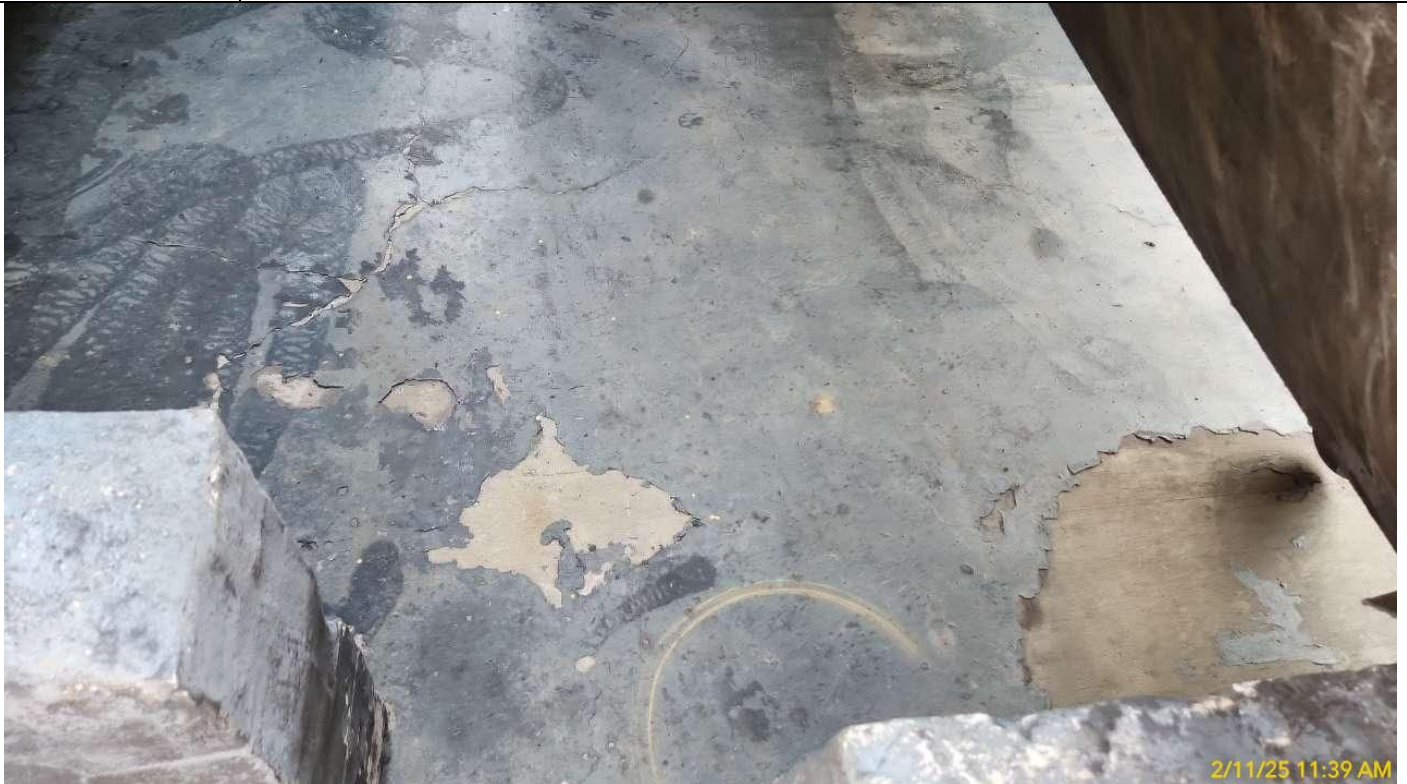
Image #:	48
Photo Description:	Exposed concrete in the secondary containment area of the used oil processing plant
Photo Location:	27°45'41.1"N 82°41'32.0"W

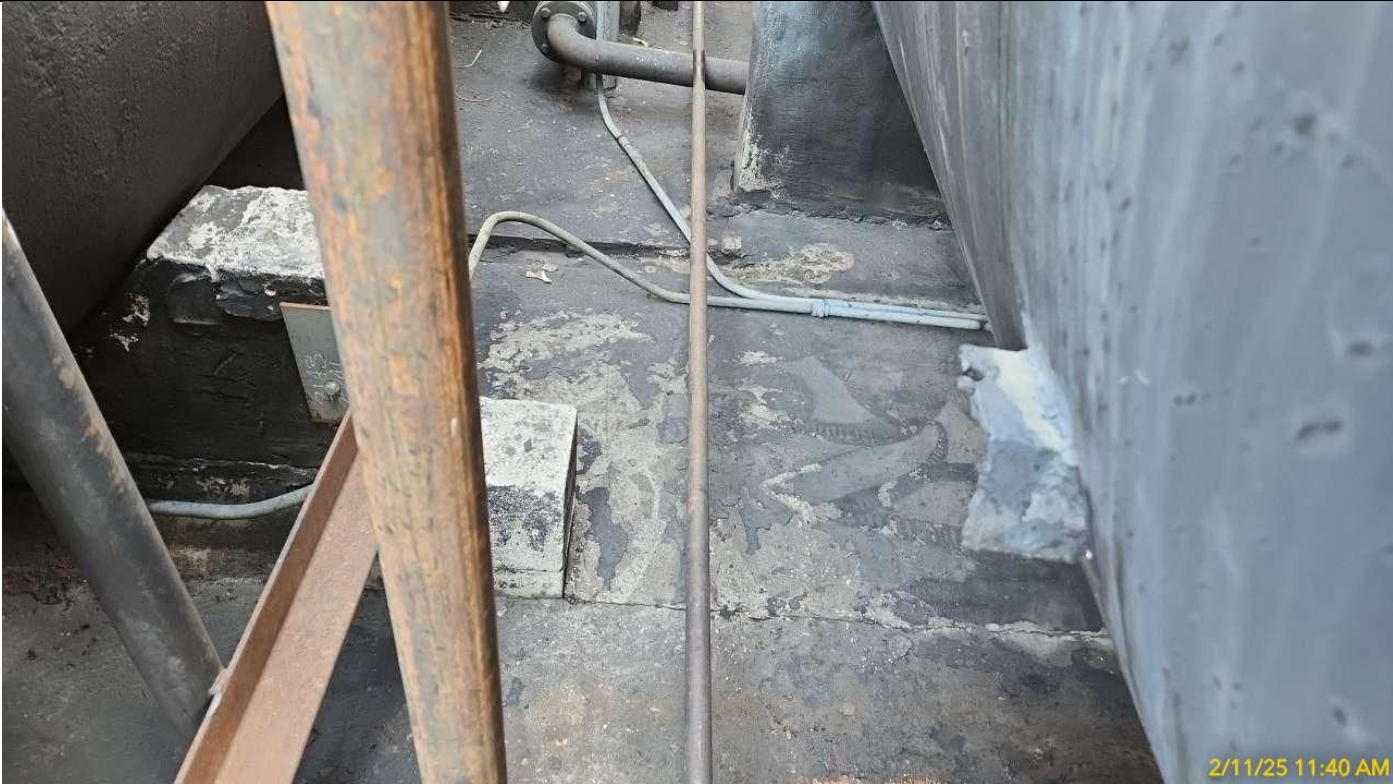
Image #:	49
Photo Description:	Exposed concrete in the secondary containment area of the used oil processing plant
Photo Location:	27°45'41.1"N 82°41'32.0"W

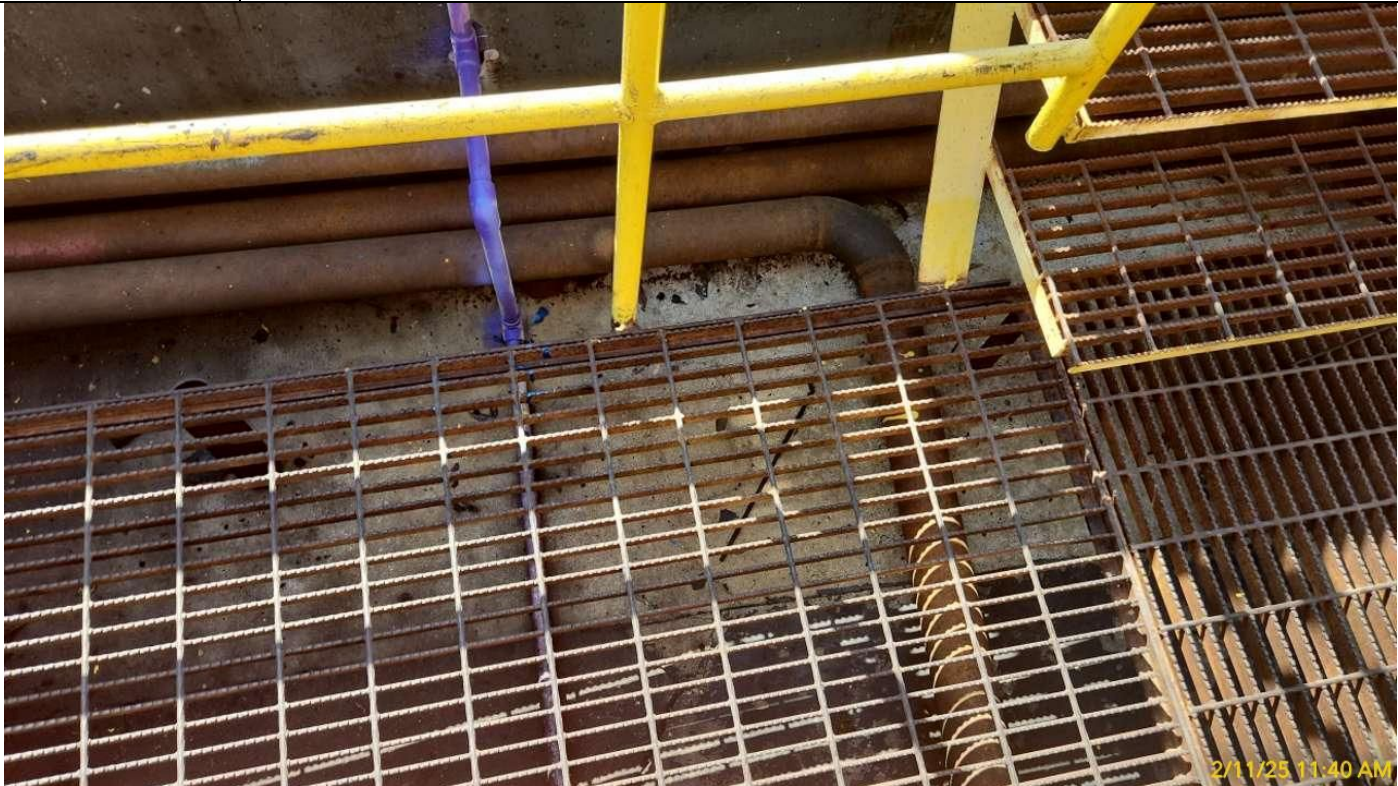
Image #:	52
Photo Description:	Exposed concrete in the secondary containment area of the used oil processing plant
Photo Location:	27°45'41.2"N 82°41'32.7"W

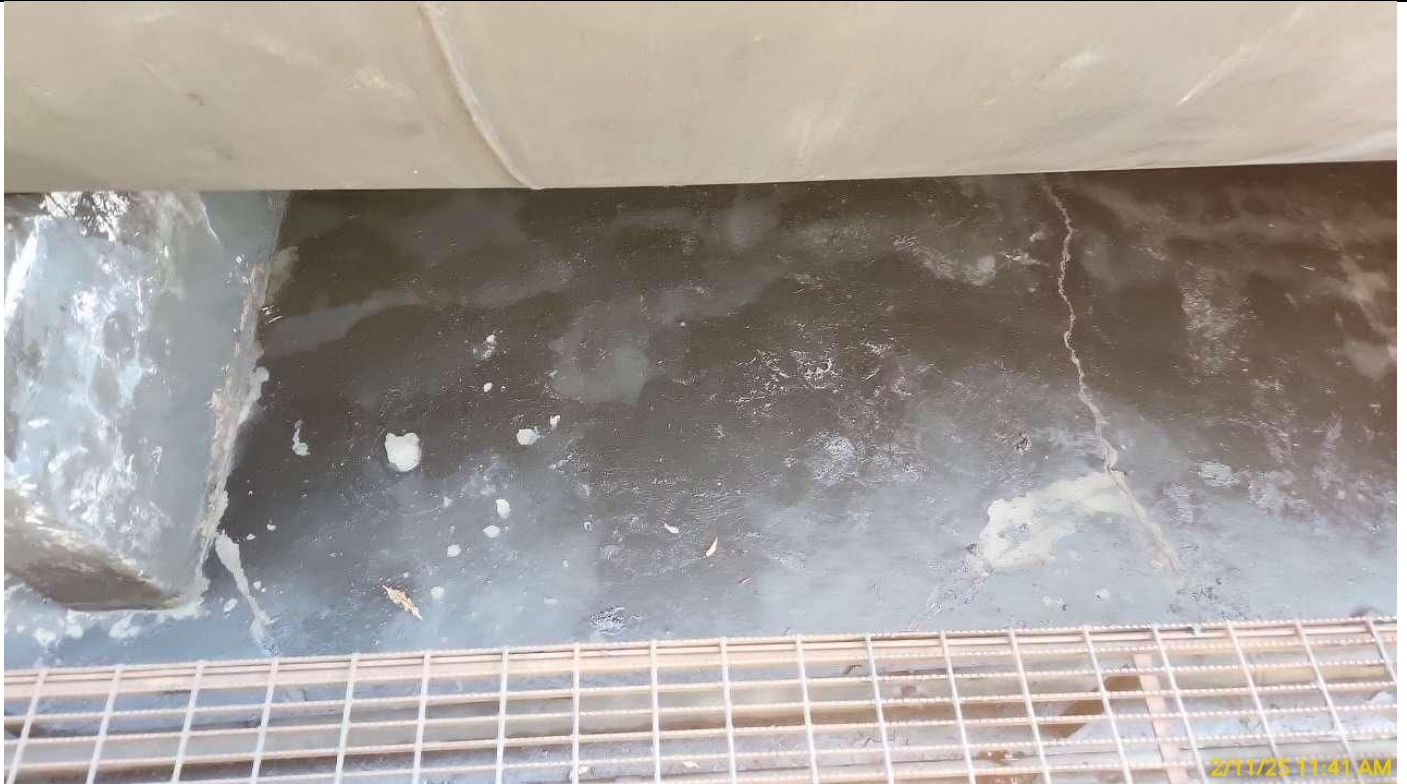
Image #:	53
Photo Description:	Exposed concrete and cracks in the secondary containment area of the used oil processing plant
Photo Location:	27°45'41.2"N 82°41'32.5"W

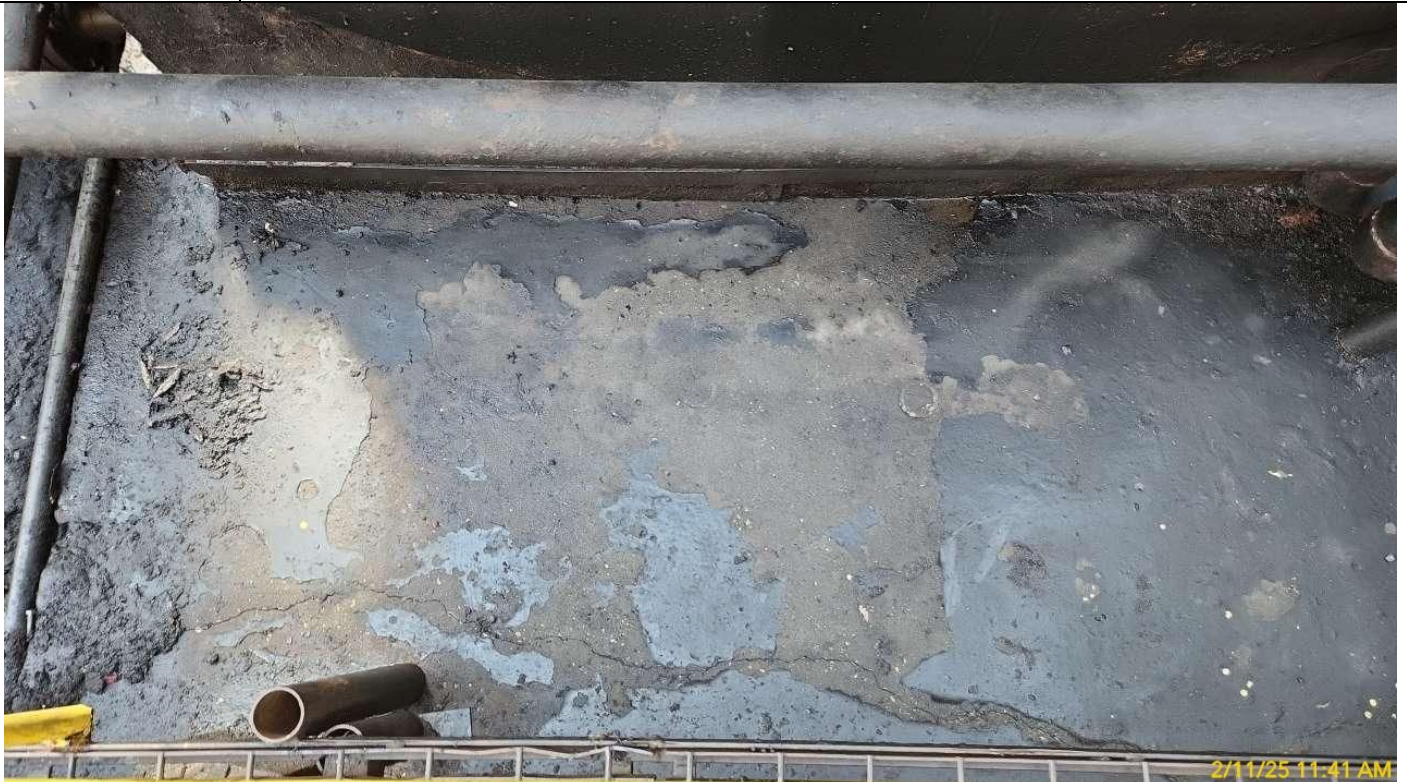
Image #:	54
Photo Description:	Exposed concrete and cracks in the secondary containment area of the used oil processing plant
Photo Location:	27°45'41.3"N 82°41'32.5"W

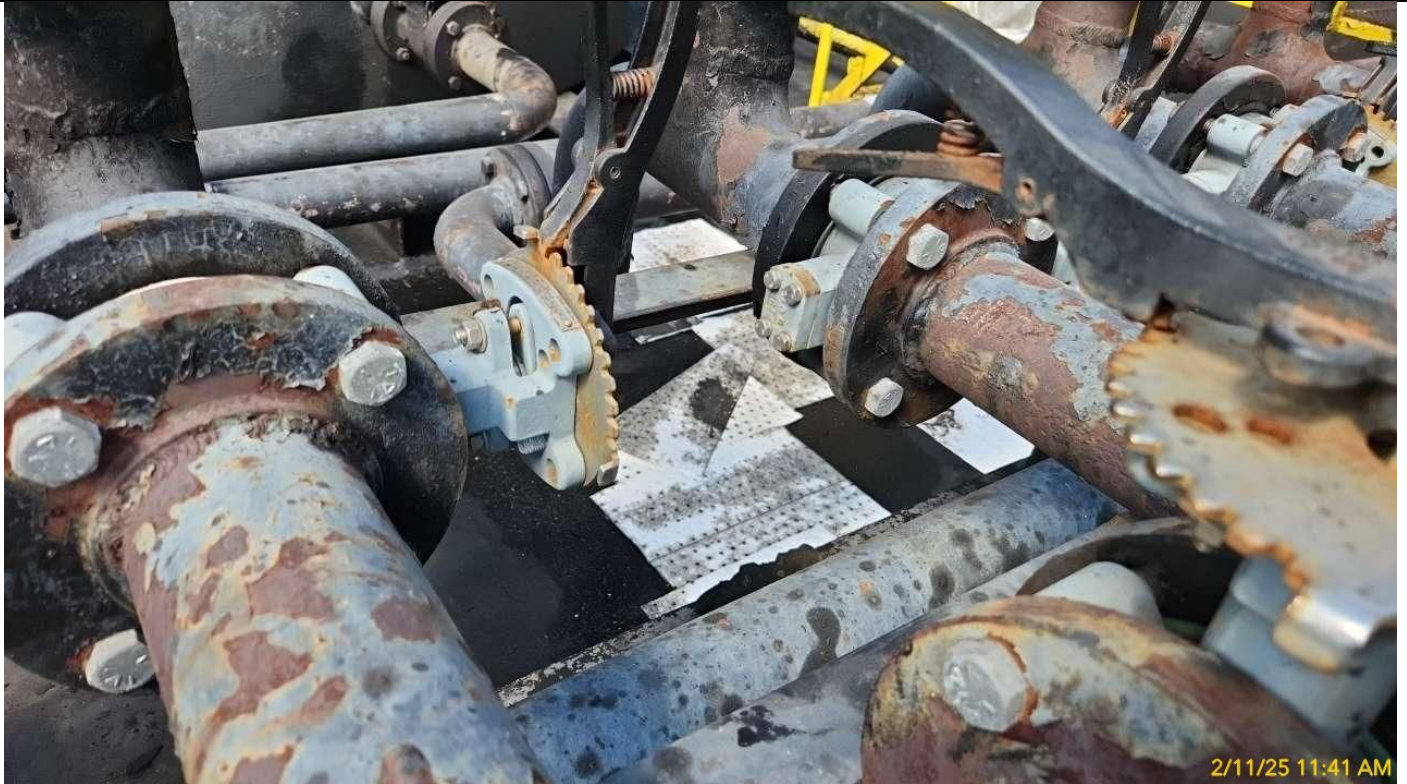
Image #:	55
Photo Description:	Absorbent material the secondary containment area of the used oil processing plant
Photo Location:	27°45'41.5"N 82°41'32.5"W

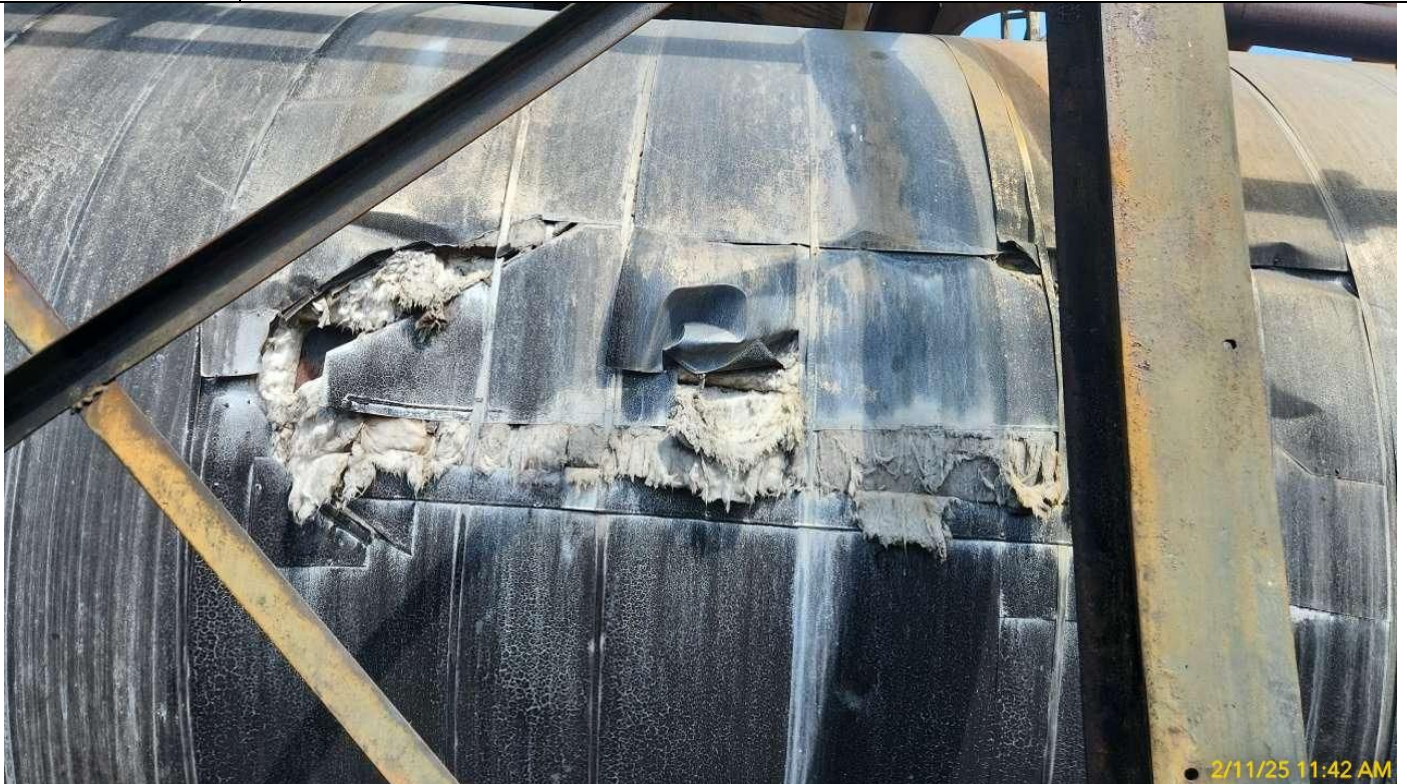
Image #:	56
Photo Description:	Tear observed
Photo Location:	27°45'41.3"N 82°41'32.3"W

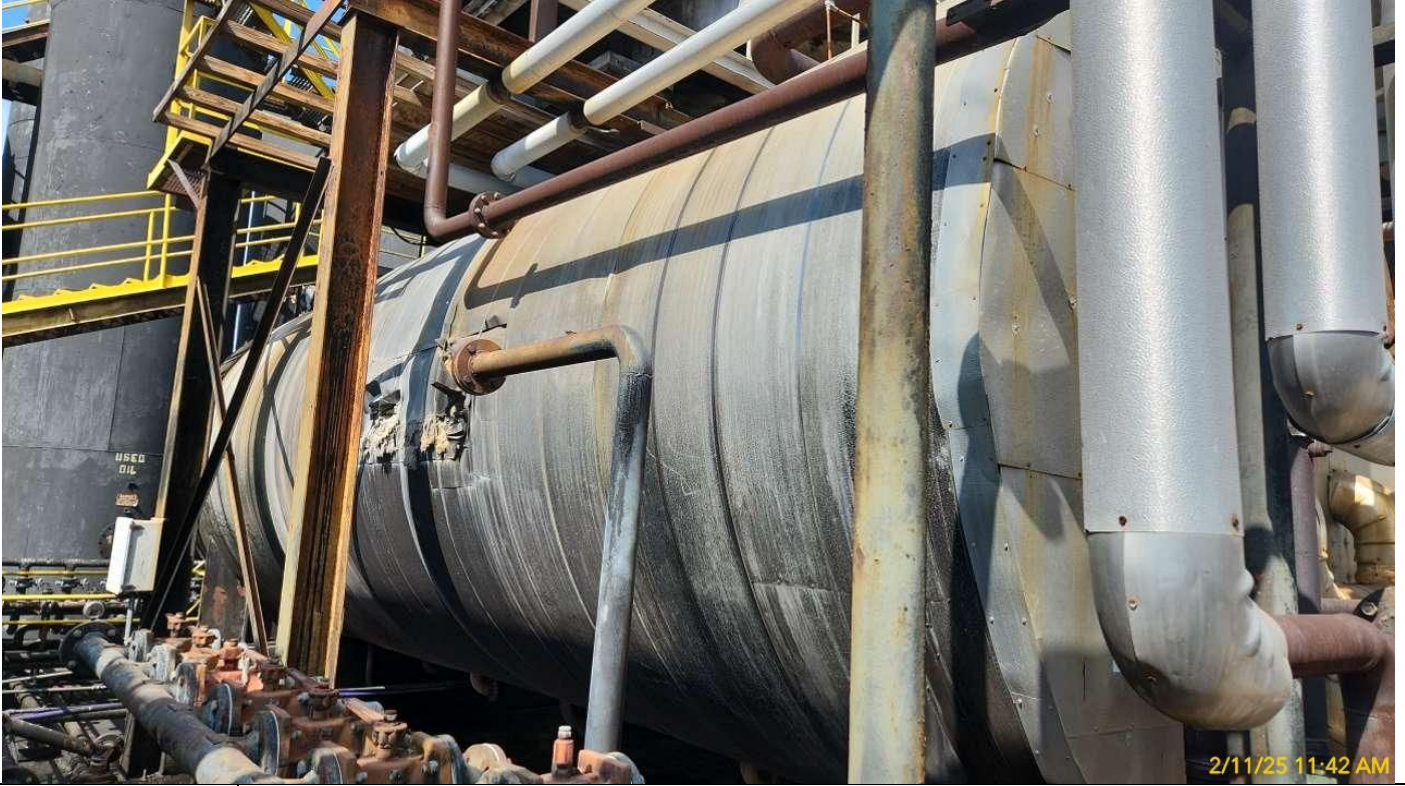
<b>Image #:</b>	57
<b>Photo Description:</b>	Tear observed
<b>Photo Location:</b>	27°45'41.3"N 82°41'32.2"W

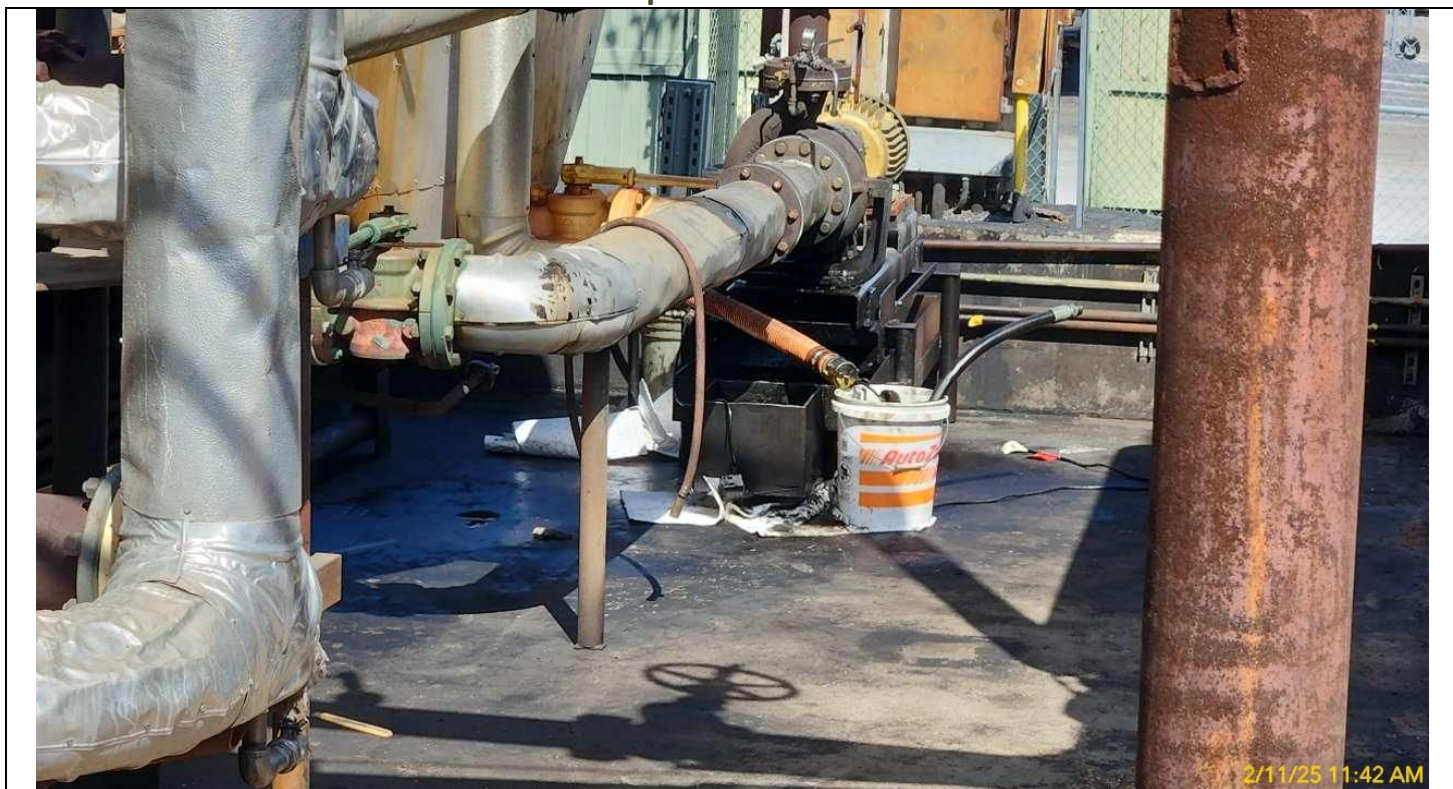
<b>Image #:</b>	58
<b>Photo Description:</b>	Exposed concrete and a release of used oil in the secondary containment area in the used oil processing plant
<b>Photo Location:</b>	27°45'41.5"N 82°41'32.0"W

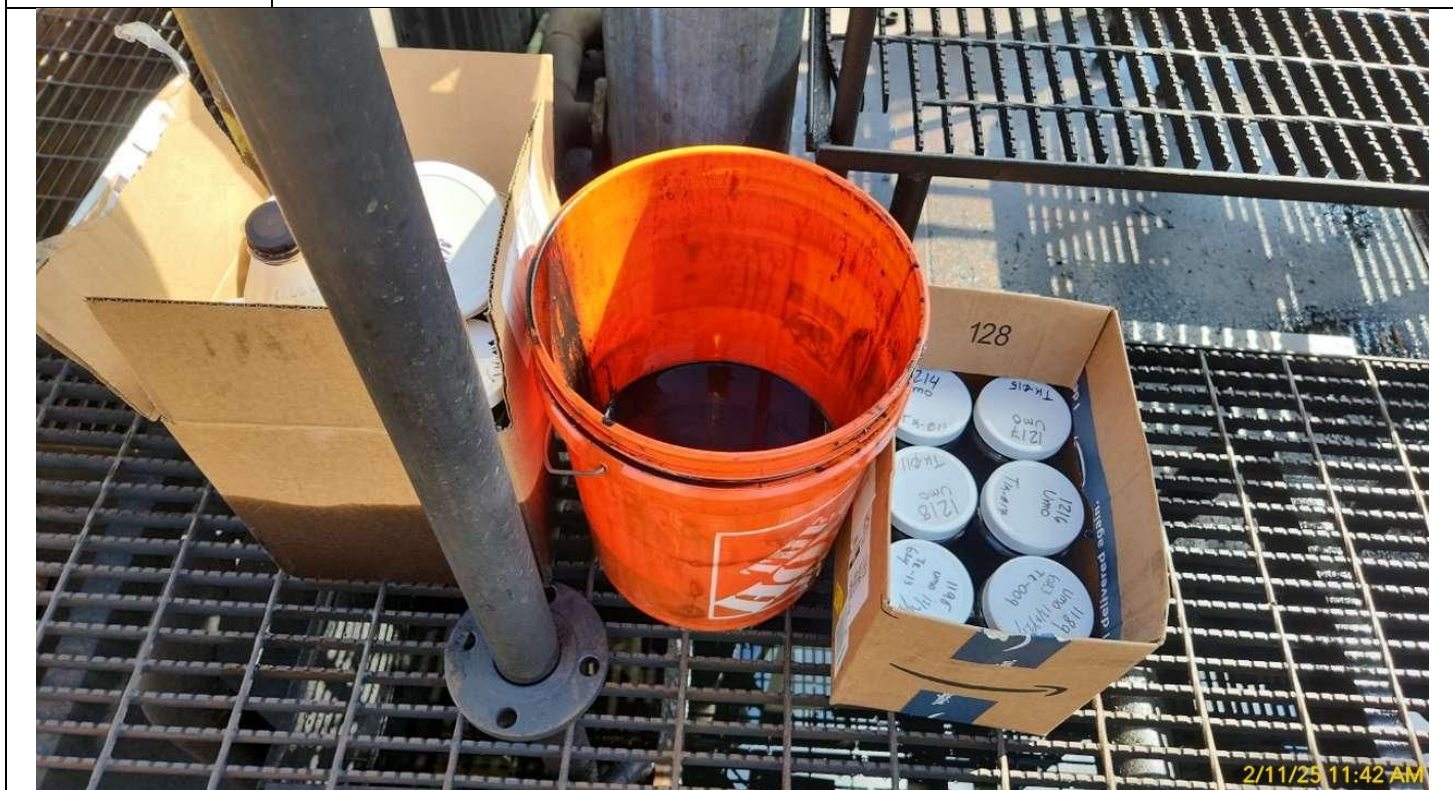
<b>Image #:</b>	59
<b>Photo Description:</b>	Unlabeled 5-gallon bucket
<b>Photo Location:</b>	27°45'41.4"N 82°41'32.0"W

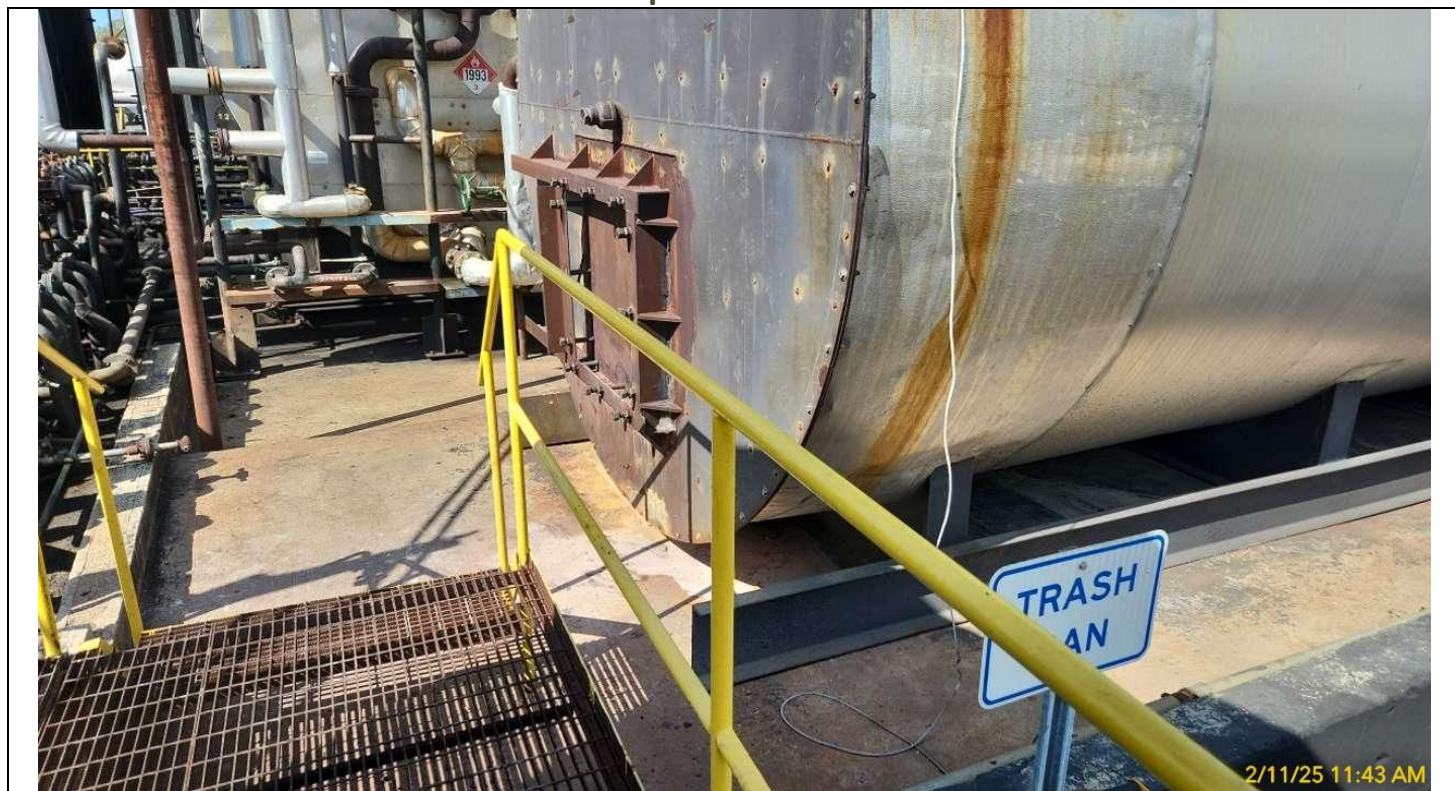
<b>Image #:</b>	60
<b>Photo Description:</b>	Exposed concrete in the secondary containment area of the used oil processing plant
<b>Photo Location:</b>	27°45'41.5"N 82°41'32.0"W

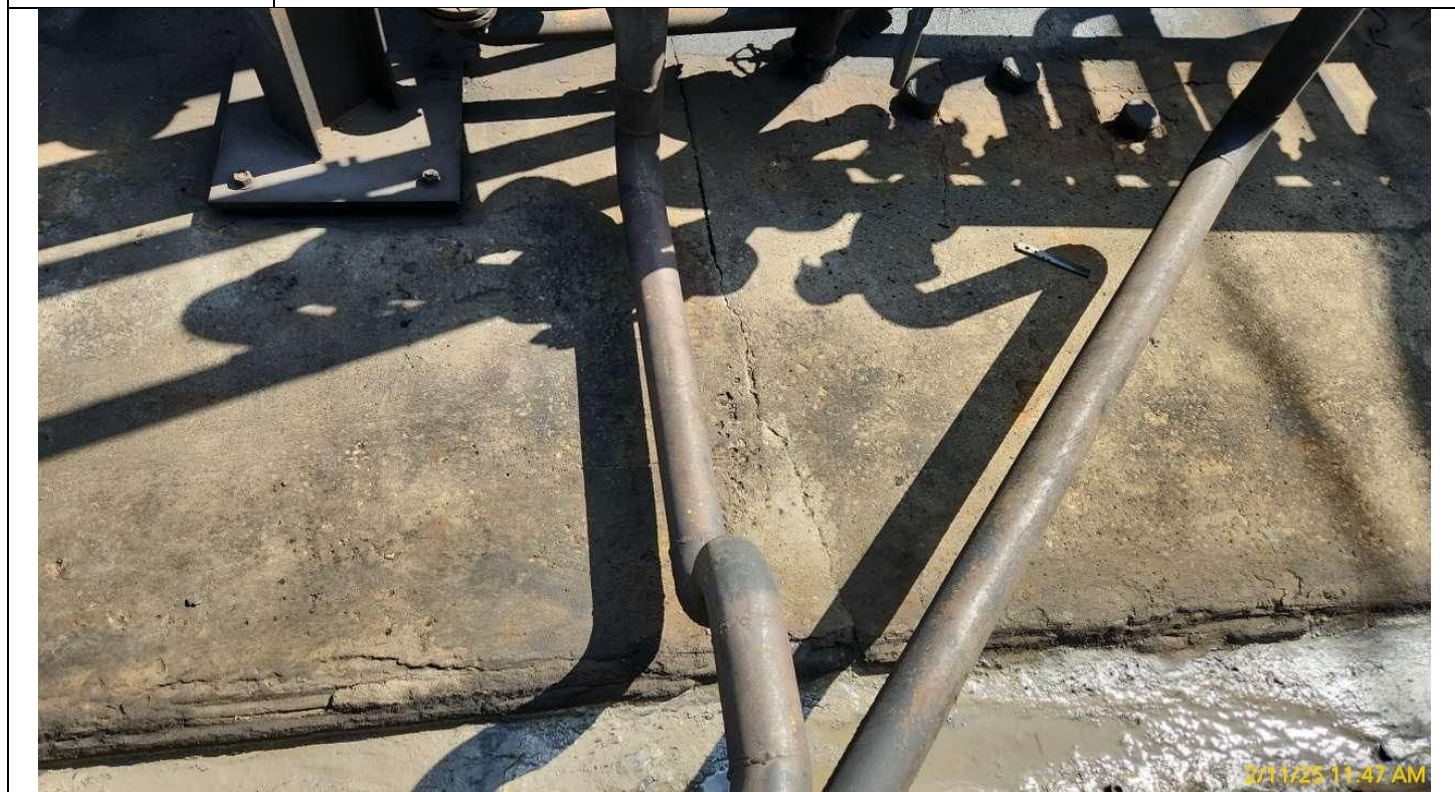
<b>Image #:</b>	61
<b>Photo Description:</b>	Exposed concrete and cracks in the secondary containment area
<b>Photo Location:</b>	27°45'41.2"N 82°41'31.2"W

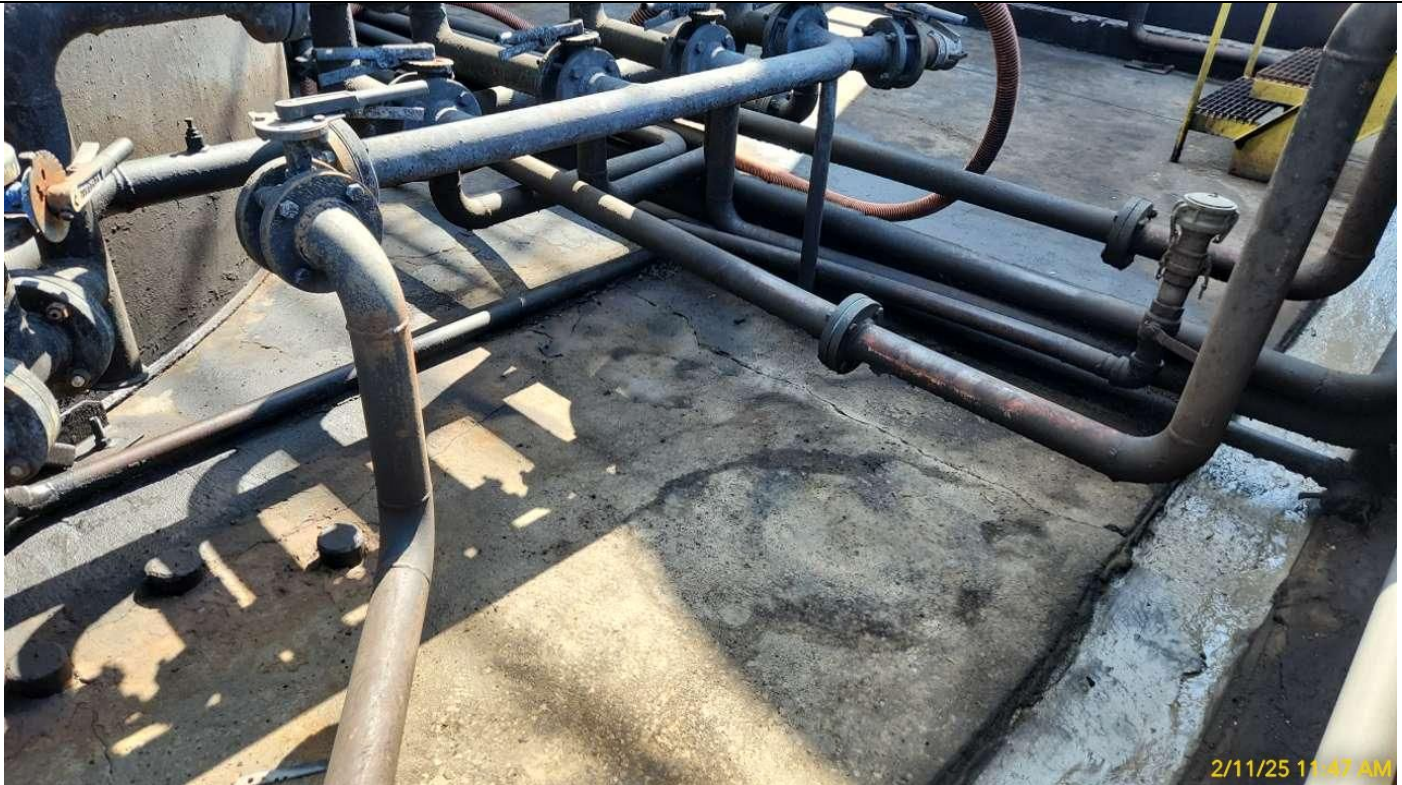
<b>Image #:</b>	62
<b>Photo Description:</b>	Exposed concrete and cracks in the secondary containment area
<b>Photo Location:</b>	27°45'41.3"N 82°41'31.2"W

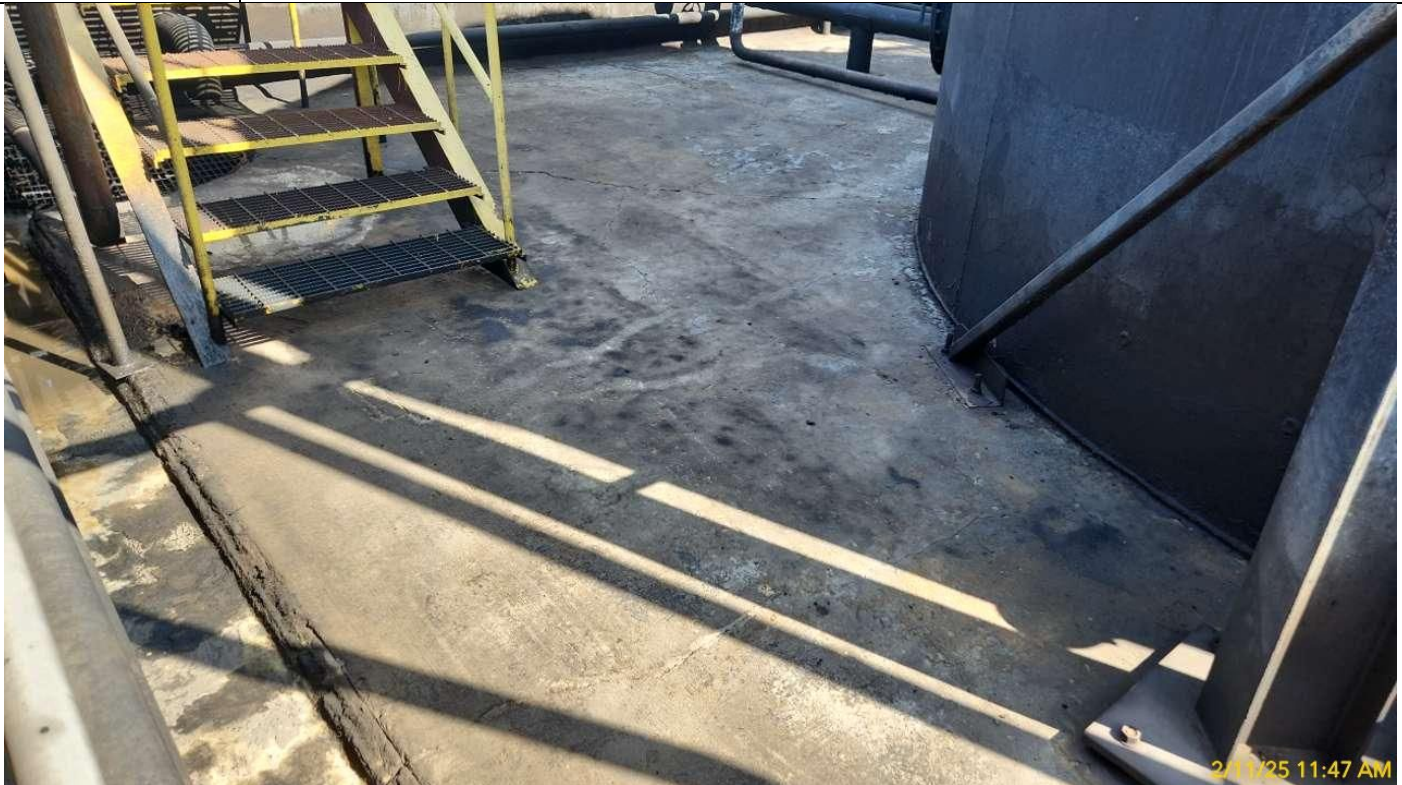
<b>Image #:</b>	63
<b>Photo Description:</b>	Exposed concrete and cracks in the secondary containment area
<b>Photo Location:</b>	27°45'41.3"N 82°41'31.2"W

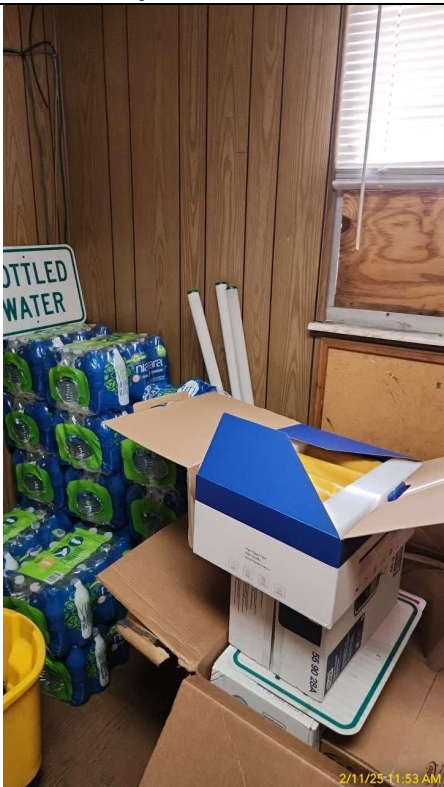
<b>Image #:</b>	64
<b>Photo Description:</b>	Open, unlabeled bulbs not provided with an accumulation start date
<b>Photo Location:</b>	27°45'40.2"N 82°41'30.5"W
