Florida Department of
Environmental Protection
Inspection Checklist

Facility Name: TOMOKA FARMS ROAD LANDFILL

On-Site Inspection Start Date: 09/28/2011

Follow-up Operation Inspection for Landfill - Class I facility

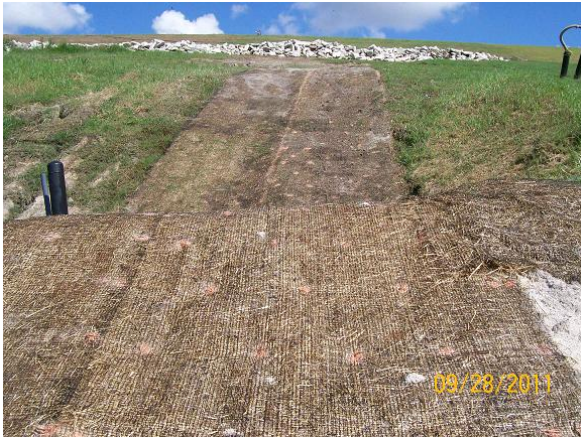
Corrective activities on the south slope were in progress. A portion of the turf reinforcement mat was installed. The erosion on the side slope and accumulation of leachate will be abated when all corrective activities are completed.

South slope reinforcement mat

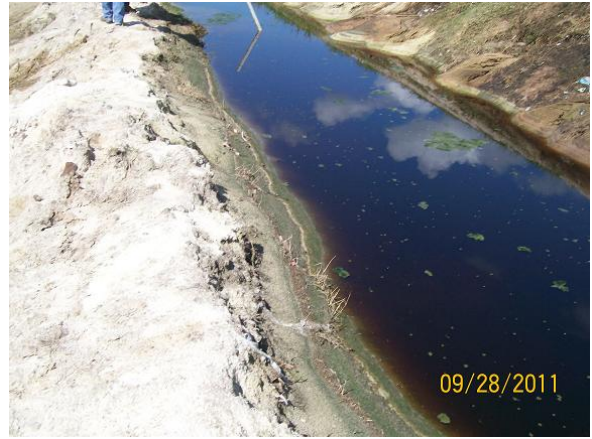
Explanation: The area upslope of the 200 ft. section of the toe drain and toe berm is showing significant erosion with exposed waste.

Explanation: The 200 ft. section of toe drain and toe berm is not functioning as designed. This was constructed as a corrective action in response to Non-Compliance Letter OCD-SW-11-045. Erosion upslope of the toe drain appears to be accumulating within the toe berm and is limiting the capacity for leachate drainage resulting in pooled leachate.

South slope toe drain

Corrective Action: All erosion areas must be repaired and steps must be taken to prevent further erosion of these slopes.

Corrective Action: The toe drain must be repaired to allow for leachate drainage.

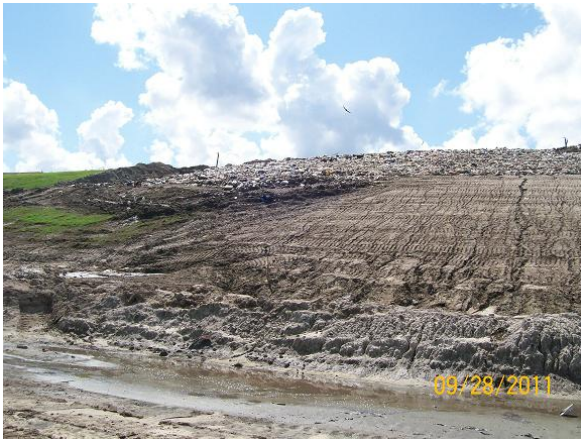
Disposal activities were occurring on the north side slope. Minor erosion was noted. A berm was installed along the bottom of the slope. A mixture of leachate and storm water accumulated inside the berm. The inspectors recommended pumping the leachate and storm water mix into the leachate collection system.

North - current disposal area

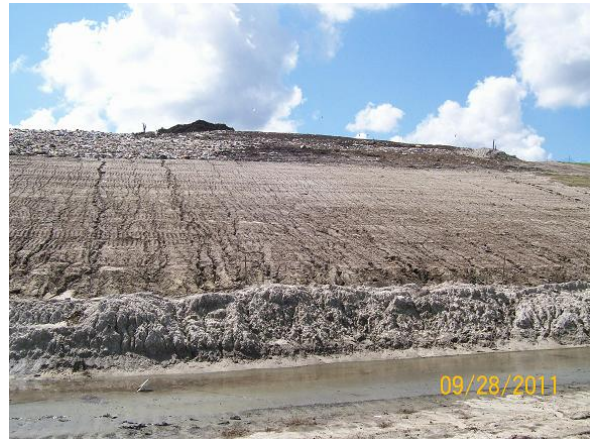
North - disposal area

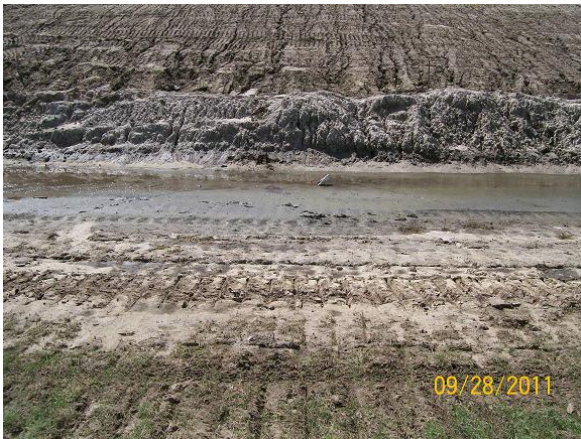
Berm at the bottom of slope
