Subject: Corrective Action Plan - Phase 3 Expansion, Central Landfill
Citrus County Central Landfill, Lecanto, Florida

ATTACHMENT A
REPRESENTATIVE PHOTOGRAPHS

Corrective Action Plan – Phase 3 Expansion, Central Landfill
Citrus County Central Landfill, Lecanto Florida
Report of Fire Damage Photos

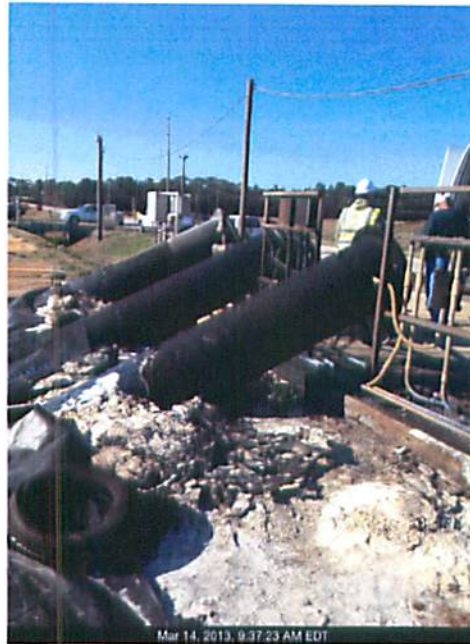
Photo 1: Date: 3/14/13
Phase 3 side slope riser pipes.

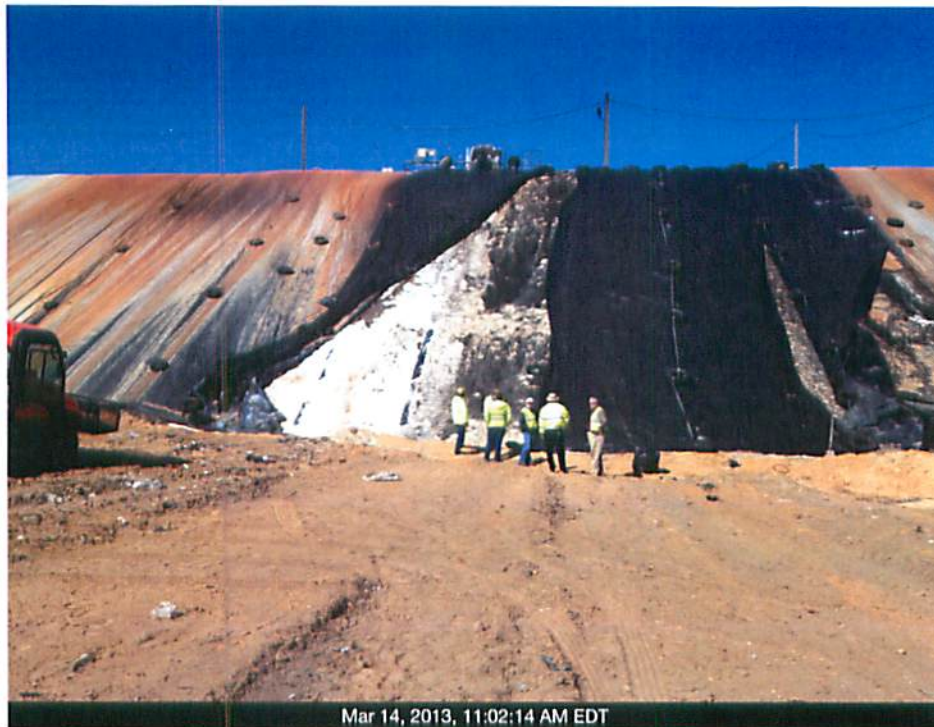
The fire started in the waste and due to wind direction made its way up the side slope of the landfill. Approximate side-slope system damaged was a 100-foot wide by 300-foot long swath of raintarp and liner. It also damaged components of the pumping system primarily the wiring and the cover plate on the northern most riser (detection riser). The fire and the repairs will

Photo 2: Date: 3/14/2013
Phase 3 side slope. Rain tarp is pulled back to expose damaged area.

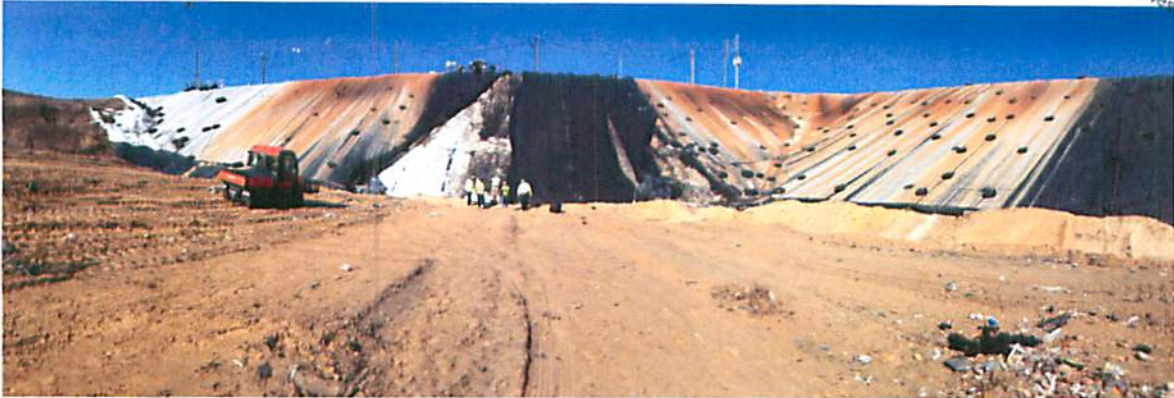
Photo 3: Date: 3/14/2013
Panoramic view of Phase 3 side slope.

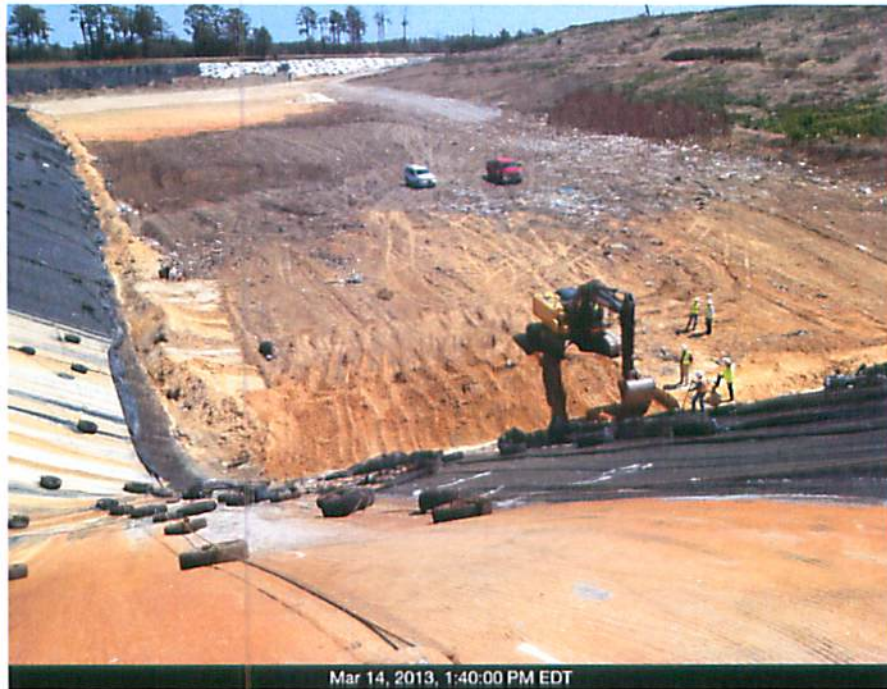
Photo 4: Date: 3/14/2013
Northwest corner of Phase 3.

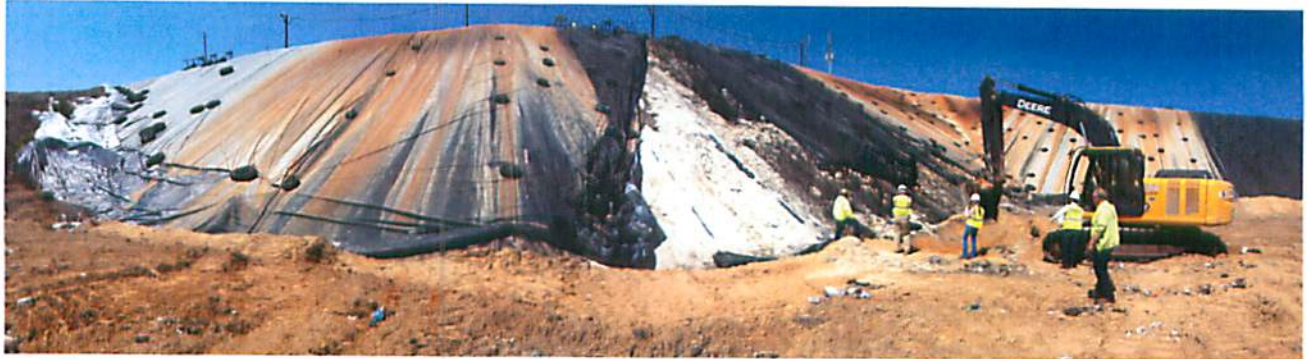
Photo 5:

Panoramic view of Phase 3 side slope in preparation of excavating cover and waste at the base of the slope in an attempt to determine if fire damage occurred below current waste levels.

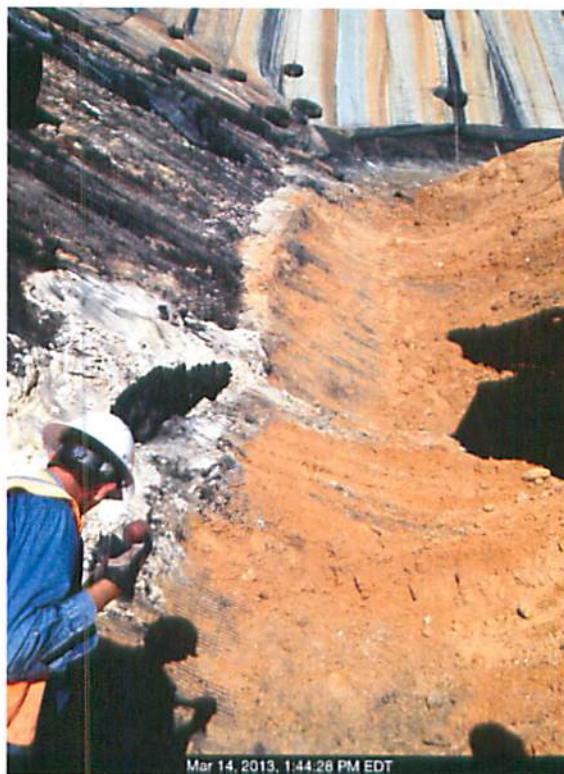
Photo 6:

On March 14, 2013, SCS met with Comanco and the County to examine the liner system. The County had previously constructed a soil berm at the toe of the slope that proved to be a protection for the liner system. The berm and some waste was pulled away from the liner utilizing a track hoe to exposed the liner in order to evaluate the extent of the damage below grade. The result of this process confirmed that the fire did not impact the liner below the soil level at the bottom of the slope. The County surveying crew surveyed the fire impact area.

Intermediate cover and waste pulled back utilizing a track hoe and the liner exposed to evaluate the extent of the damage below grade. The fire did not impact the liner below the soil.

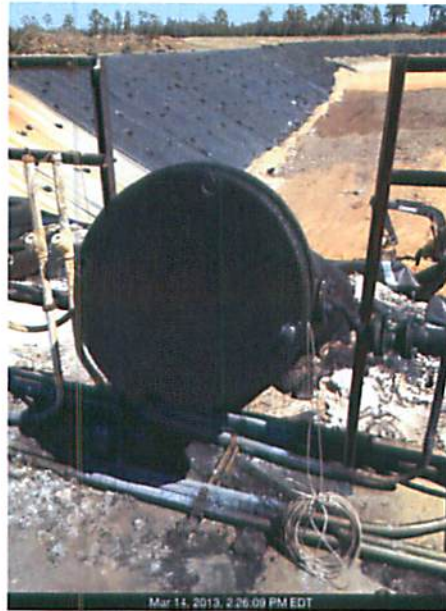
The County engaged Jet Clean to be on-site March 14, 2013, to video the riser pipes from the surface to the sump to determine if any internal damage can be identified in the risers. Video confirmed that water levels were below the top of the pump. Internally no damage to the riser pipes was observed. The jet clean camera was able to advance to the bottom of the sump in the Phase 3 primaries and secondary to approximately 165 ft below grade. It is noted that the layer of select sand installed over the riser pipes during construction protected the risers from fire damage. The only damage at that location was the destruction of the raintarp.

Photo 7: Date: 3/14/2013
Phase 3 side slope riser 24" diameter pipe.

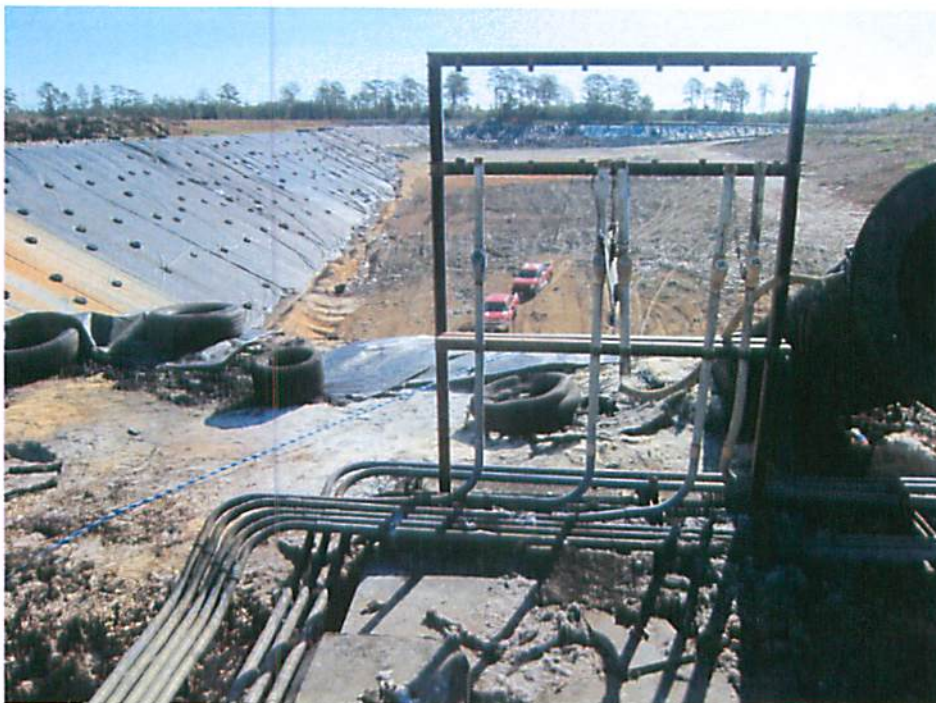
Photo 8: Date: 3/14/2013
Phase 3 detection pump riser controls.
