RE: Taft Recycling Inc. Materials Recovery Facility

Permit No. SW-022429-MRF/TF-06-1105 Monthly Compliance Inspection Report

INSPECTION REPORT MATERIALS RECOVERY FACILITY | TRANSFER STATION

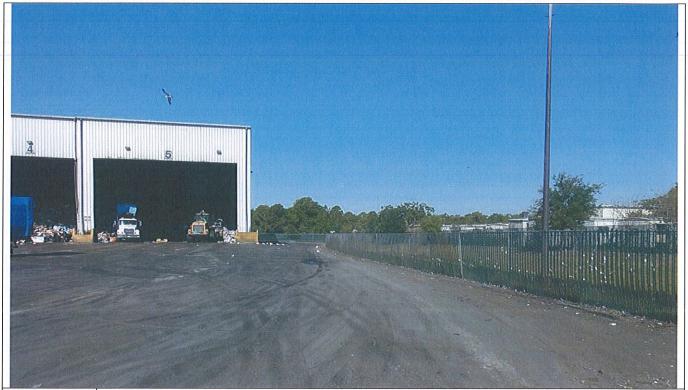
Photograph Access road parking lot facing W. # 1

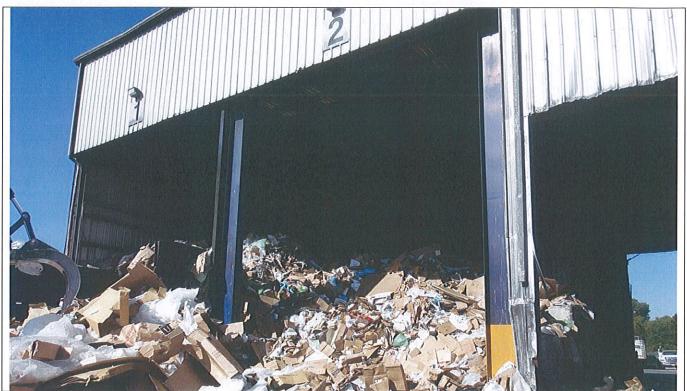
Photograph | Waste was observed standing beyond doors 1 and 2 on access road. Please see notes # _2 | section.

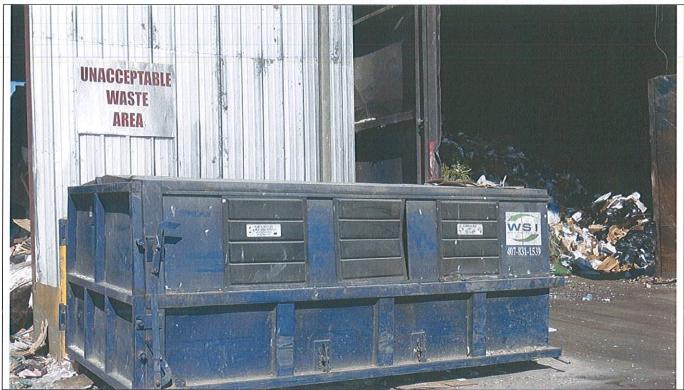
Photograph # 3 Fully enclosed unauthorized waste storage roll off.

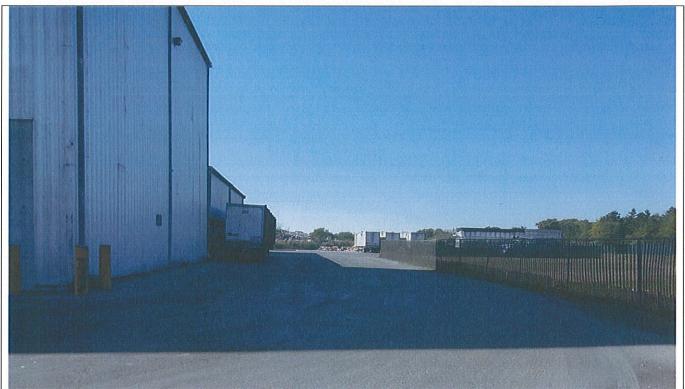
Photograph Access road/parking lot on the W. side of the facility facing S. #_4_

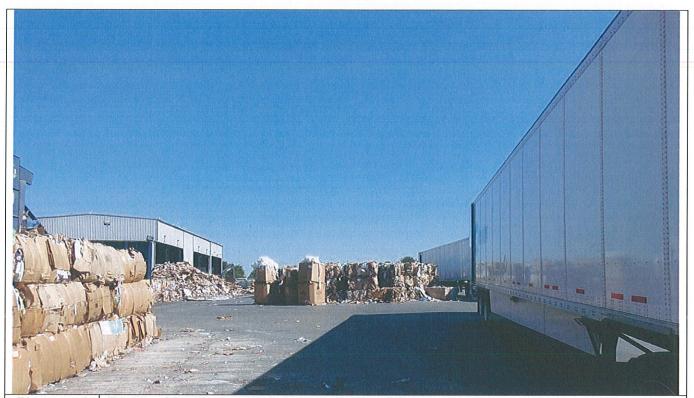
Photograph # _5

E. side of facility access road/parking lot facing N.

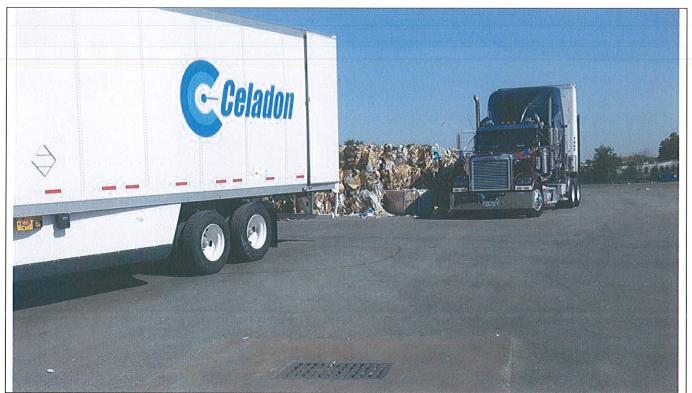
Photograph S.E. storm water retention pond drain appears unobstructed.

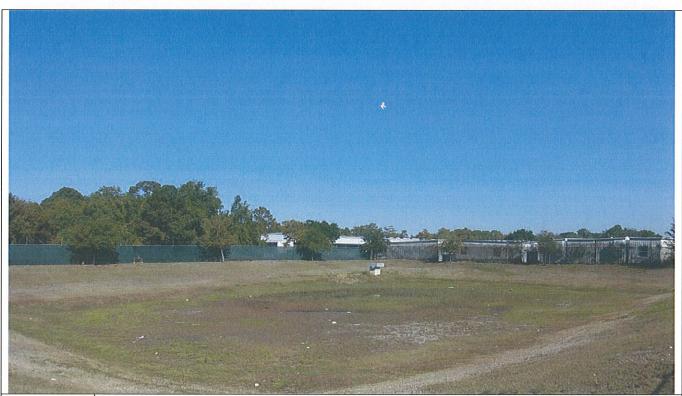
Photograph Storm water retention pond was clean.

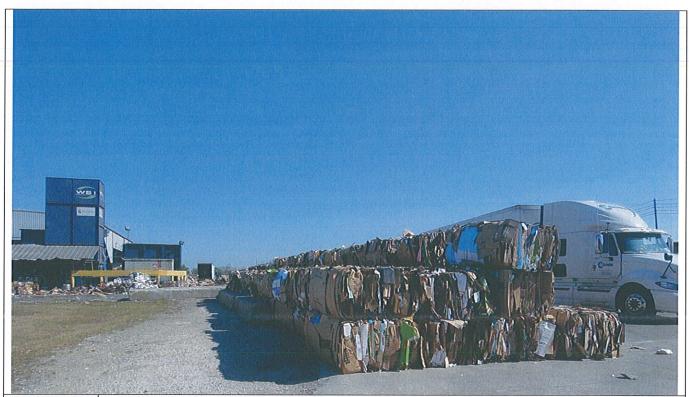
Photograph B

Bailed cardboard stored on E. side of facility access road/parking lot.

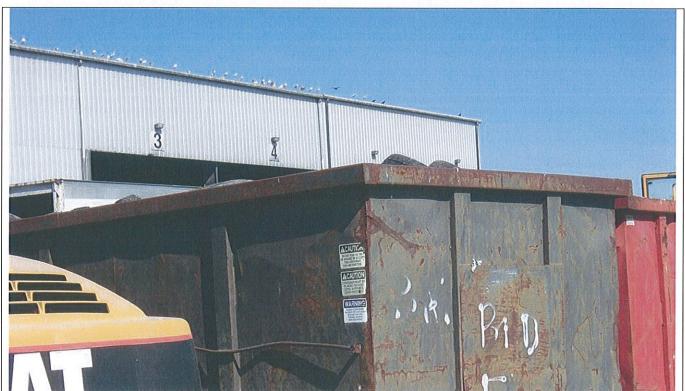
Photograph # <u>10</u>

Roll off filled with waste tires.
