**ANNUAL LEACHATE POND LINER INSPECTION
SUMTER COUNTY SOLID WASTE MANAGEMENT FACILITY
SUMTERVILLE, SUMTER COUNTY, FLORIDA
PREPARED FOR**

May 4, 1993

92-1100.00

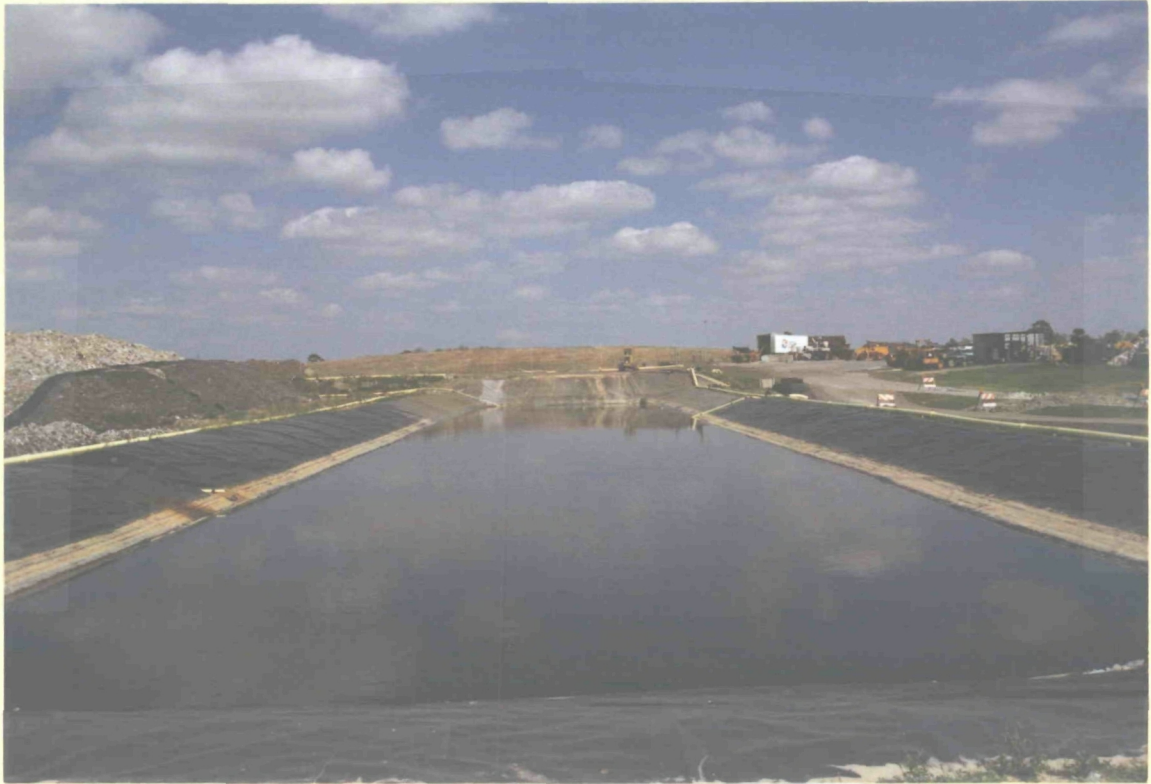
— #1 Pond before pumping —

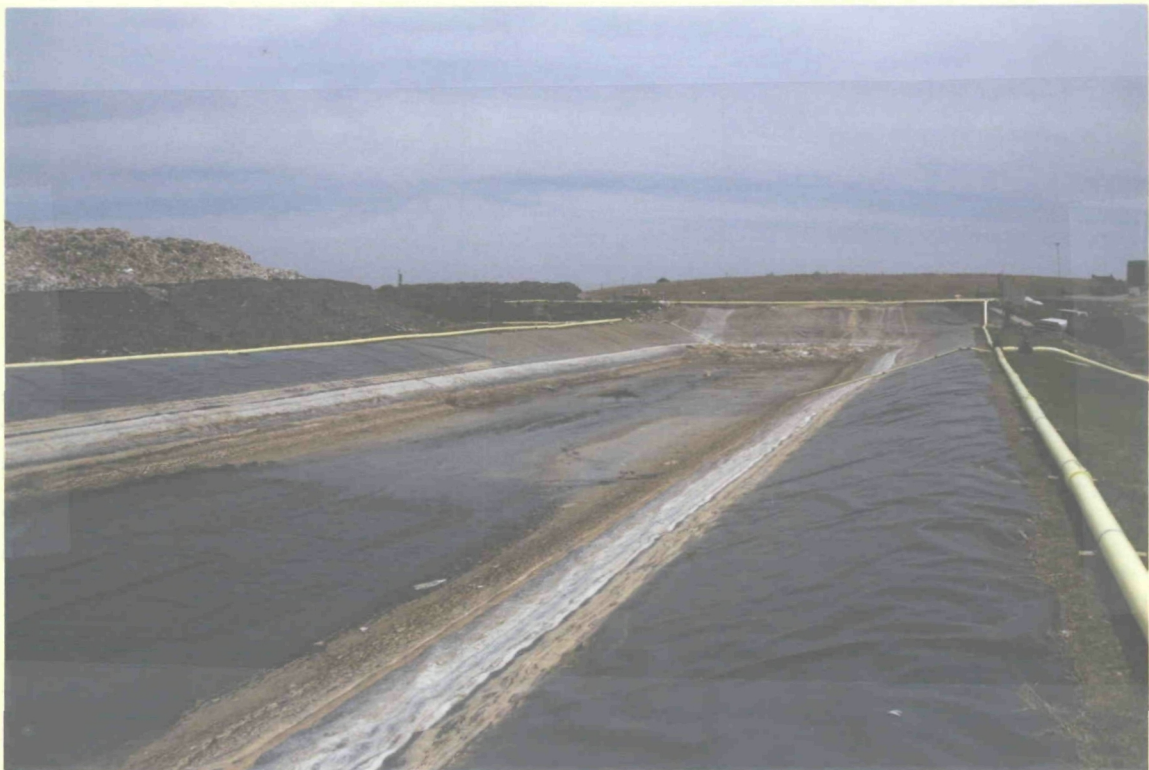
— #2 Pond after pumping —

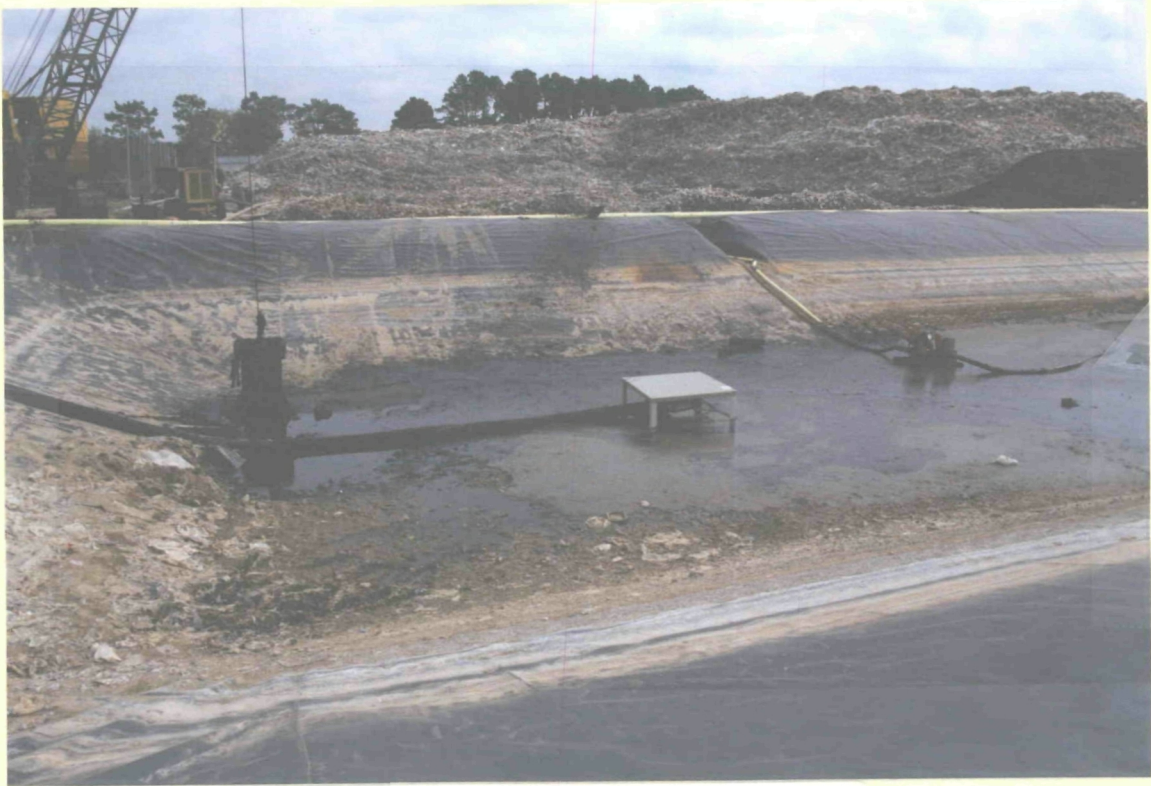
— #3 Pond before cleaning —

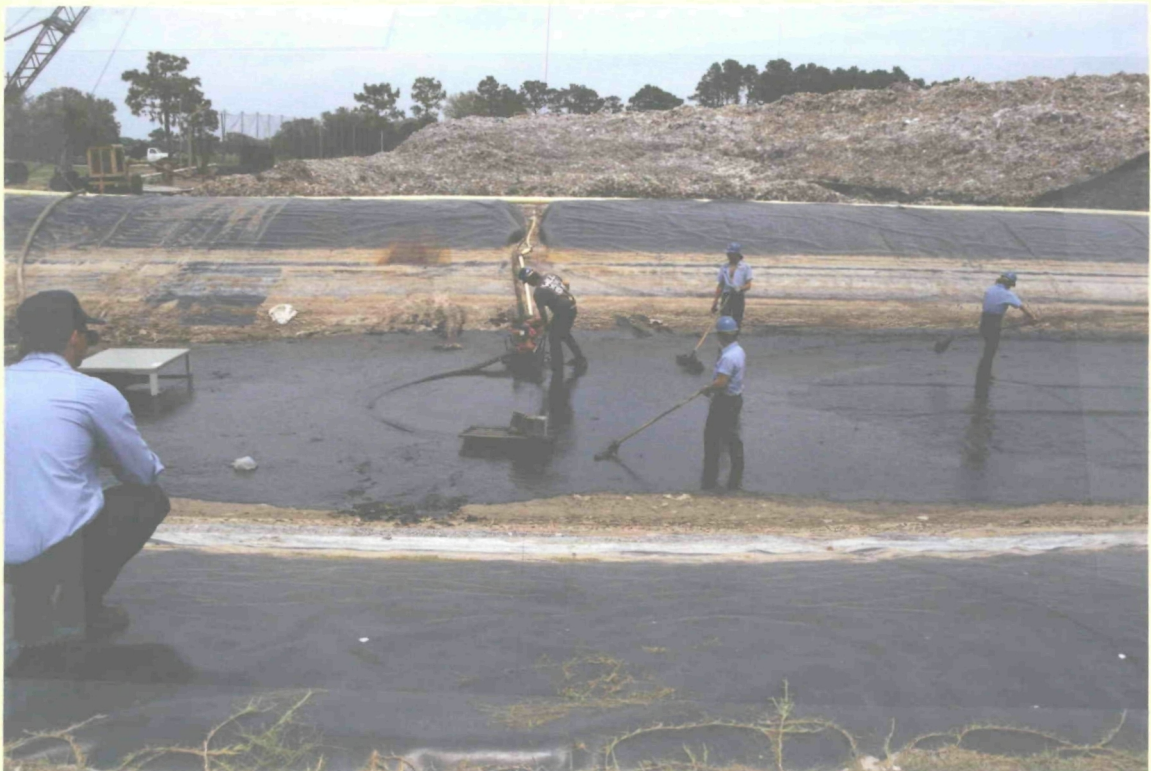
The cleaning was accomplished by sweeping the sediments to the west end of the pond and using plastic scoops to pick up the sediment and place it in a metal container. The container was lifted out of the pond with a dragline and its contents deposited in the Class I lined cell.

— #4 Method of cleaning —

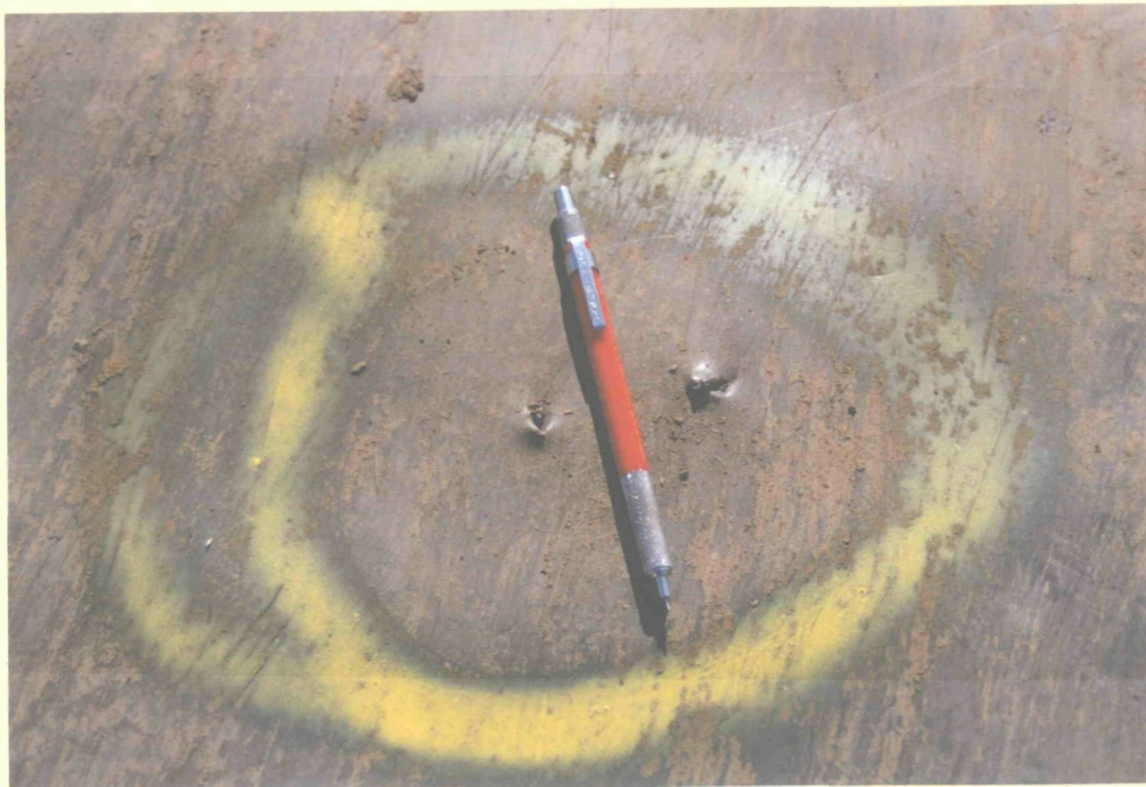
— #5 Typical punctures before cleaning —

The repair consisted of patching 97 individual punctures and repair using 3 overlays, 24" x 15", 12" x 12" and 9'-6" x 6'-6" in size. The overlays were used to cover numerous small punctures. It was felt the overlays would be better than patching each individual puncture.

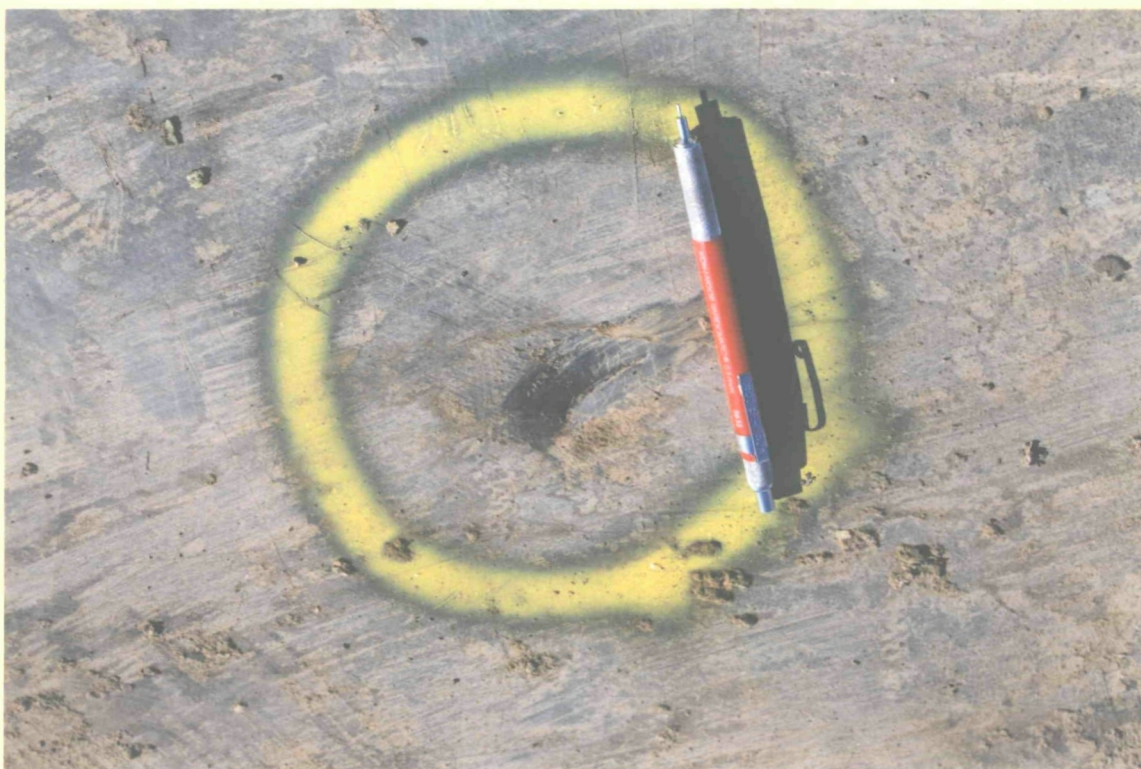
— #6 Typical puncture before cleaning —

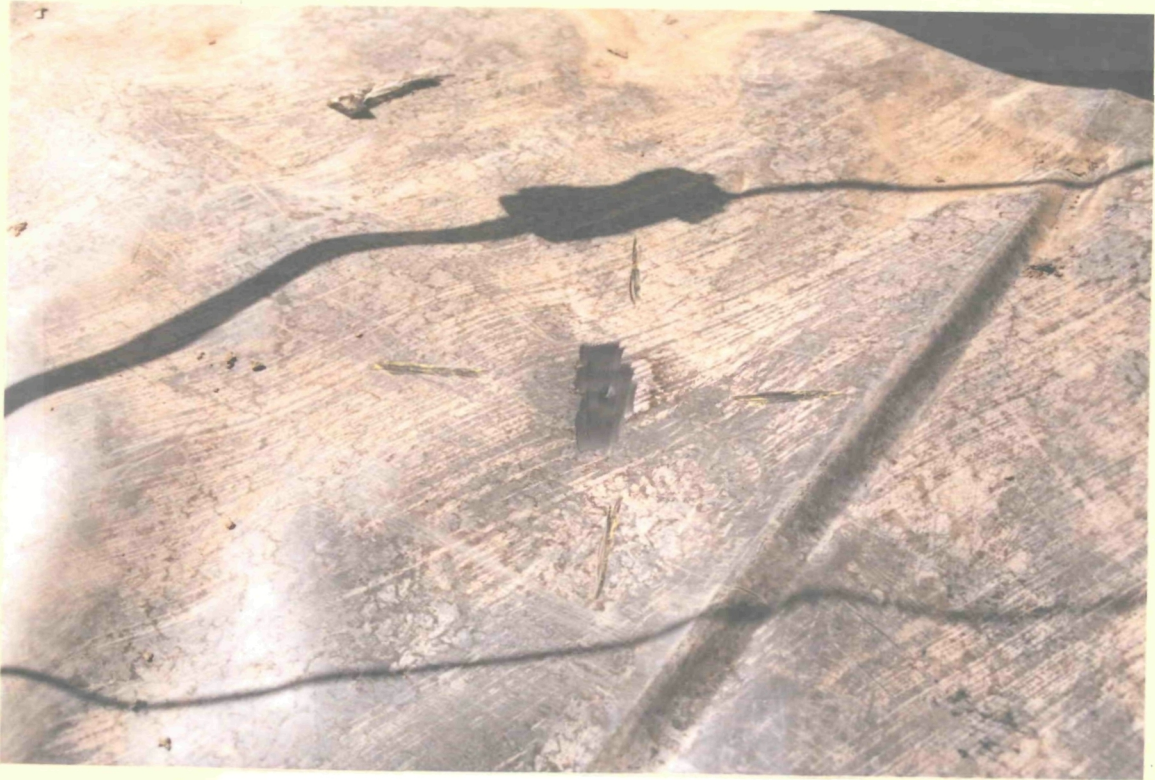
— #7 Typical punctures after cleaning —

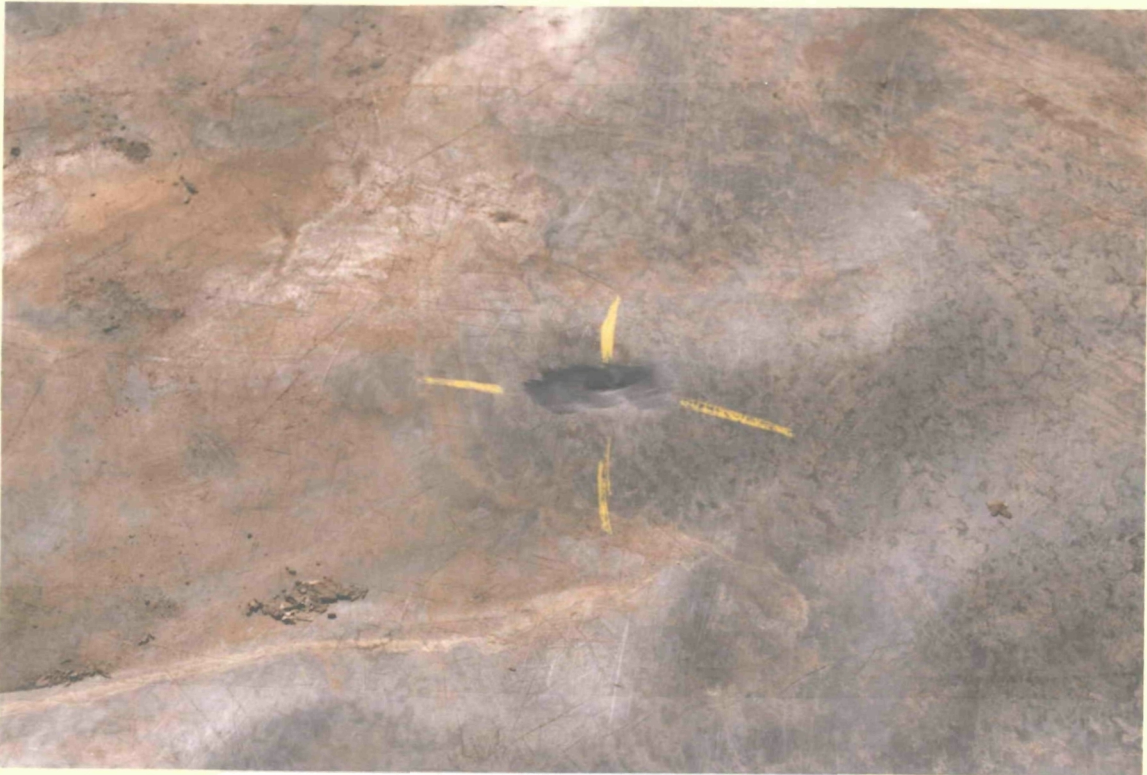
— #8 Typical punctures after cleaning —

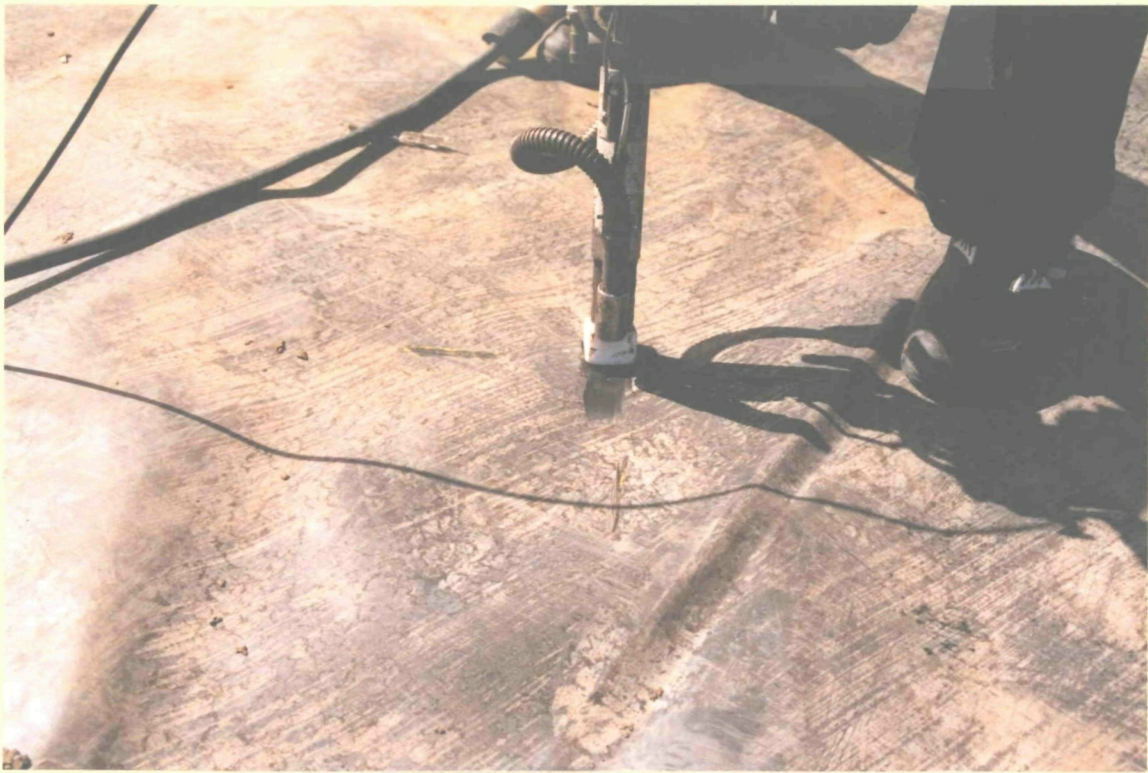
— #9 Method used to patch —

The method used to patch the punctures was heat extrusion using a heat application extrusion gun, type R180MUI manufactured by Dr. Bender (See Photo).

The area to be patched was cleaned with a rotary brush prior to the application of the extruded weld. The extrusion rod was manufactured by Poly-Flex. The part number of the rod was PAWR-C5MM.

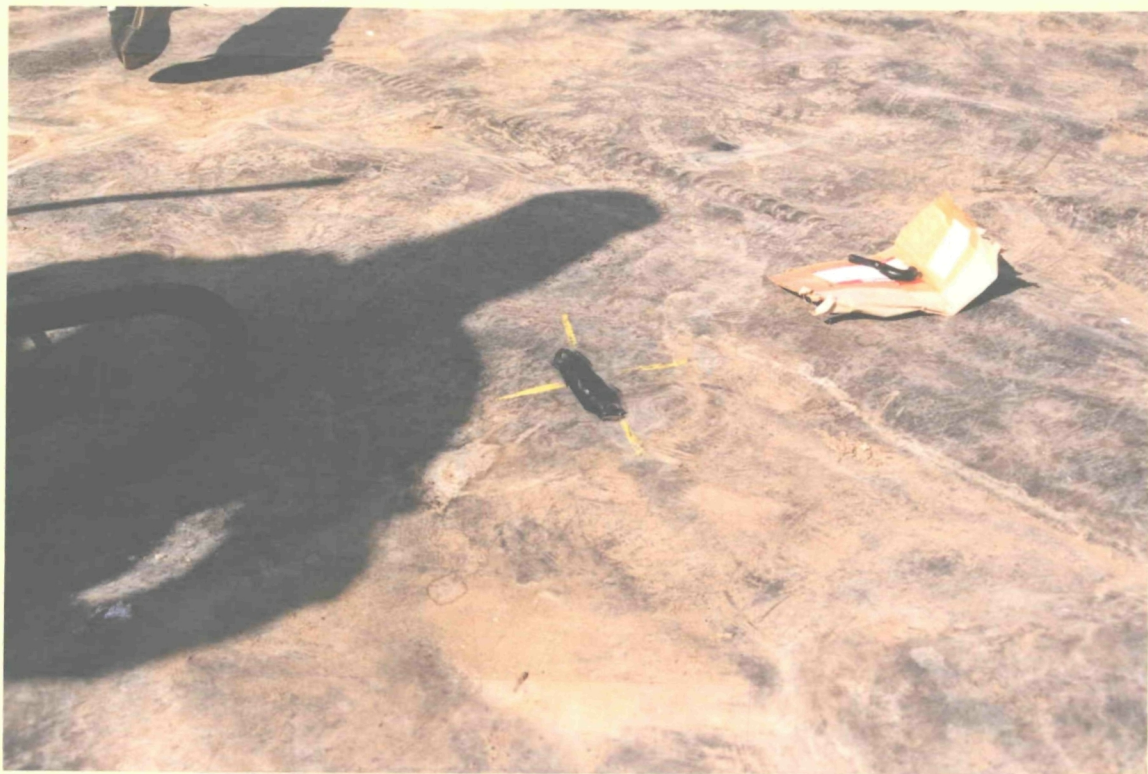
— #10 After Patching —

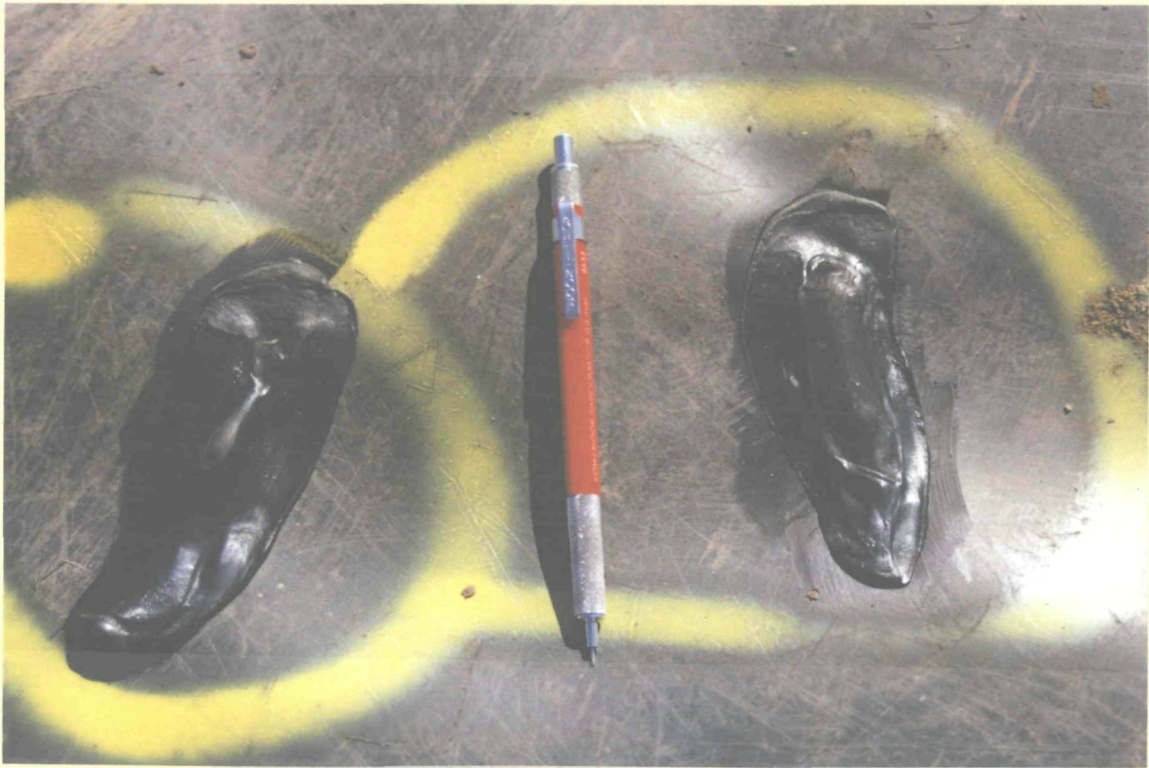
— #11 After patching —

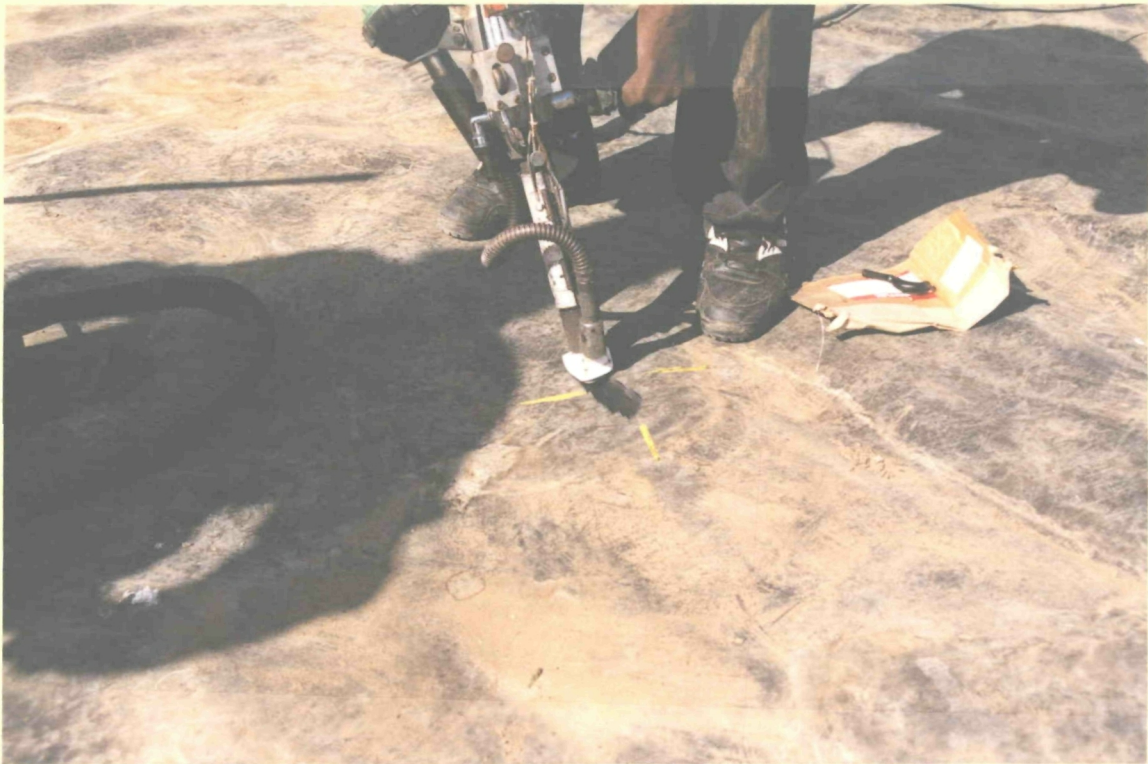
— #12 Method used to patch —

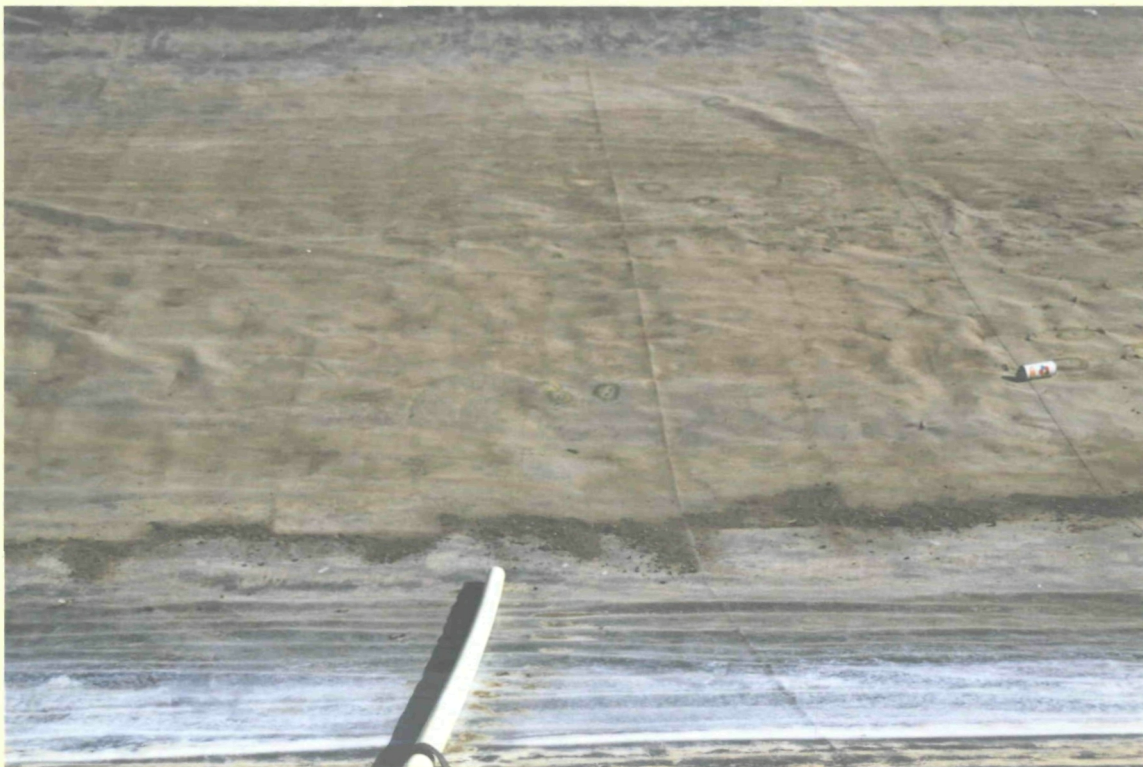
— #13 Photo of liner —

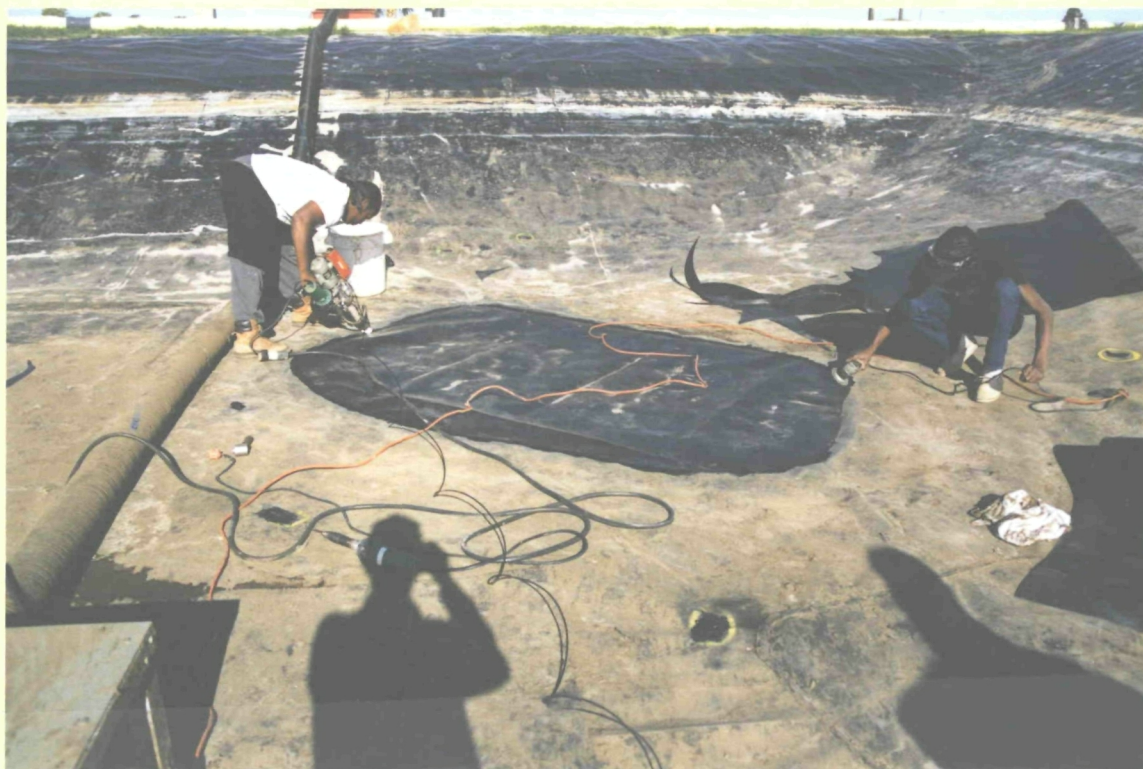
— #14 Method of patching large area —

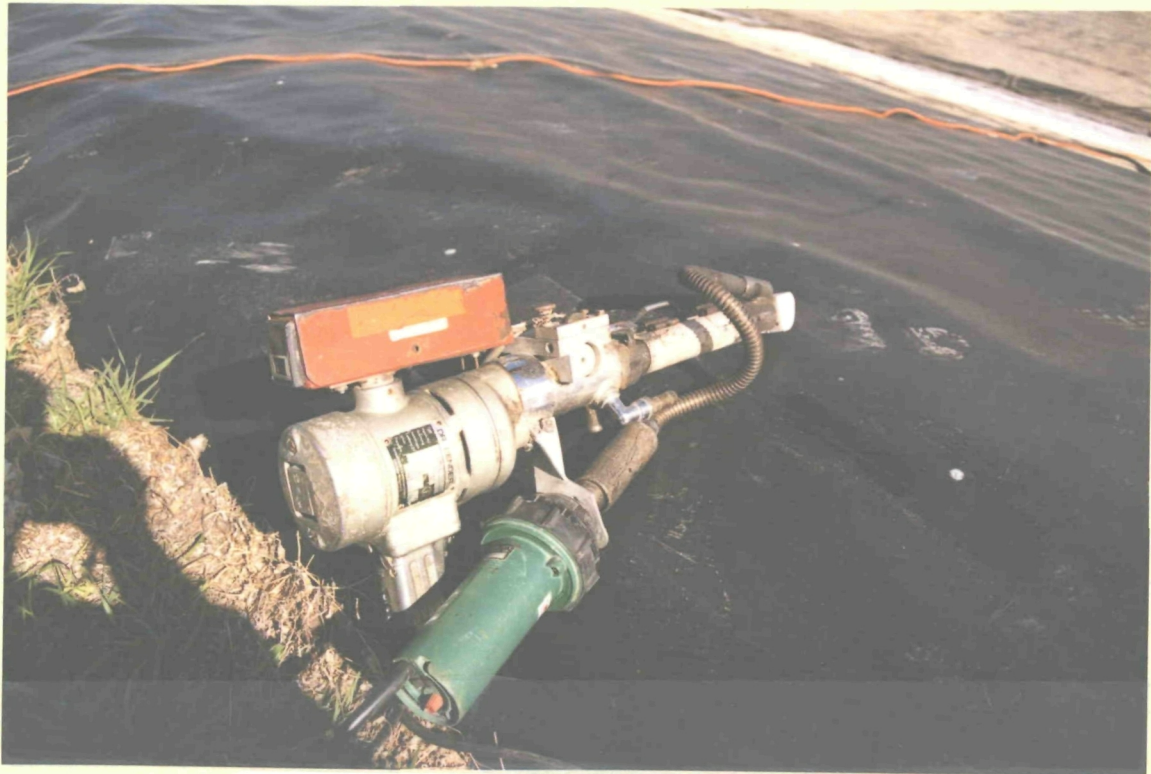
— #15 Heat extruder gun —

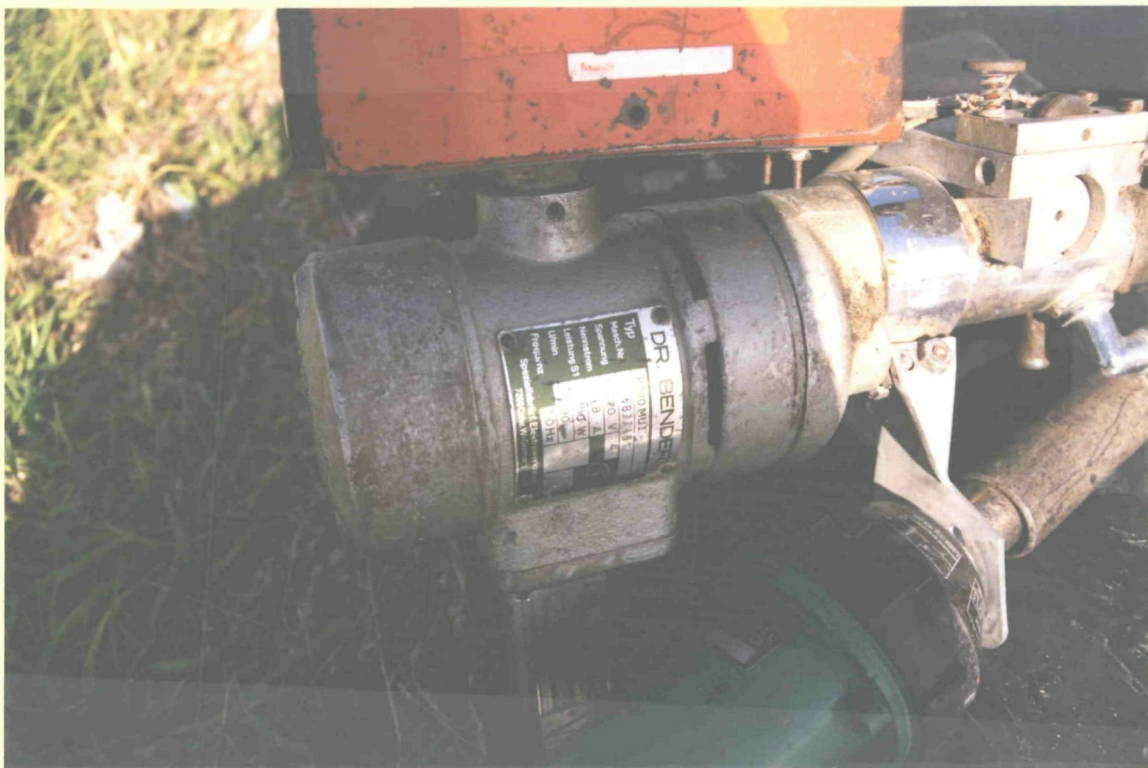
— #16 Photo showing specification plate —

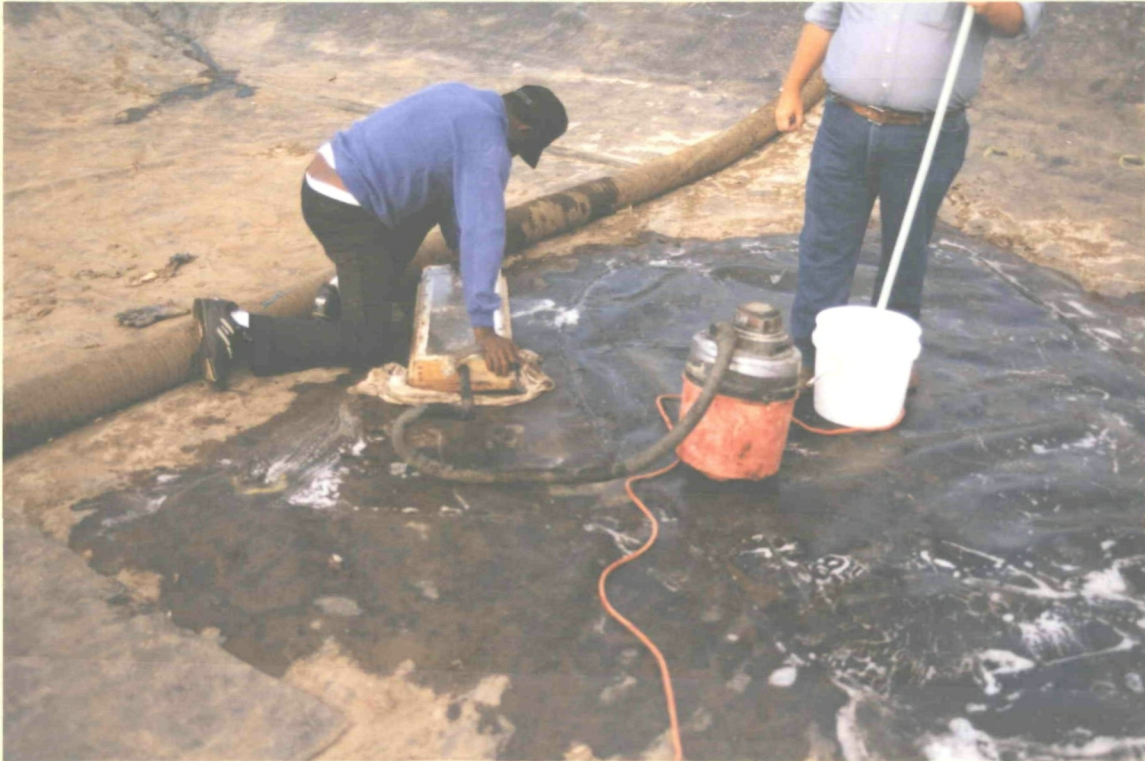
The equipment used for the vacuum test was a commercial vacuum to provide the vacuum which was attached to a wooden box 3'7' with sponge rubber placed on the bottom edges to provide a leak proof seal where the box was in contact with the liner. The box had a plexiglass top for observation of the patch during testing. Liquid soap and water was placed on seams and patches and the vacuum box was placed over the patch and vacuum applied to the box to check for bubbles around the patch. No bubbles were detected, therefore, no leaks were present. Testing was completed @ 11:30 a.m.

— #17 Equipment used to vacuum test patches —

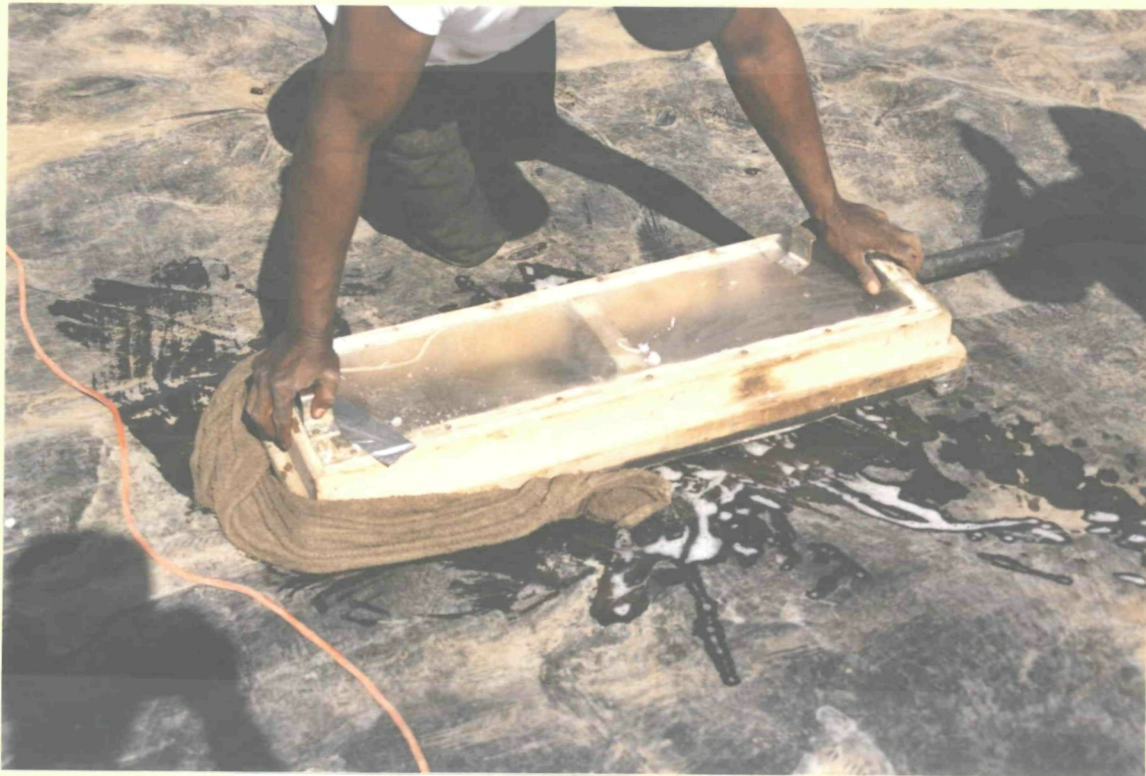
Stafford Cosby's employee, Mr. Prentiss Duhart, returned on April 29, 1993 at 8:00 a.m. to perform vacuum tests on all repaired areas. All locations tested good, meaning there were no leaks.

— #18 Vacuum test in progress —
