Florida Department of
Environmental Protection
Inspection Checklist

Facility Name: SUMTER COUNTY TS / LANDFILL LTC

On-Site Inspection Start Date: 06/11/2014

Follow-up Long-Term Care Inspection for Landfill - Class I Closed - Long Term Care facility

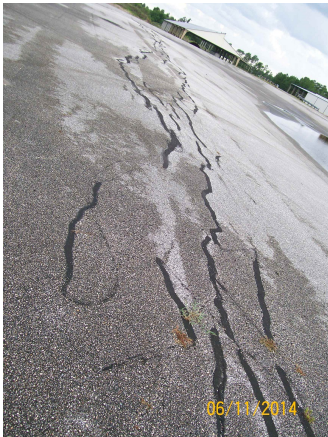
Six months prior to this inspection, the cracks in the asphalt were sealed; no new cracks were noted at the time of this inspection. The asphalt area is not being used by the county. Major ponding was evident on the asphalt due to the rain event; some areas drained to the nearby stormwater ponds. The southeast corner of the asphalt area adjacent to the grass area (noted above) was not draining and was approximately 3" deep. The west side of the asphalt area was draining off the asphalt and causing erosion. Major settlement of the asphalt was evident. The settlement mimics that of a trench and fill landfill with valleys running north-south. The integrity of the asphalt itself at the time of this inspection was good.

Asphalt Cover Crack Repairs

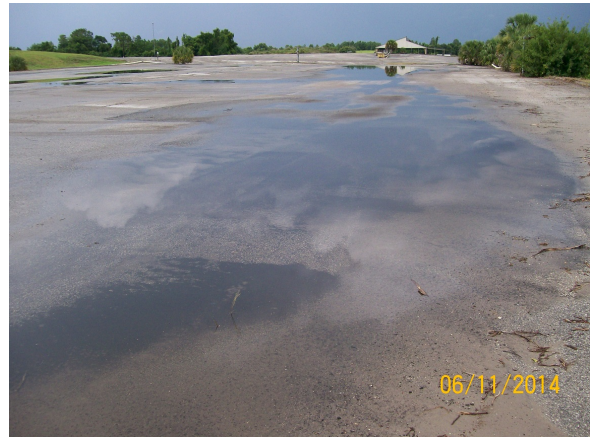
Asphalt Cover Ponding

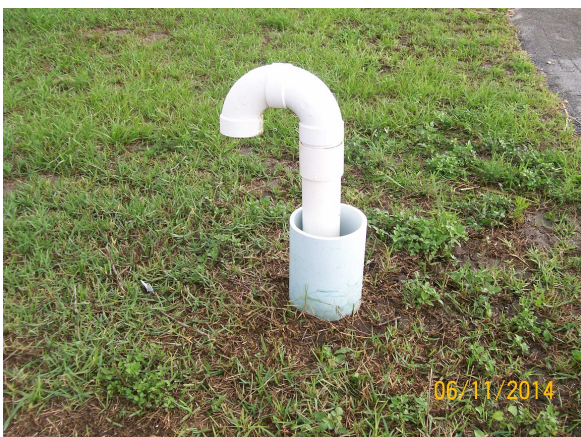
Approximately 50 vents are installed in the closed class I landfill area with grass cover. The vents are installed in a grid pattern and were in good condition at the time of this inspection. It is believed that the vents are installed to the bottom of waste. Vents are occasionally damaged during a mowing event and repaired. The county has begun pre-mowing with a smaller mower in between the vents to eliminate the larger mower from needing to get too close to the vents. It is recommended to verify the depth of the vents after being repaired to ensure depth is maintained. 5 vents were noted on the west side of the asphalt; it is recommended to add these to the gas monitoring plan.

Gas Vent on West Side of Asphalt

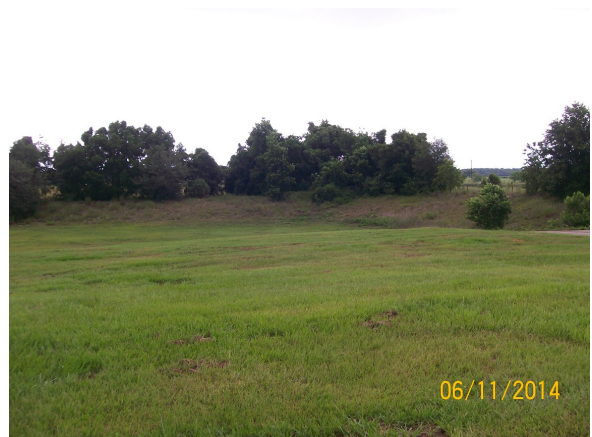
The grass cover overlays a PVC liner. Subsidence and erosion repairs were made the previous week. Overall integrity of the grass area was good. At the time of this inspection, no major areas

of subsidence were evident, no ponding was evident, no damage to the liner system was evident. The southeast corner at the grass-asphalt interface experienced erosion and ponding due to the rain event during the inspection.

Landfill - Grass Cover

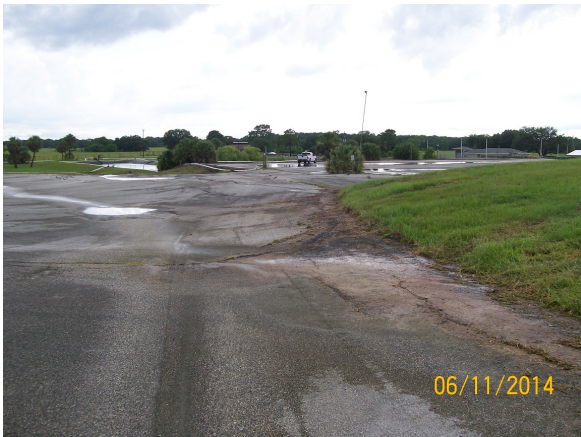
landfill asphalt-grass interface

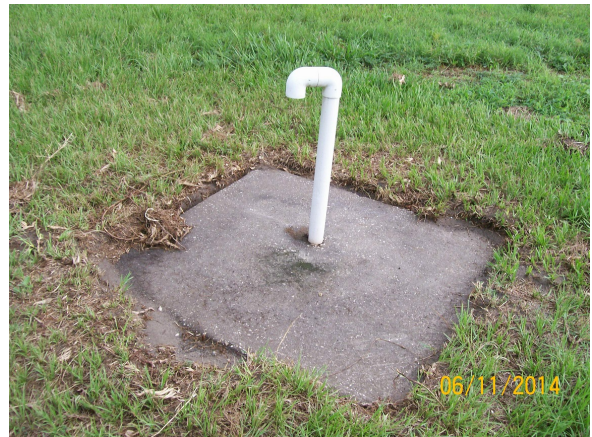
Landfill Gas Vent

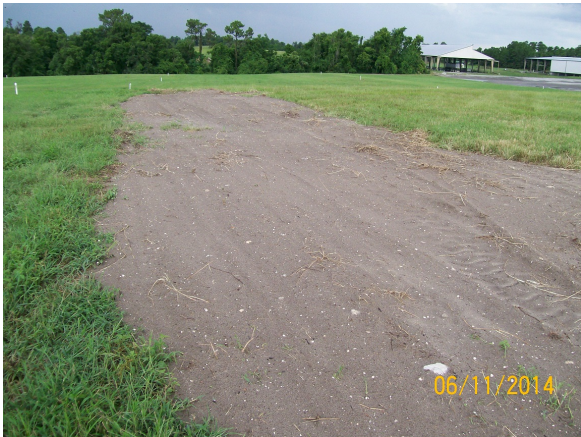
Landfill - Repairs to Grass Cover

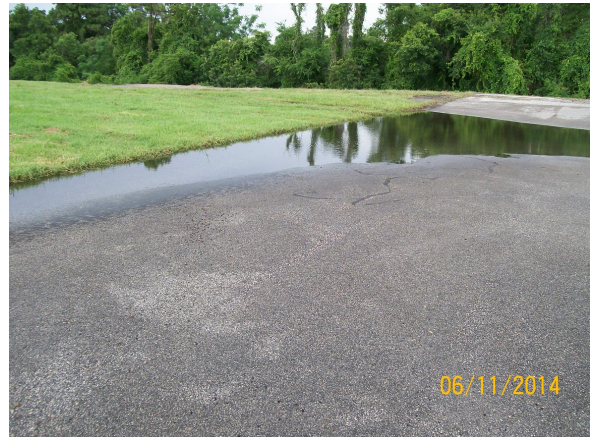
SE Asphalt Corner Stormwater - 1

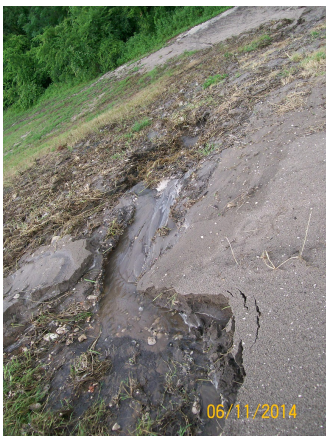
SE Asphalt Corner Stormwater - 2
