Enterprise Class III Landfill Angelo's Aggregate Materials, Ltd. 41111 Enterprise Road Dade City, FL 33525

Cell 3
Construction Completion Report
FDEP Permits: 177982-001-SC & 177982-002-SO

March 2007

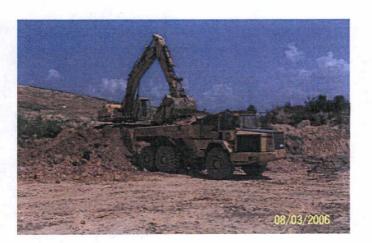
Picture 9

_				
		-				
		- - -			·	
		- - -				
		- - - -				
		- - - -				
		- - - - -				
		- - - - -				
-		- - - - -	Photographs (expla	in activity for each)		
Photo#	9	Trackhoe k	Photographs (expla	in activity for each)		
Photo#	9	Ì				
1		Ì	oading end dump with material.

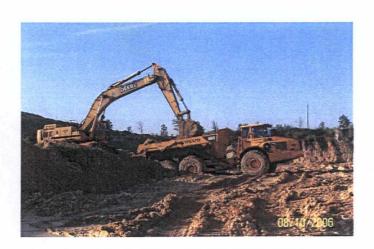
Picture 21

-						
		- –						
		.						
						····		
		-						
		· <u> </u>				<u> </u>	 	
		. <u> </u>						
				<u></u>				
•		. <u> </u>						
		1	Pho	otographs (explain a	activity for each)		
Photo #	21	Trackhoe load	ling end dur	mp with mate	erial.			
Photo #	22	End dump unl	oading mat	erial, Bull do	zer pushi	ng material.		
Photo #	23	End dump cor	npacting lift	: 3				
Photo #								##-W

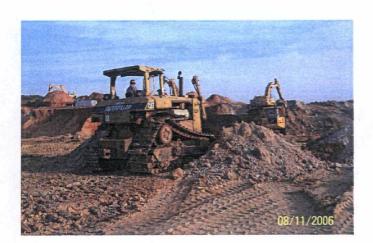
Picture 24

-				
		_	·		<u> </u>	
		_				
		-			·	
		-	<u> </u>			
		-				
		-				
		. -	Photographs (expla	ain activity for each)		
Photo #	24	- Bull dozer		ain activity for each)		
Photo #	24		pushing material.	ain activity for each)		
Photo #	25	Trackhoe k	pushing material. pading material in end dump.			
		Trackhoe k	pushing material.

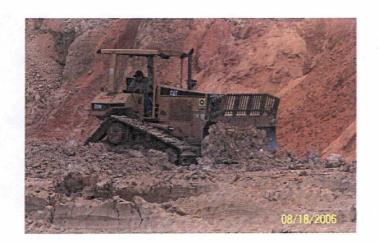
Picture 33

. <u></u>	
		-				
		Pho	tographs (explai	n activity for each)		
Photo # 33	Bull dozer p	ushing Materia				
Photo# 34		inloading mate				
Photo # 35		ading material				
Photo #
