**CELL #5
SITE INSPECTION REPORTS
PICTURES
TEST RESULTS
TEST LOCATION MAPS**

Project #: 80540-001-02

Angelo's Aggregate Materials

DADE CITY LANDFILL CELL #5

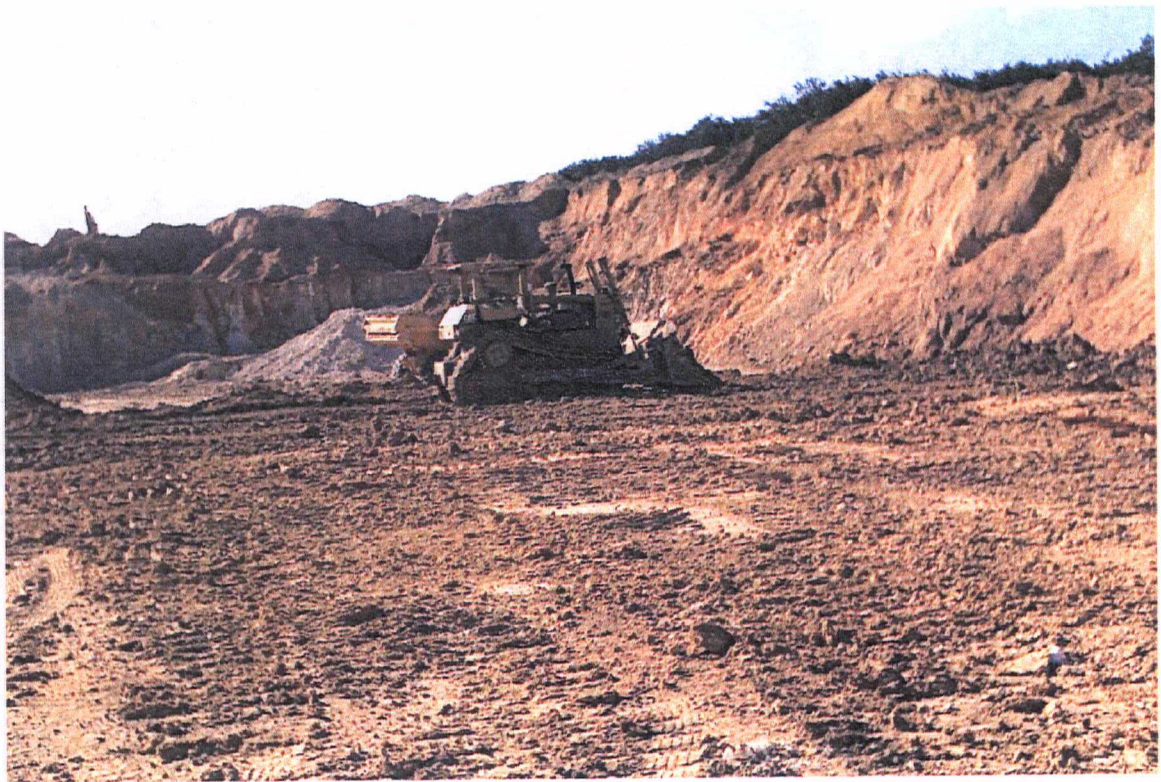
Photo #	21A	Bull Dozer pushing material for third lift. (Facing South)
---------	-----	--

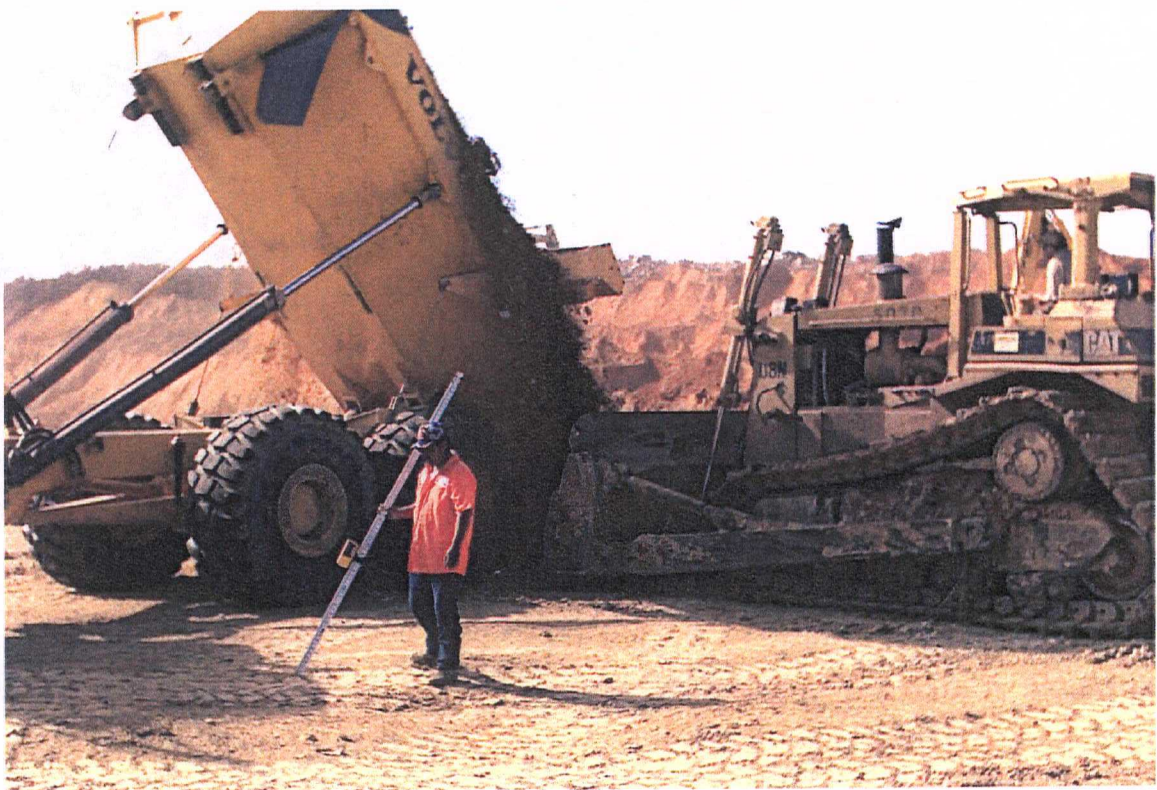
Photo #	22A	End Dump unloading material for third lift, and contractor checking grade. (Facing South)
---------	-----	---

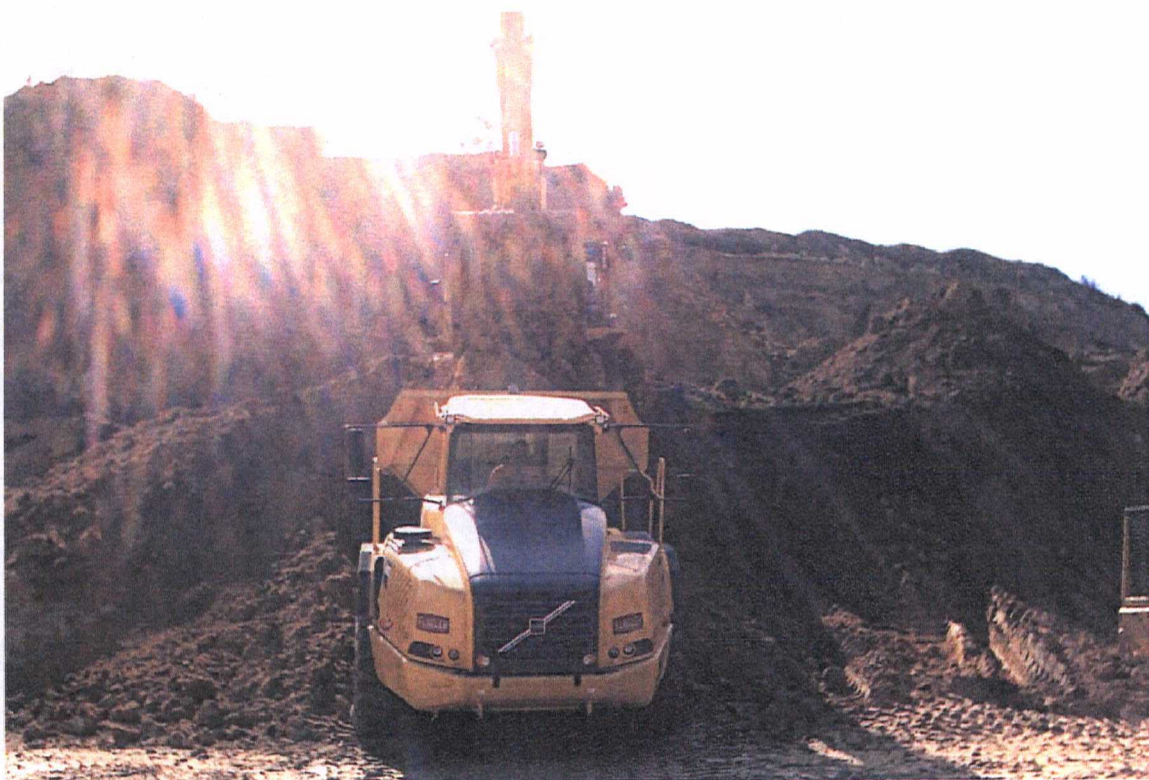
Photo #	23A	TrackHoe loading end dump with material for third lift. (Facing South)
---------	-----	--
