**CERTIFICATION REPORT  
CONSTRUCTION OF CELL 1B  
Oak Hammock Disposal Facility  
Osceola County, Florida**

Osceola County SW  
Oak Hammock Disposal Facility  
Certification of Construction Completion

Oak Hammock Disposal Facility  
Osceola County, Florida

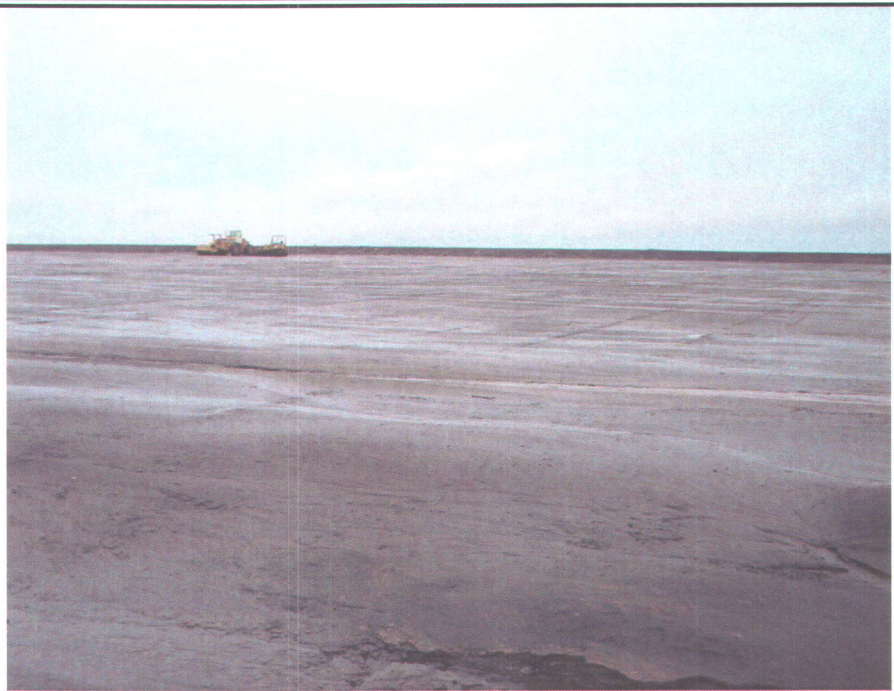
Placement and  
compaction of materials  
in Cell 1B.

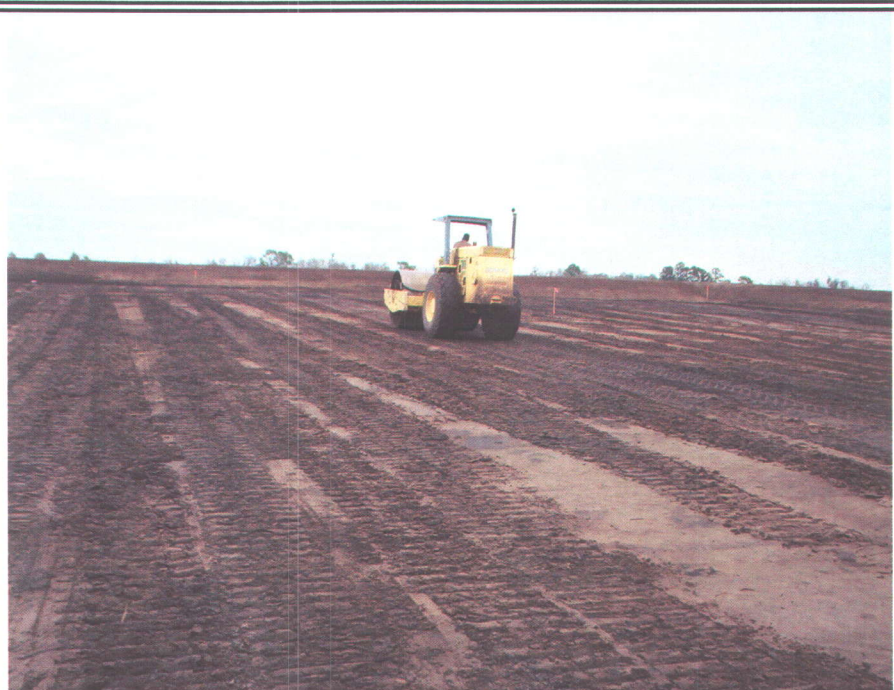
Photograph 2

Smooth drum compacting  
subgrade in Cell 1B.

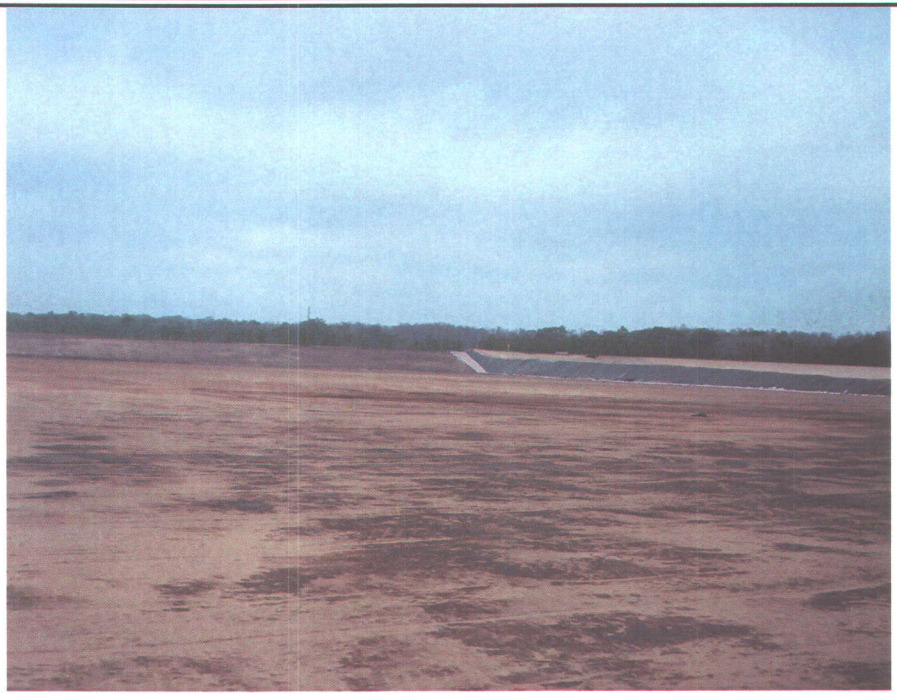
Subgrade in Cell 1B.

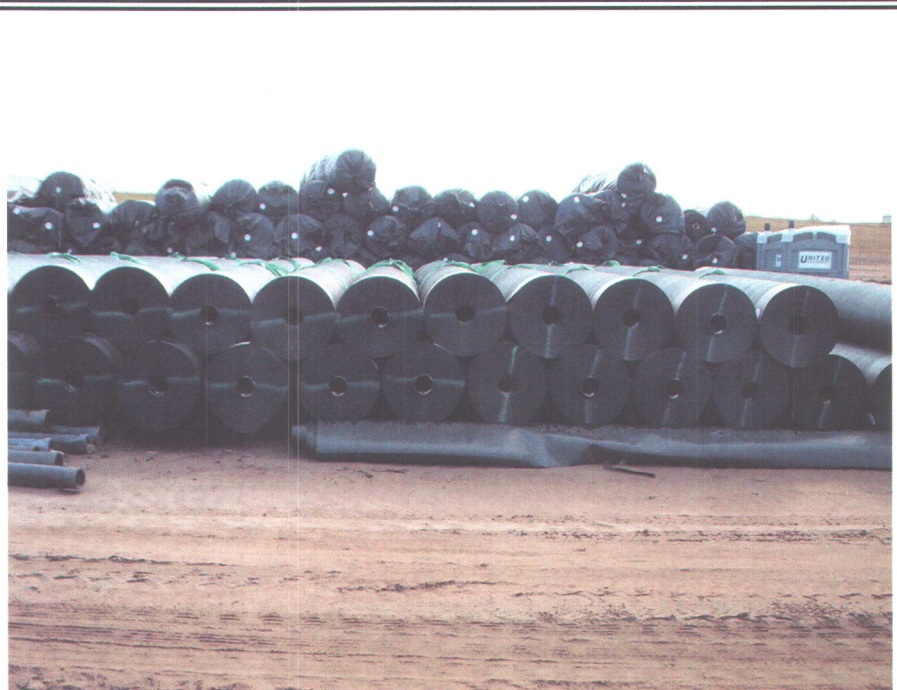
Photograph 4

Liner and geocomposite  
(at the back) stored.

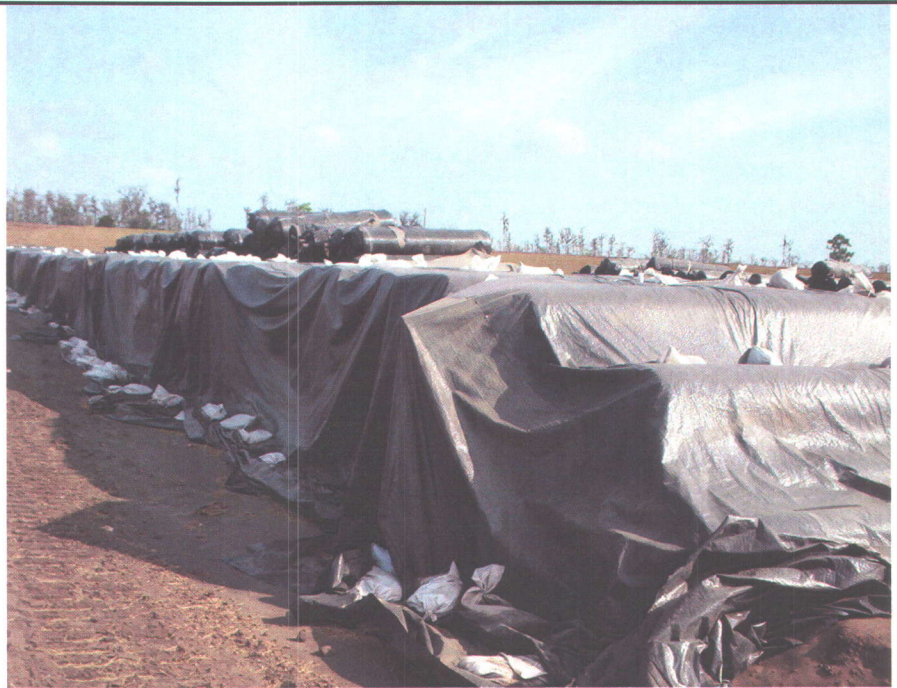
GCL stored.

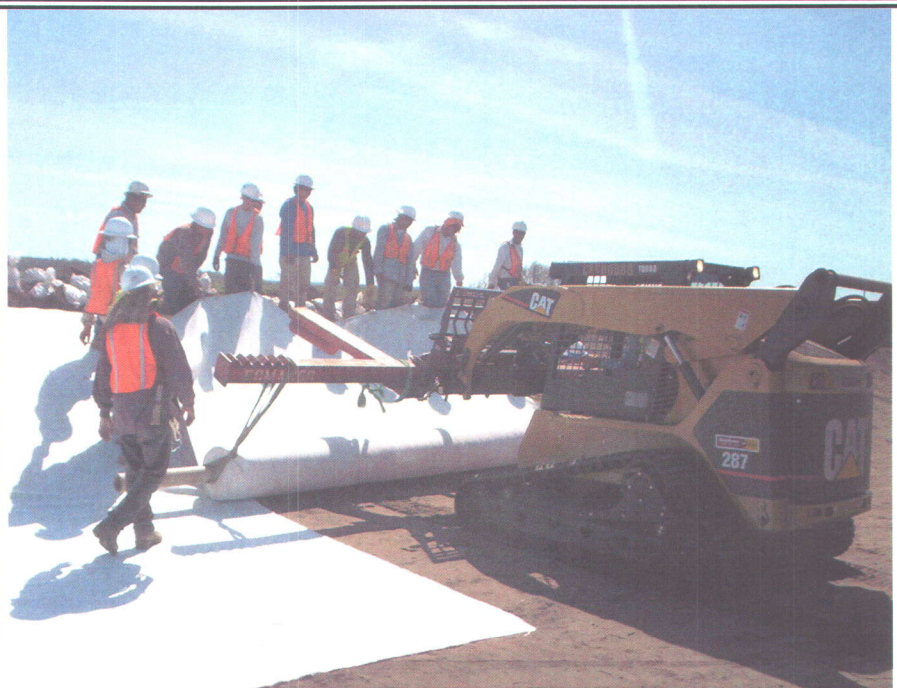
Photograph 6

Installation of secondary  
GCL over subbase in Cell  
1B.

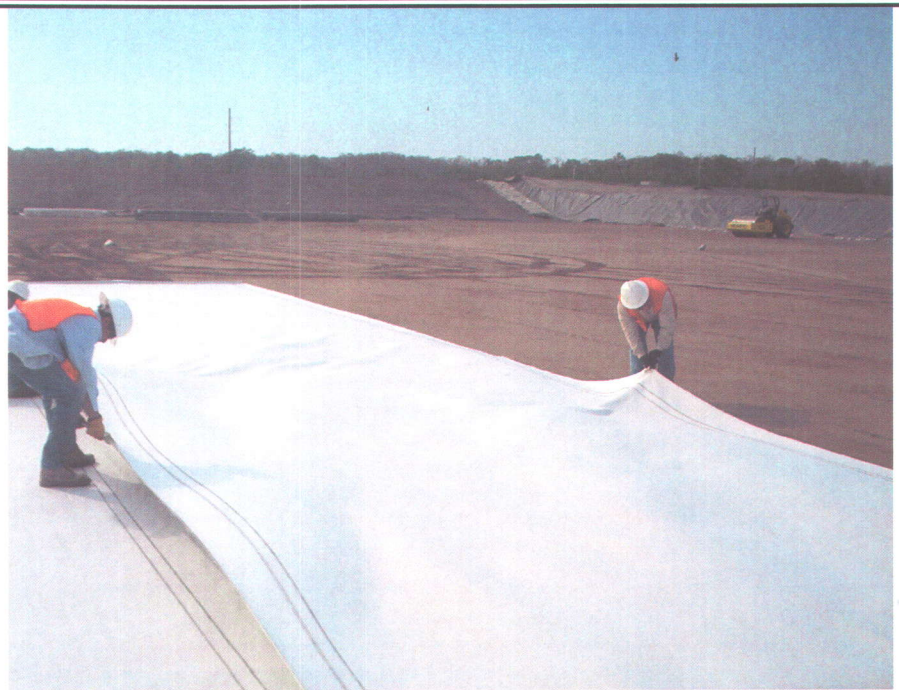
Installation of secondary  
GCL in Cell 1B.

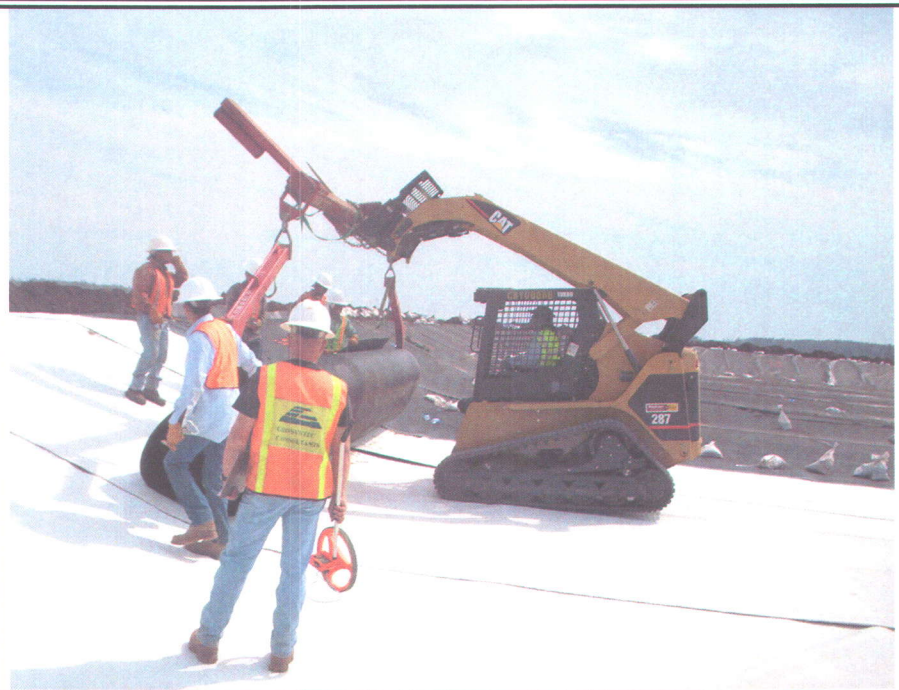
Photograph 8

Installation of secondary  
liner over GCL in Cell  
1B.

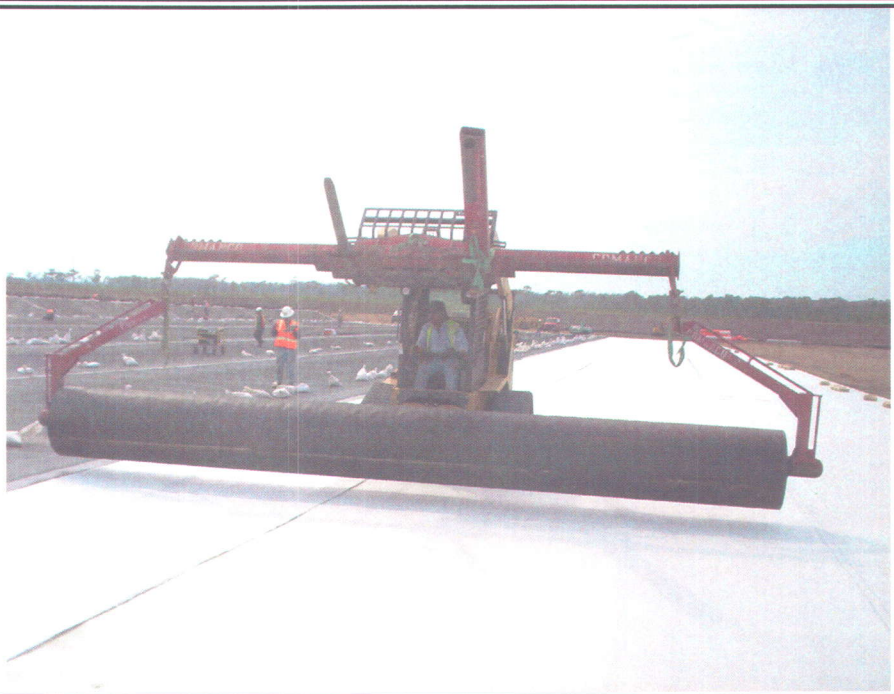
Deployment of secondary  
liner over GCL in Cell  
1B.

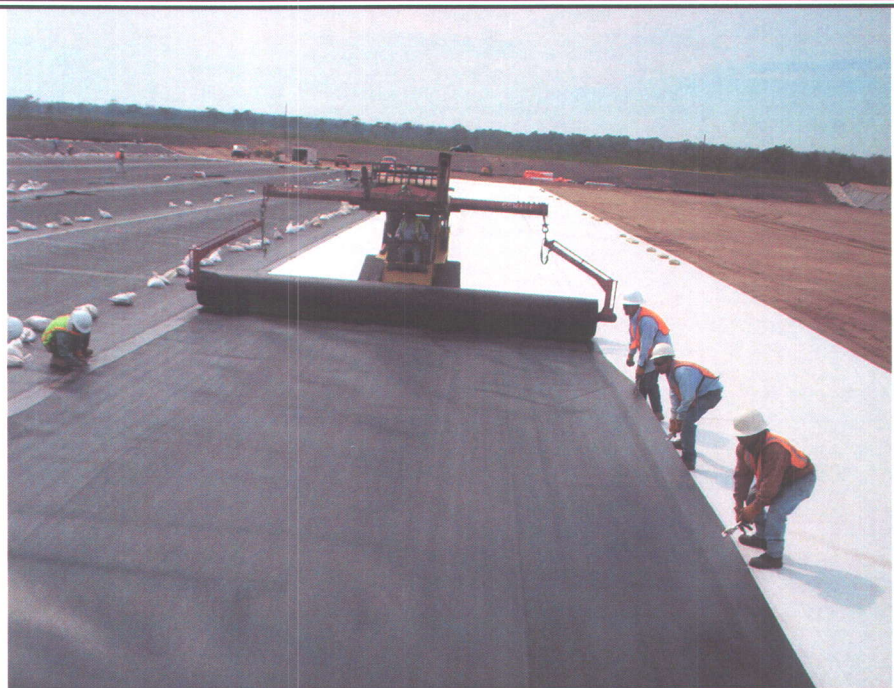
Photograph 10

Deployment of secondary  
liner over GCL in Cell  
1B.

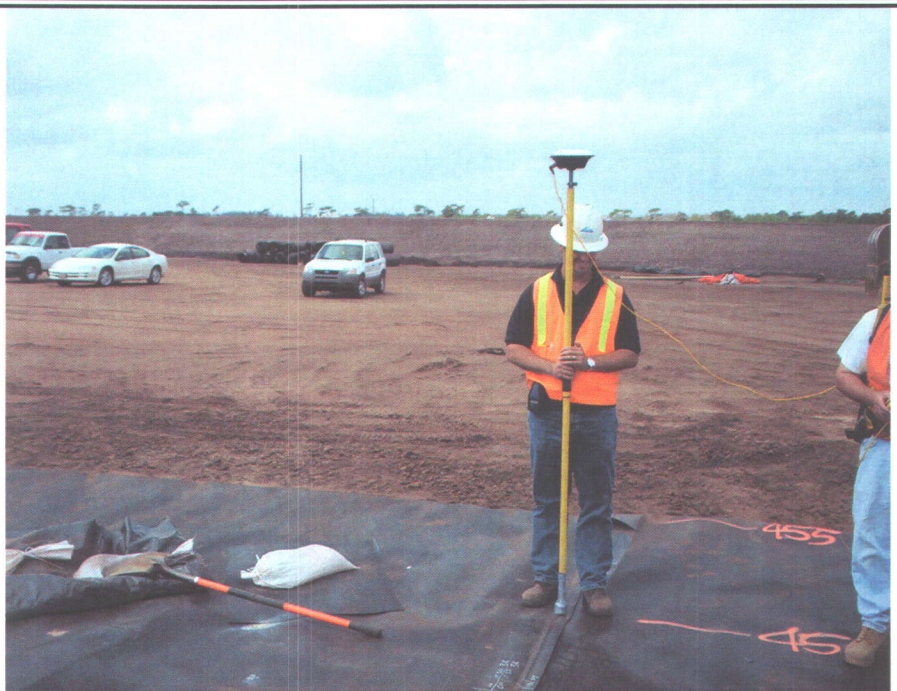
As-built survey of liner  
by CQA personnel.

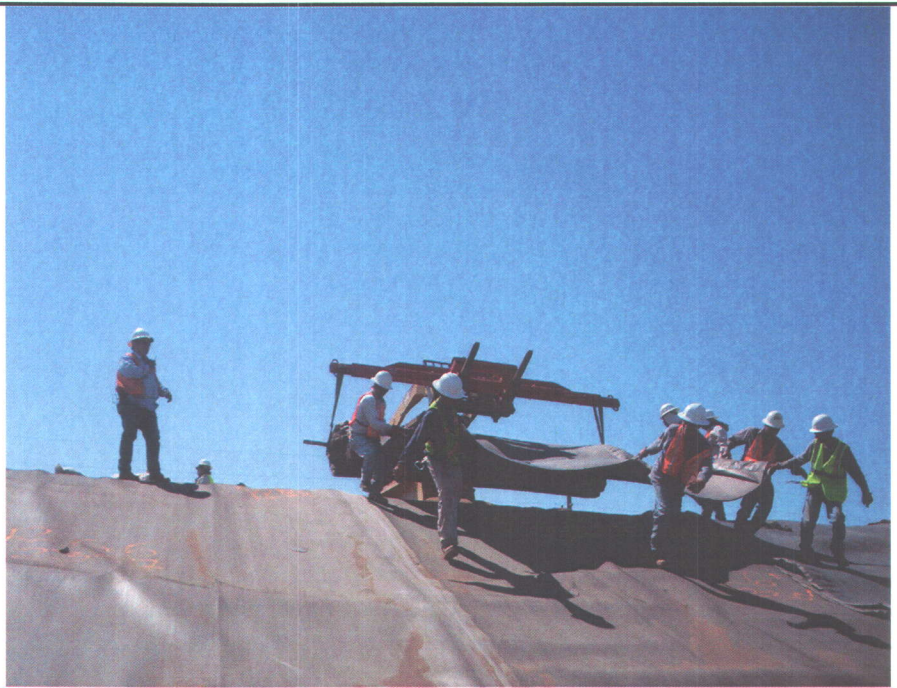
Photograph 12

Deploying tri-planar  
geocomposite.

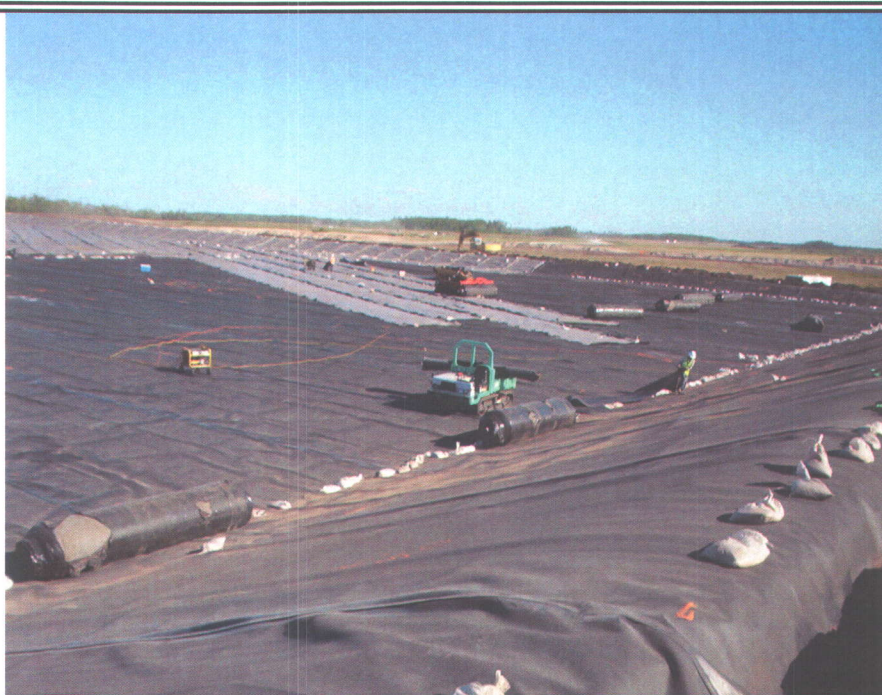
Geosynthetics installation  
in Cell 1B.

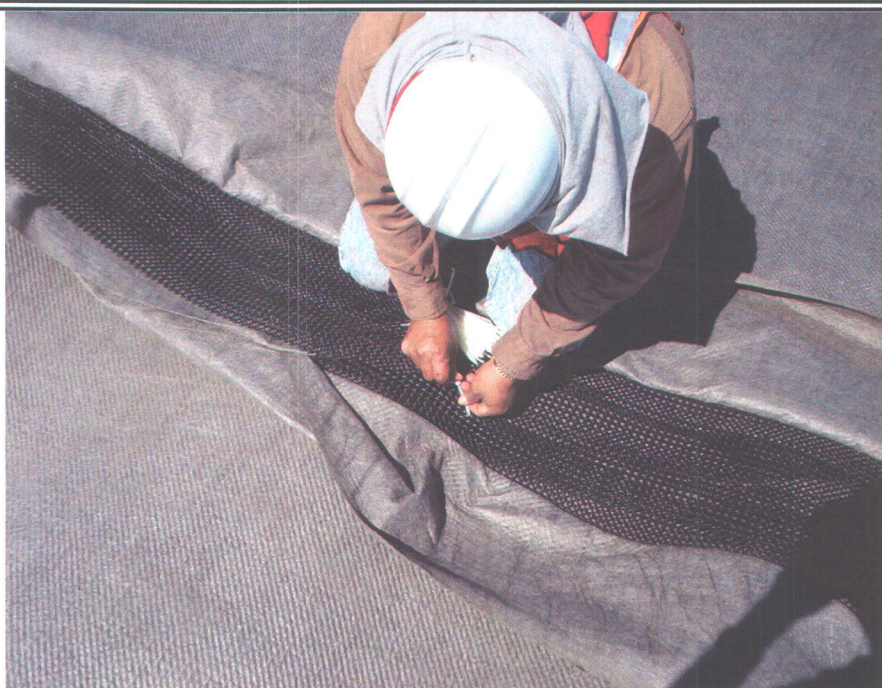
Photograph 14

Tying geonet for tri-  
planar geocomposite.

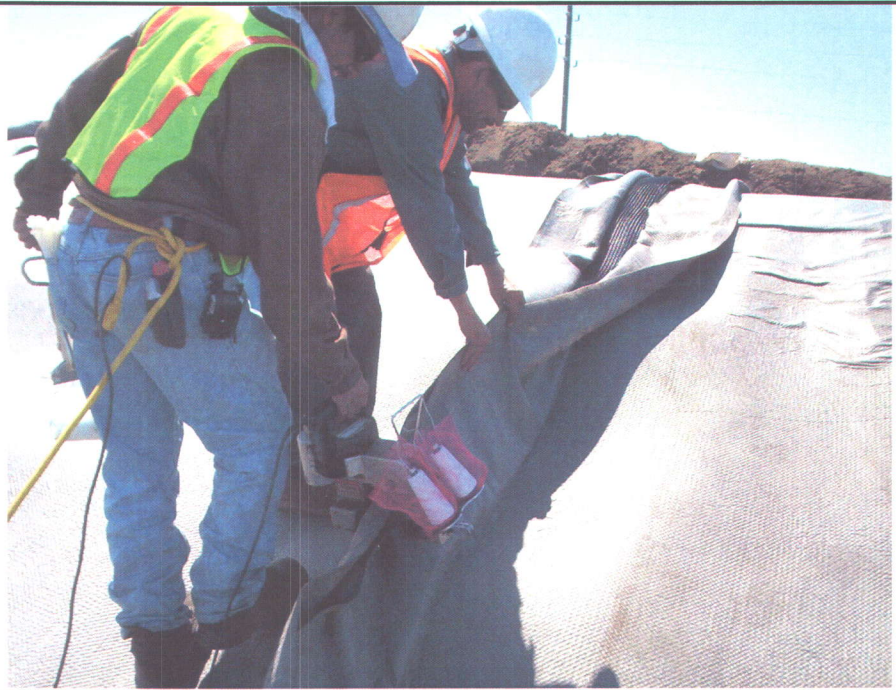
Sewing seams for tri-planar geocomposite.

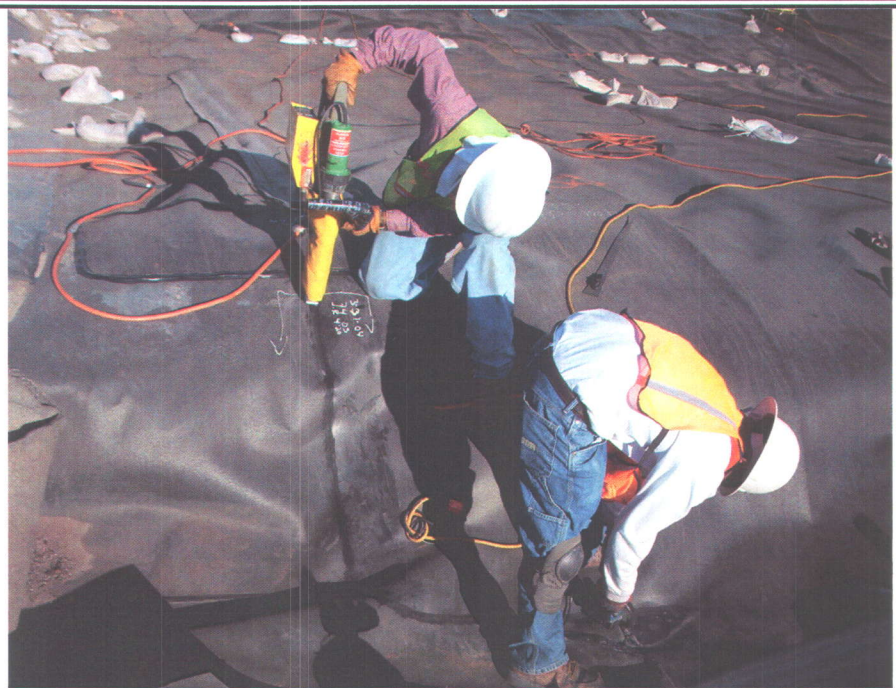
Photograph 16

Extrusion welding at the anchor trench.

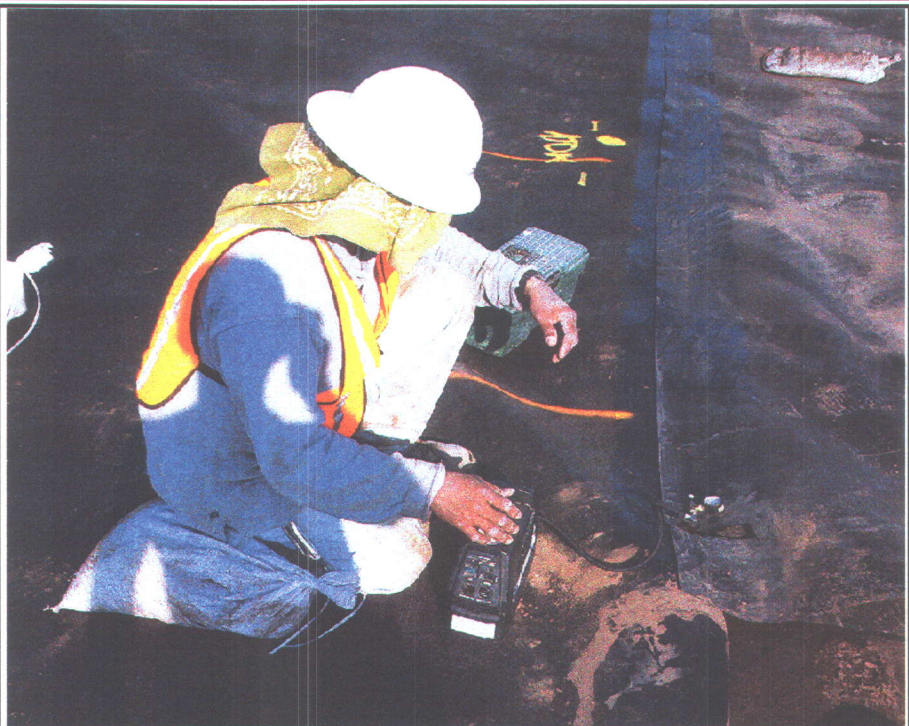
Air pressure test for  
fusion weld.

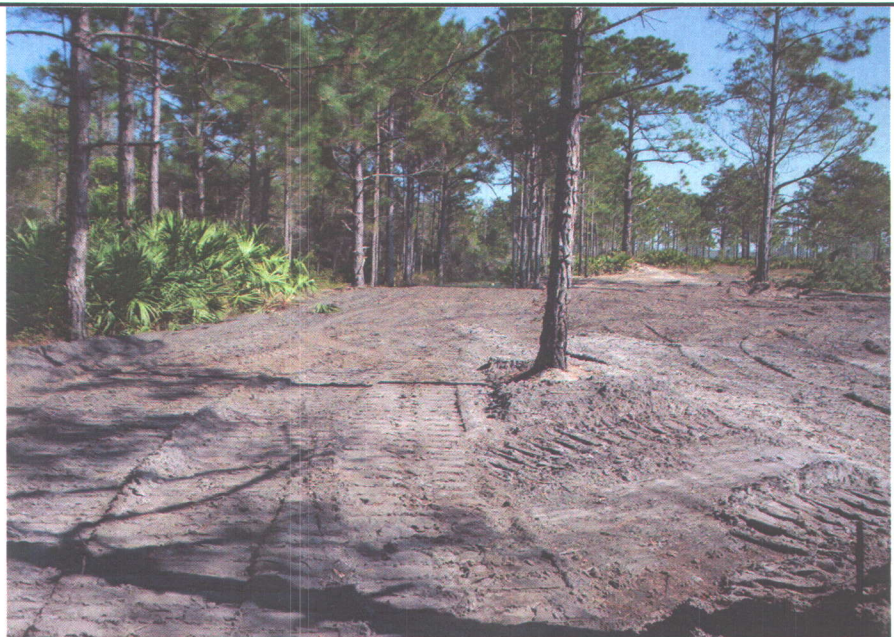
Photograph 18

Check Dam # 1.

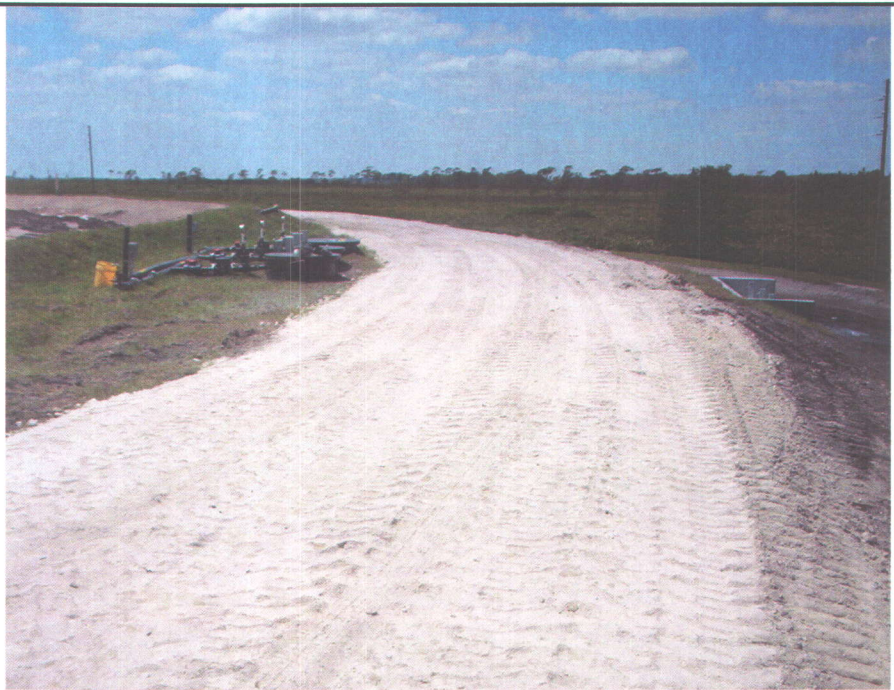
Perimeter maintenance  
road with base material.
