CERTIFICATION REPORT CONSTRUCTION OF CELL 3

OAK HAMMOCK DISPOSAL FACILITY
Osceola County, Florida

GEOSYNTEC CONSULTANTS

Project Number FQ0952
October 2006

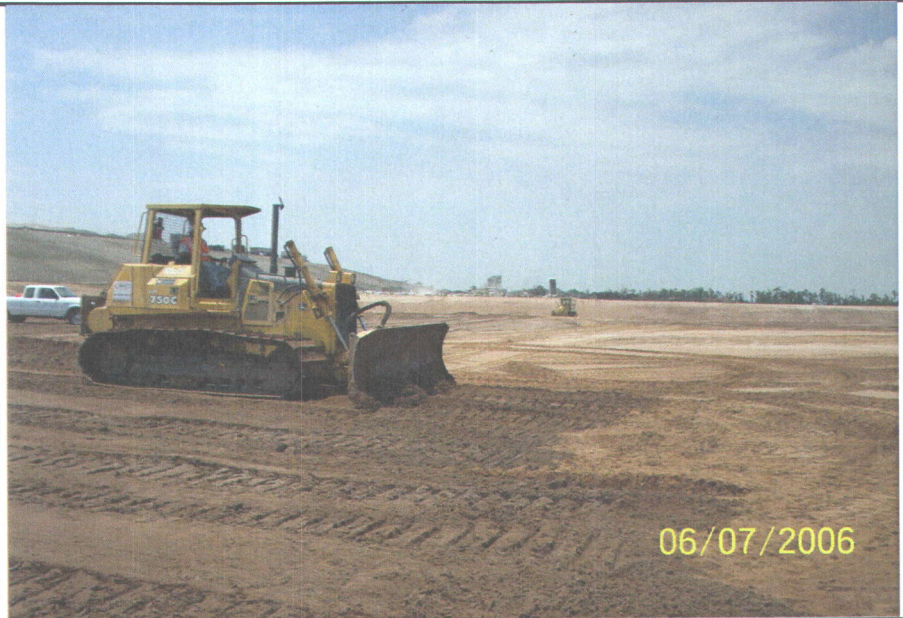
Comments:
Dozer spreading general fill for Cell 3 subgrade construction.

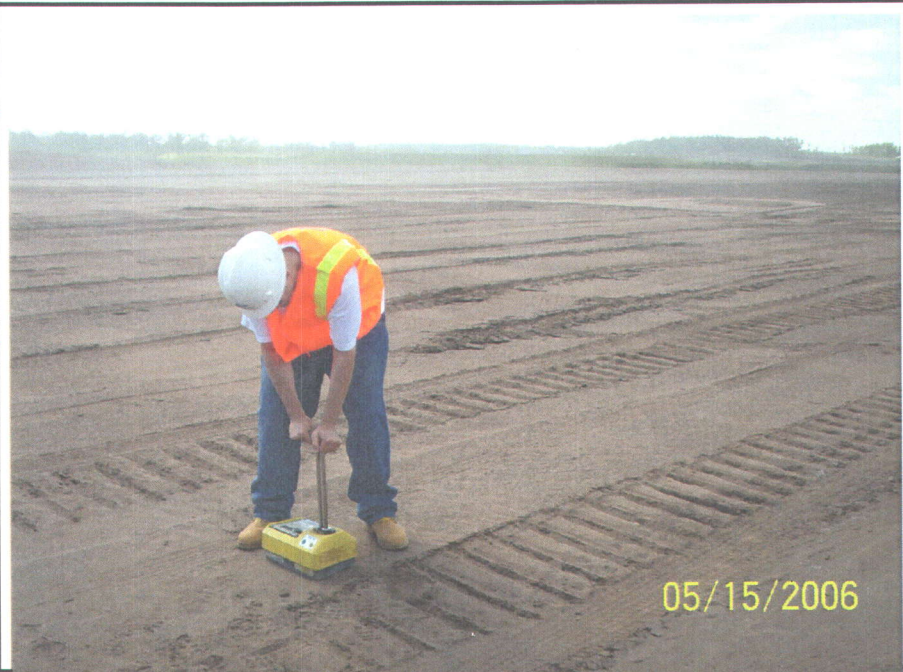
Photograph 2

Comments:
CQA technician performing nuclear moisture/density test.

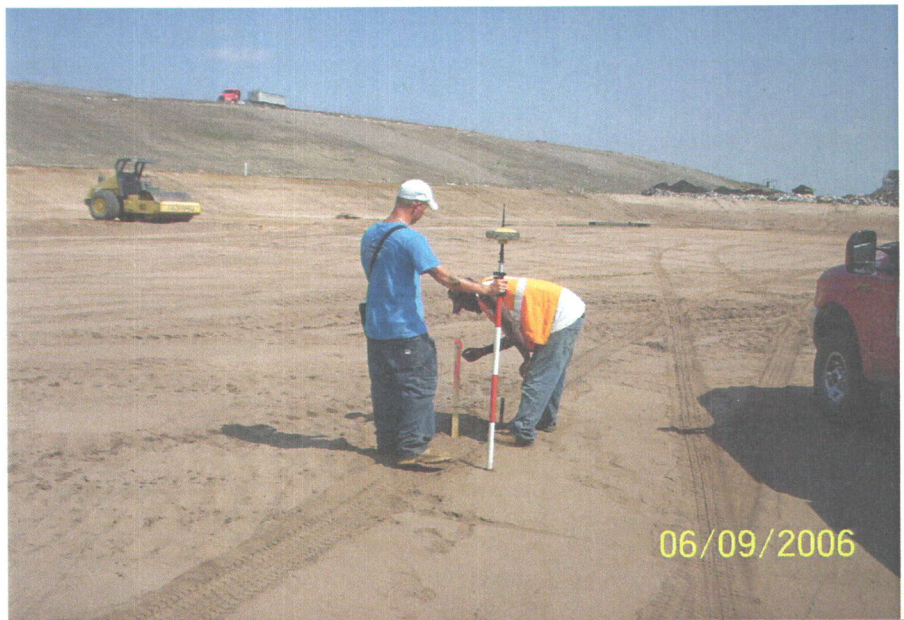
Comments:
GPS surveyor setting
grade stakes.

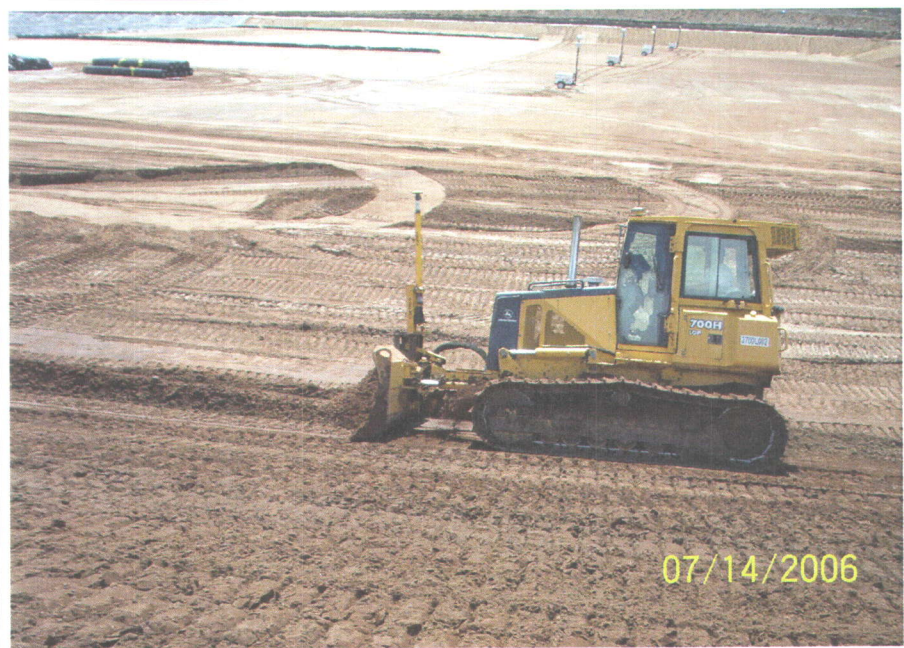
Photograph 4

Comments:
Dozer w/GPS final
grading liner subbase
layer on east slope of Cell
3.

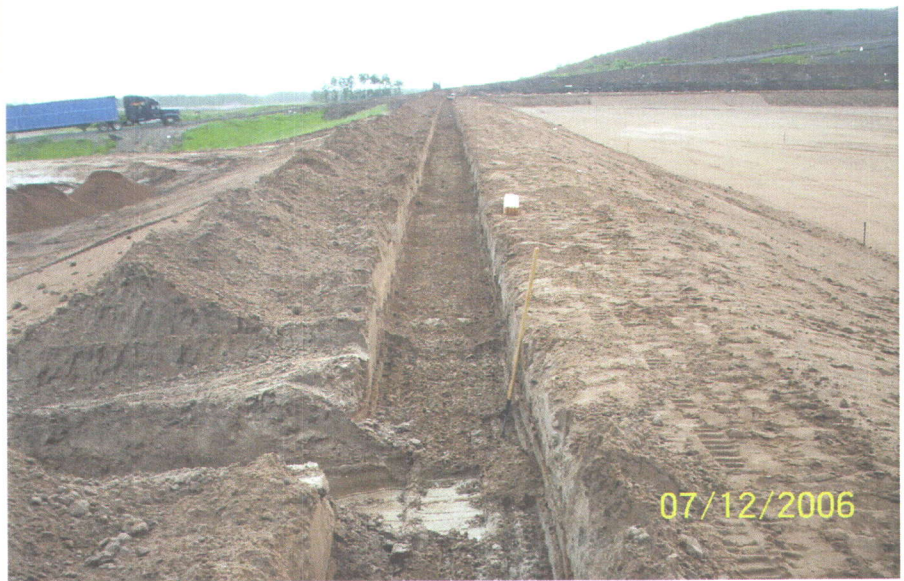
Comments:
Geosynthetics anchor
trench excavated along
southern intercell berm.

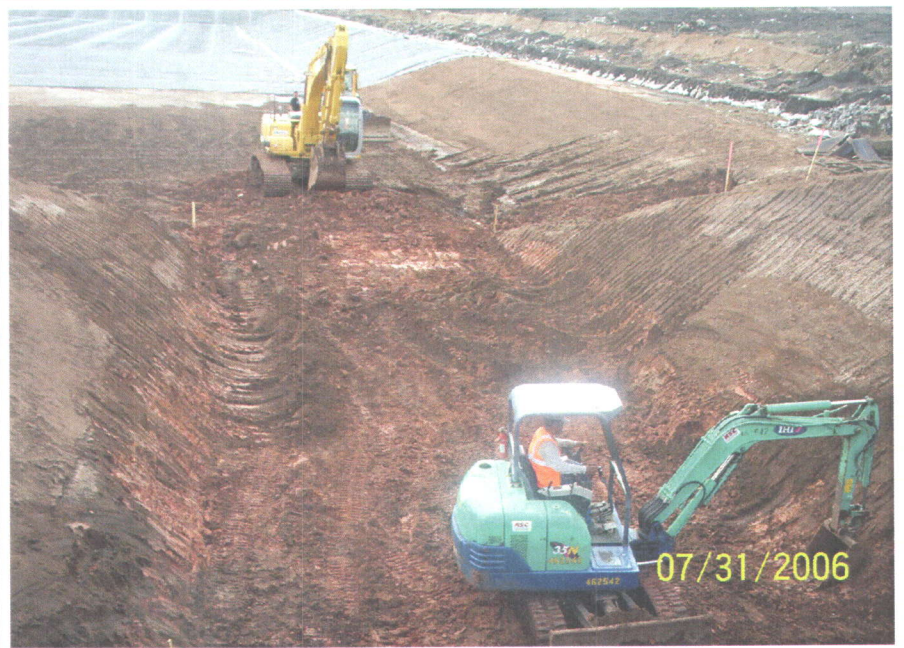
Photograph 6

Comments:
Excavation of Cell 3
sump area.

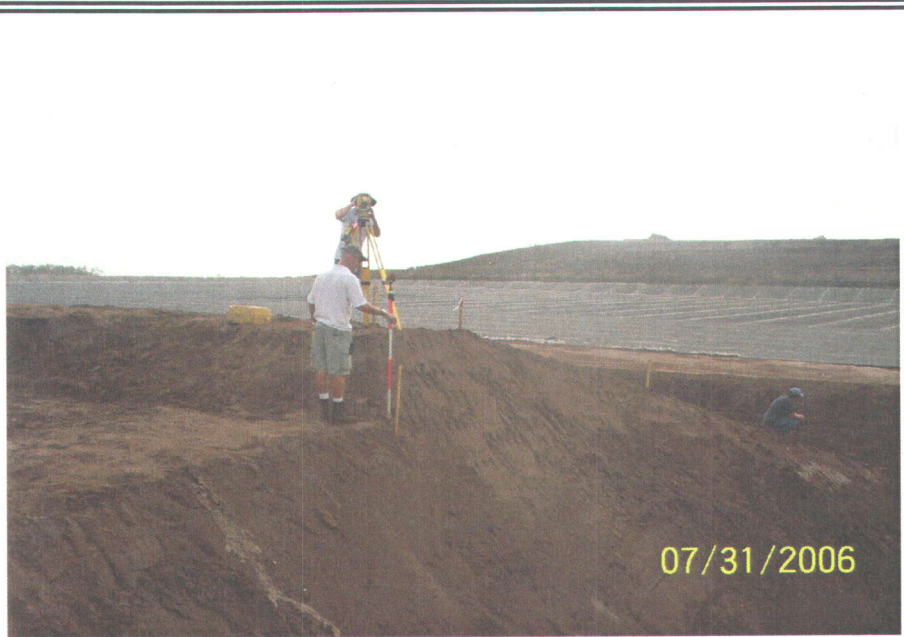
Comments:
Licensed surveyor
performing as-built
survey of Cell 3 sump
area.

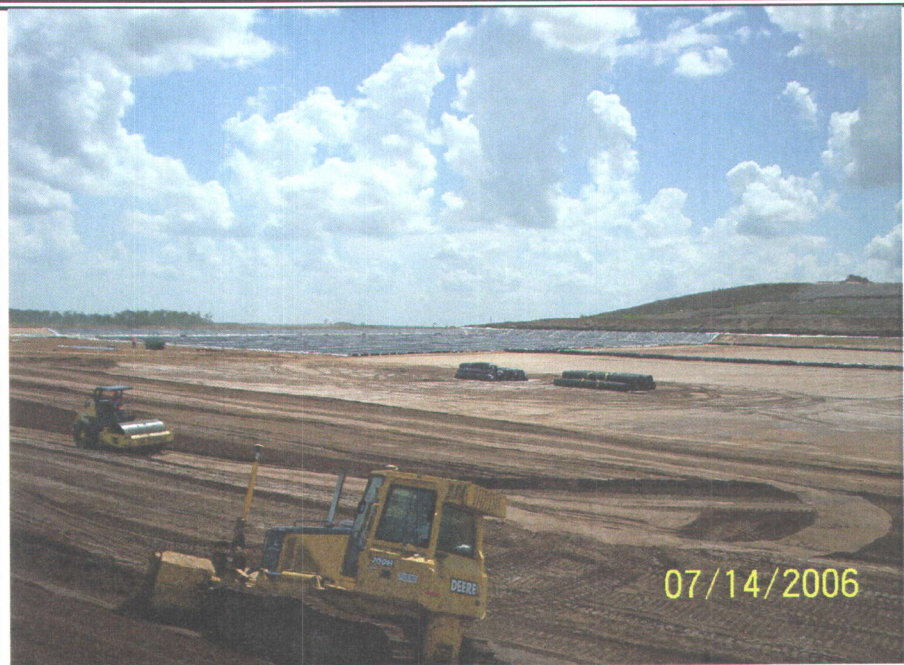
Photograph 8

Comments:
Cell 3 construction
progress photograph.
Liner subbase preparation
in foreground.

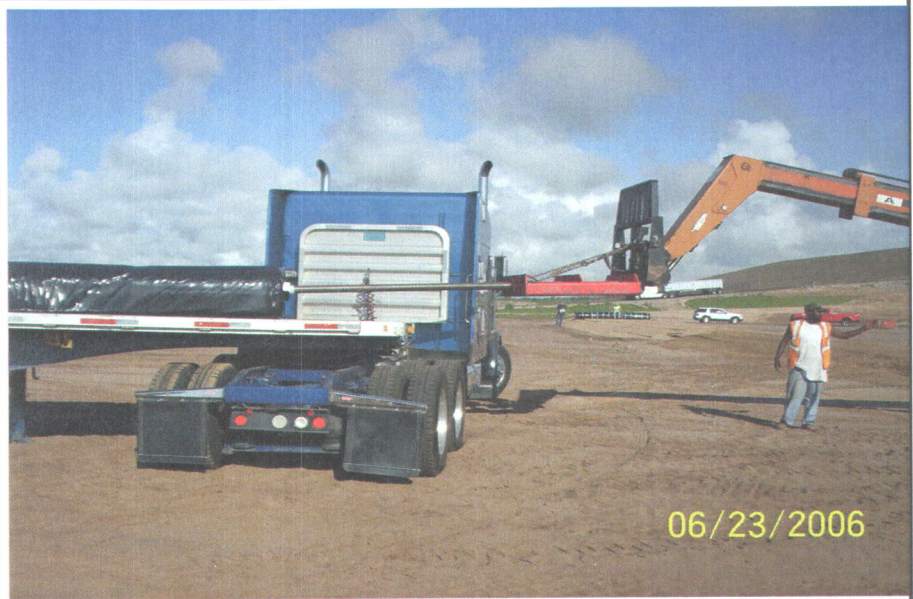
Comments:
Unloading of GCL using
forklift with stinger bar.

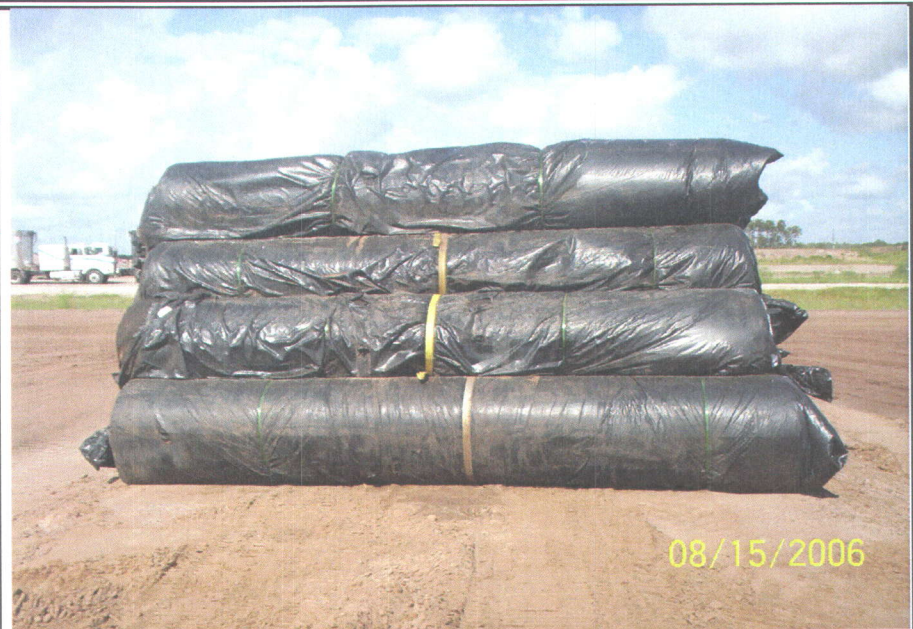
Photograph 10

Comments:
Staging of geocomposite
rolls.

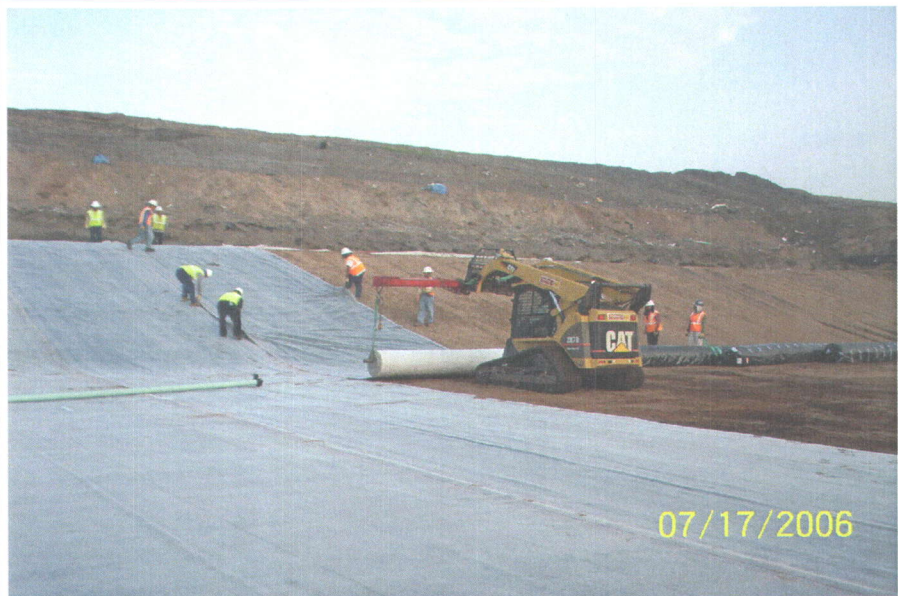
Comments:
Installation of secondary
GCL over prepared
subbase along western
side of Cell 3.

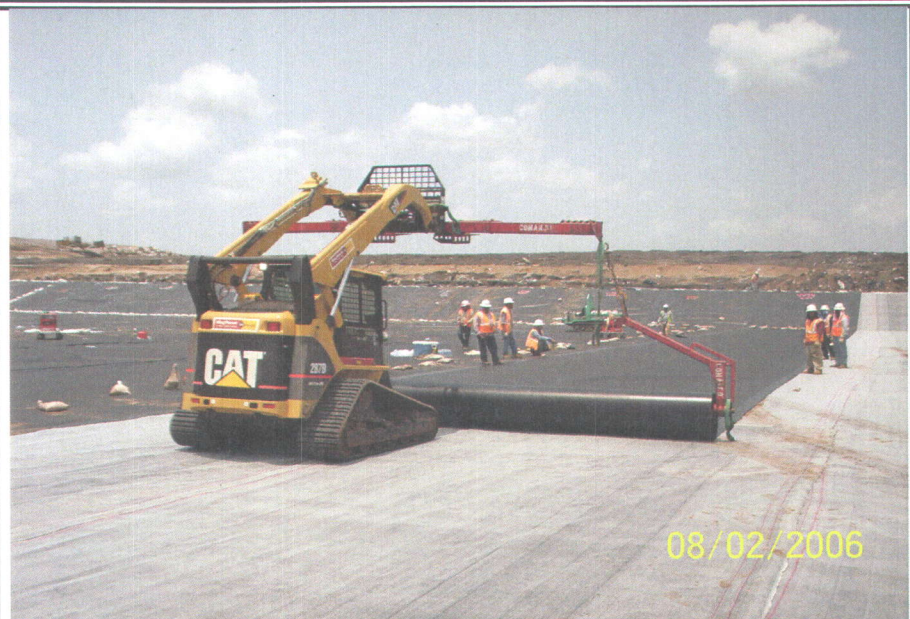
Photograph 12

Comments:
Deployment of secondary
geomembrane liner.

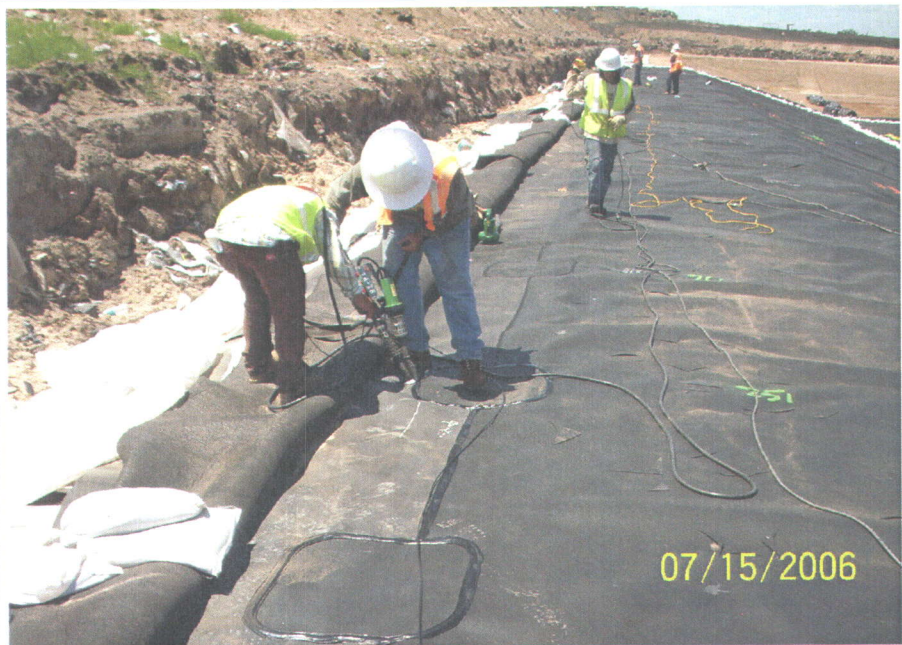
Comments:
Extrusion welding of
geomembrane panels
along Cell 3/Cell 4 tie in.

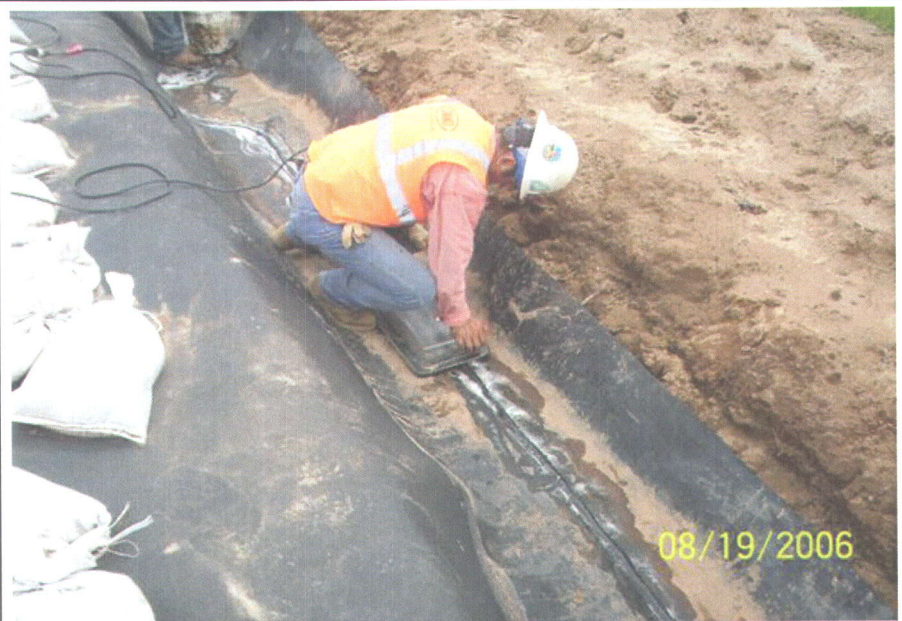
Photograph 14

Comments:
Vacuum box testing of
extrusion welded seam.

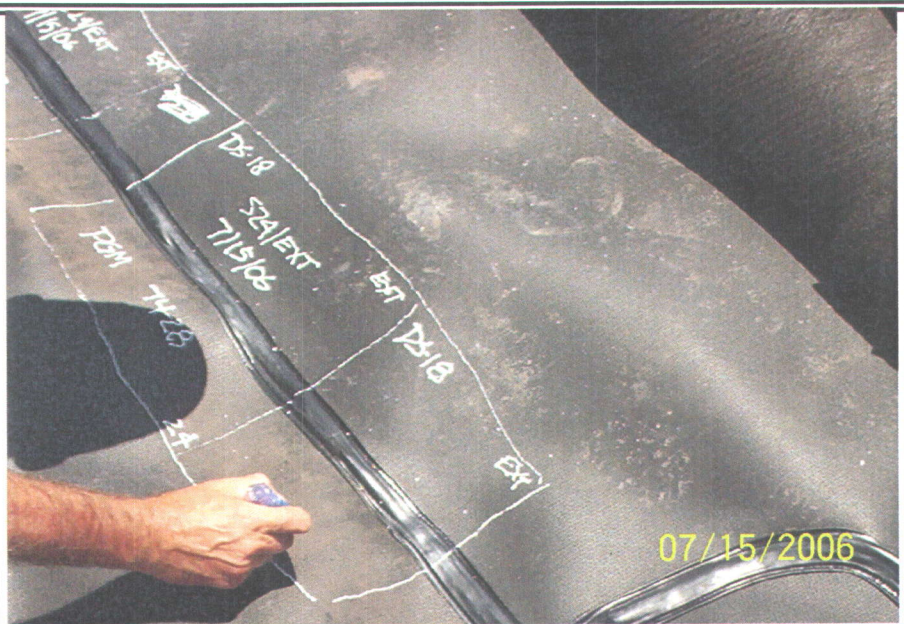
Comments:
CQA Technician marking
destructive seam sample
on extrusion welded
seam.

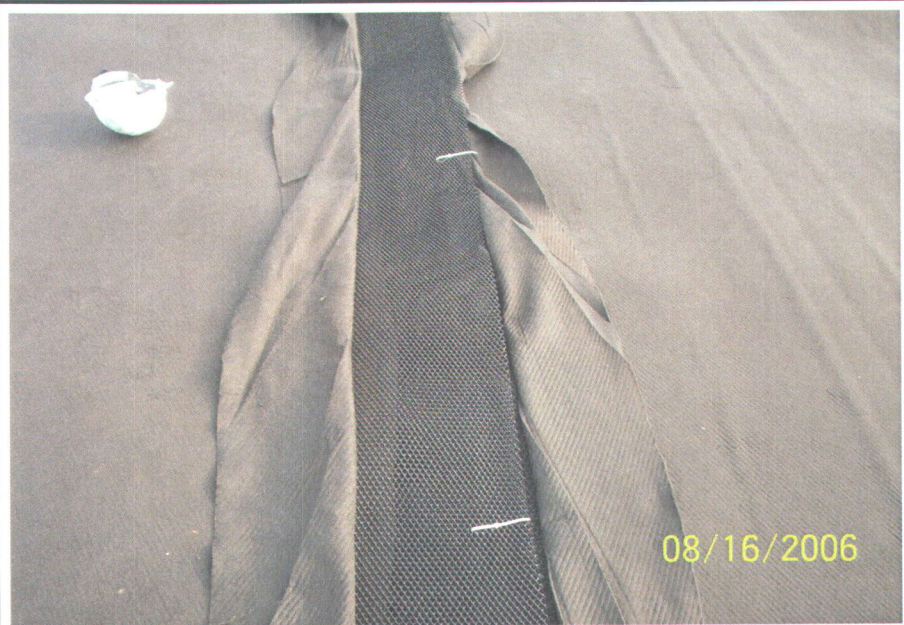
Photograph 16

Comments:
Attachment of geonet
components of adjacent
geocomposite panels
using nylon cable ties.

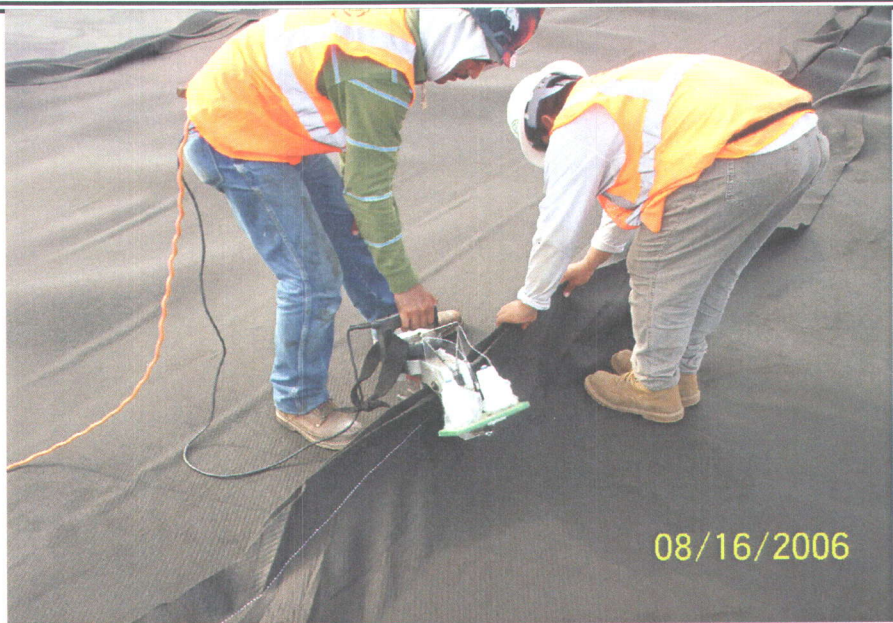
Comments:
Continuous sewing of
upper geotextile
component of adjacent
geocomposite panels.

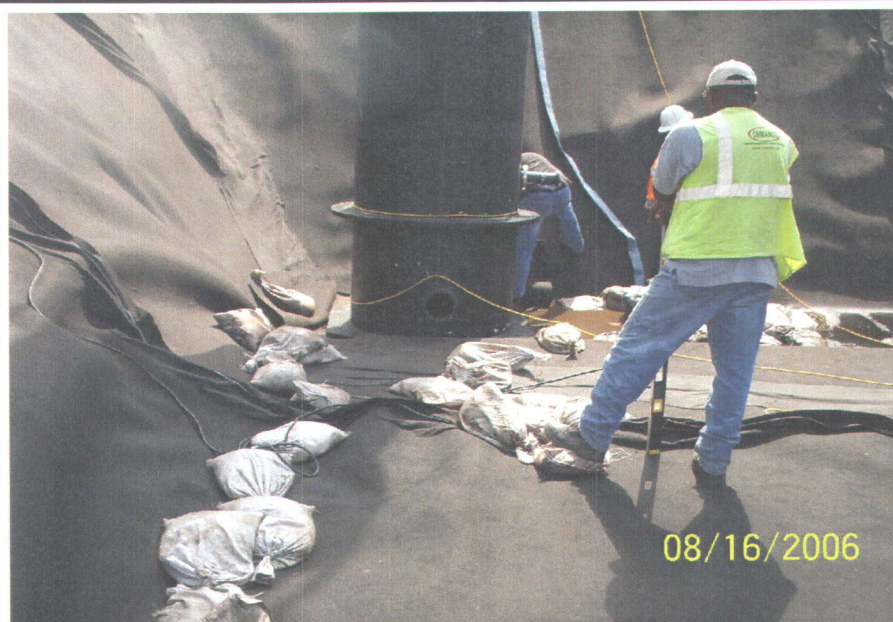
Photograph 18

Comments:
Installation of secondary
sump riser within Cell 3
sump area.

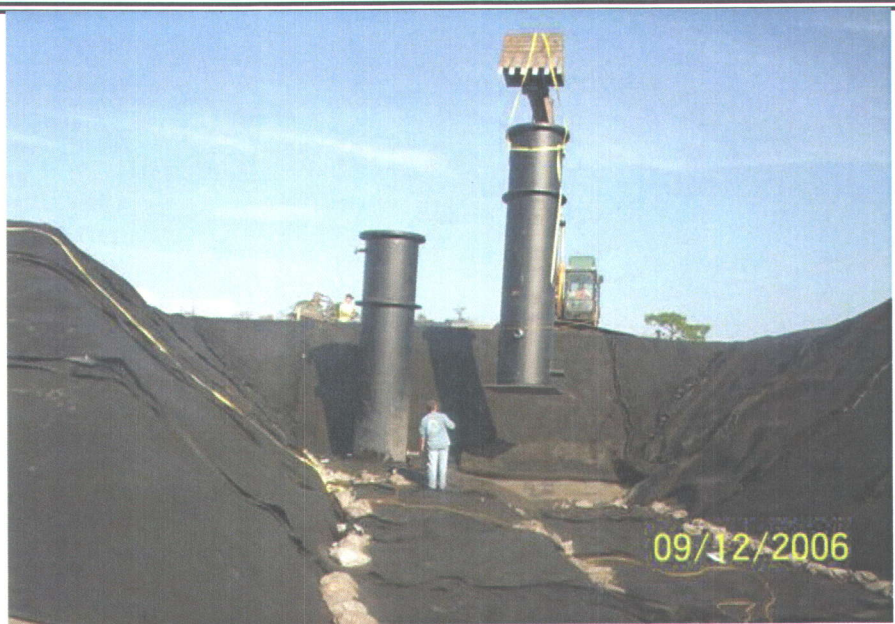
Comments:
Setting of primary sump riser within Cell 3 sump area.

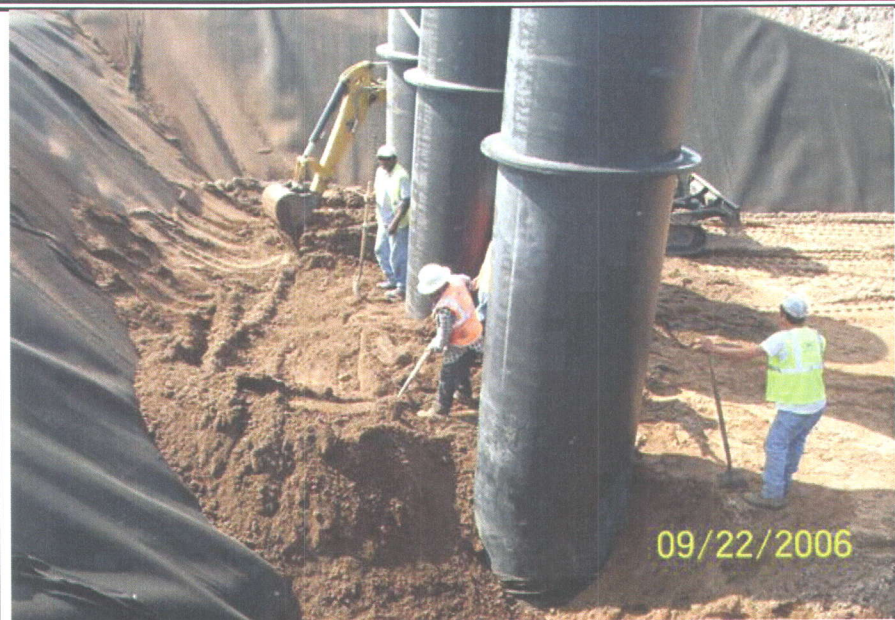
Photograph 20

Comments:
Placement of general fill around sump risers within Cell 3 sump area.

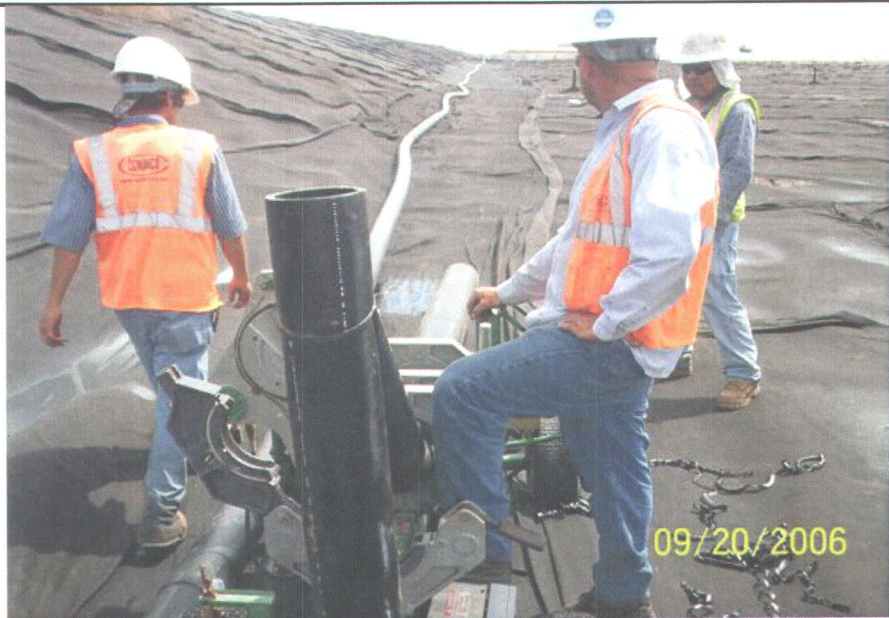
Comments:
Thermal butt fusion
welding of HDPE
leachate collection
piping.

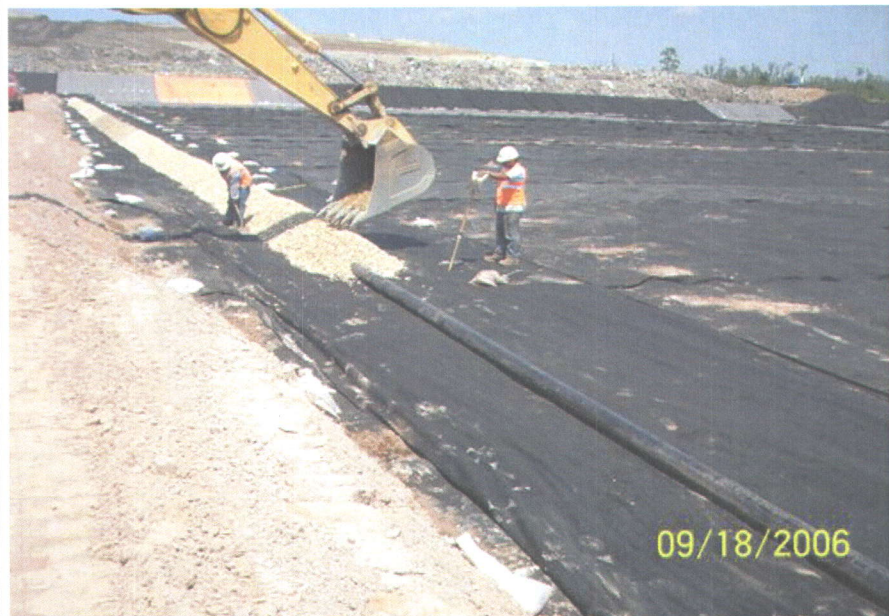
Photograph 22

Comments:
Placement of drainage
gravel for the central
leachate collection drain
Within Cell 3.

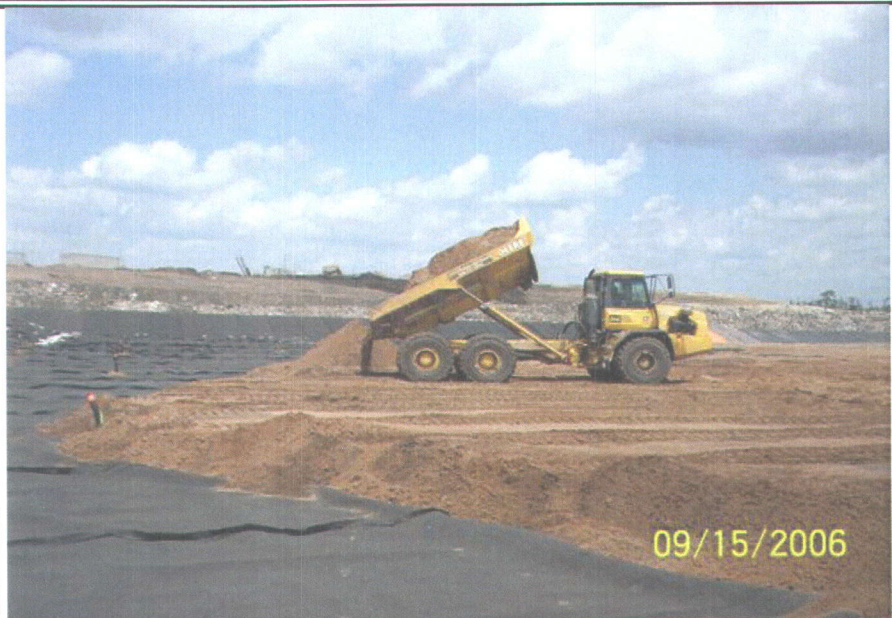
Comments:
Placement of protective
cover soils within Cell 3.

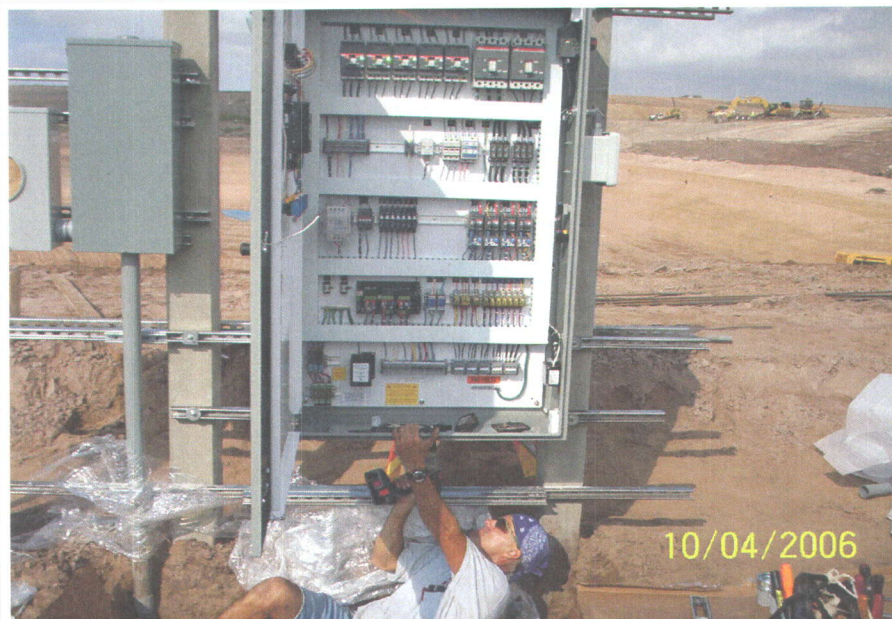
Photograph 24

Comments:
Installation of control
panel at Cell 3 sump area.
