**Re: Permit No: 291114-003-SF/14 Pore Water Collection System - Video Inspection**

In compliance with Specific Condition # C.5.d., Alcoa World Alumina LLC is submitting this Video Inspection report of the Pore Water Collection System for CEAT-3.

# Project: CEAT 3

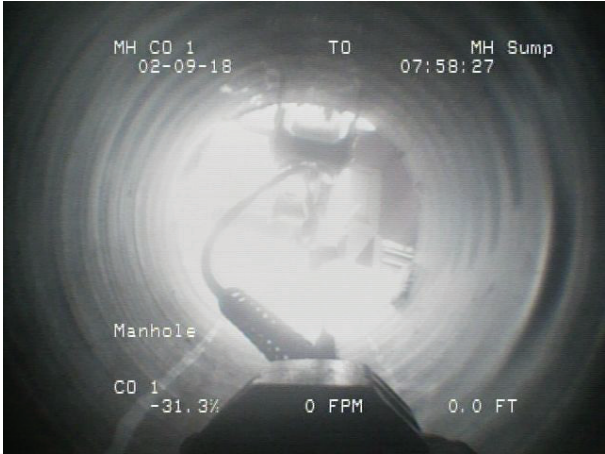
Distance	Fault Observation	Time	Picture
0.0	Manhole Severity: None Remarks: CO 1	01:31

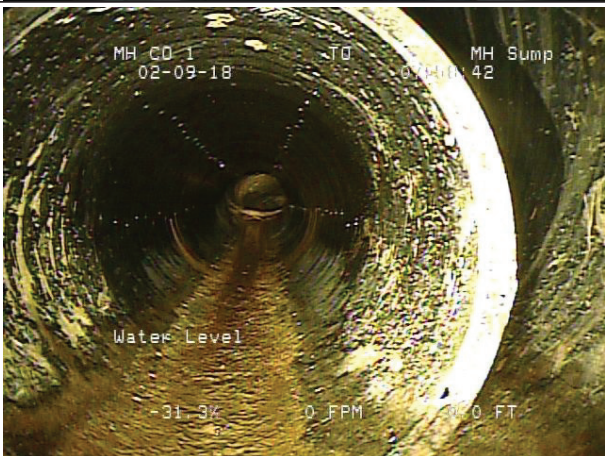
0.0	Water Level Severity: None Percent: 0	01:46

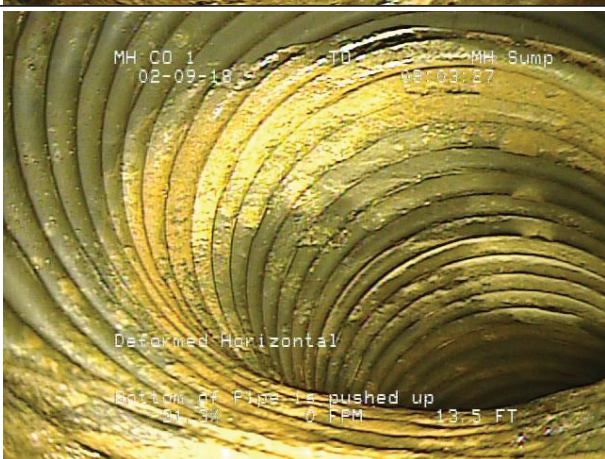
13.5	Deformed Horizontal Severity: None Percent: 10 Remarks: Bottom of Pipe is pushed up Struct Weight: 5	06:31

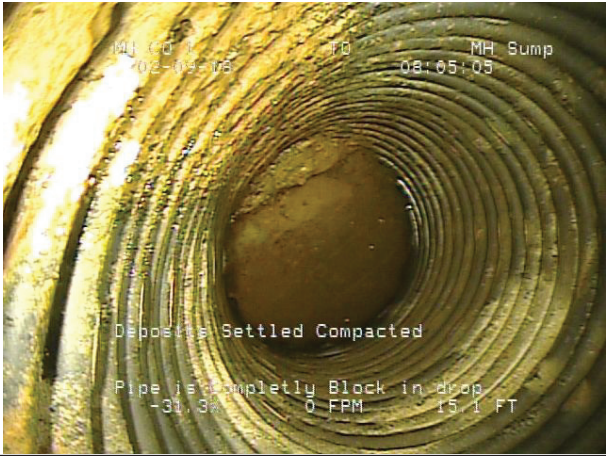
Distance	Fault Observation	Time	Picture
15.1	<b>Deposits Settled Compacted</b> <b>Position: 12 To 12</b> <b>Severity: None</b> <b>Percent: 100</b> <b>Remarks: Pipe is Completly Block in drop</b> <b>Maint Weight: 5</b>	08:09

- Attempt to execute a jet cleaning of the main line between CO1 and the sump. This comes with some potential risks, such as additional damage to the pipe joints and filter fabric which lines the piping system.
- Pump the sump dry and take additional video from the sump toward CO1, as with current condition, with the sump high due to winter moratorium on pumping (as has been the standard for the last few years) the camera could not run from the sump toward CO1.

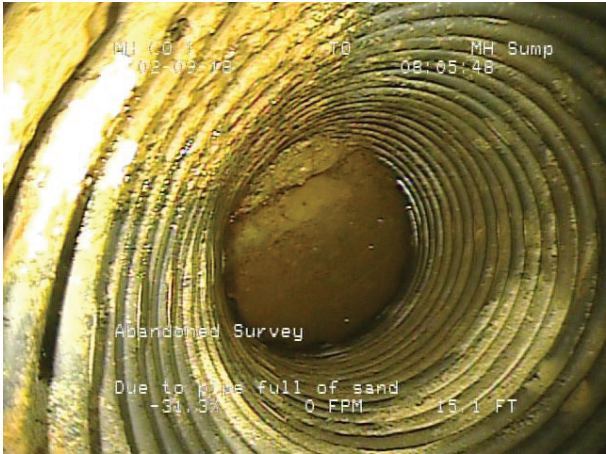
15.1	<b>Abandoned Survey</b> <b>Severity: None</b> <b>Remarks: Due to pipe full of sand</b>	08:51

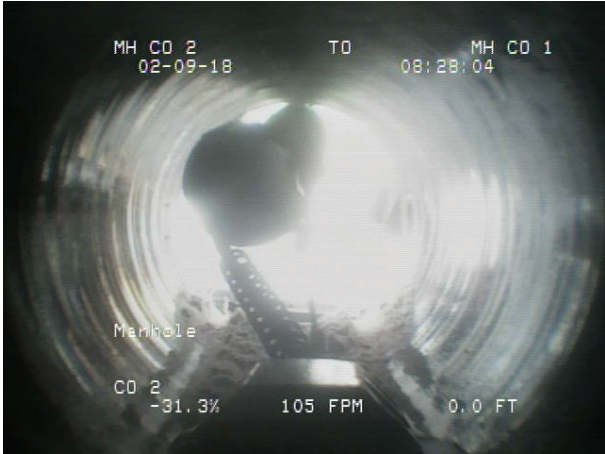
Distance	Fault Observation	Time	Picture
0.0	Manhole Severity: None Remarks: CO 2	41

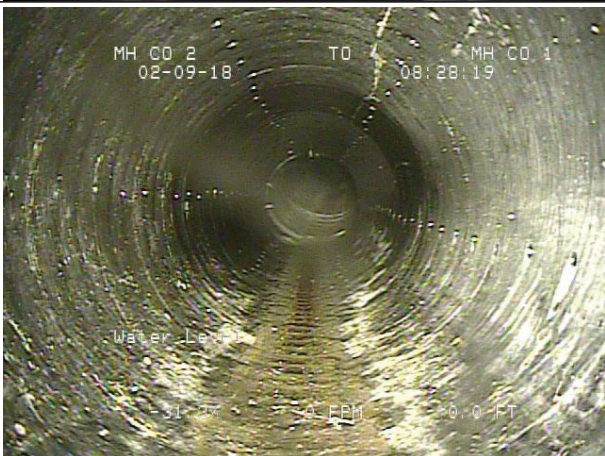
0.0	Water Level Severity: None Percent: 0	55

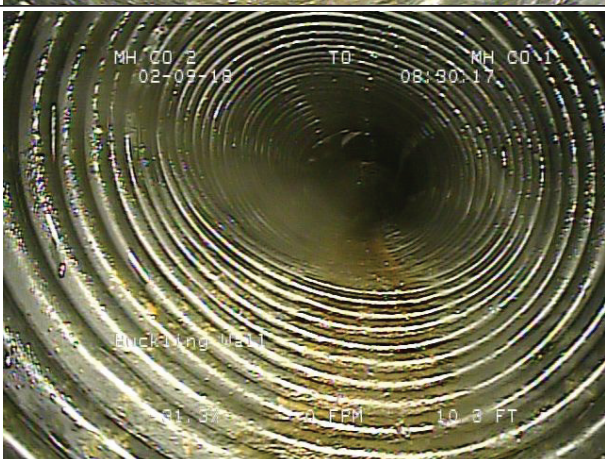
10.3	Buckling Wall Position: 5 To 10 Severity: None	02:53

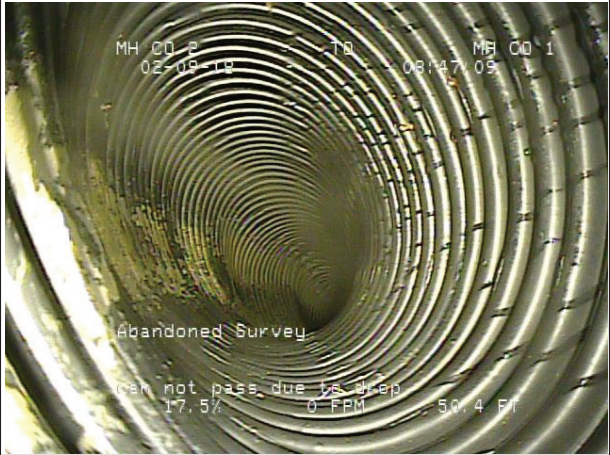
Distance	Fault Observation	Time	Picture
50.4	<p><b>Abandoned Survey</b>  <b>Severity: None</b>  <b>Remarks: can not pass due to drop</b></p>	19:45

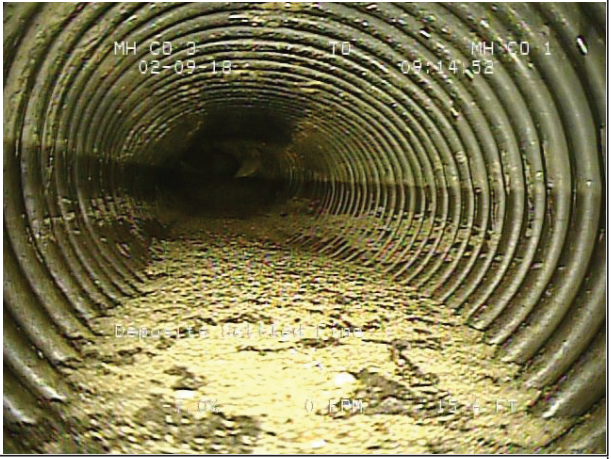
Distance	Fault Observation	Time	Picture
15.6	<b>Deposits Settled Fine</b> <b>Position: 5 To 7</b> <b>Severity: None</b> <b>Percent: 5</b> <b>Maint Weight: 2</b>	03:37

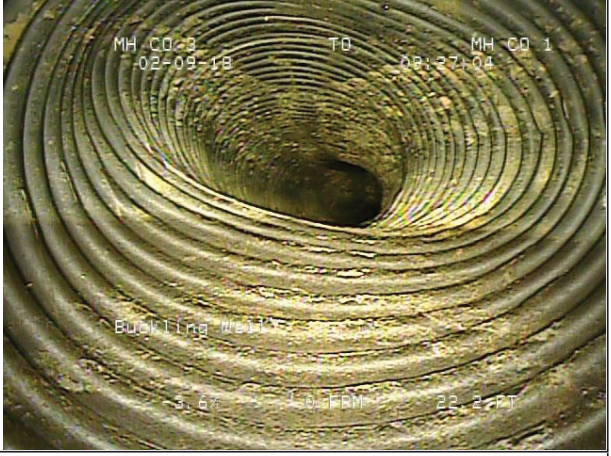
22.2	<b>Buckling Wall</b> <b>Position: 5 To 9</b> <b>Severity: None</b>	15:49

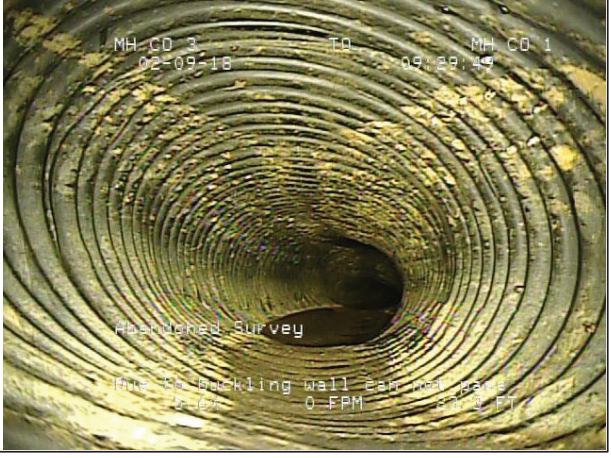
23.3	<b>Abandoned Survey</b> <b>Severity: None</b> <b>Remarks: Due to buckling wall can not pass</b>	18:33

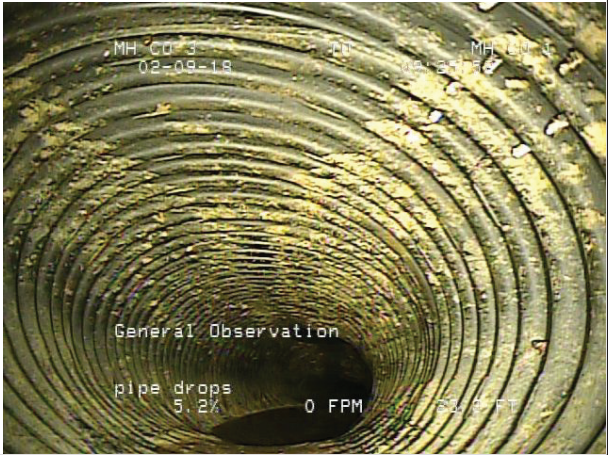
Distance	Fault Observation	Time	Picture
23.8	<b>General Observation</b> <b>Severity: None</b> <b>Remarks: pipe drops</b>	14:38

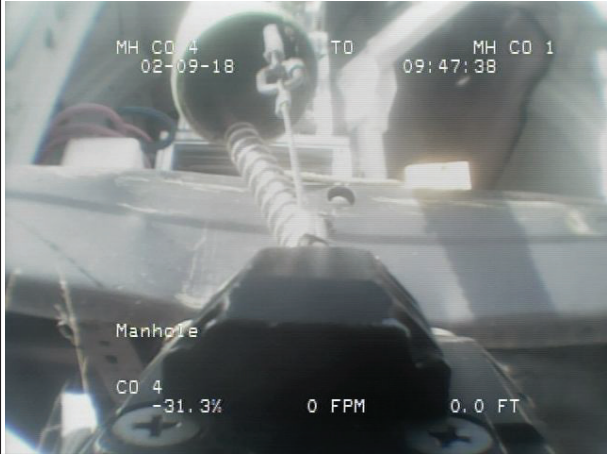
Distance	Fault Observation	Time	Picture
0.0	Manhole Severity: None Remarks: CO 4	01:18

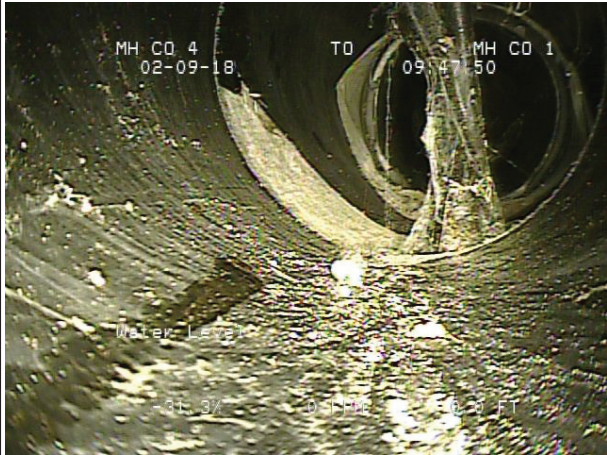
0.0	Water Level Severity: None Percent: 0	01:31

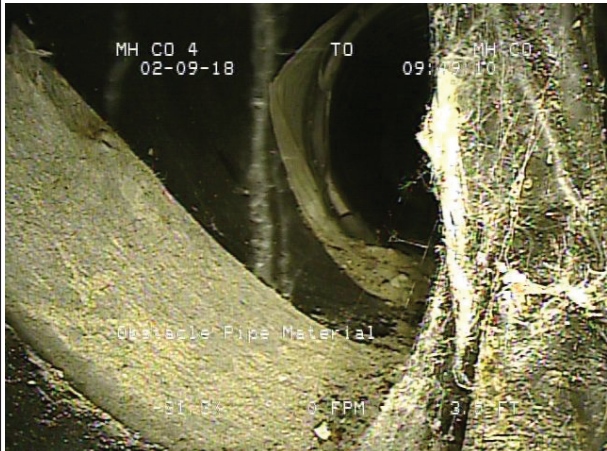
3.5	Obstacle Pipe Material Position: 12 To 6 Severity: None Percent: 5 Maint Weight: 2	02:50
