From: Justin G. Roessler <jroessler@pascocountyfl.net>
Sent: Thursday, August 8, 2019 4:00 PM
To: Black, Alexis <Alexis.Black@FloridaDEP.gov>
Cc: John Power <jpower@pascocountyfl.net>; David J. Ostuno <dostuno@pascocountyfl.net>; Curt E. Heiseler <cheiseler@pascocountyfl.net>
Subject: Pasco Inspection Response

CUSA18A7

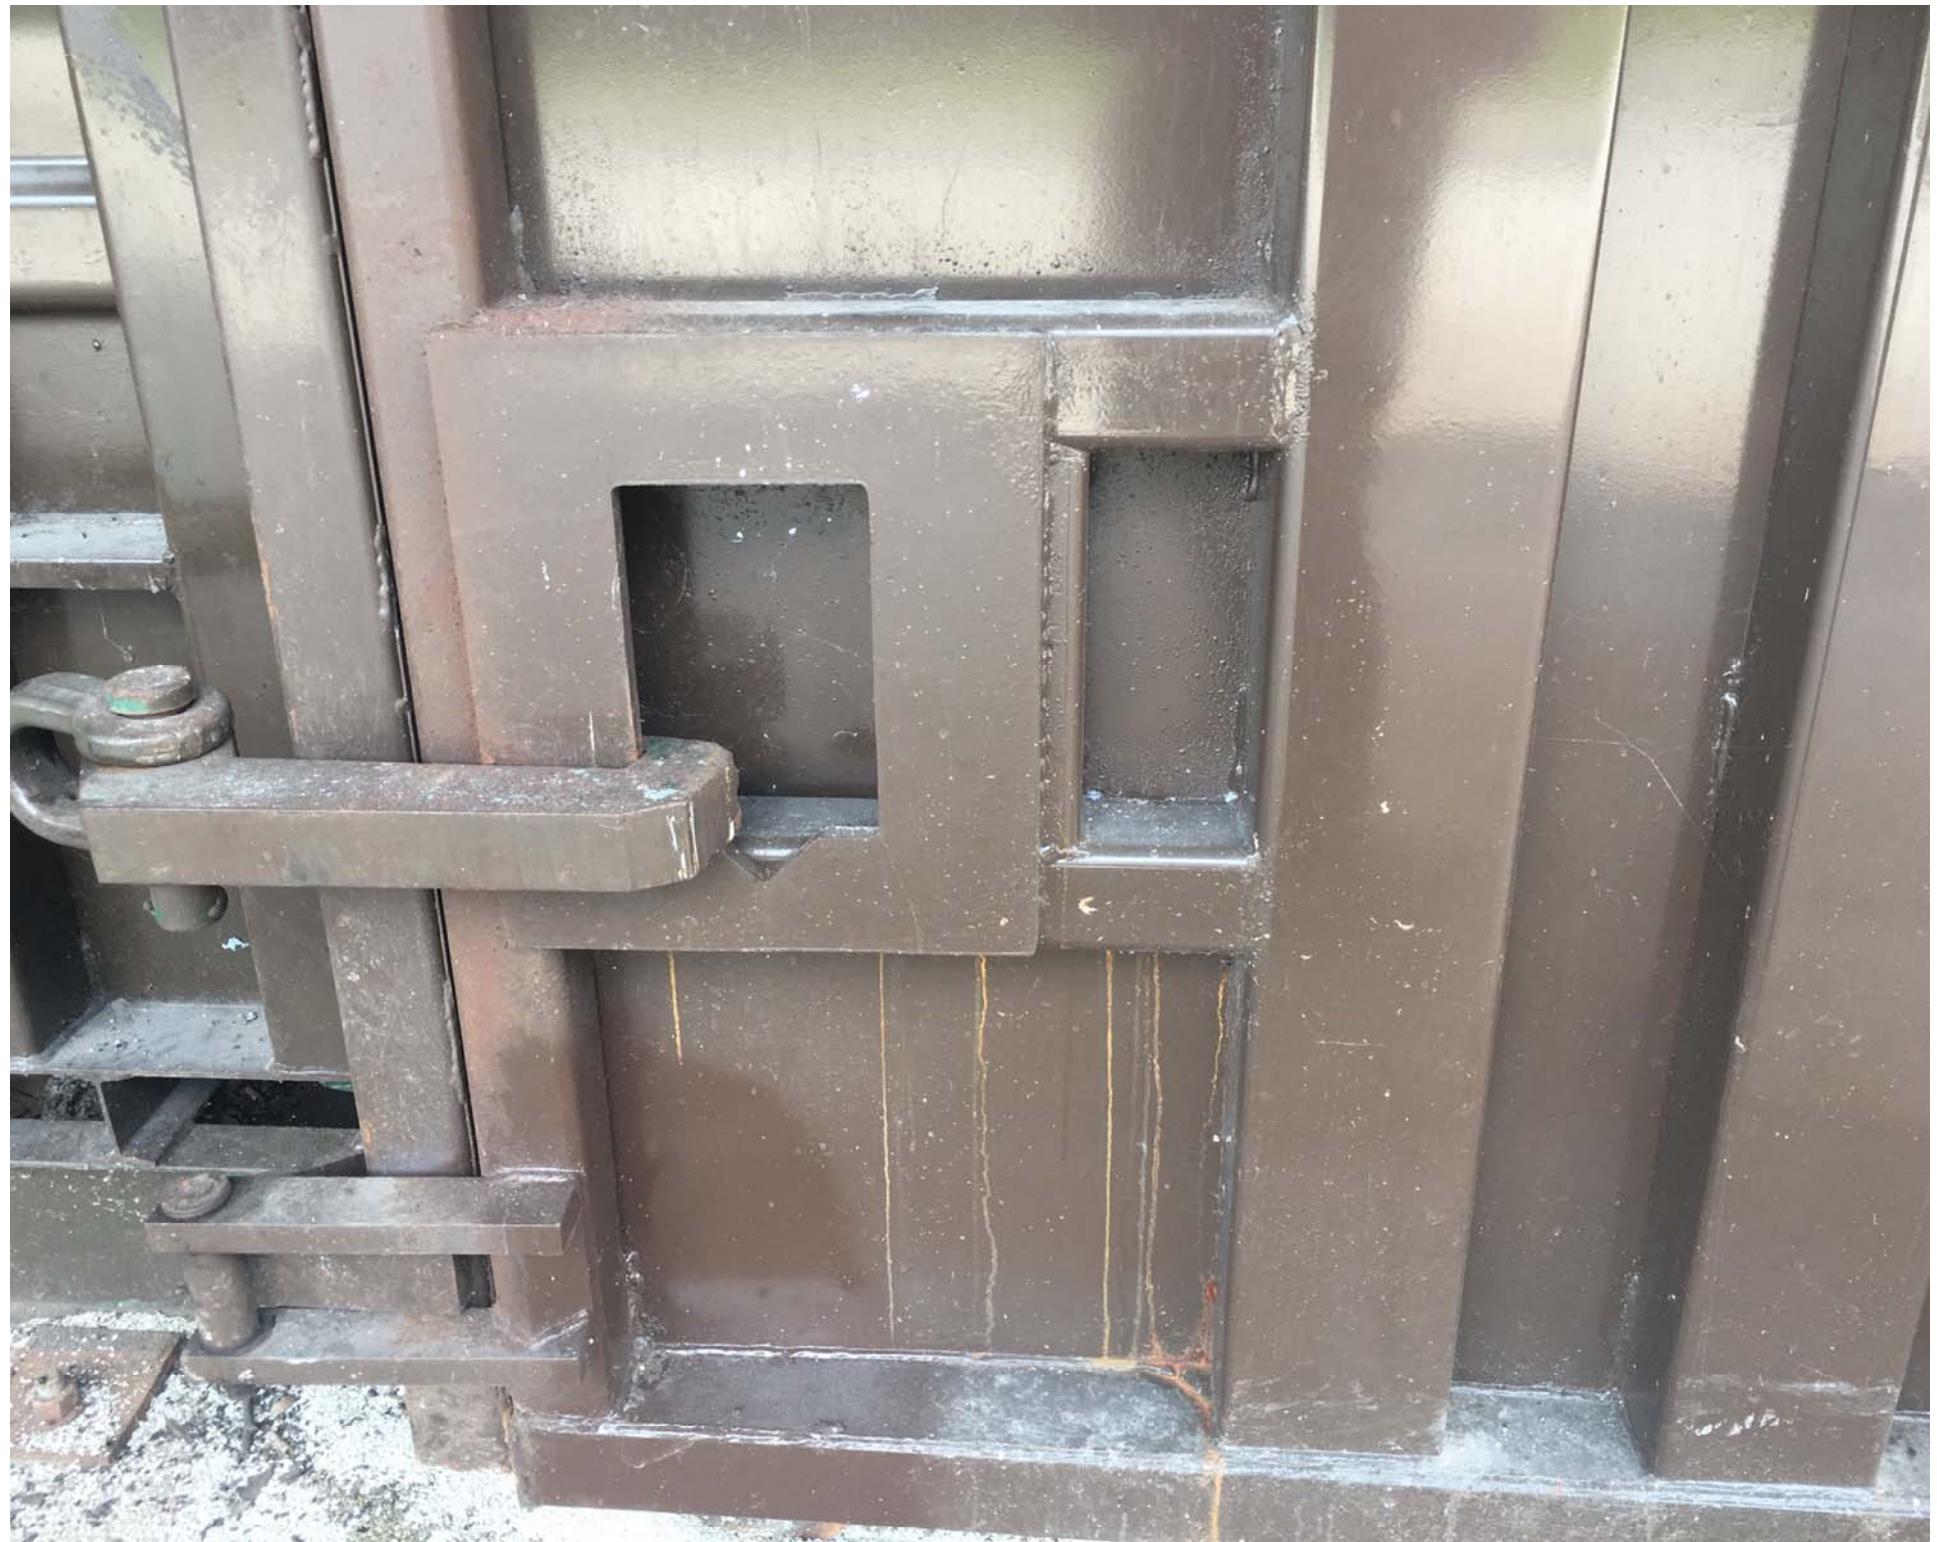
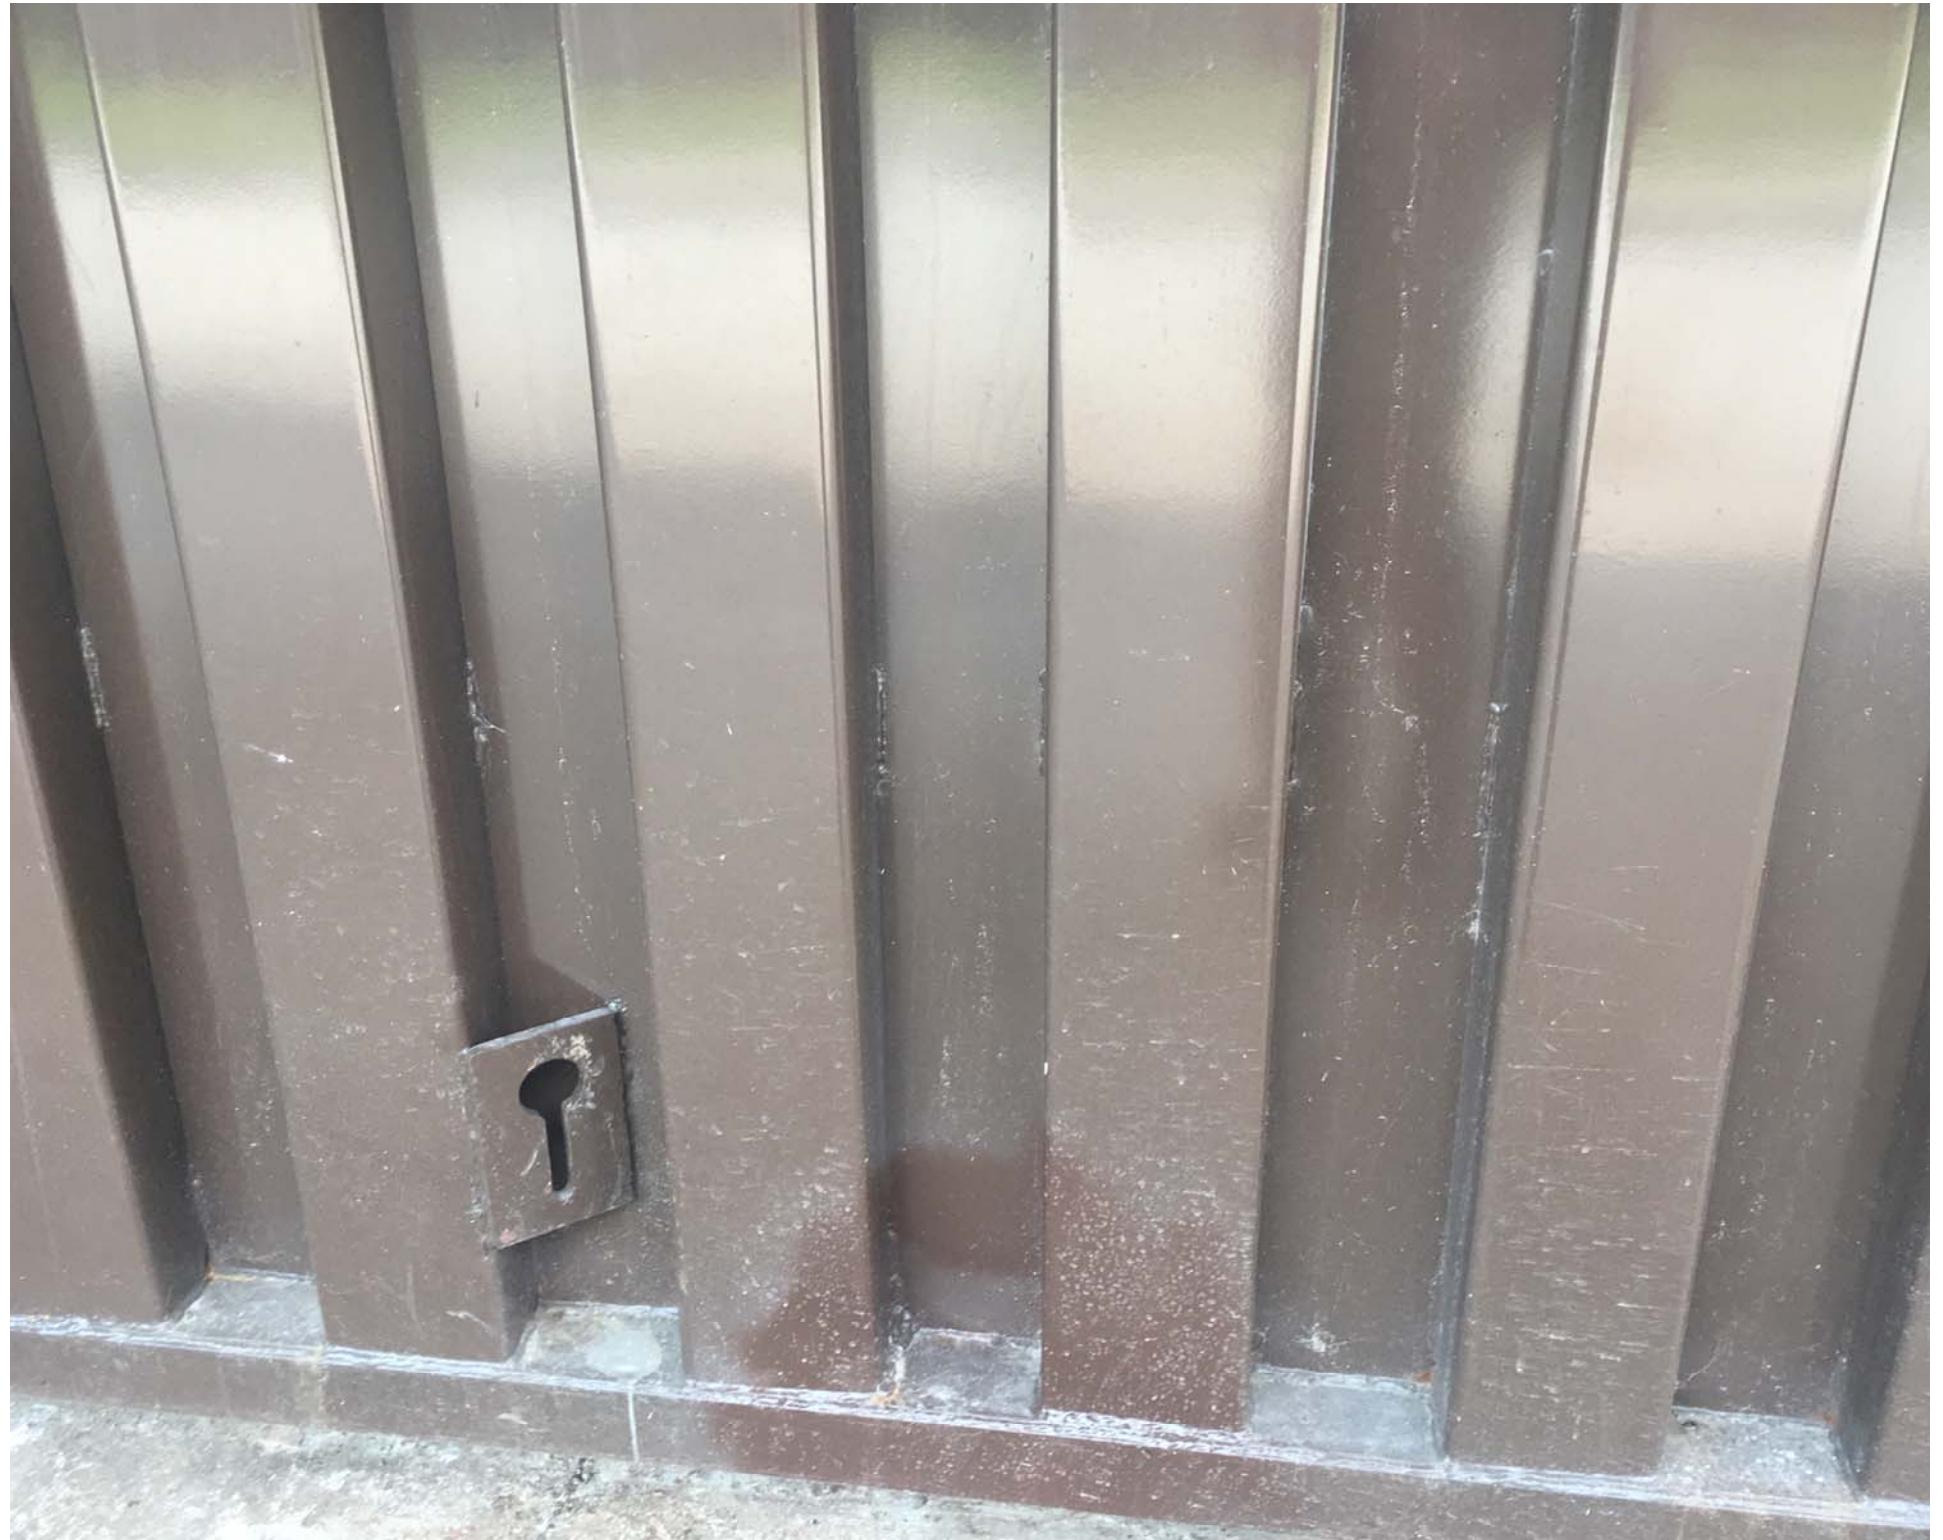
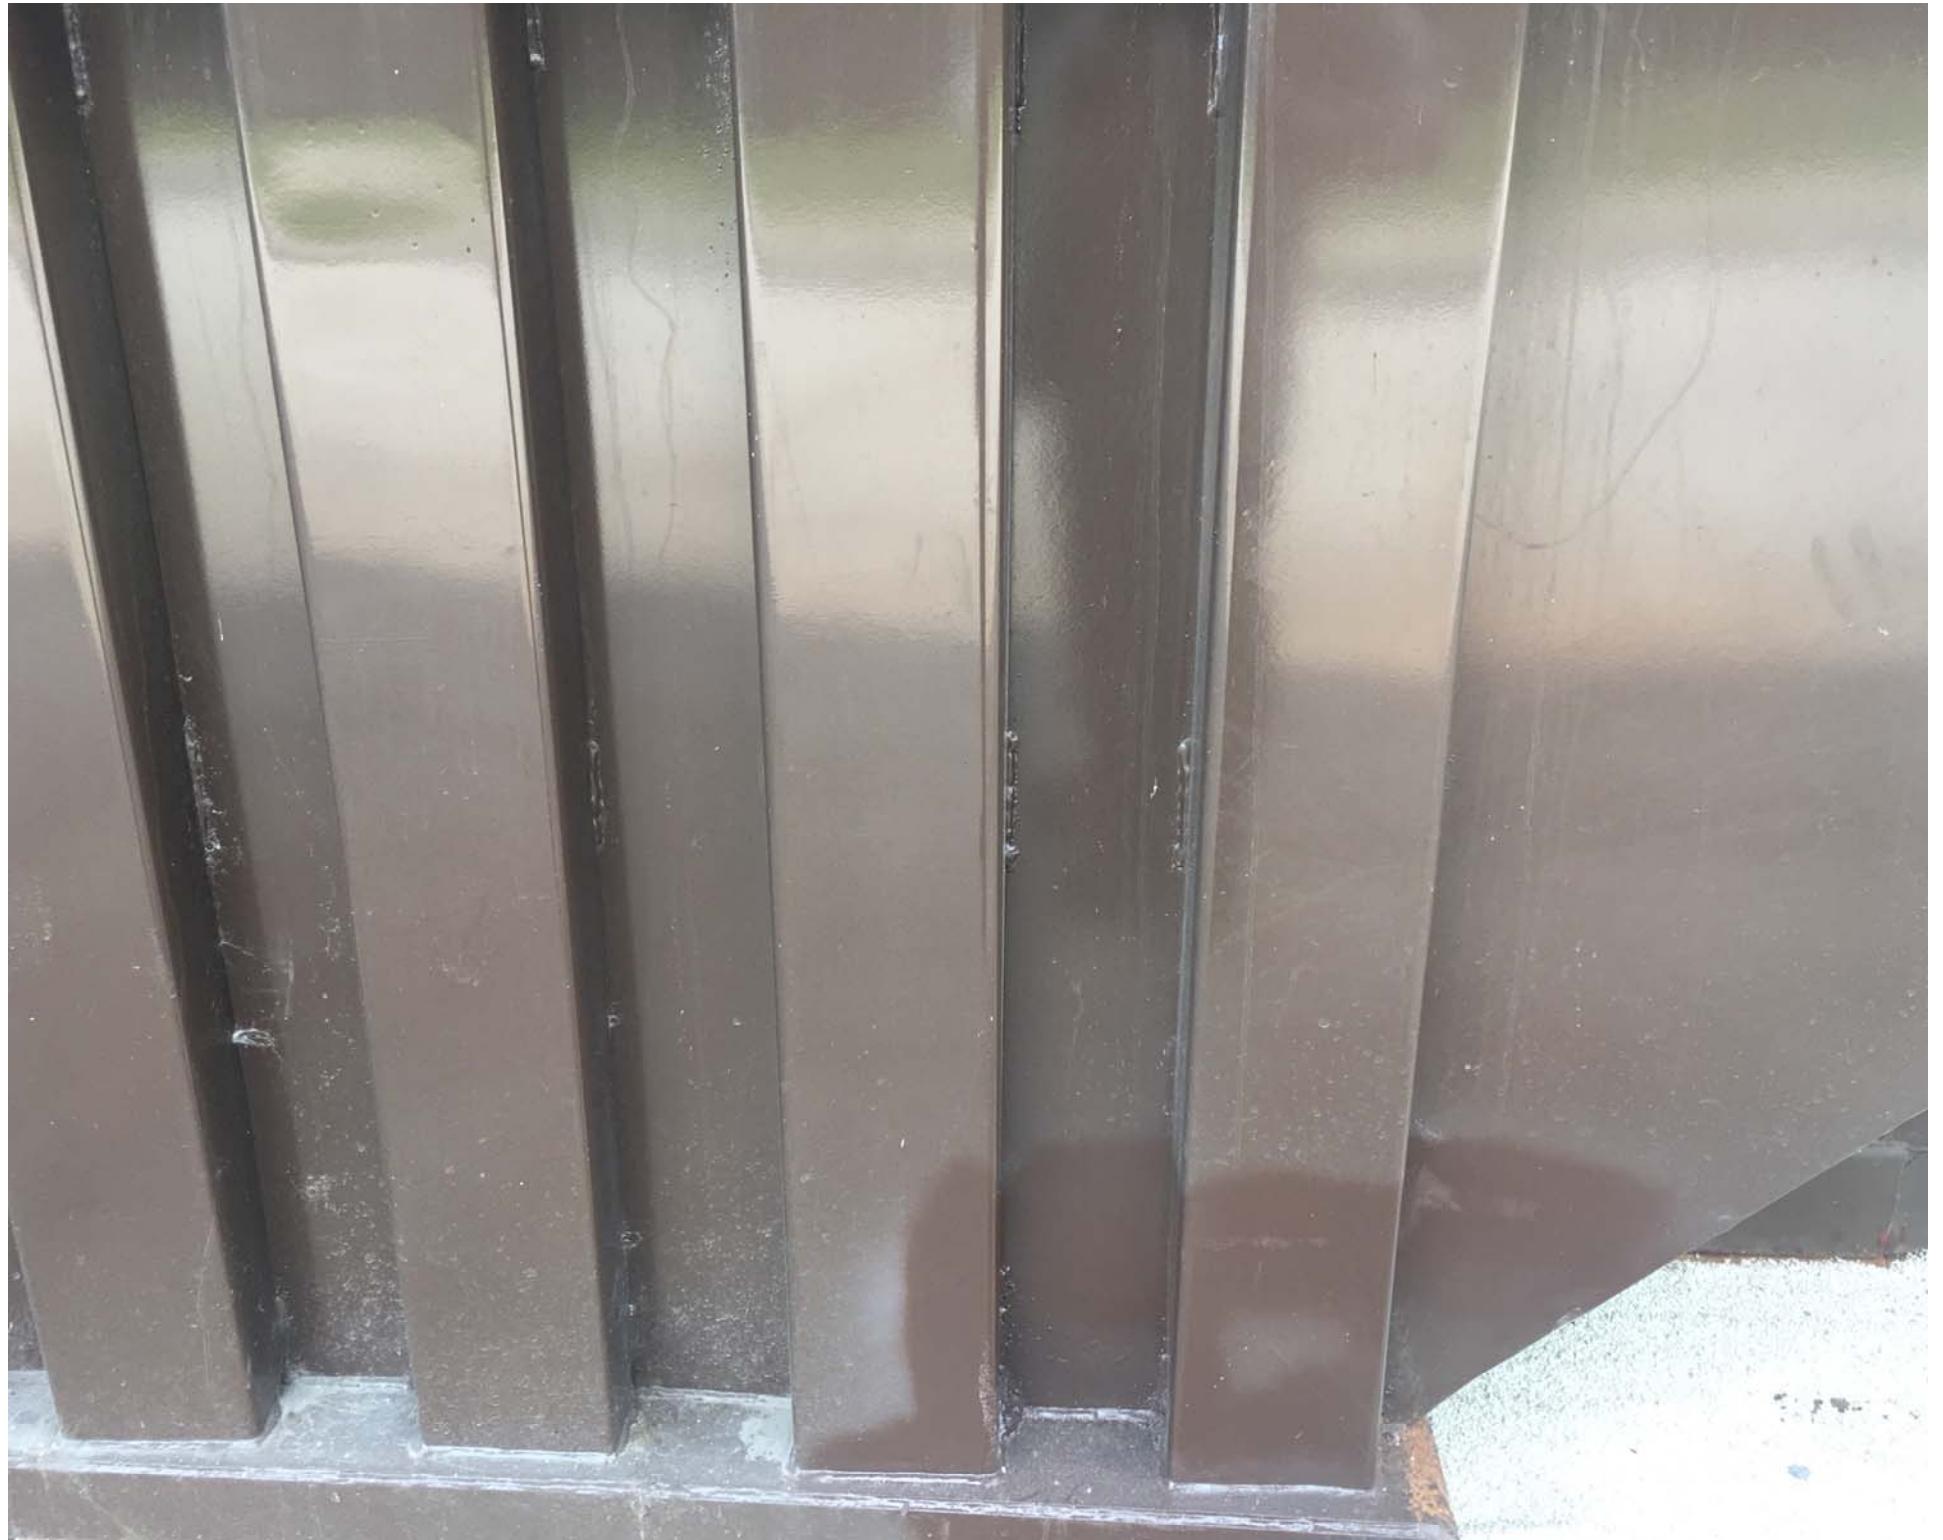
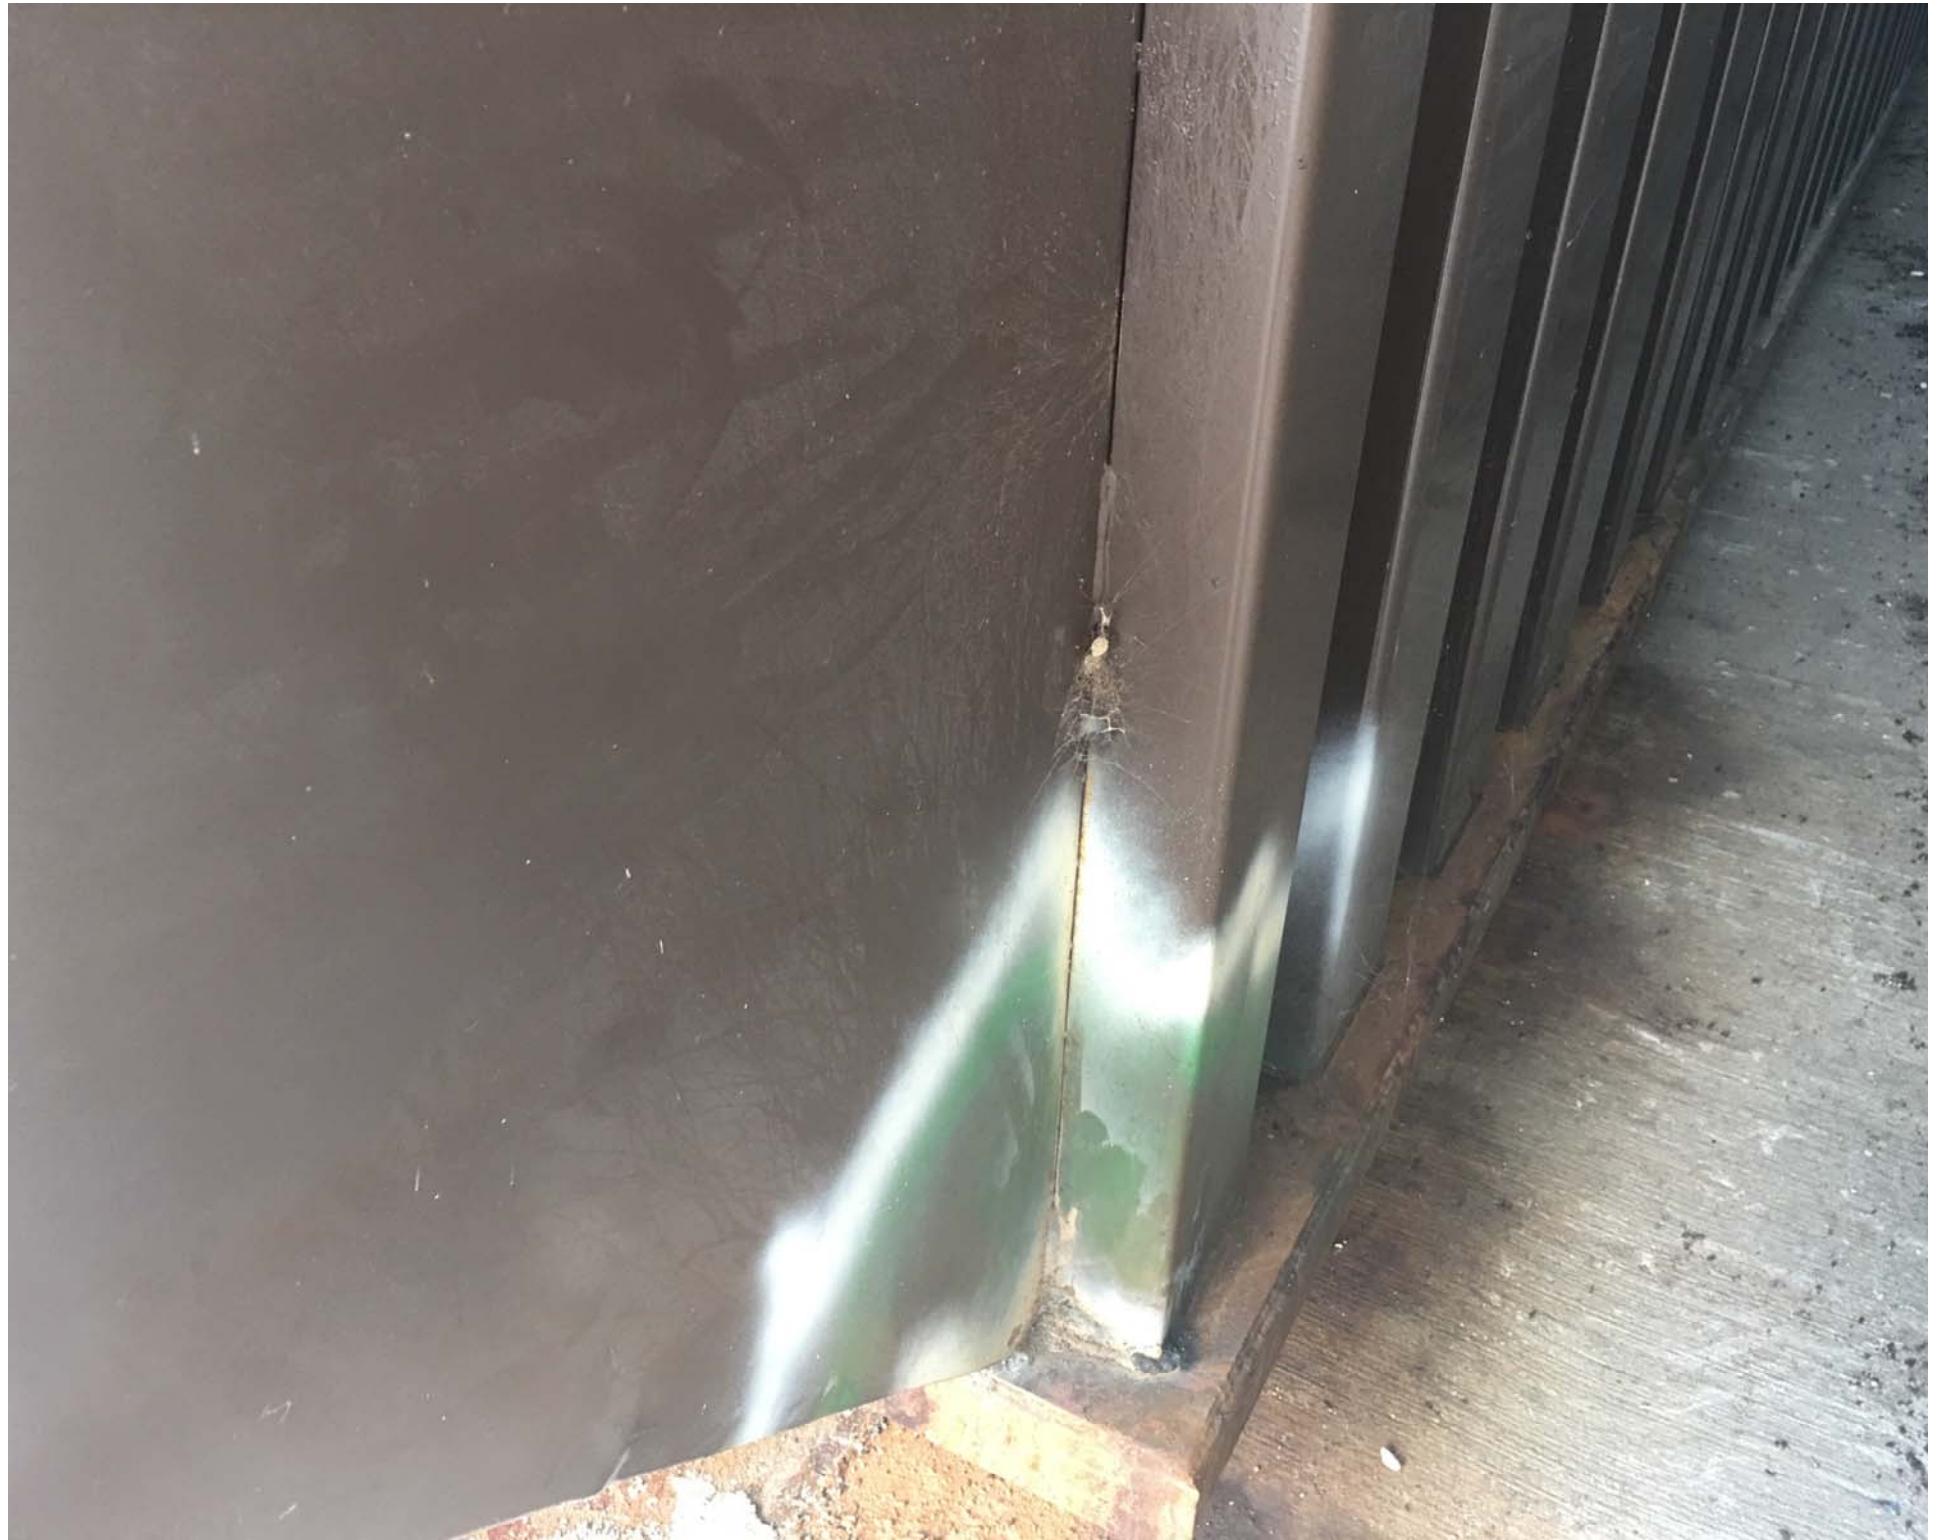
<p>Two containers (numbered 5 and 6) within the Citizen Drop-off Area were leaking</p> <p>leachate. The stream of leachate beneath Container 6 caused the concrete beneath it to degrade to create a small hole. No measures to contain the leachate from mixing with stormwater were observed. Pasco County representatives indicated that the two containers are new and that they were aware of the issue and working to resolve it. Please provide the Department with documentation within 30 days of receipt of this inspection report demonstrating that the containers were either replaced and do not leak or that the existing containers were repaired and no longer leak, and that the degraded concrete beneath Container 6 is repaired</p>	<p>Leaking areas in the compactor boxes were identified and welded and repainted (illustrated in the attached photos). The area around the compactor boxes was pressure washed.</p>
