# Leachate Collection and Removal System Effectiveness Evaluation

Pasco County Resource Recovery Facility

## Report Assessing the Effectiveness of the Leachate Collection and Removal System at the Pasco County Resource Recovery Facility

June 2016

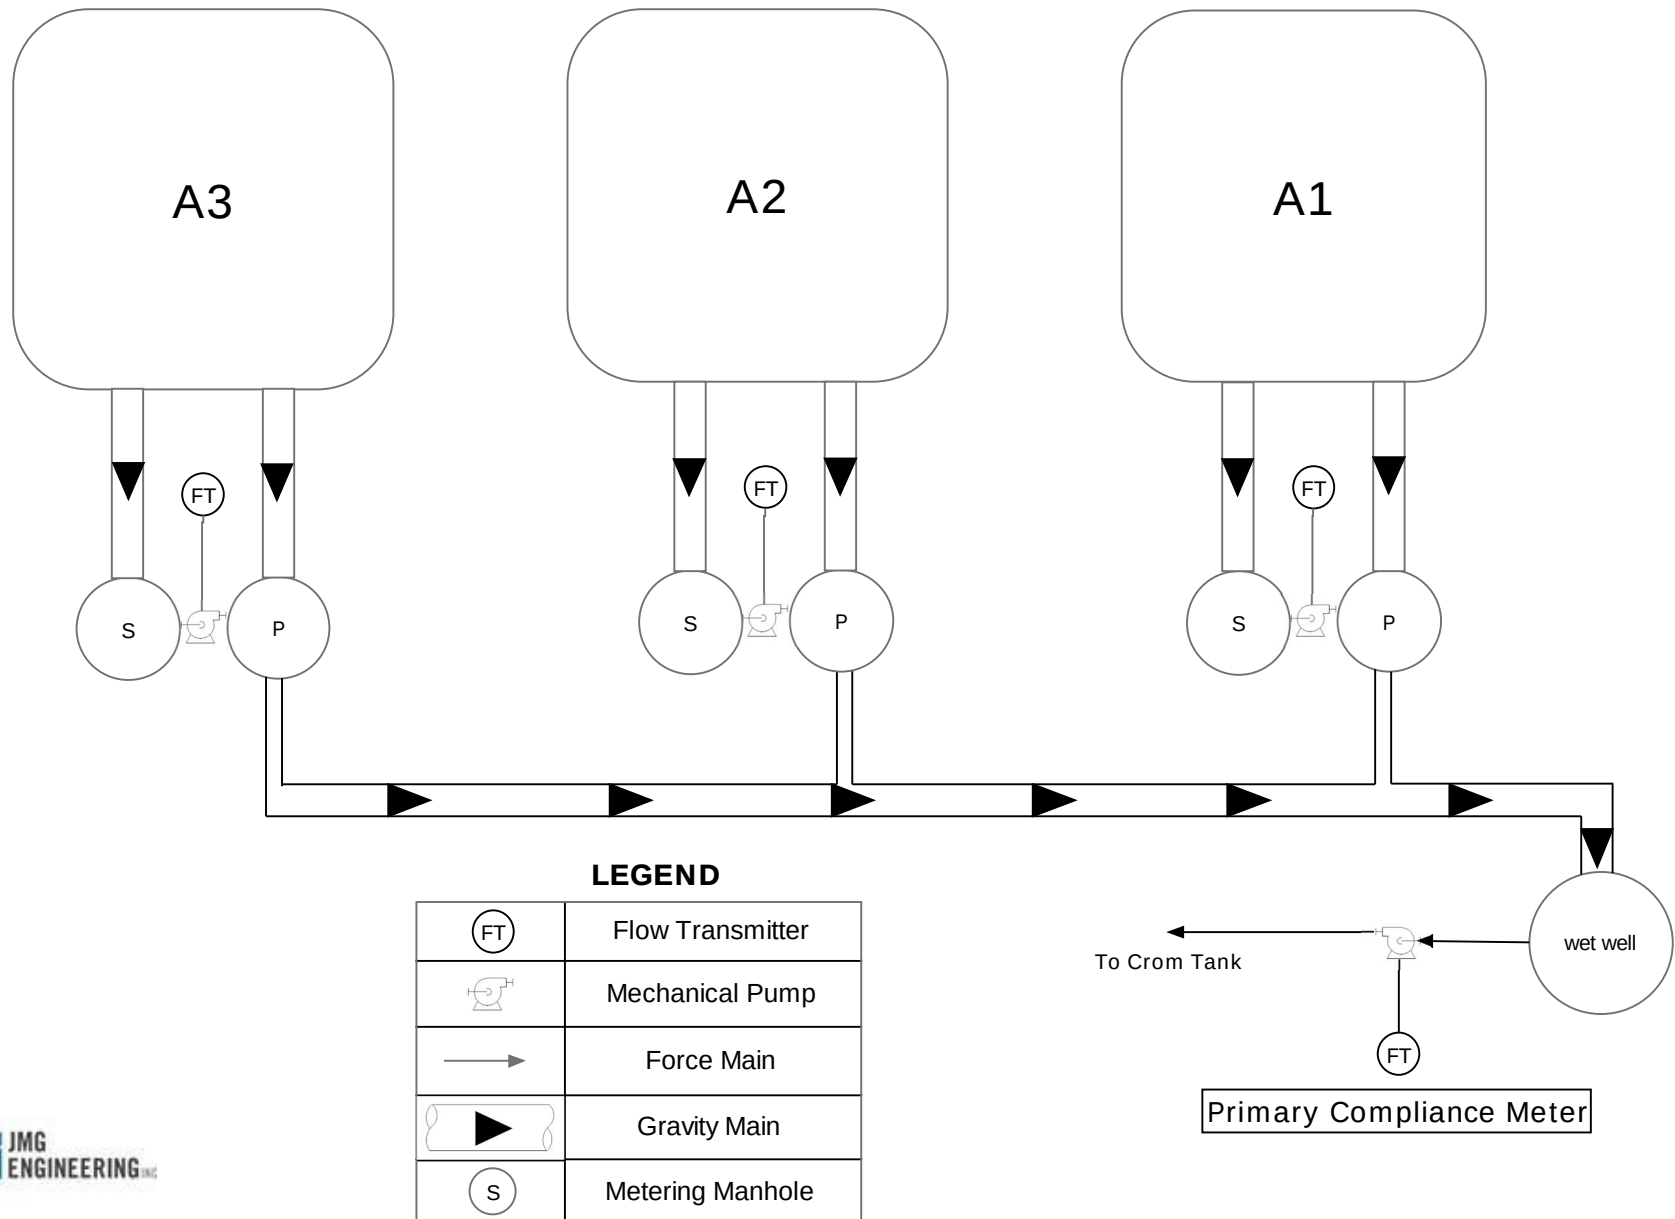
**FIGURE 1**  
**ASH DISPOSAL CELLS A1 THROUGH A3 LEACHATE COLLECTION**

No issues were noted or observed in cells A1 and A3.

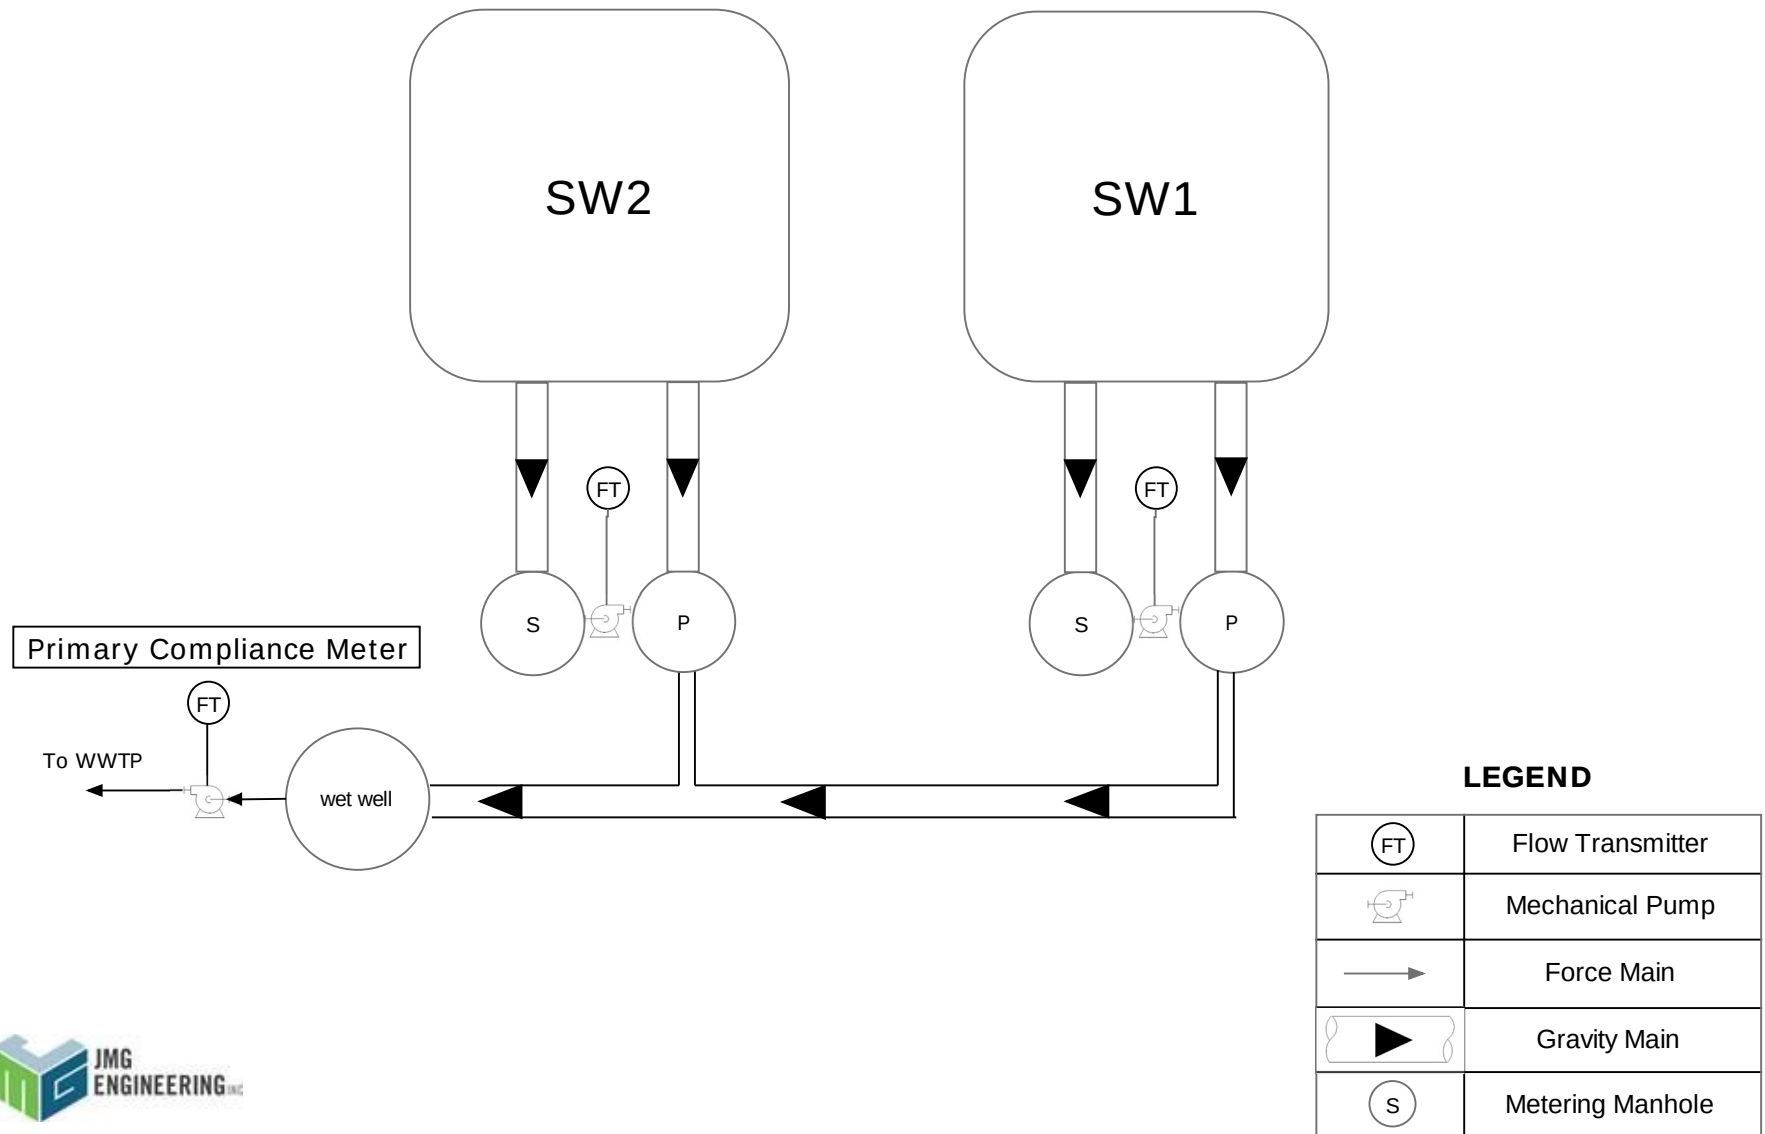
**FIGURE 3**  
**SOLID WASTE DISPOSAL CELLS SW1 AND SW2 LEACHATE COLLECTION**

No issues were noted or observed in Cells SW-1 and SW-2.

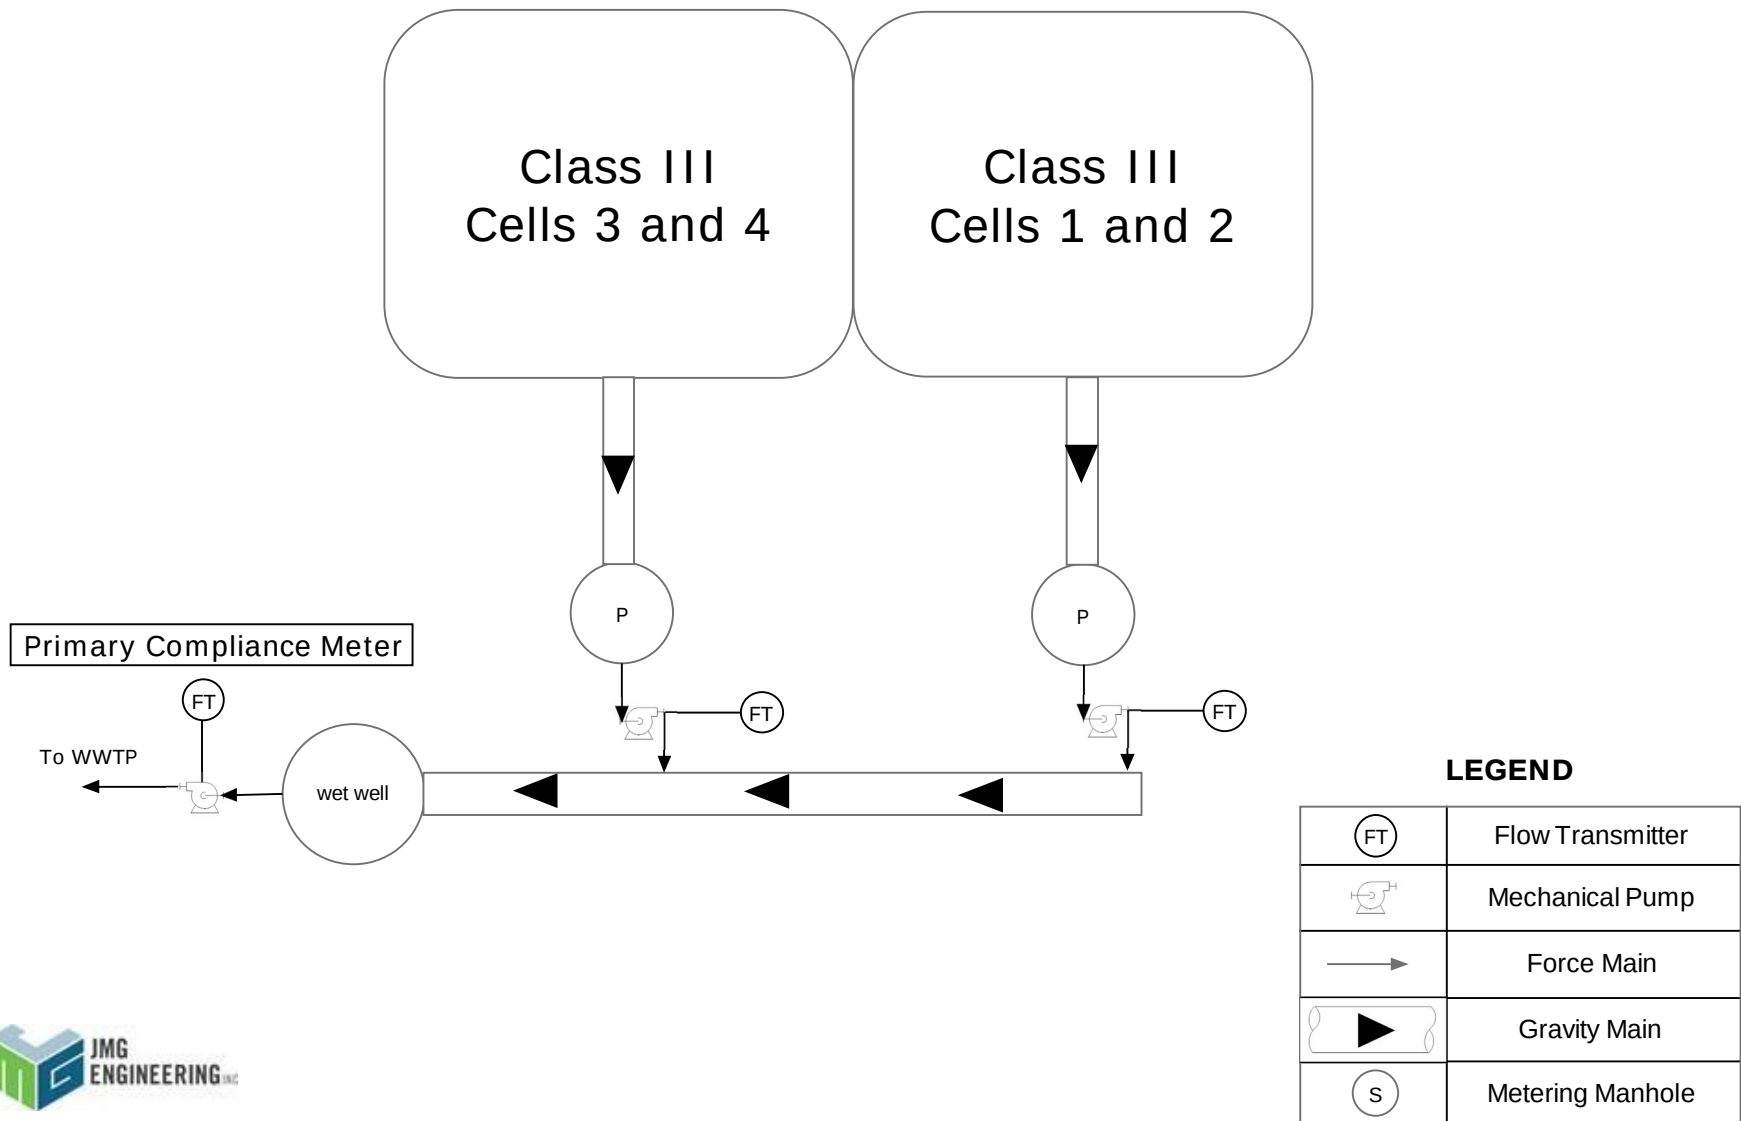
**FIGURE 4**  
**CLASS III DISPOSAL CELLSLEACHATE COLLECTION**

No issues were noted or observed in the Class III disposal cells.

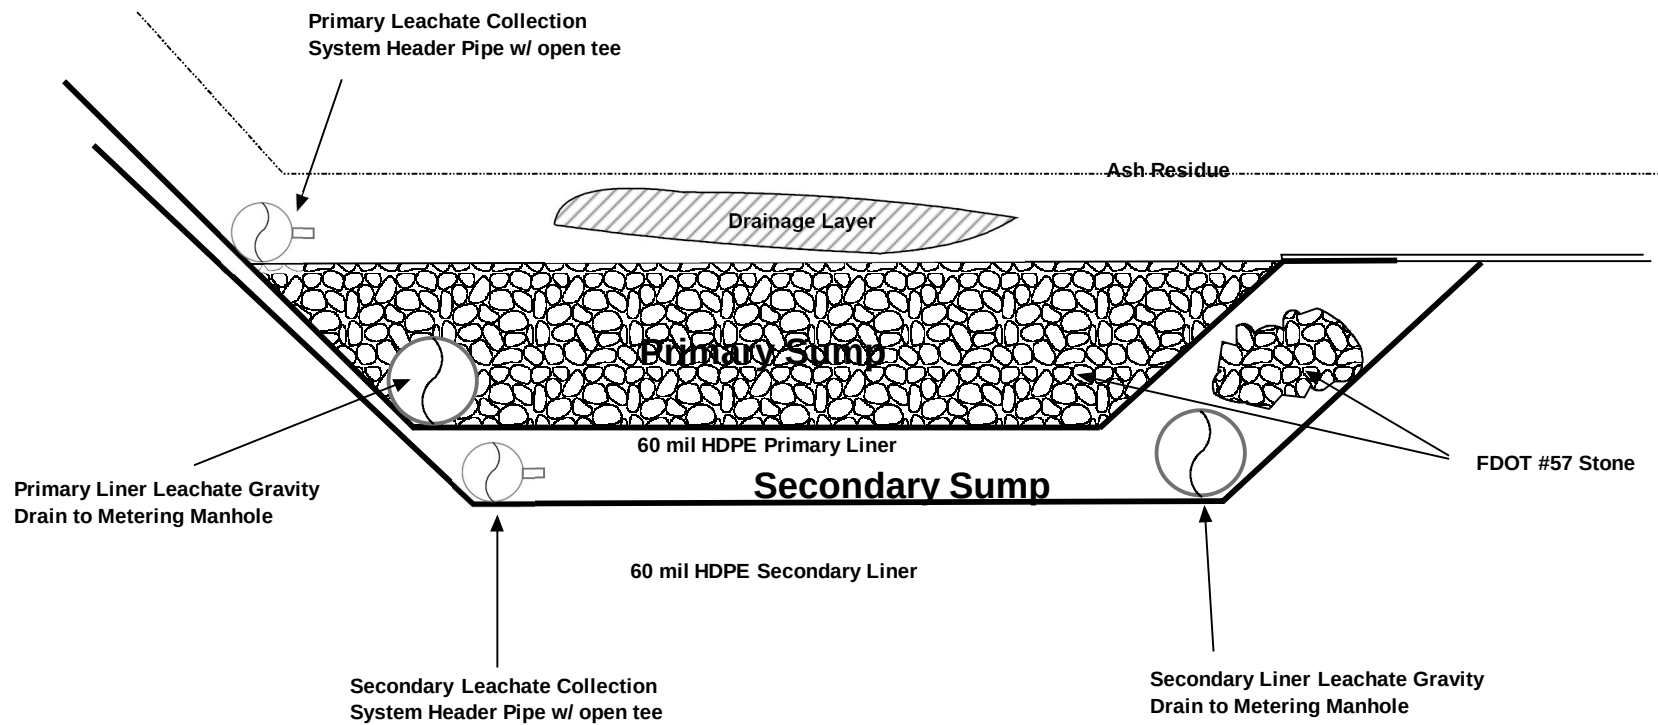
**FIGURE 5**  
**SECTION THROUGH PRIMARY TEE AND INTO SUMP**  
**DISPOSAL CELL A2**

A review of the operating record indicates that little to no leachate is flowing to the metering manhole of the primary liner system. A review of the Florida JetClean Report indicates that leachate *is* properly flowing through the entirety of the primary leachate header pipe and that the gravity drain *is free* of obstruction between the metering manhole and the collection sump. This indicates that the leachate is not properly flowing between the open tee on the leachate header pipe and the gravity drain (by way of the stone-filled sump). The most likely reason for this is that the stone within the sump has become calcified and no longer allows leachate to flow to the gravity drain. The secondary liner leachate collection system appears to be working properly and not affected by such blockage within the secondary sump.

Proper drainage of the A2 disposal cell must be restored to remain in compliance with Chapter 62-701, F.A.C. The following are potential options for restoring the functionality of cell A2:

1. In-situ chemical treatment of the drainage rock within the sump to restore its ability to drain leachate;
2. Excavation of ash to expose the 8" tee on the primary leachate header followed by hard-piping the tee to the gravity drain line (thus by-passing the sump);
3. Abandonment of the gravity line draining the sump accompanied by construction of a side slope riser type pumping system and associated forcemain to evacuate leachate from the disposal cell.

Following a discussion with the FDEP Southwest District Solid Waste staff on April 7, 2016, it was agreed that the option providing the highest likelihood of success would be Option 3. A follow up teleconference was conducted with FDEP Bureau of Solid Waste Staff on May 10, 2016, and it was further agreed that Option 3 presented a viable option for restoring the functionality of the A2 leachate removal system. Accordingly, Pasco County should initiate design and permitting of a side slope riser type pumping system to restore the functionality of cell A2. All other leachate removal system components at the Pasco County Resource Recovery Facility are operating properly.
